Report on the investigation of the capsized and sinking
of the cement carrier
Cemford
in the Pentland Firth, Scotland
with the loss of all eight crew
on 2 and 3 January 2015

Cemfjord

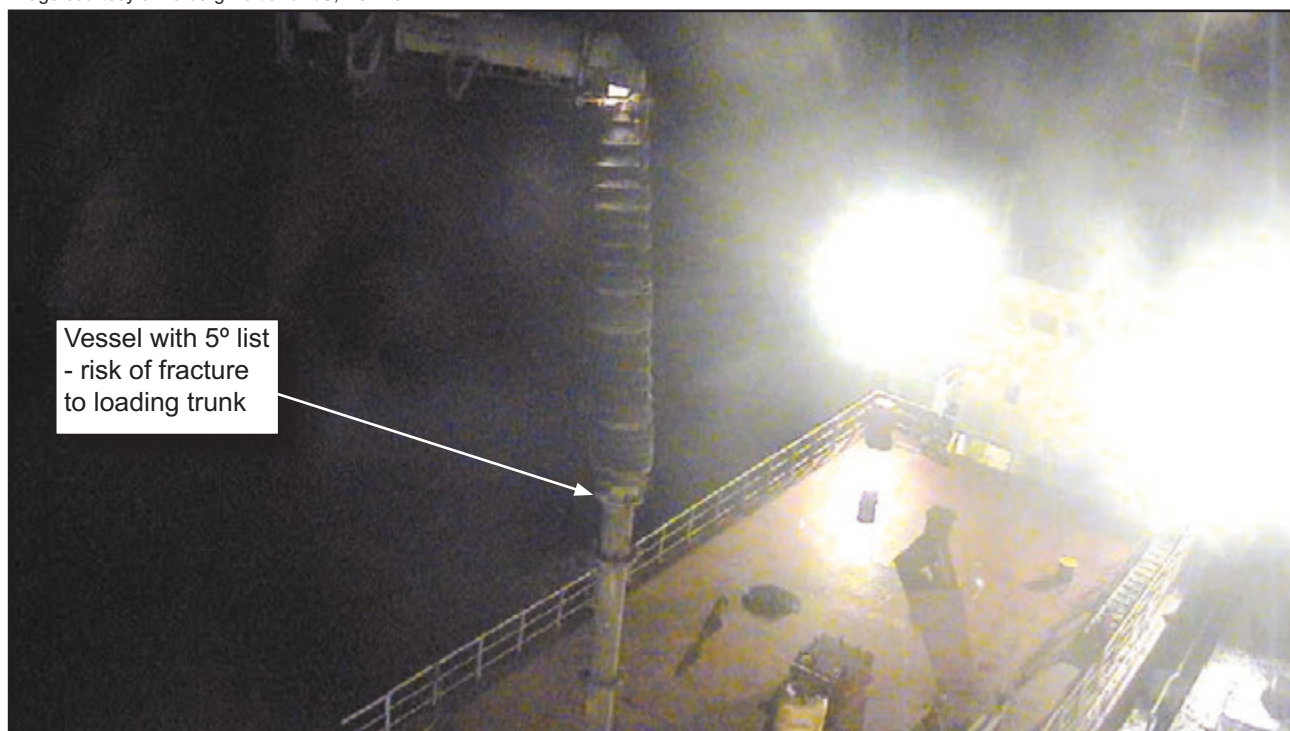
During the loading, the port ballast pump was not working effectively, which caused the vessel to start listing to port. At 0139 (30 December), the loading operation was suspended by the shore workers because the vessel was listing to port by about 5° and there was concern about a risk of fracture to the loading trunk (**Figures 1a and b**). Loading was resumed at 0430 but a further unplanned stop occurred at 0457 due to the persistent poor performance of the port ballast pump.

Figure 1b: CCTV image of *Cemfjord* alongside in Rordal at 0139, 30 December 2014. Vessel listing 5° to port, risk of fracture to loading trunk

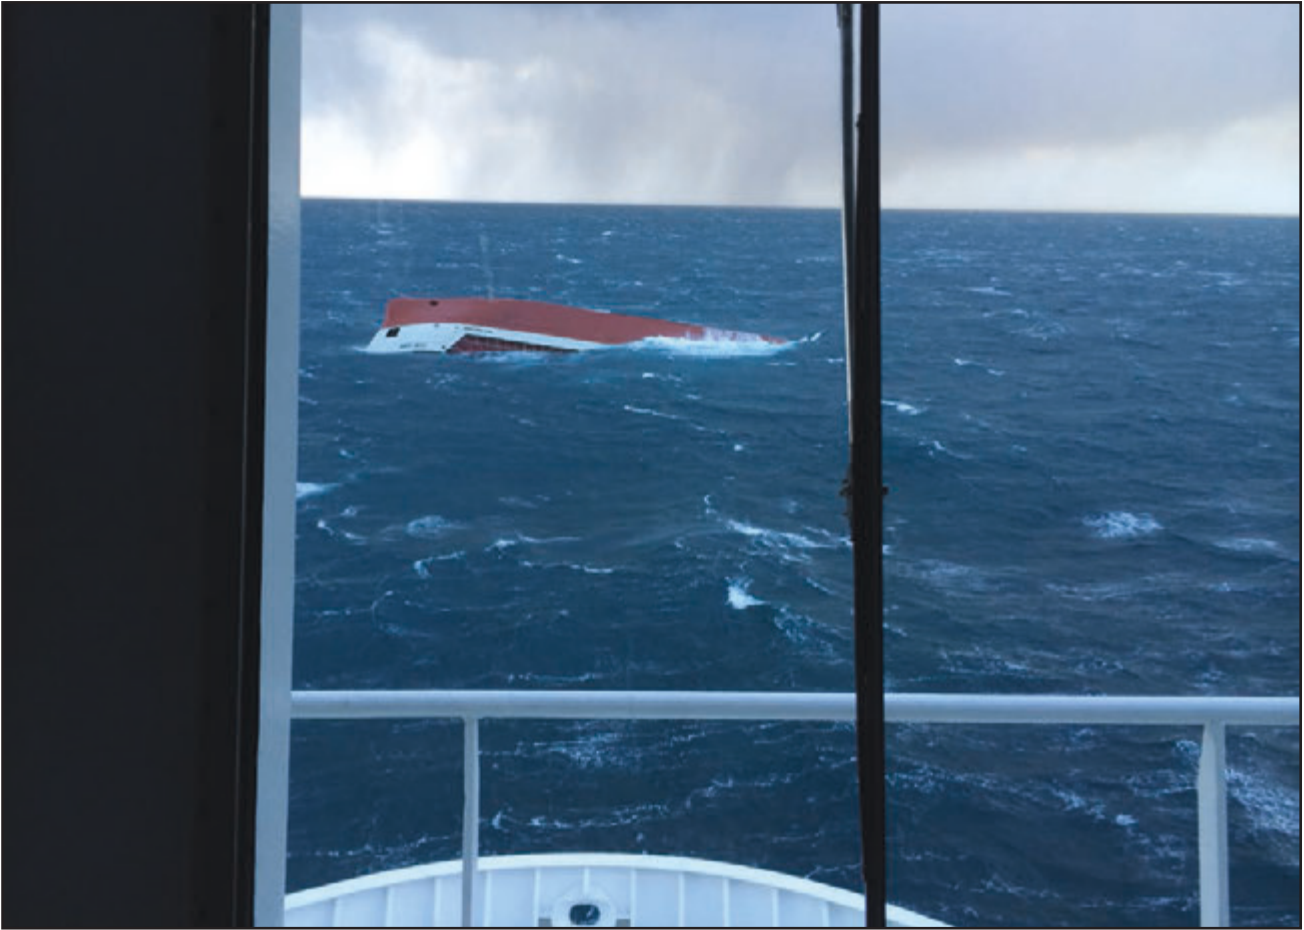
Figure 7: *Cemfjord's* capsized hull as seen from the bridge of the ferry, *Hrossey*

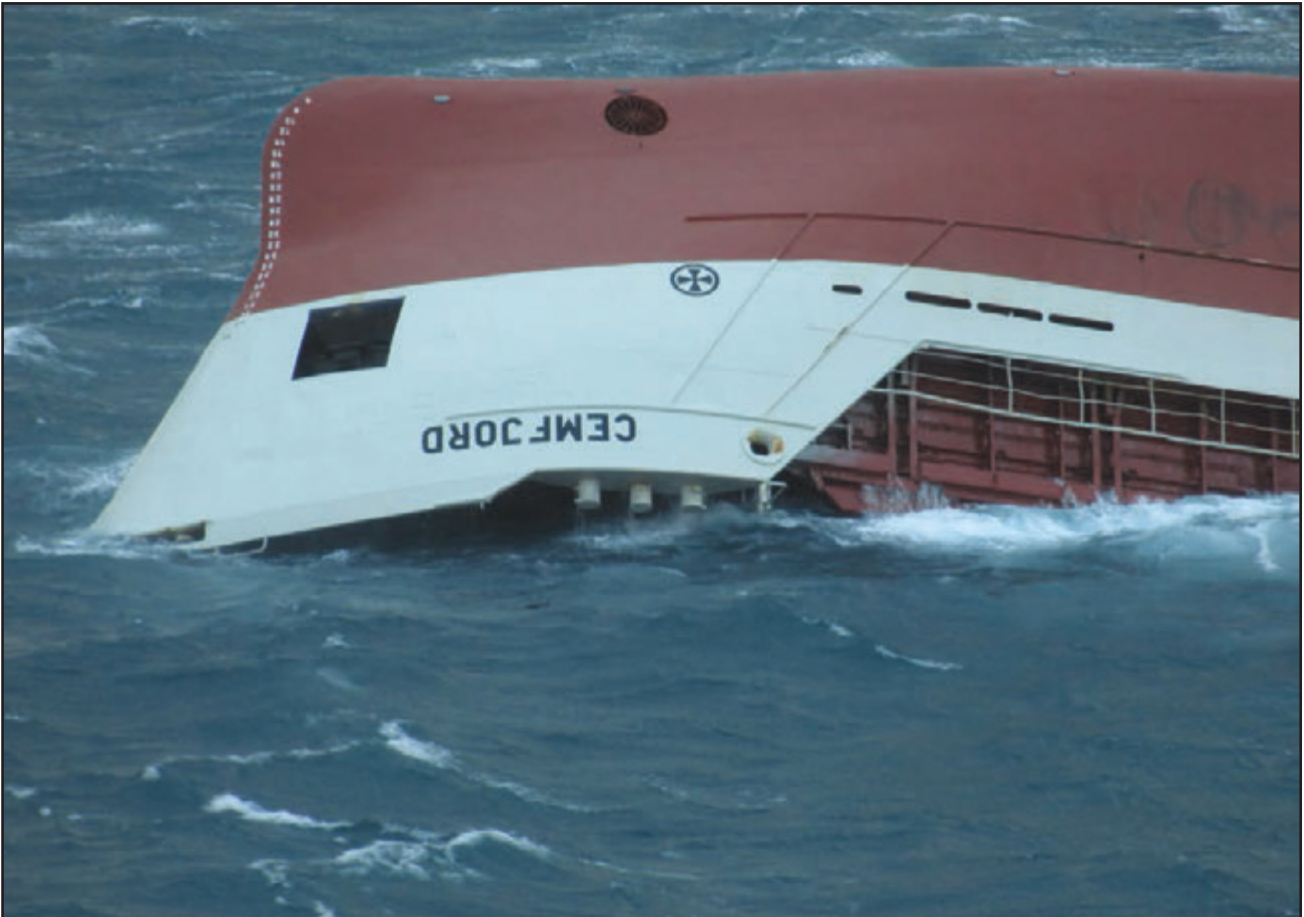
Figure 8: *Cemfjord's* capsized hull when the ferry, *Hrossey*, was close by

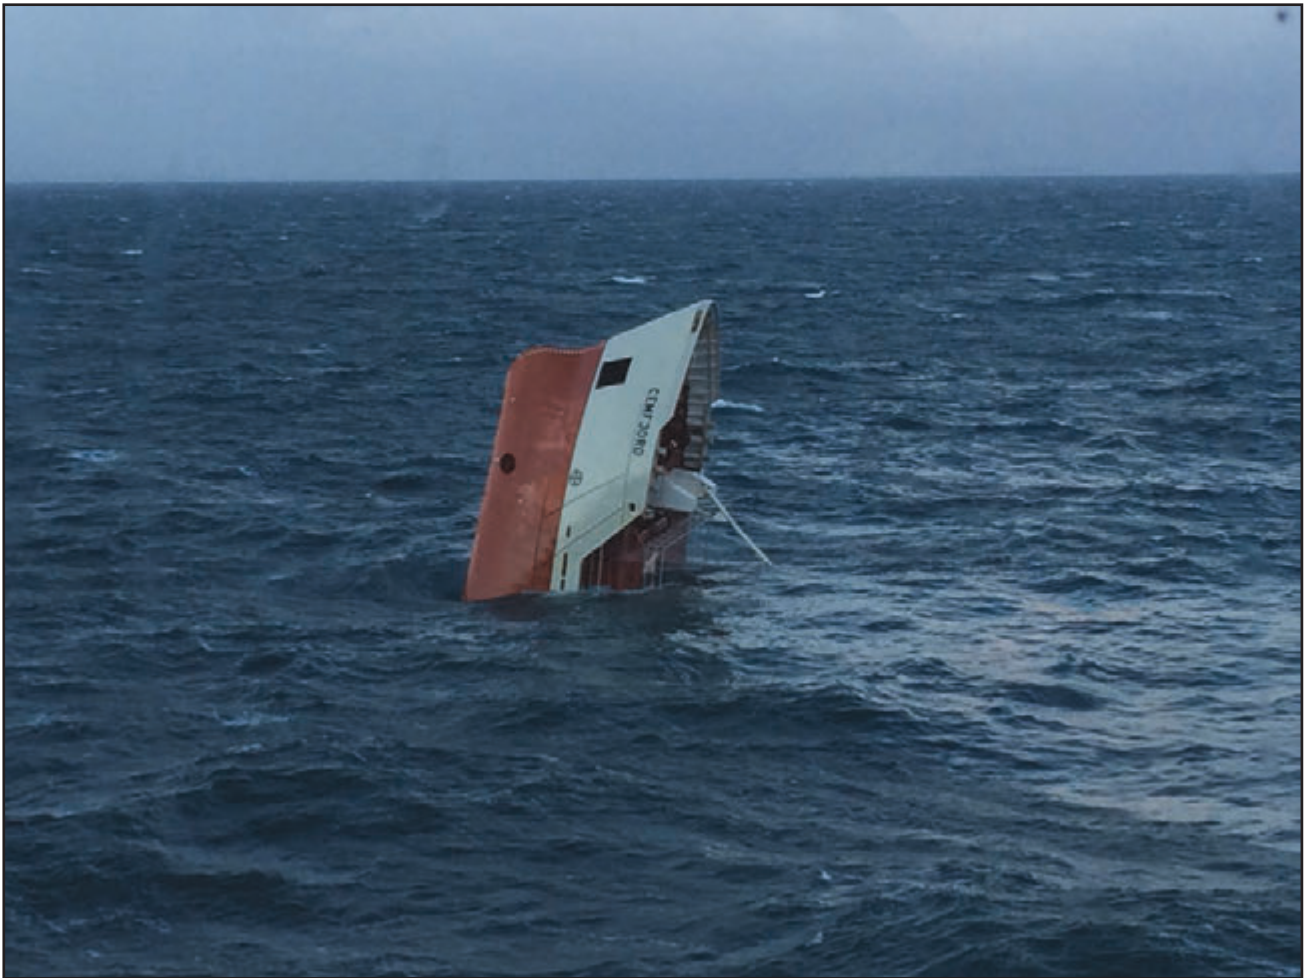
At about 1500, *Hrossey's* bridge team observed *Cemfjord's* bow move to a vertical position as its stern sank towards the seabed (**Figure 9**). A short time later, with a lifeboat and helicopter on scene, *Hrossey* was released from the SAR effort and continued its passage south to Aberdeen.

Figure 9: *Cemfjord's* hull after moving to a vertical position

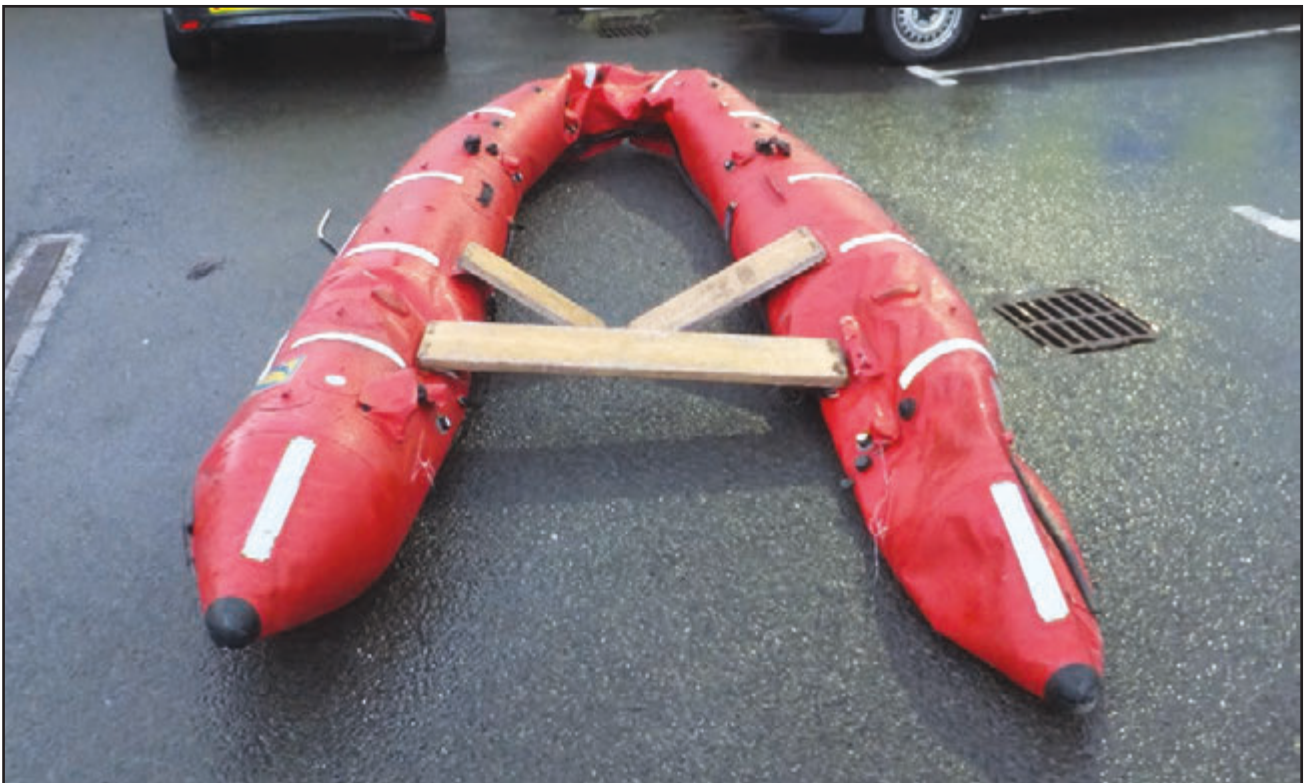
Figure 10: Inflatable section of the Zodiac rescue boat found on South Ronaldsay on 4 January 2015

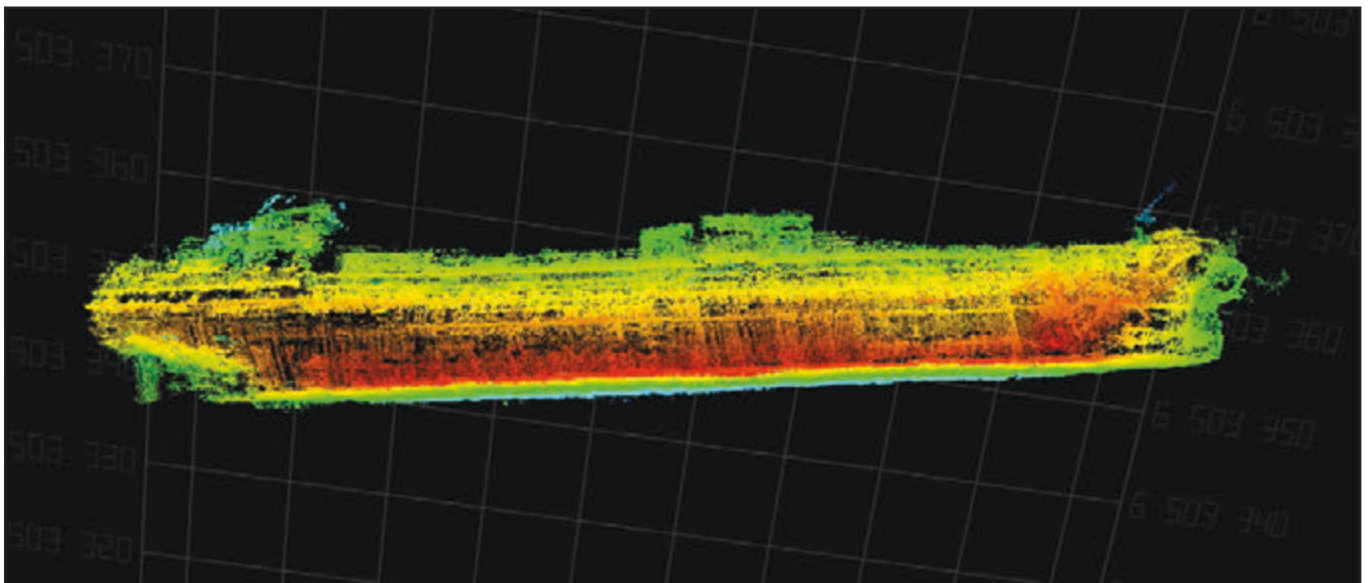
The second survey, using S3 ROVs was conducted between 8 and 10 February 2015. A multi-beam echo sounding survey (**Figure 23**) confirmed that the vessel was intact and there was no evidence of structural failure of the hull. The key observations made during this survey were:

Figure 23: Wreck of *Cemfjord* - multi-beam echo sounding image of entire vessel

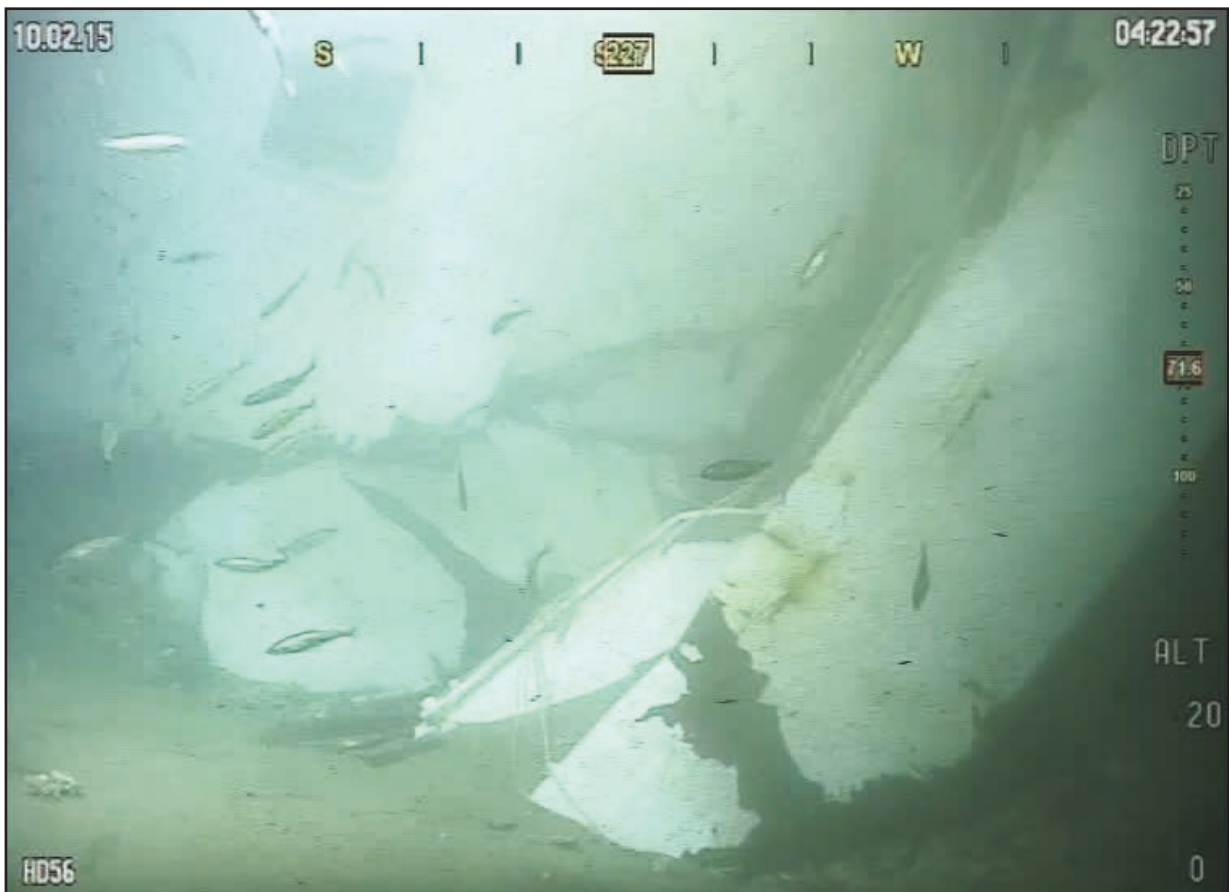
- The wooden, hinged starboard bridge door was missing (**Figure 24**).
- The main superstructure was significantly distorted and the port bridge wing area was partially buried in the seabed (**Figure 25**).

Figure 25: Wreck of *Cemford* - port bridge wing and superstructure impacted on seabed

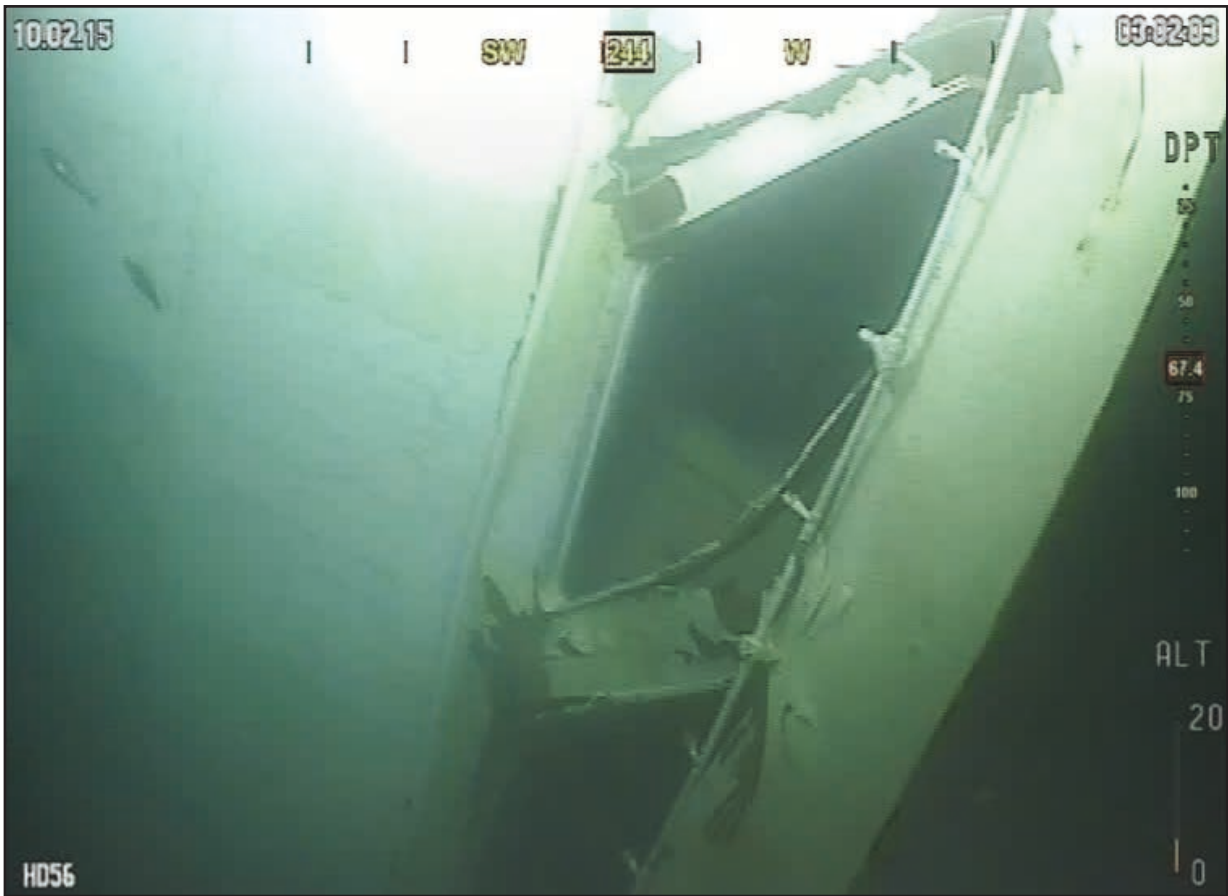
- All the bridge windows were broken and missing (**Figure 26**).
- The starboard side door beneath the bridge wing, accessing the accommodation spaces, was closed (**Figure 27**).

Figure 26: Wreck of *Cemfjord* - bridge windows detail

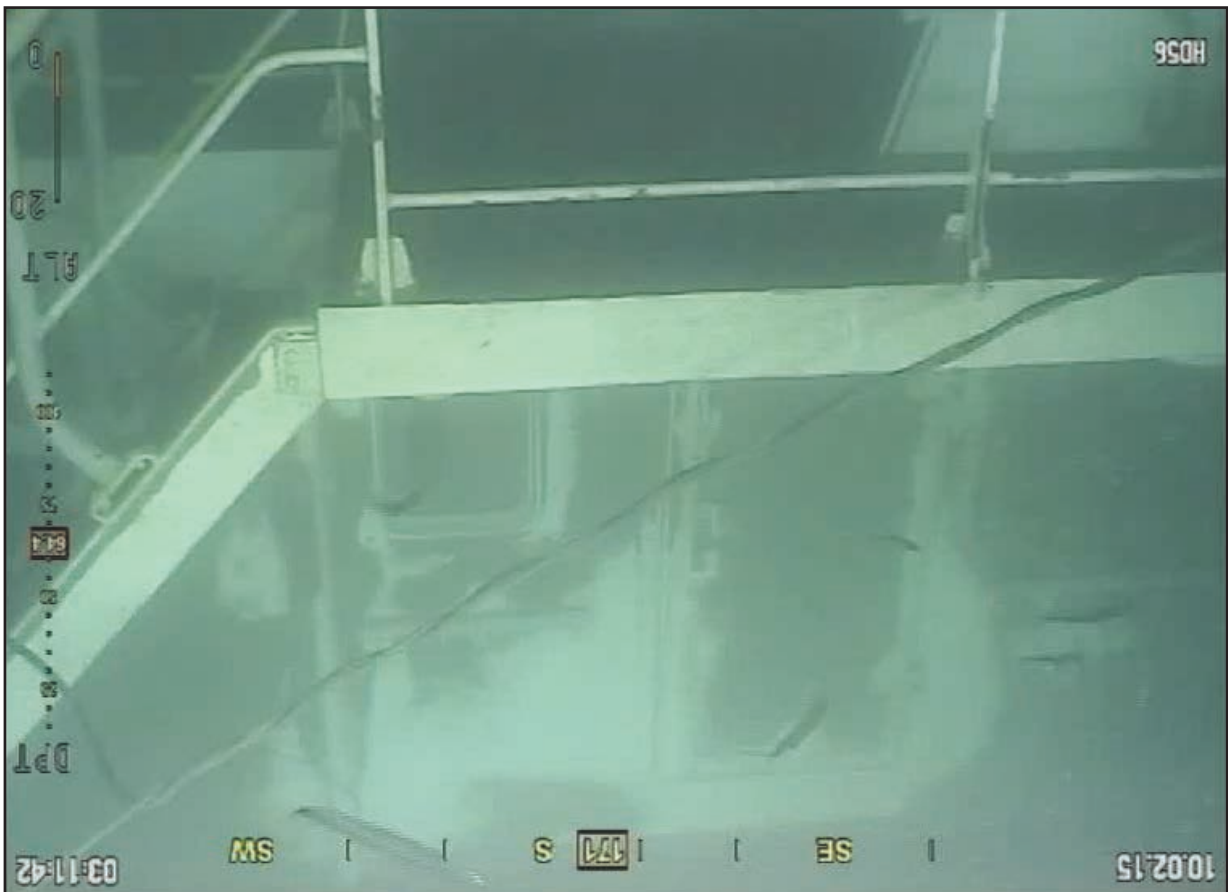
Figure 27: Wreck of *Cemfjord* - starboard side accommodation door closed (image inverted)

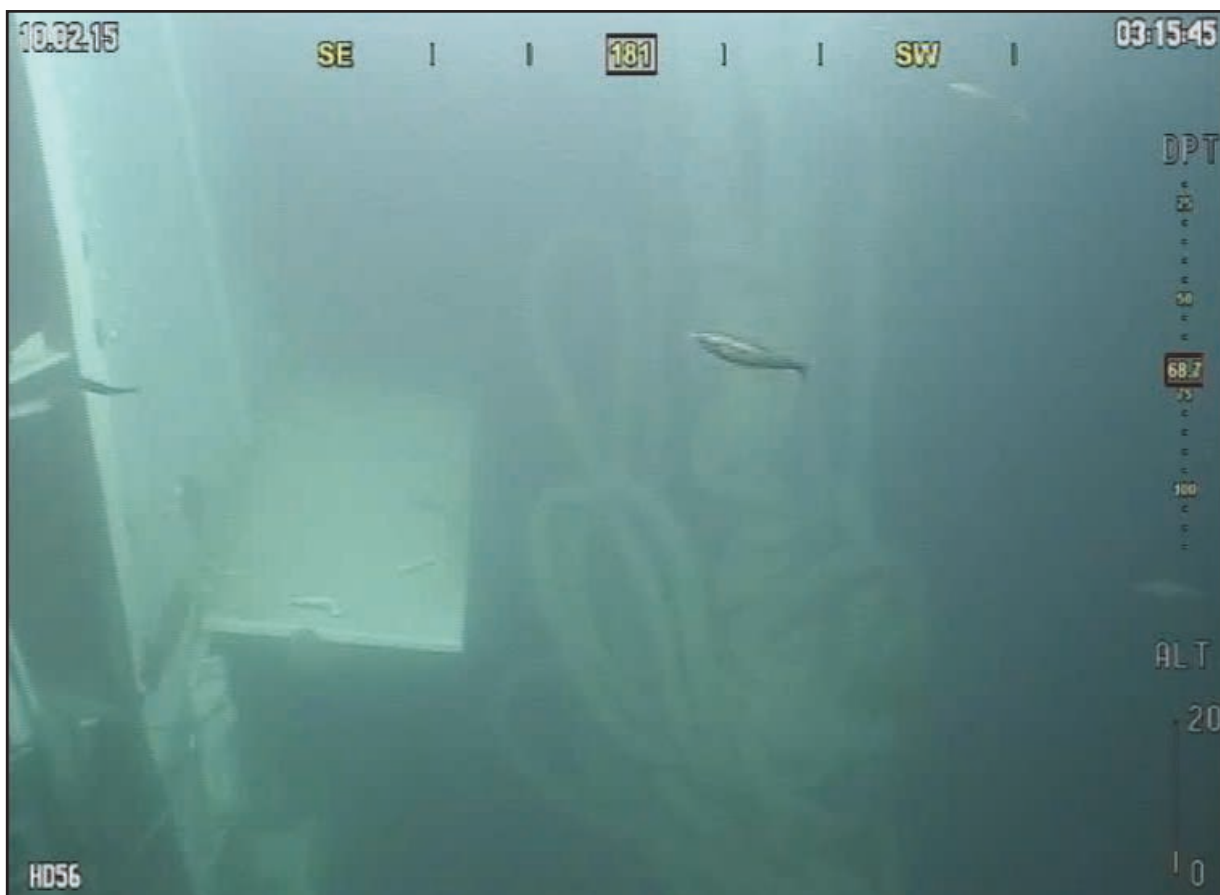
- The stern door between the poop deck and internal fan space was open (**Figure 28**).
- The rescue boat was missing.
- The rescue boat davit was in its fully stowed position and the davit fall wire had not been lowered (**Figure 29**).

Figure 28: Wreck of *Cemfjord* - poop deck door to fan space open

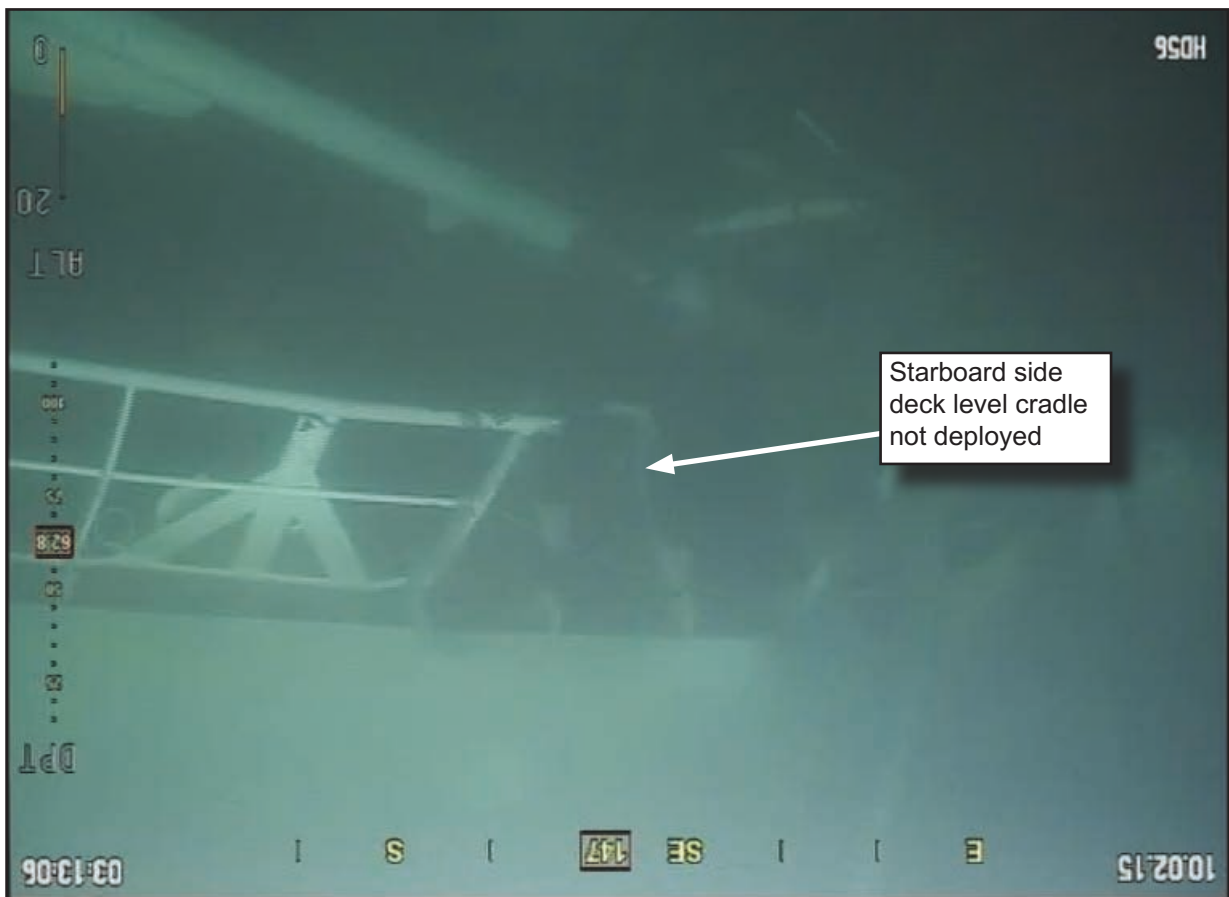
- The starboard liferafts were missing; the cradle for the starboard deck mounted liferaft was in the stowed position but its guardrail section had broken away (**Figure 30**). The port liferaft stowage was not accessible.

Figure 30: Wreck of *Cemfjord* - starboard deck level liferaft cradle empty and guardrails missing (image inverted)

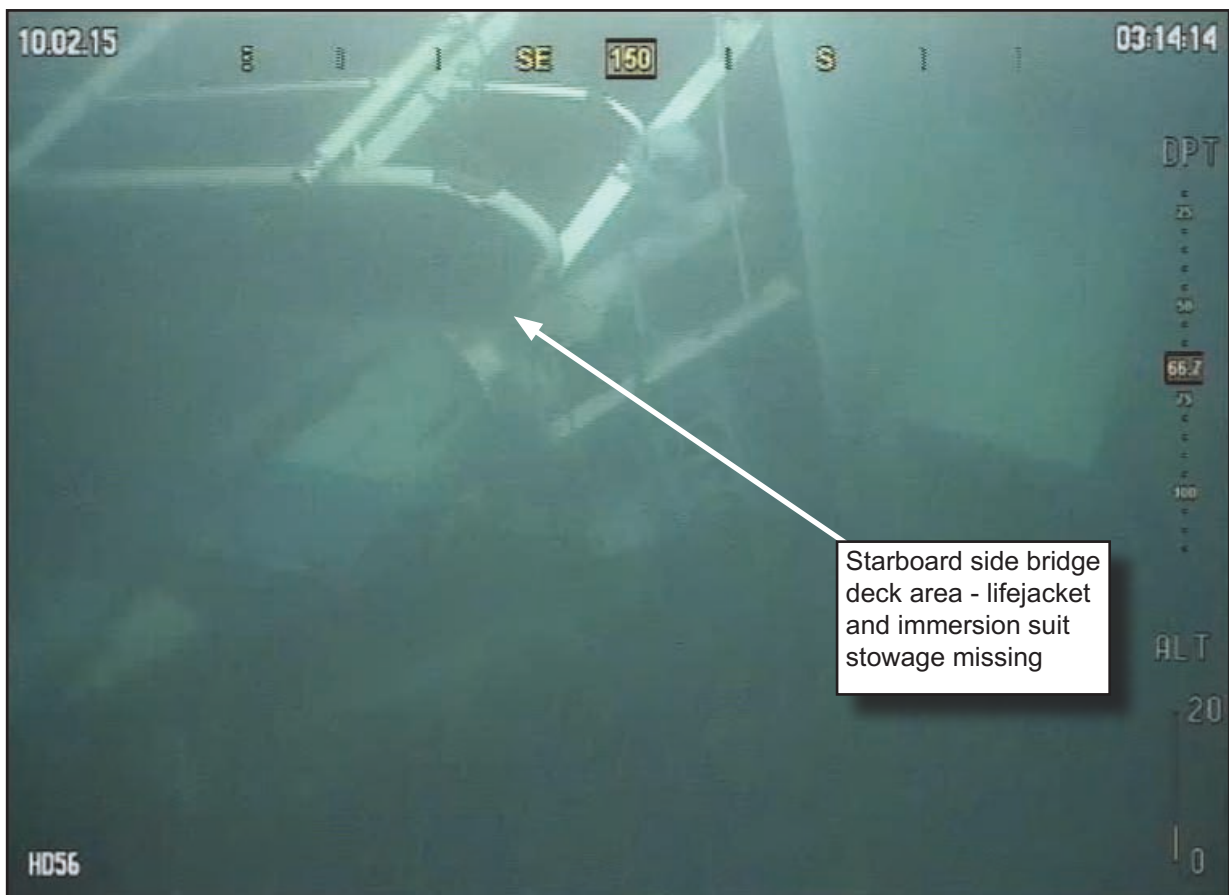
- The lifebuoys had gone from the stowages observed.
- The deck stowage for the crew lifejackets and immersion suits was missing (**Figure 31**).
- All four of the cement loading ports were shut and secured (**Figure 32**).

Figure 31: Wreck of *Cemfjord* - starboard bridge deck area showing that crew immersion suit and lifejacket stowage was missing

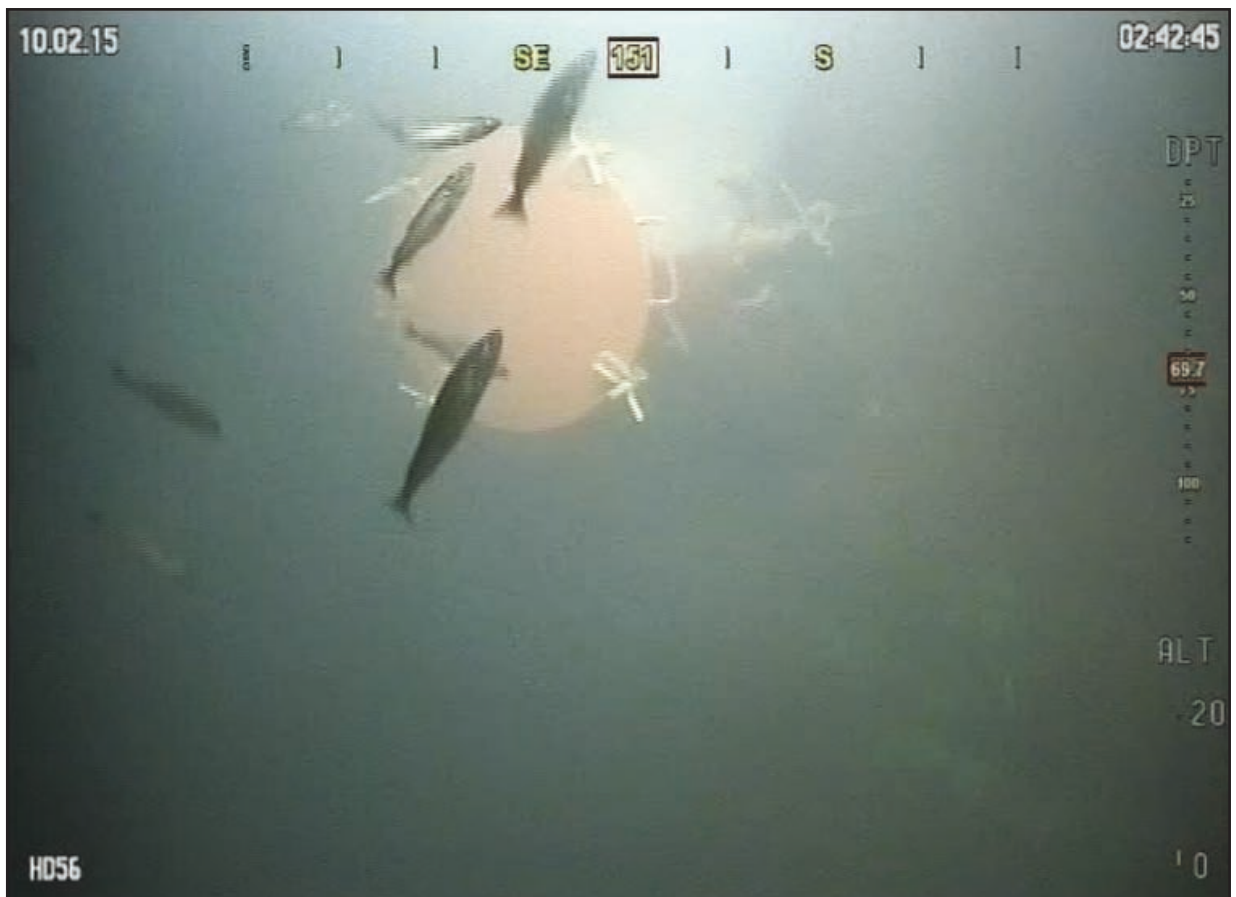
Figure 32: Wreck of *Cemfjord* - closed cement loading port

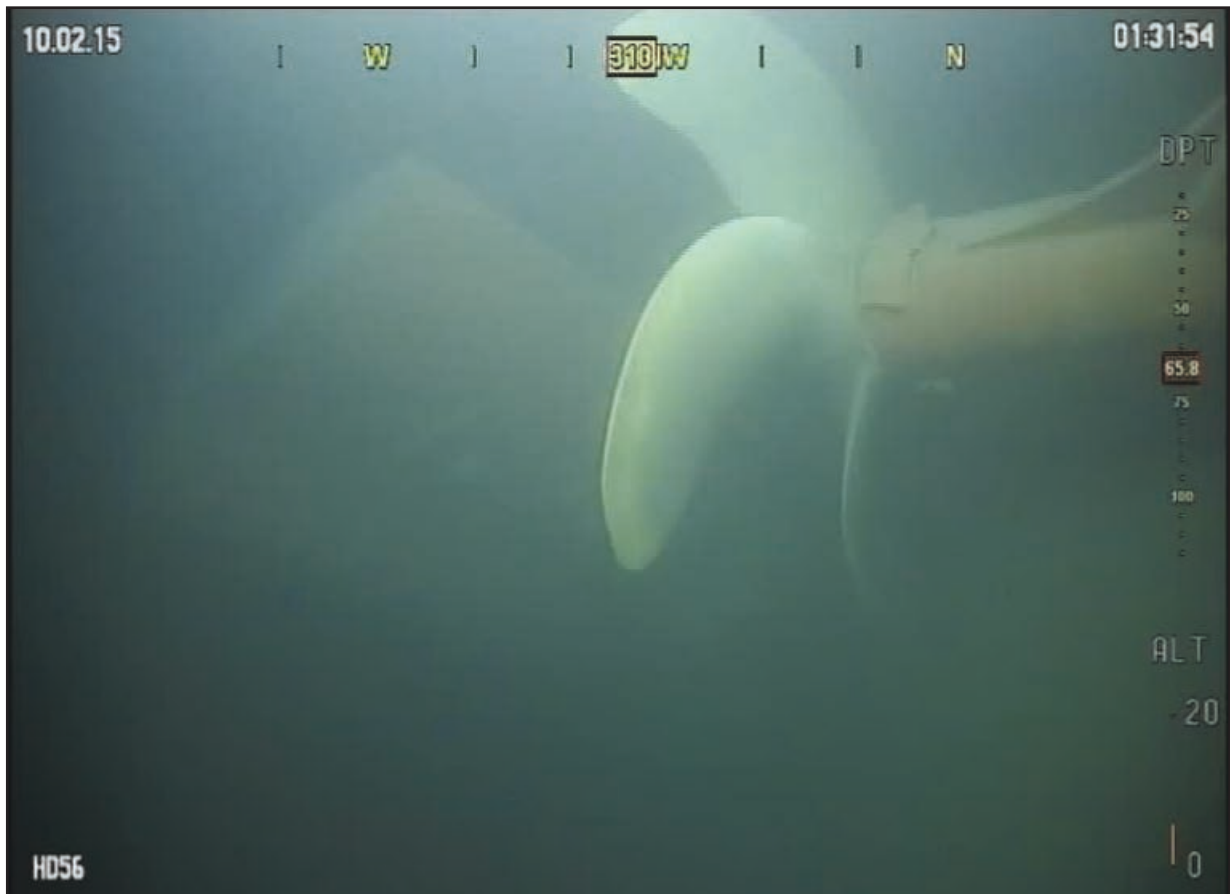
Figure 34: Wreck of *Cemfjord* - propeller with rudder set to approximately 10° to port
