**ACCIDENT**

<b>Aircraft Type and Registration:</b>	Embraer EMB-505 Phenom 300, HZ-IBN	
<b>No &amp; Type of Engines:</b>	2 Pratt & Whitney Canada PW535E turbofan engines	
<b>Year of Manufacture:</b>	2010 (Serial no: 50500040)	
<b>Date &amp; Time (UTC):</b>	31 July 2015 at 1408 hrs	
<b>Location:</b>	Blackbushe Airport, Surrey	
<b>Type of Flight:</b>	Private	
<b>Persons on Board:</b>	Crew - 1	Passengers - 3
<b>Injuries:</b>	Crew - 1 (Fatal)	Passengers - 3 (Fatal)
<b>Nature of Damage:</b>	Aircraft destroyed	
<b>Commander's Licence:</b>	Airline Transport Pilot's Licence	
<b>Commander's Age:</b>	57 years	
<b>Commander's Flying Experience:</b>	11,000 hours (of which 1,181 were on type) Last 90 days - 23 hours Last 28 days - 5 hours	
<b>Information Source:</b>	AAIB Field Investigation

**Synopsis**

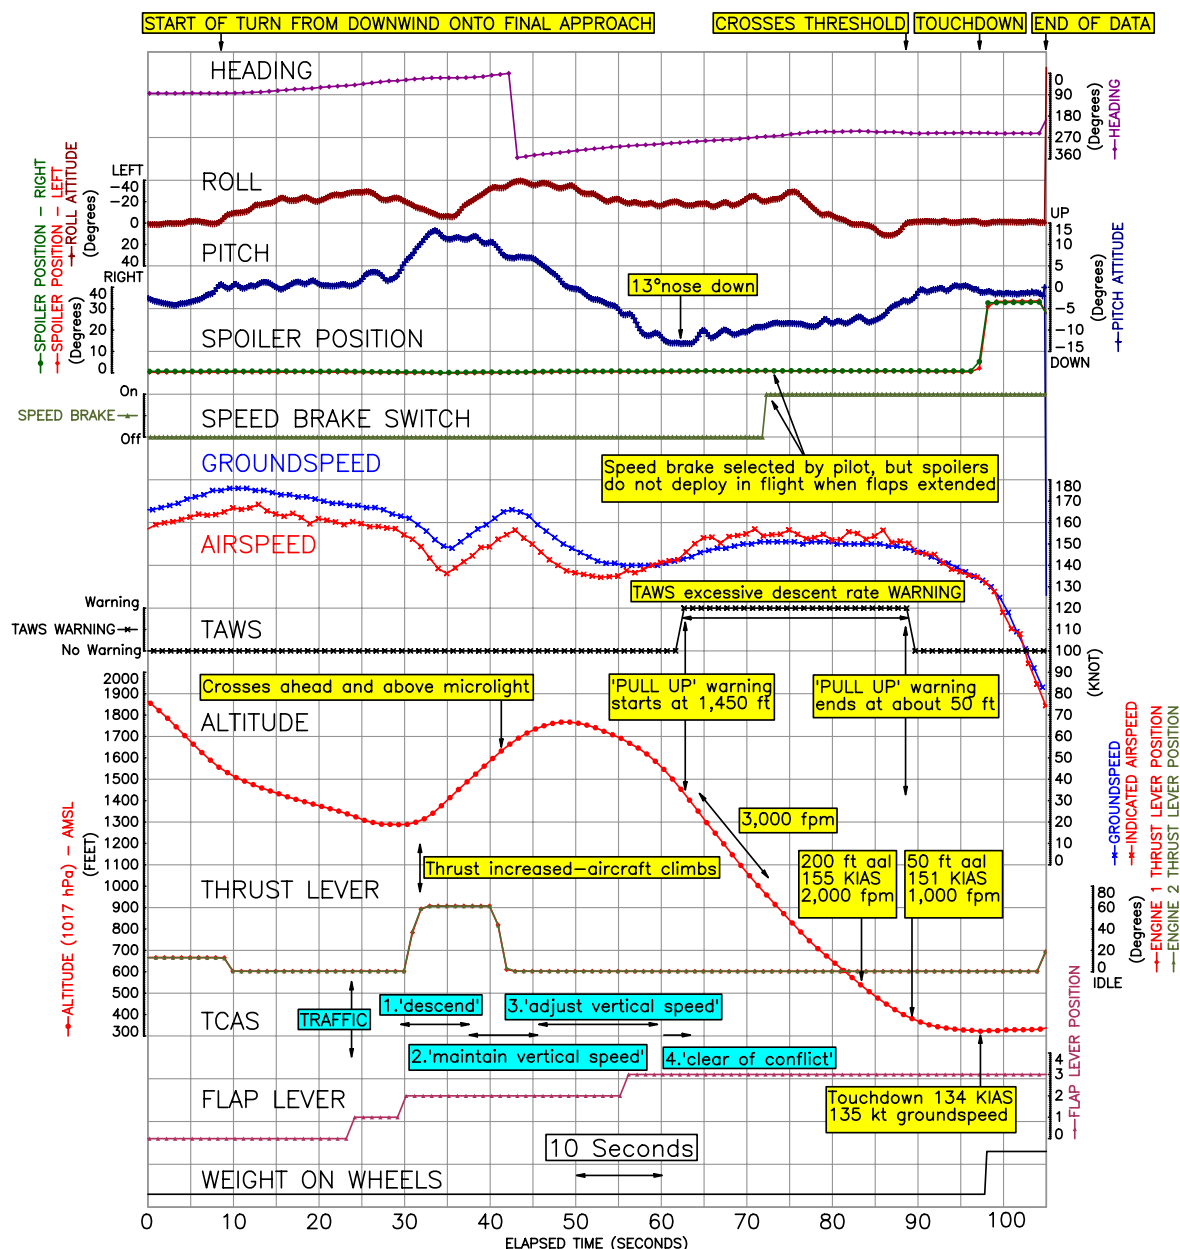
**Figure 4**  
CVFDR data of approach

As HZ-IBN continued its approach the rate of descent increased to about 3,000 fpm and the airspeed stabilised at about 153 KIAS, with the pitch attitude reaching 13° nose-down. At 1,450 ft amsl (1,125 ft aal), the first of six TAWS excessive descent rate warnings occurred, which provided an aural “PULL UP” warning in the cockpit. At 675 ft aal the pilot selected the speed brakes out; however, they remained retracted because they are inhibited from deploying when the flaps are extended. As the aircraft descended through 500 ft aal the TAWS issued a “FIVE HUNDRED” automated announcement; the aircraft’s airspeed was 156 KIAS and the rate of descent was about 2,500 fpm. At 200 ft aal the airspeed was 155 KIAS and the rate of descent was 2,000 fpm. During this period the controller advised the runway was clear for landing; no response to this transmission was recorded.

The approach continued and the aircraft crossed the threshold at about 50 ft aal at an airspeed of 151 KIAS with a rate of descent of about 1,000 fpm but reducing. This coincided with the sixth (and final) TAWS warning. The aircraft touched down about nine seconds later at an airspeed of 134 KIAS and a groundspeed of 135 kt. The ground spoilers deployed and the brakes were applied almost immediately. The aircraft decelerated at an average longitudinal deceleration of  $-0.45g$  (Figure 11). When the aircraft reached the end of the paved surface of the runway its groundspeed was 83 kt and its airspeed was 84 KIAS. In the second before the end of the CVFDR data, both thrust levers were recorded as having been advanced from the idle position and the spoilers had started to close.

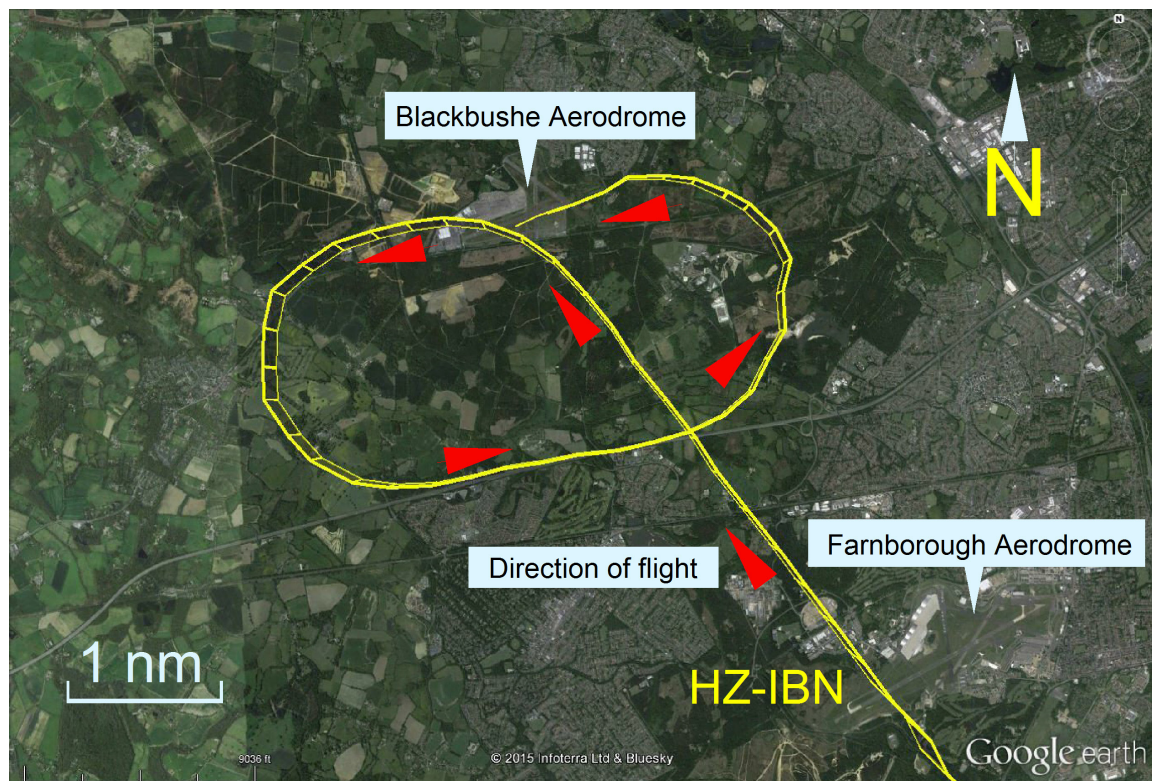
**Figure 5**  
Approach path of HZ-IBN (Bovington radar)

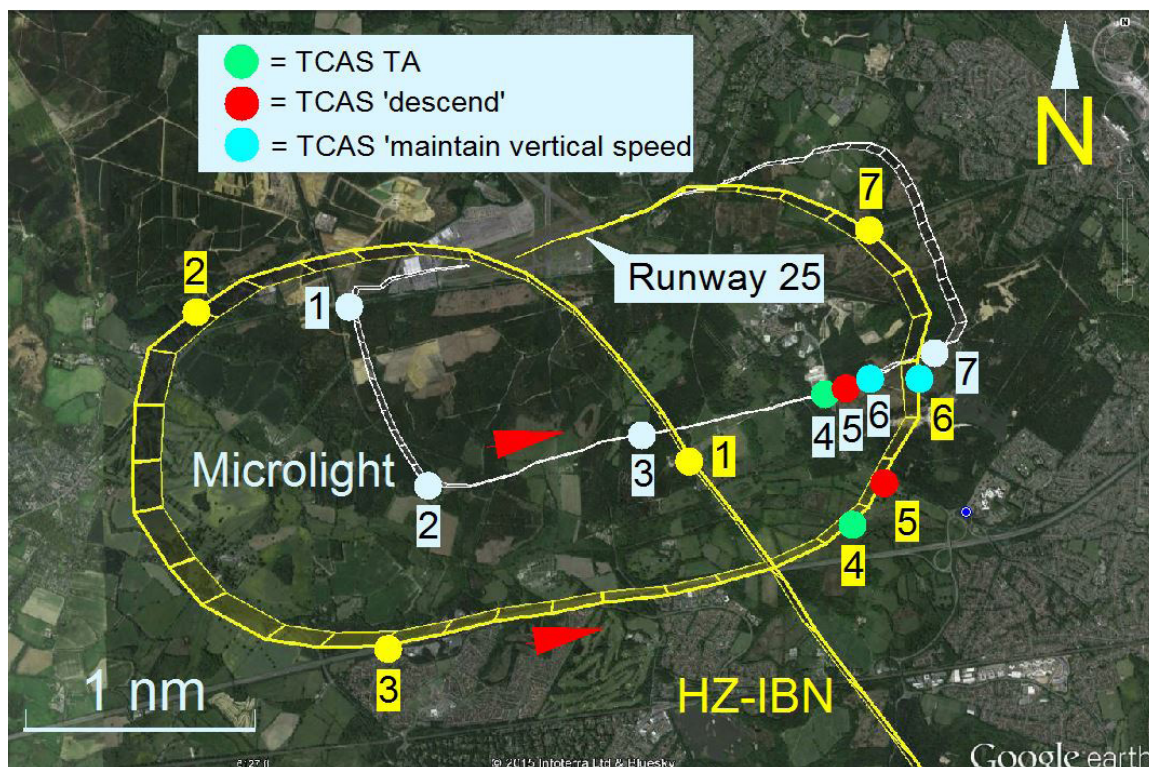
Relative positions of HZ-IBN and microlight  
(Paired numbers and colour codes indicate relative positions of the aircraft when the TCAS alerts were generated on HZ-IBN – the other aircraft were not TCAS equipped)

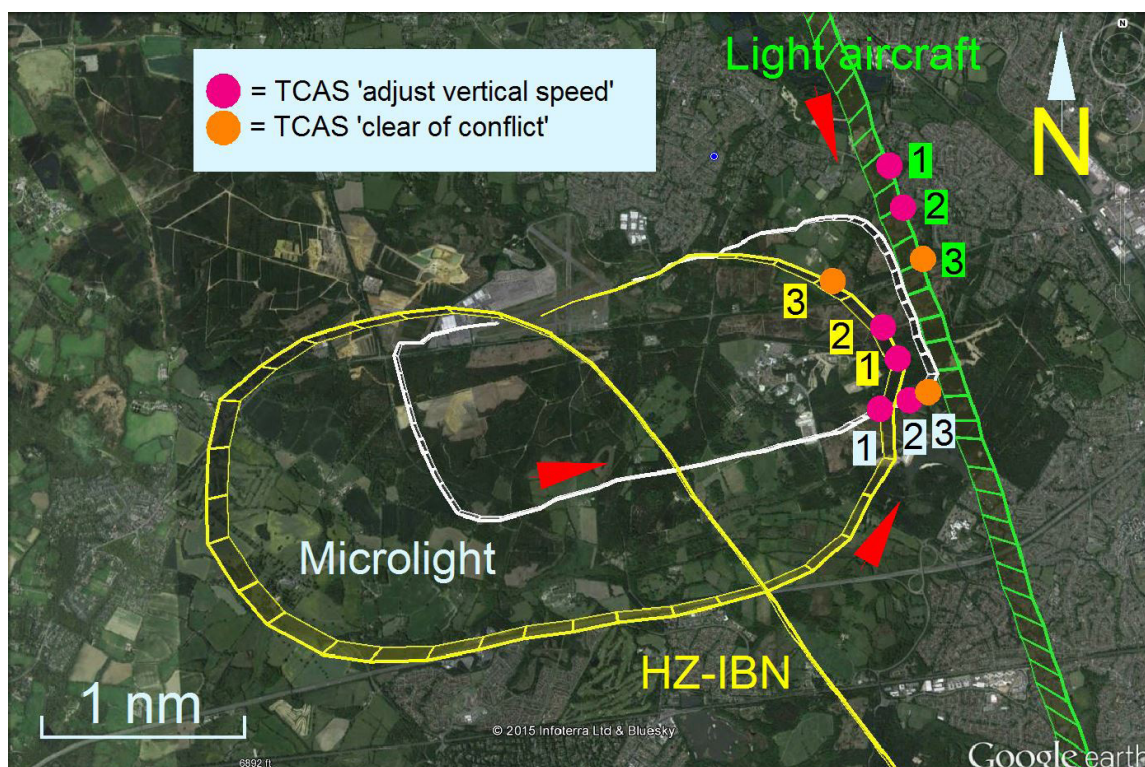
Relative positions of HZ-IBN, microlight and light aircraft  
(Paired numbers and colour codes indicate relative positions of the aircraft when the TCAS alerts were generated on HZ-IBN – the other aircraft were not TCAS equipped)

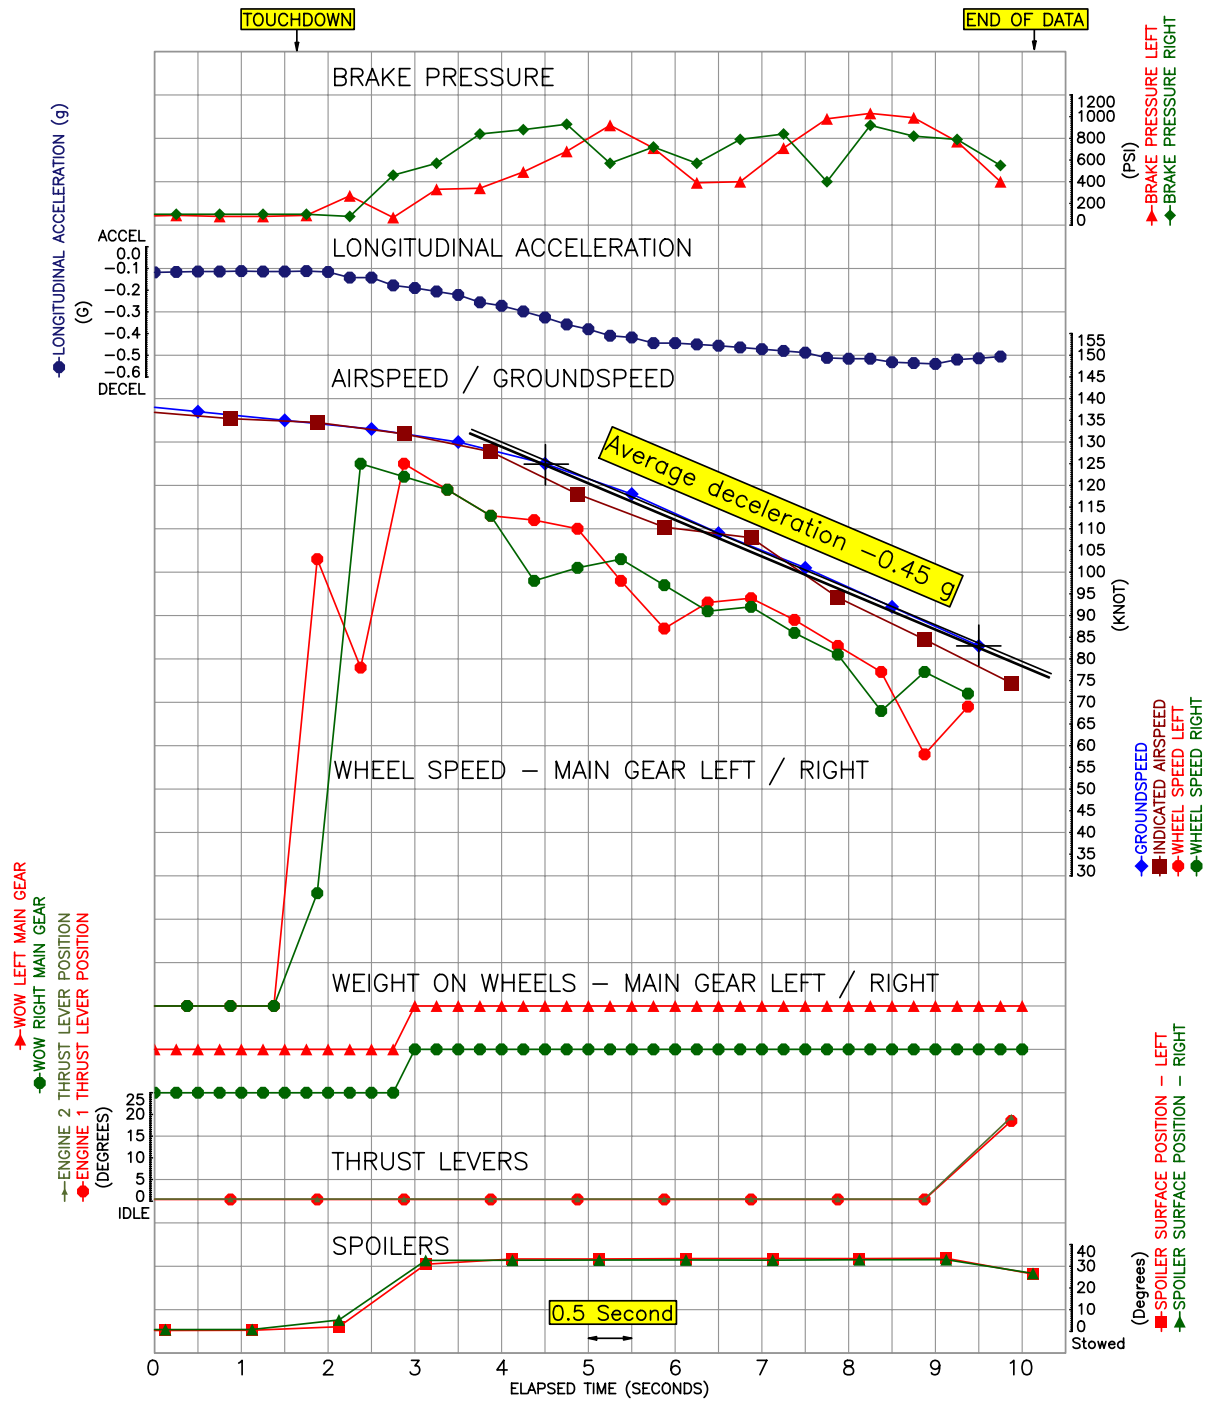
**Figure 11**  
Braking system performance recorded by CVFDR

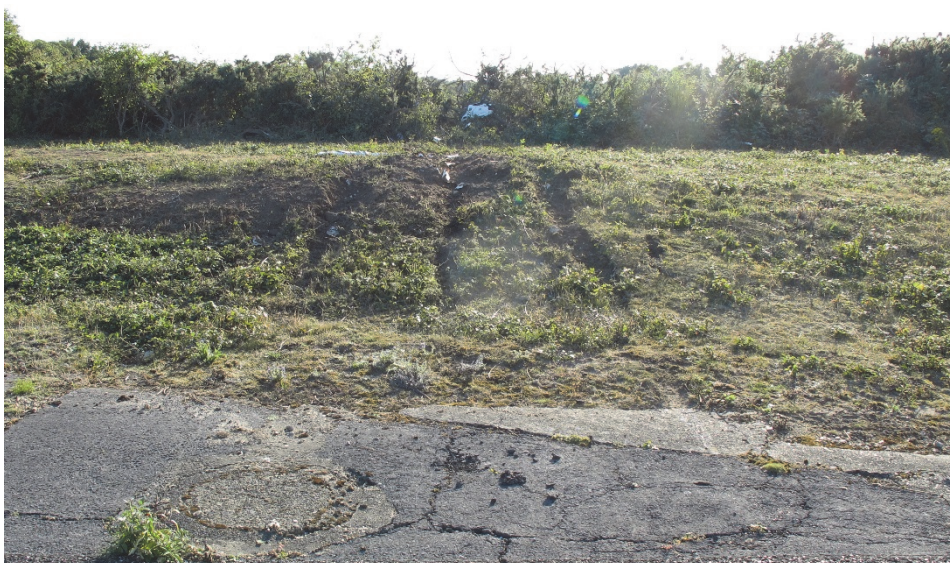
There were three tyre tracks in the earth bank at the end of the runway, formed by the two main wheels and the nosewheel, where the aircraft departed the runway (Figure 12). There were also two rubber tyre marks on the paved surface corresponding to where the main wheels departed the runway. These rubber tyre marks could be traced back to the point where the aircraft touched down (Figure 13). At touchdown the wheel spin-up causes rubber to be deposited on the runway surface causing the dark marks from each wheel shown in Figure 13. The marks showed that the left wheel touched down first, followed by the right wheel and then the nosewheel. The left wheel touched down 438 m from the end of the paved surface, and the right wheel 4.3 m closer. There were short breaks in the initial touchdown marks which were probably the result of the wheels skipping before they settle. The brakes would not yet have activated at this point.

Tyre tracks from the main wheels and nosewheel in the earth bank at the end of Runway 25

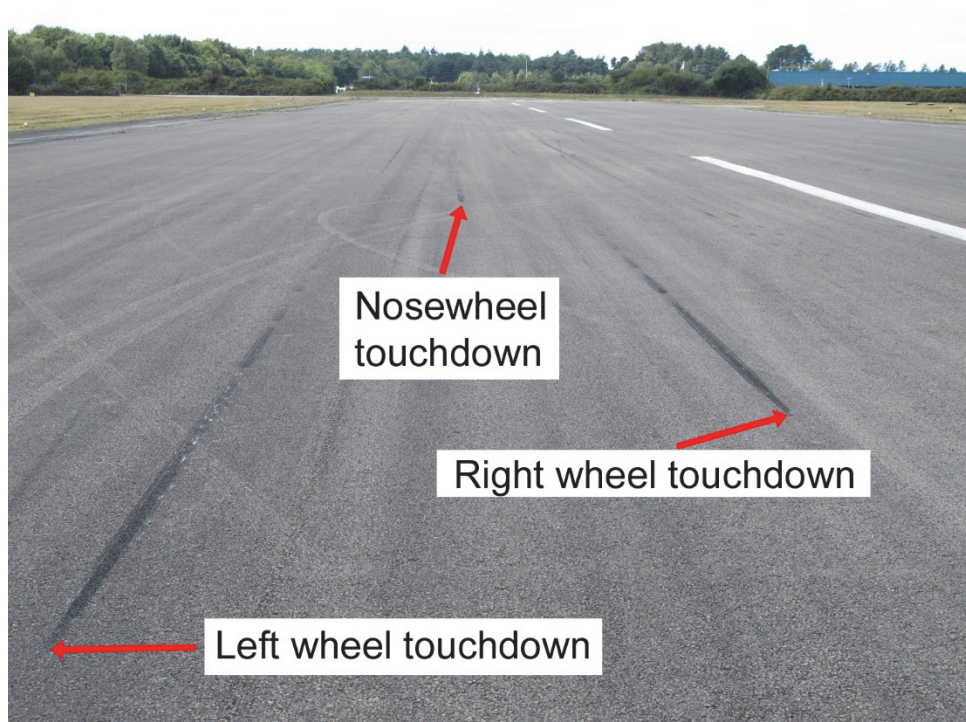
Touchdown tyre marks (looking in the direction of travel)

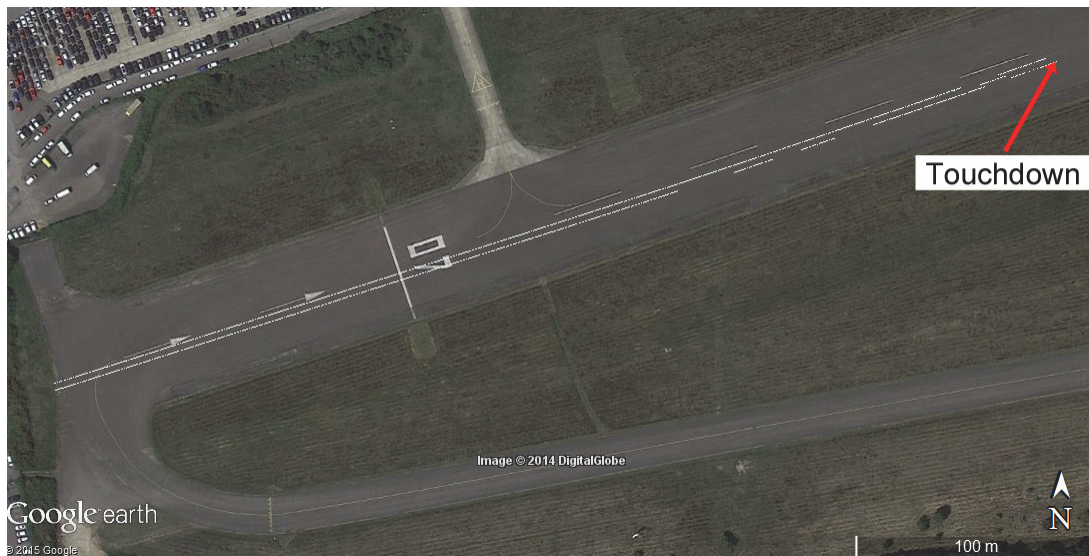
Tyre marks made by the aircraft at touchdown indicated that it landed 710 m beyond the Runway 25 threshold. The Runway 25 declared Landing Distance Available (LDA) was 1,059 m; therefore the aircraft touched down 349 m before the end of the declared LDA. The paved runway surface extended 89 m beyond the end of the LDA.

Tyre marks from touchdown to the end of the paved surface (white lines)  
– GPS survey of marks overlaid on Google Earth image

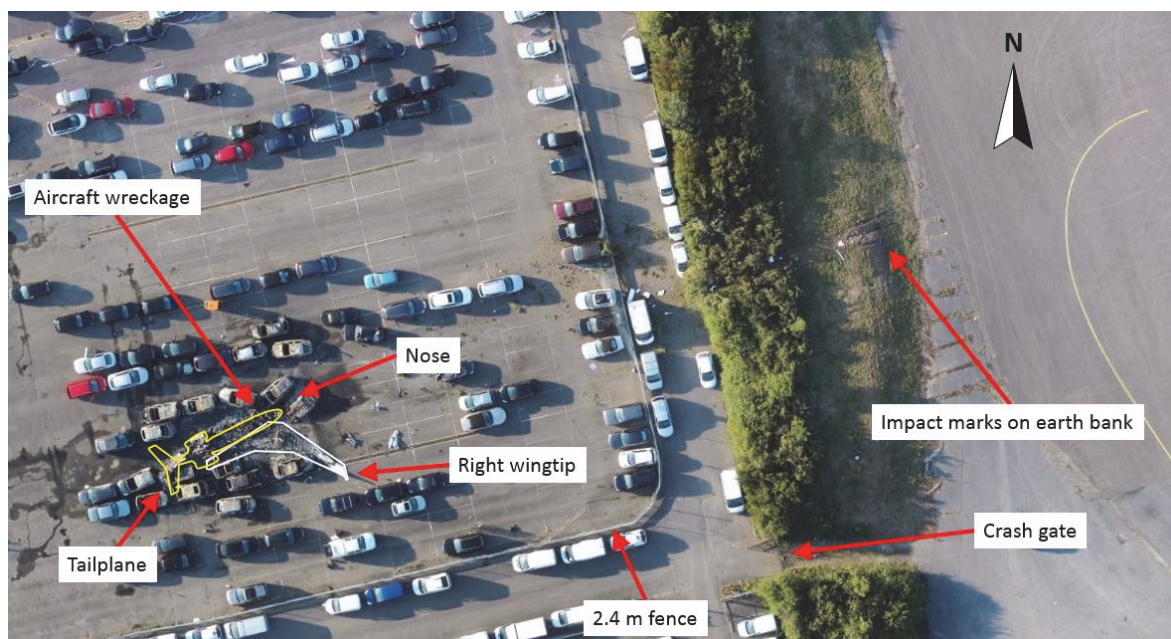
Overhead view of accident site, with outline showing wing and fuselage

CCTV footage of the car park was reviewed by the AAIB. It showed the aircraft touched down in the car park in an approximately 20° right wing low roll attitude, and a level pitch attitude. Within 0.1 seconds of touchdown, the entire wing was observed to separate from the fuselage, following which the fuselage rolled to the left through approximately 350°, before coming to rest laying on its right side, on a heading of 064°M and at a roll angle of about 30° to the horizontal. The fuselage was observed to be largely intact as it came to rest, on top of the detached wing. The wing was oriented on a heading of north (Figure 15).

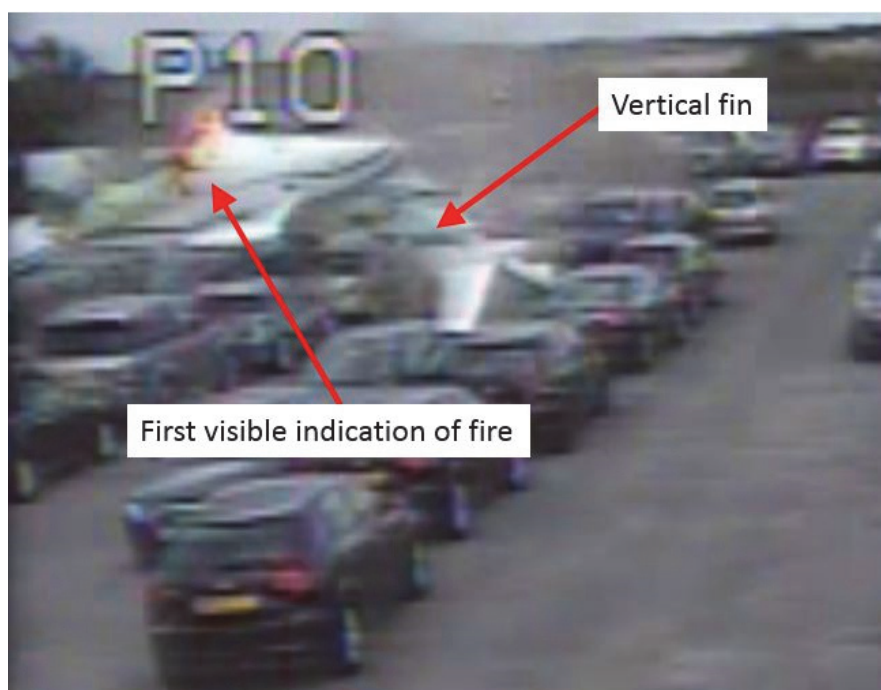
The first indications of fire visible on the CCTV footage occurred approximately 0.8 seconds after the aircraft's impact in the car park, as the fuselage was inverted following detachment of the wing (Figure 16). Visible flames were centred on the lower rear fuselage at the aft end of the fuselage belly fairing, immediately aft of where the wing was attached to the fuselage and close to the location of the aft main battery. The fire continued to burn with increasing intensity, consuming most of the aircraft.

CCTV image of aircraft approximately 0.8 seconds after touchdown in the car park (first visible indication of fire as the fuselage rolls through the inverted position)

The CCTV images showed that the fire ignited approximately 0.8 seconds after the detachment of the aircraft's wing assembly, with the initial seat of the fire located in the aft belly fairing, just behind where the wing had detached. The only significant fuel source in this area was fuel leaking from the severed wing-to-fuselage engine fuel supply fuel pipes, which contained fuel fed from the wing fuel tanks. The ignition source of the fire was not positively identified due to disruption of the aircraft in the accident and from the severity of the post-accident fire.

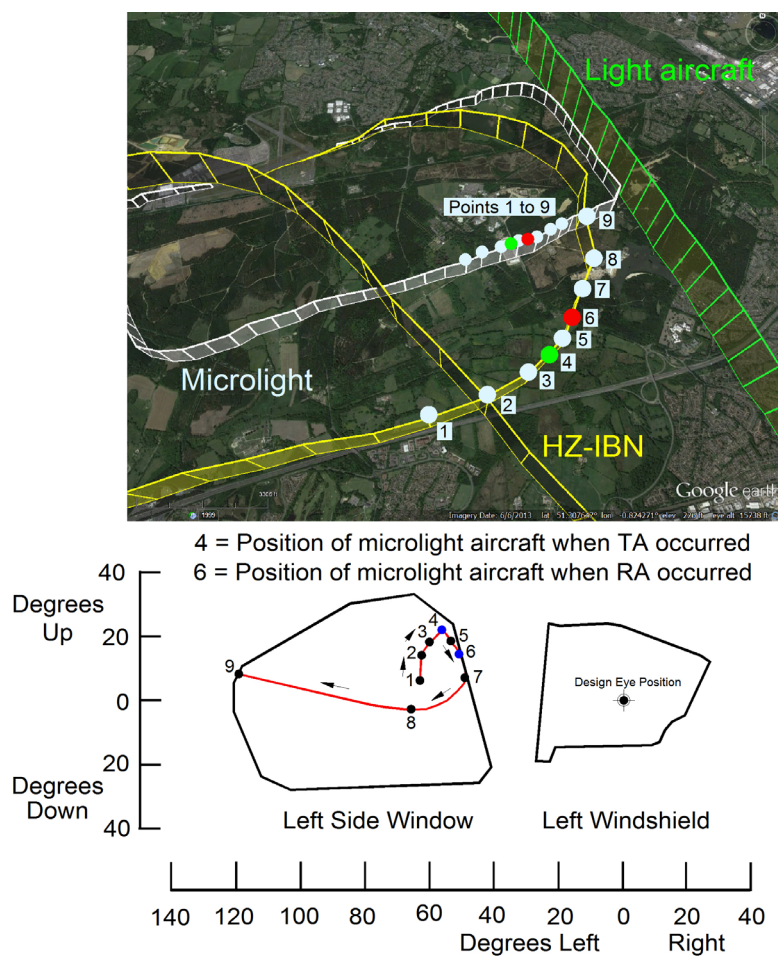
Perspective view of microlight viewed from HZ-IBN cockpit left seat design eye position  
1406:54 hrs to 1407:23 hrs

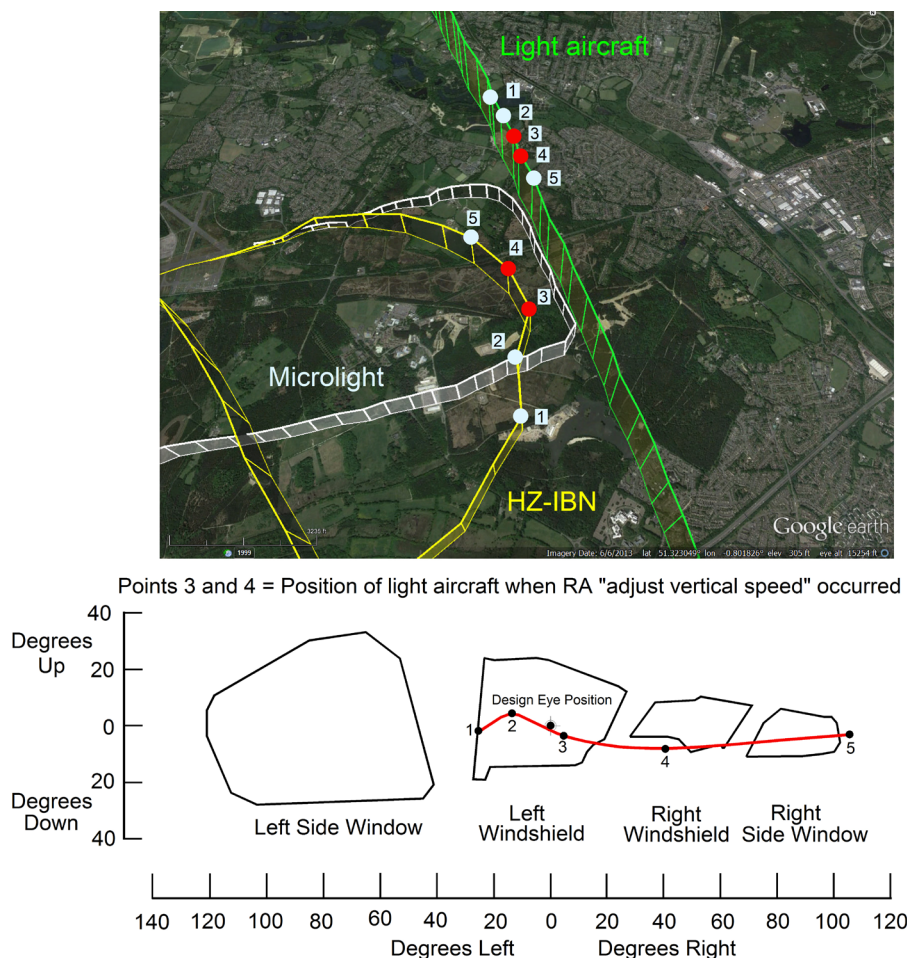
Perspective view of light aircraft viewed from HZ-IBN cockpit left seat design eye position  
1407:18 hrs to 1407:43 hrs
