# ***AAIB Bulletin***

***9/2021***

**CONTENTS****SPECIAL BULLETINS / INTERIM REPORTS**

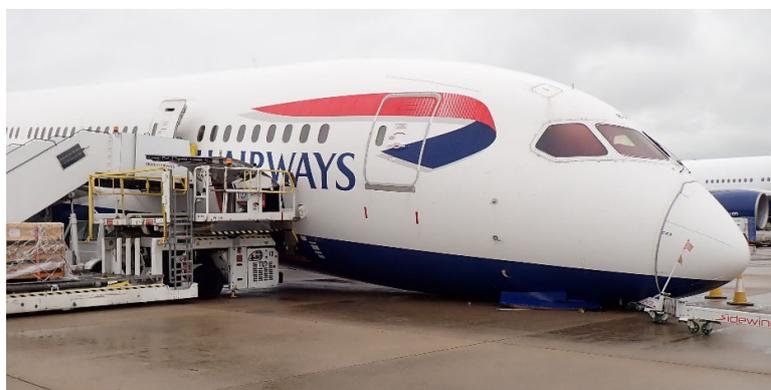
**Figure 1**

One of the ground loading team who was on the pallet loader and under the cargo door was slightly injured as the door moved down with the fuselage (Figure 1). The co-pilot, sat in the cockpit received a minor injury and the three personnel who were stood in the forward cabin and galley fell to the floor but were otherwise uninjured.

Pallet cargo loader positioned at the forward cargo door

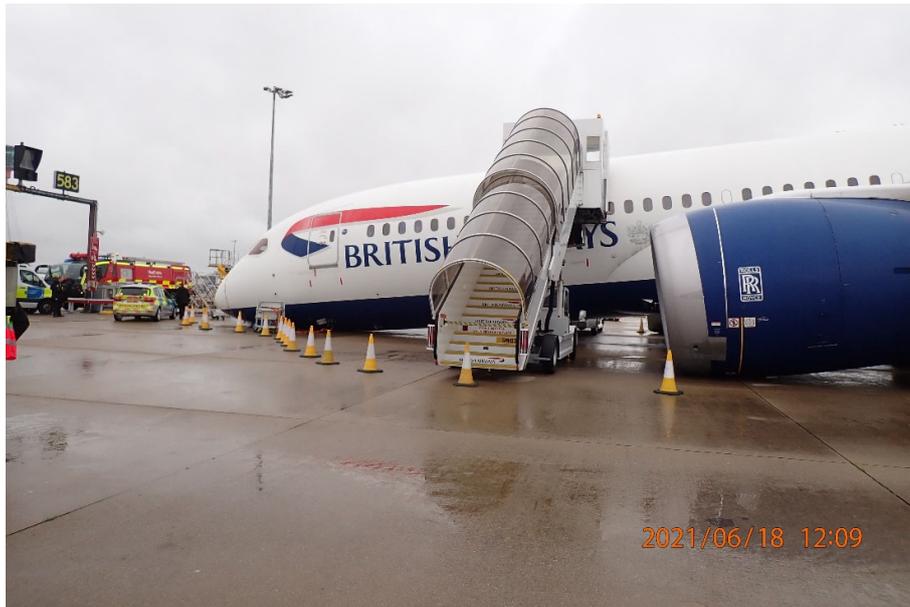
**Figure 2**

The aircraft's nose came to rest on the articulated arm of a ground power unit, crushing the cable arm. The aircraft sustained damage to the lower forward fuselage, NLG doors and both engine cowlings, which had also struck the ground. Door 2L had been severely damaged by contact with the stairs positioned at the door aperture as the aircraft sank onto its nose (Figure 2). The door hinges and actuating mechanism had failed and the door, which was resting on the top platform of the stairs, remained attached to the fuselage by the remains of its wiring loom.

G-ZBJB with stairs in position at Door 2L

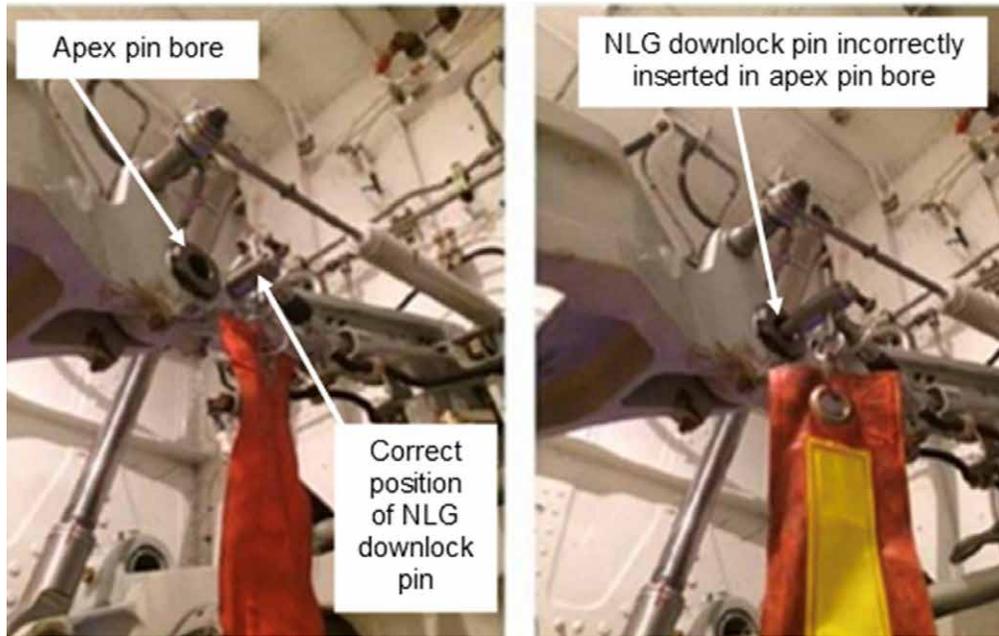
**Figure 3**

When the aircraft nose was lifted, during the recovery operation, the NLG was examined and the NLG downlock pin was found fitted in the NLG apex pin bore (Figure 3). With the downlock pin inserted in this position, when the LOCK OVRD is pressed and the landing gear lever selected to UP with hydraulic power applied, the NLG will retract.

In 2018, another Boeing 787 experienced a retraction of the NLG while the aircraft was on the ground which had been caused by the NLG downlock pin being accidentally installed in the apex pin inner bore, which is adjacent to the correct hole for the downlock pin in the NLG lock link assembly (Figure 3).

Illustrative image of the correct and incorrect installation of NLG downlock pin

As a result of this event the aircraft manufacturer published Issue 01 of Service Bulletin (SB) B787-81205-SB320040-00 on 12 March 2019. The SB provides instructions to install an insert into the NLG lock link apex pin inner bore (Figure 4). The insert prevents the NLG downlock pin from being inserted in the apex pin bore instead of the adjacent NLG downlock pin hole. Issue 02 of the SB was subsequently published on 23 October 2020.

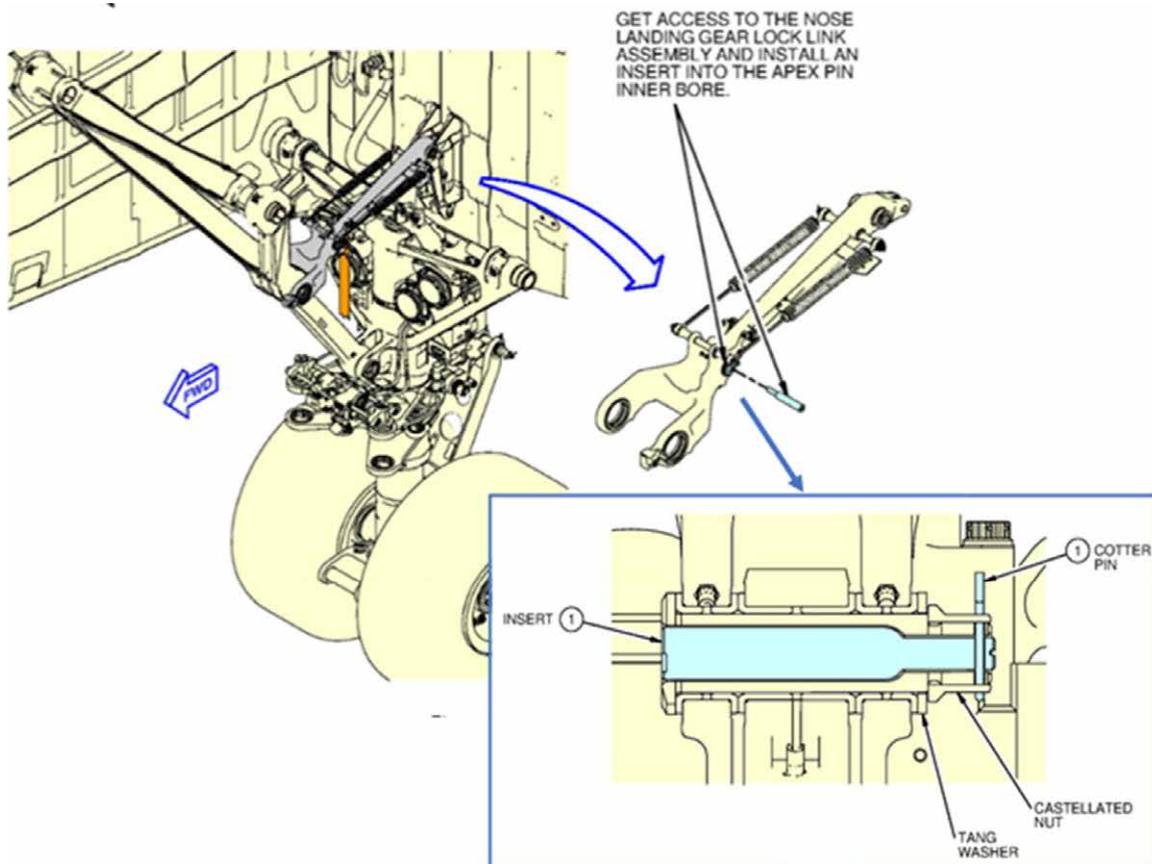
**Figure 4**

Installation diagram of NLG apex pin inner bore insert

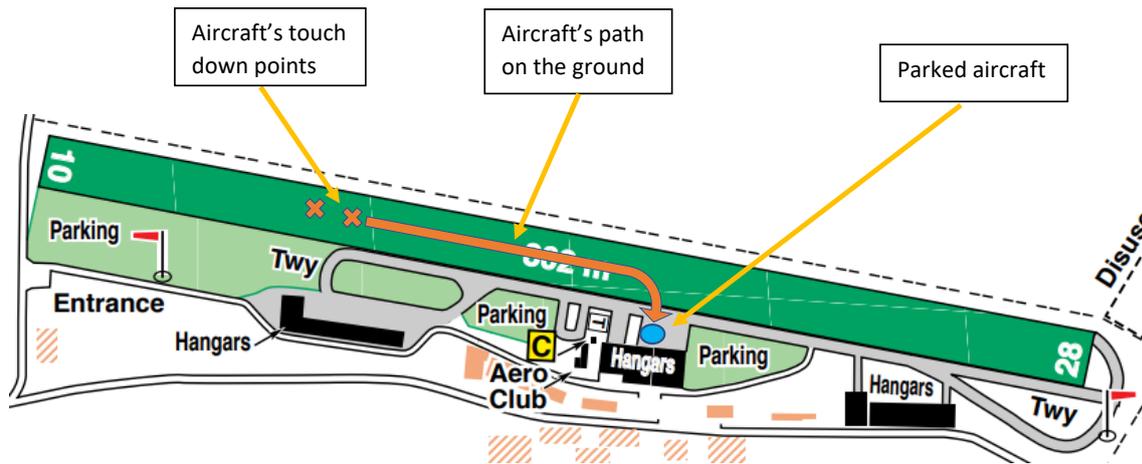
**Figure 1**

During a bounced 'three-point' landing the pilot applied momentary full rudder which caused the tailwheel steering to disengage. The aircraft veered off the runway and struck a parked aircraft. Information from pilots of the type indicates the aircraft may be best suited to 'wheeler' landings.

Pilot's description of the incident

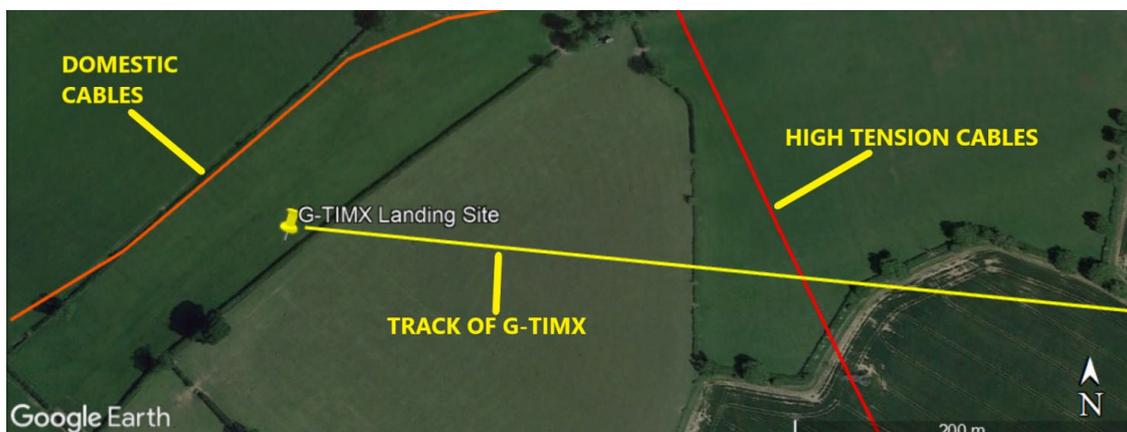
**Figure 2**

As the balloon approached the M1 motorway the pilot was preparing to select an area for landing. He discounted an area of fields adjacent to and west of the motorway due to the presence of a horse and concerns that the balloon crossing the road at low-level would constitute a distraction for drivers. Just west of the motorway there is a set of high-tension electricity cables and the pilot decided to land to the west of these. Many of the fields were planted in crop and to avoid damage to crops the pilot chose a narrow grass field. The western edge of the field was bounded by low, domestic electricity cables, so the pilot intended to land in the first quarter of the field to allow room for the balloon to deflate without becoming entangled in the cables. The landing site is shown in Figure 2.

Landing site

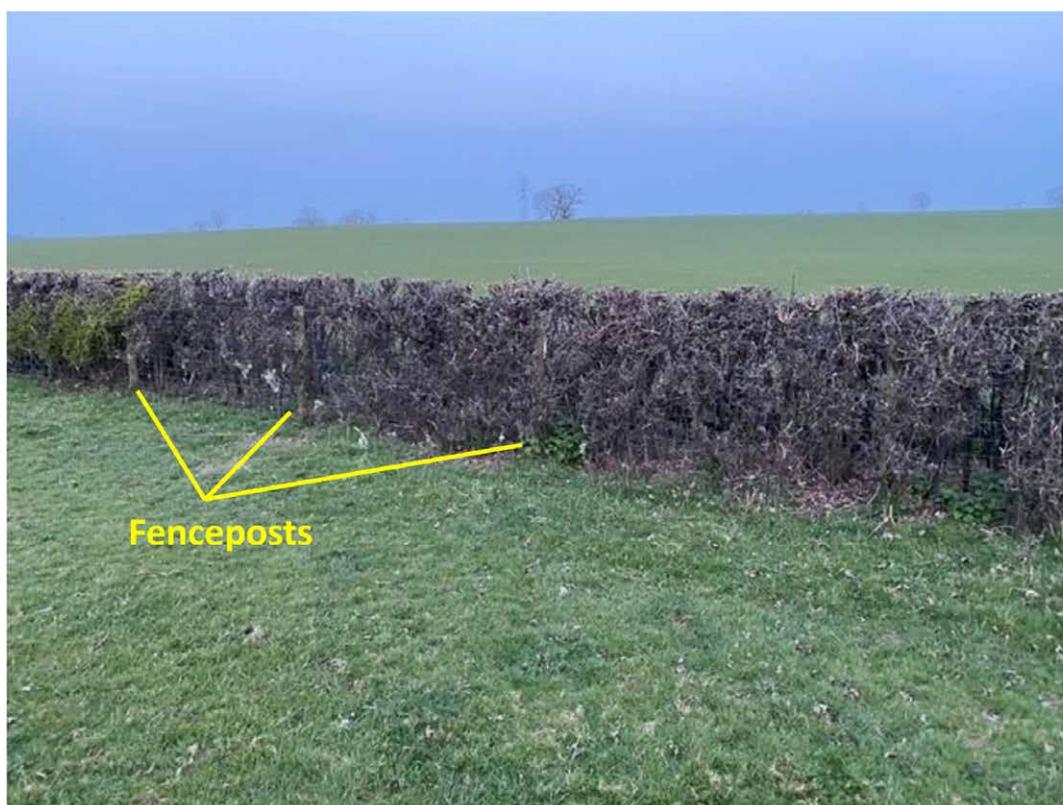
**Figure 3**

After crossing the high-tension cables, the pilot descended to approximately 80 ft agl. His handheld GPS indicated a groundspeed of 8 to 9 kt, which was below the limit for landing. As the balloon approached the chosen landing field the pilot instructed the passengers to adopt the brace position. The eastern side of the landing field is bounded by a hedgerow and the pilot decided to allow the balloon basket to make contact with this to reduce the groundspeed for touchdown. The hedge and landing area are shown in Figure 3, which shows a view looking upwind. There were fence posts embedded in the hedge which were not visible to the pilot.

He reduced the height of the balloon to bring the basket level with the top of the hedge and made contact as he intended. One passenger described the impact with the hedge as “hard” and believed it dislodged her from the brace position. As a result, the passenger did not believe she was in the planned brace position when the basket struck the ground. The wind then carried the balloon past the hedge pulling the basket clear and it dropped approximately one metre into the field. The pilot described the touchdown as a “small bump on the landing which is normal and expected with the wind conditions”. During touchdown the basket fell onto its side and the balloon then deflated normally.

Hedge and fenceposts bordering landing site

It is difficult to assess the hazard posed by the possibility of solid obstructions within a hedge line and so CAA FSO considered that the fast landing technique as described in the BBAC Pilot Training Manual would have been preferable.

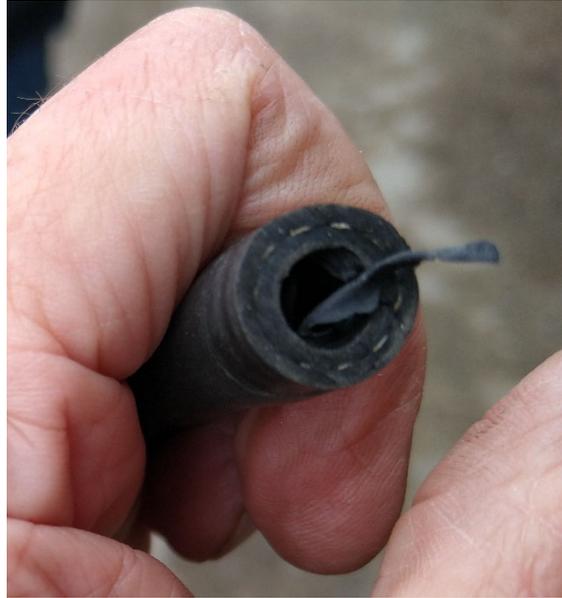
**Figure 2**

To facilitate the recovery of the aircraft from the field the fuel tanks were drained. The combined outlet of the left tank was disconnected but it was found that no fuel would flow from the pipe when the aircraft was in a nose high attitude, even though fuel was visible in the tank. When the aircraft was placed in a level attitude fuel was able to flow from the tank.

Examination of the fuel lines by the owner found a sliver of material within one of the pipes that ran from the combined left tank outlet to the fuel selector valve (Figure 2). It is likely that this obstruction caused the engine to stop in flight.

Sliver of material found in the fuel pipe between the left tank and engine  
(photograph reproduced with permission)

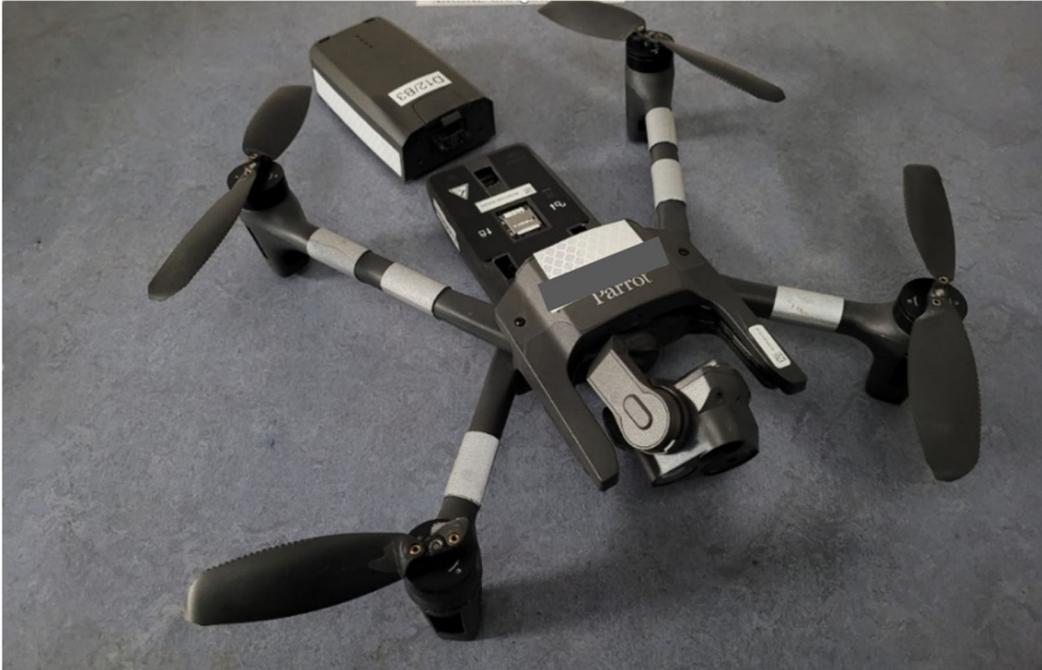
**Figure 1**

The observer watched as the UA pitched forwards and rapidly descended into the ground in nearby woodland. The aircraft was found 300 m away upside down. One rotor blade had snapped, a rotor arm had been dislodged, the rotor arms were unable to fold out and the battery had been released and was located next to the aircraft. (Figure 1).

UA showing damage to rotor and dislodged battery

The UA was recovered and sent to the manufacturer for examination. The manufacturer reported it was likely that during the component surface mounting process, an abnormal solder connection between the UA's battery and the aircraft's printed circuit board (PCB) power circuit caused the UA to lose power during flight.

The manufacturer has completed a check of every unit and PCB in its facility as well as their surface mounting technology process and equipment. A sample check of the UAs in storage awaiting sale, including their demonstration fleet and those units returned for after sales service, was also completed without finding any further abnormalities. There had been no previous reports of failures linked to abnormal soldering.

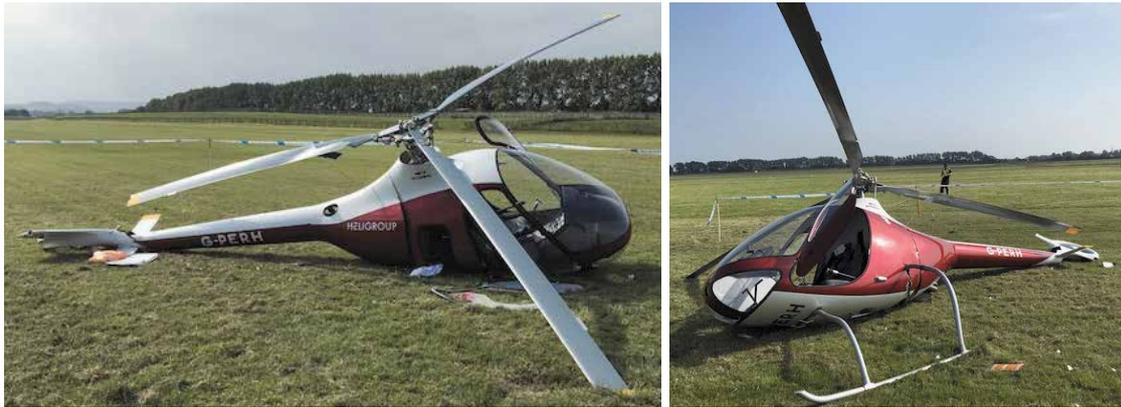
**Figure 1**

The accident site occurred in the Helicopter Training Area at Goodwood Aerodrome. The helicopter came to rest upright with the right side of the fuselage in contact with the ground and pointing in a north-east direction. The landing gear had penetrated the fuselage on the left side and the right passenger door had broken and become detached. The fenestron tail rotor had detached from the tail boom and there was evidence that two of the main rotor blades had struck the ground (Figure 1). Both landing skids had dug into the ground with no evidence of movement after contact.

G-PERH at the accident site

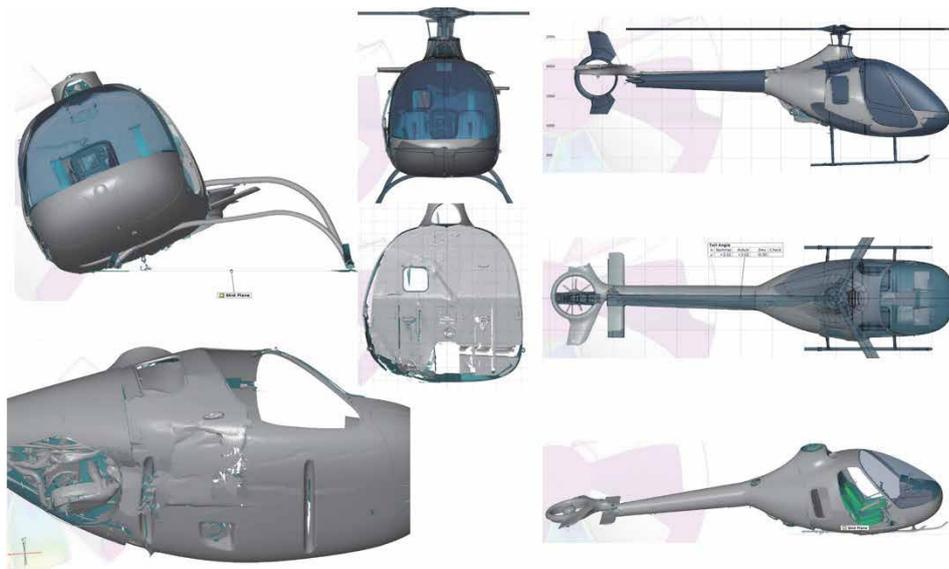
**Figure 4**  
Digital analysis of G-PERH

Following the visual examination, the helicopter was digitised using a '3D' structured light scanning system to quantify the structural deformation. All exterior surfaces were scanned, as well as the landing skids, engine bay and cabin interior. The results of the scan were then compared with the original design data obtained from the helicopter manufacturer (Figure 4).

The results of the scanning showed that the tail boom of the helicopter was misaligned by approximately 3° to the left of nominal and bent slightly upwards. The cabin bulkhead showed evidence of multiple damage locations of crushing, cracking and delamination.

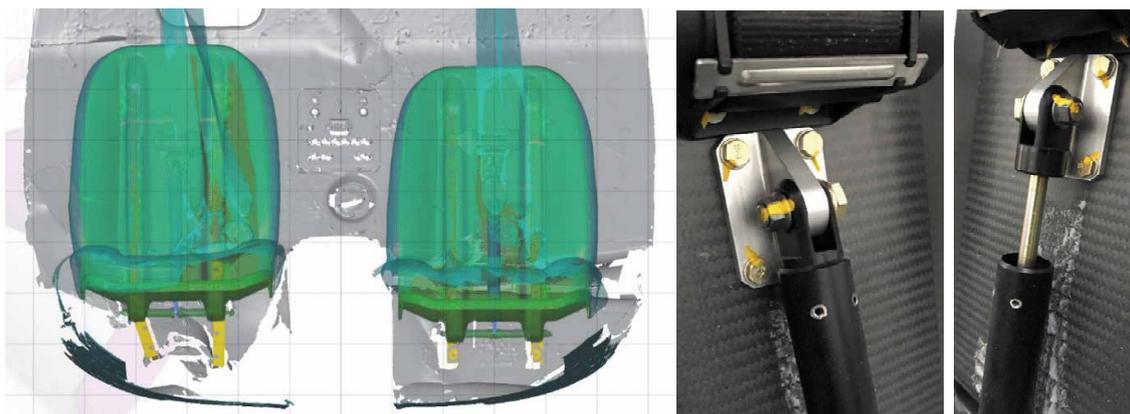
**Figure 5**

The position of the seats was recorded with the cushions removed to enable accurate measurements to be taken from the composite shell (Figure 5). Once the seat shells were removed, the length of the energy absorbing struts was measured:

Strut	Nominal Length	Measured Length	Extension
Left	302 +/- 0.5 mm	351.6 mm	49.6 mm
Right		304.5 mm	2.5 mm

Seat position and energy absorbing strut extension
