Interim report on the investigation of the contact of the passenger vessel *Waverley* with Brodick Pier, Isle of Arran, Scotland, on 3 September 2020

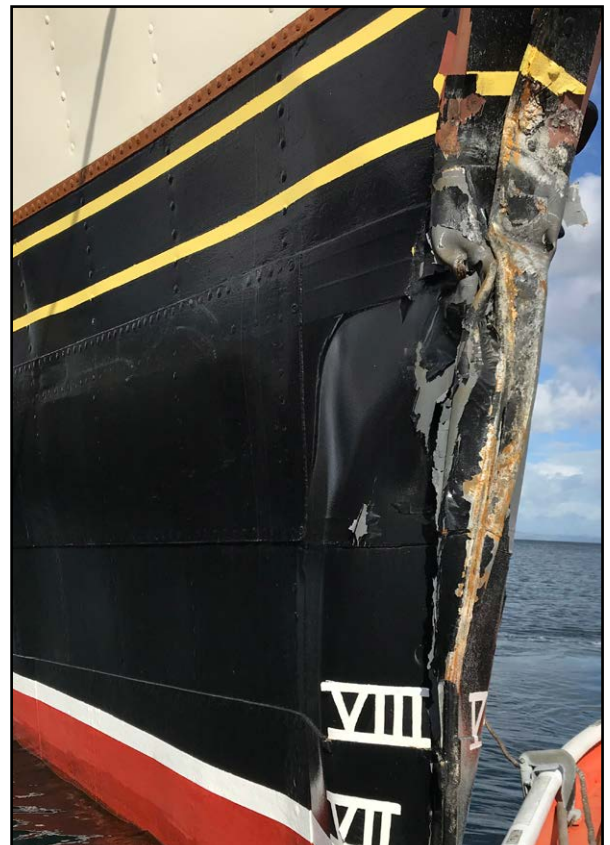
On the afternoon of 3 September 2020, the paddle steamer *Waverley* made contact with the pier while berthing at Brodick on the Isle of Arran, Scotland. In the final stages of the approach there was a delay in response when astern thrust was requested. Although the paddle wheels started going astern, this could not prevent *Waverley* overrunning the intended berth and making contact with the concrete pier ahead. As a result of the accident, 24 passengers and crew were injured, and the stem of the vessel was damaged above the waterline.

Damage to *Waverley*’s stem
