Near miss with track workers at Eccles, 22 July 2021

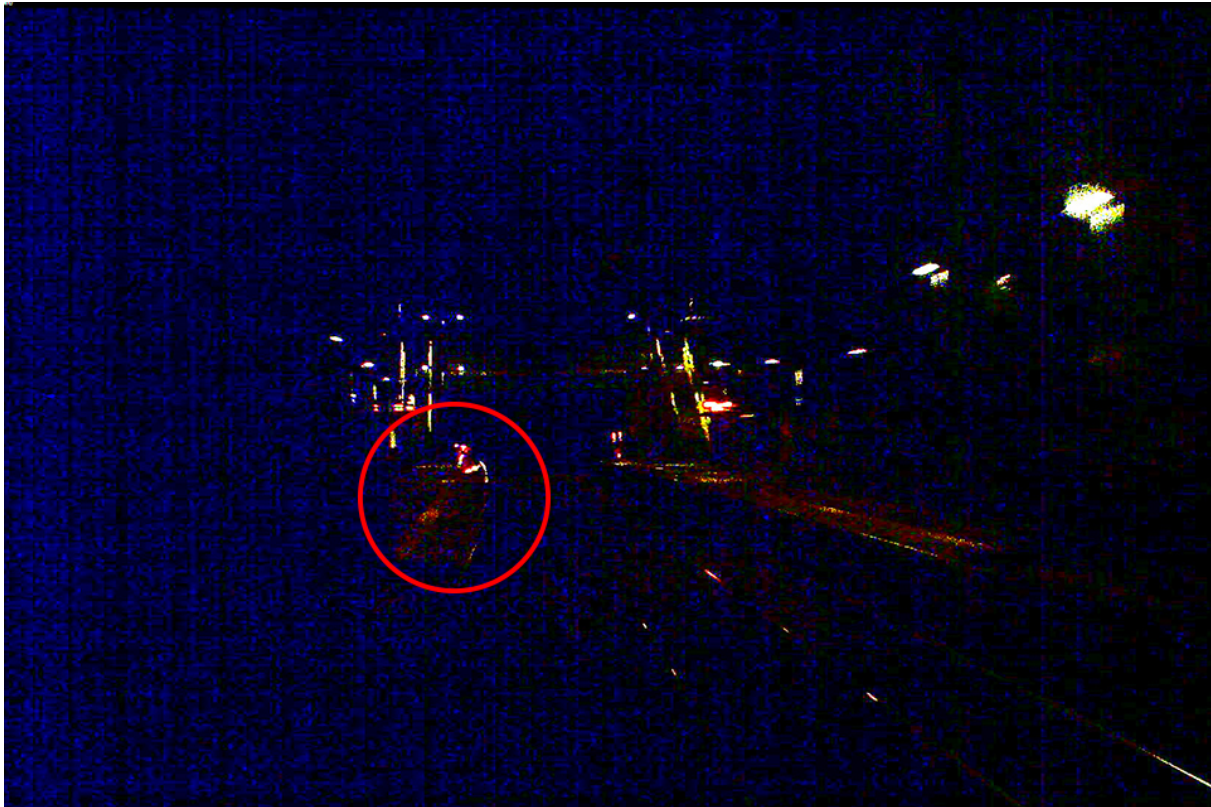
The train involved, reporting number 5C31, was operated by Avanti West Coast Ltd. It consisted of a Class 390 electric multiple unit which was travelling from Longsight depot, in Manchester, to Lancaster. On approaching Eccles and seeing the track workers' reflective clothing, the train driver sounded the train's horn and applied the emergency brake. The track workers heard the warning horn and quickly climbed onto the platform. They were clear of the track approximately four seconds before the train passed them while travelling at 69 mph (111 km/h).

Forward facing CCTV from train 5C31 showing track workers on the platform edge (Image courtesy of Avanti West Coast Ltd)

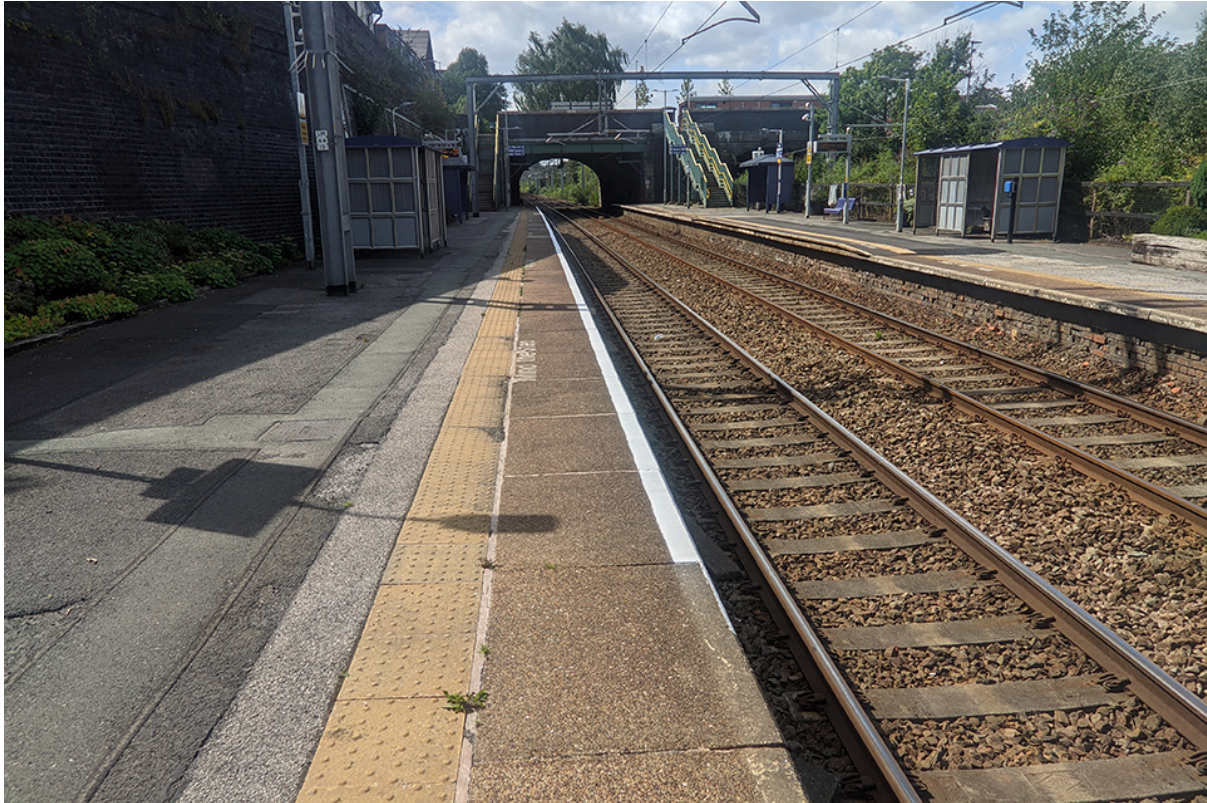
Eccles station platform 2 looking west, with bridge access in the distance

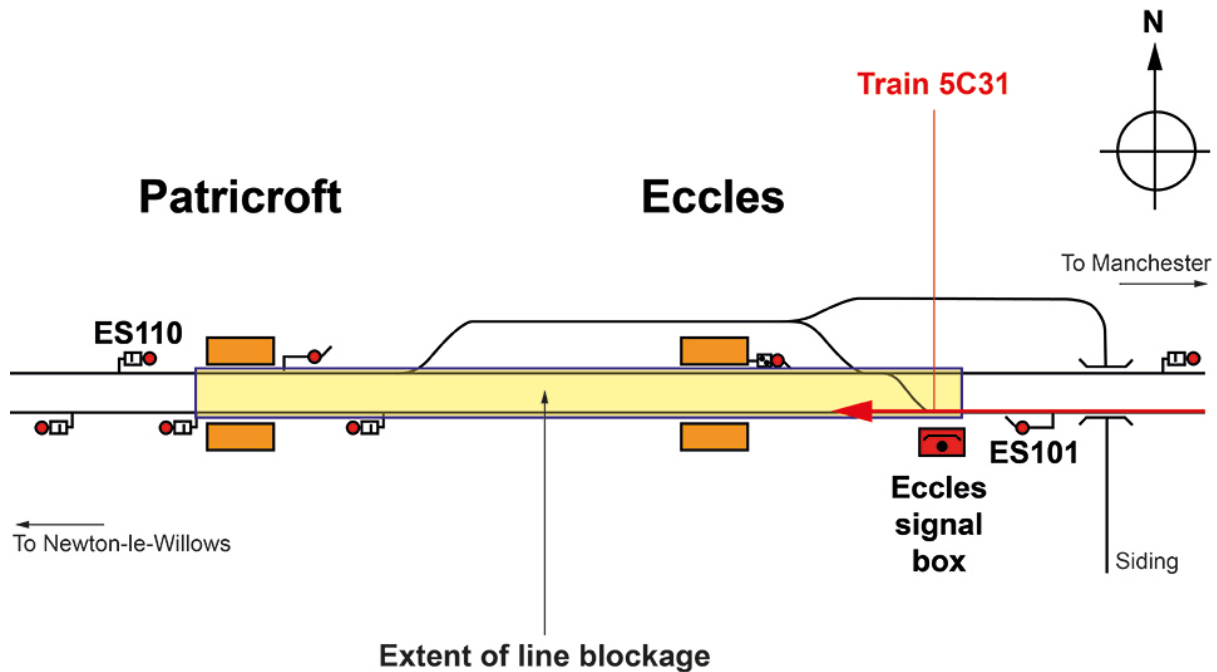
The line blockage covered both lines and was protected by signal ES101, just to the east of Eccles station and signal ES110, to the west of Patricroft station. The work was planned to run from 00:01 hrs to 05:00 hrs, with the line blockage being given up to allow trains to pass when required. Discussions between the COSS and the signaller at the start of the night confirmed that scheduled trains were running and that the work would need to stop and the line blockage be given up for each train.

Track diagram showing the extent of the line blockage
