Rail Accident Investigation Branch

Rail Accident Report

Trains overspeeding between Laurencekirk and Portlethen, Aberdeenshire 4 December 2020

Report 08/2021
November 2021

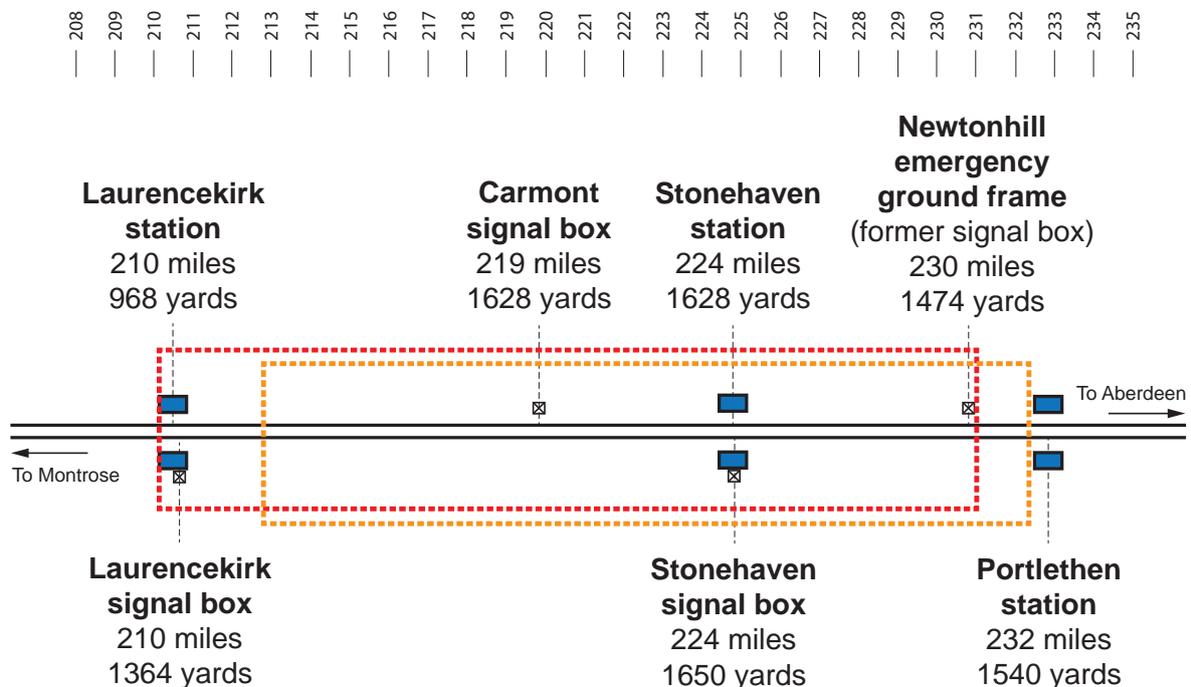
Figure 2: The BESR limits between Laurencekirk and Portlethen. The red box indicates the area defined by the locations on the form in the late notice case, the orange box the area defined by the mileages and intended by the asset managers (see paragraph 66).

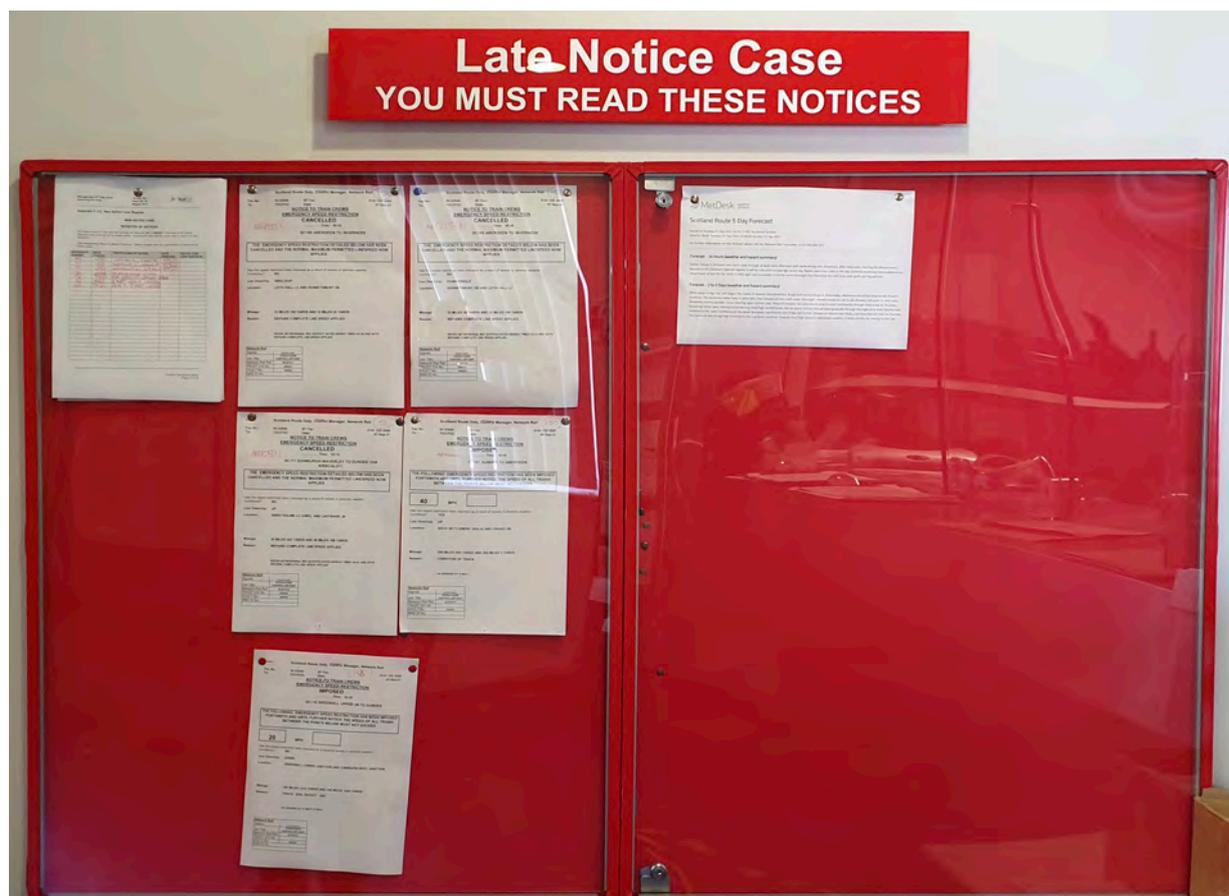
Figure 3: Late notice case at Aberdeen

- 19 A notice containing details of the BESRs, including details of the BESR between Laurencekirk and Portlethen, was emailed by route control staff to ScotRail depots and affected signal boxes at around 17:00 hrs on 3 December. The notice stated that the BESRs took effect at the start of service on 4 December and continued until 09:00 hrs. ScotRail staff placed a copy of this notice in the late notice cases at Dundee and Aberdeen depots at around 17:20 hrs. The late notice cases comprise a notice board in a glass fronted cupboard located near the places where drivers book on duty (figure 3).

52 Unlike other type of emergency and temporary speed restriction, there were no warnings, reminders or visual cues available to train drivers relating to this BESR, other than the late notice case. This meant that drivers' memory was a potential single point of failure for compliance with a safety-related speed restriction.

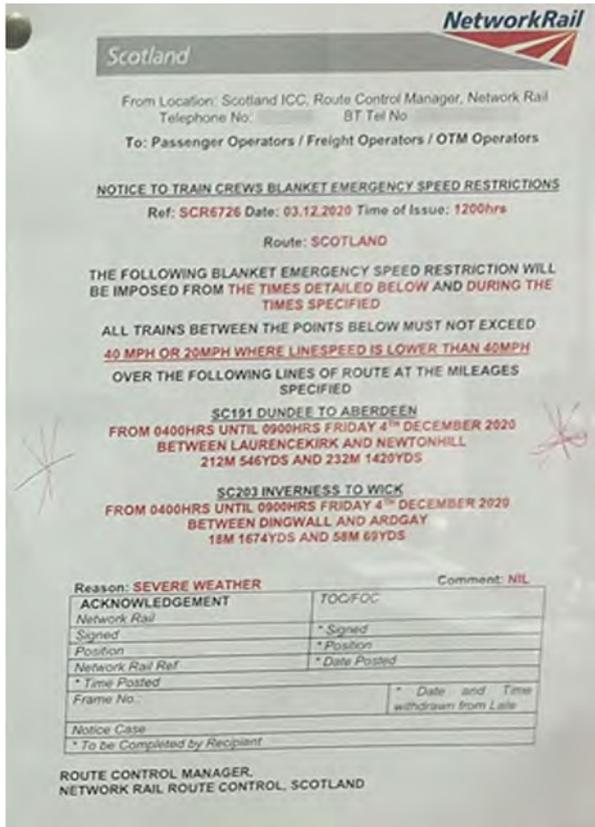
Figure 4: Late notice displayed at Aberdeen

36 Some drivers did not reduce speed as required by the blanket emergency speed restriction because they were unaware of the restriction or unaware of its exact limits.

37 Witness evidence and recordings of conversations between signallers and drivers show that some drivers were unaware of the BESR as they approached it, and others were unaware of its exact limits (table 1). BESR details (figures 4 and 5) were displayed at Aberdeen and Dundee depots as confirmed by ScotRail and evidenced by other drivers complying with them.

- 48 **Legibility:** although the size, font and spacing of alphanumeric characters is generally appropriate, nearly all the text is in capitals. If using full sentences, it is preferable to use lower case as *'during reading of upper-case words, perception occurs in a character-by-character order, thereby reducing the speed of reading and readability of the entire word'*.⁶ A study found that *'words set in capital letters are less legible than in lower case when reading text, searching for newspaper headlines, or finding a name on a map. The difference is usually attributed to the distinctive shape of lower case words, but lower case setting also emphasises capital letters at the start of sentences and for proper names'*.⁷
