Train collision with fallen tree near Glencarse, Perth & Kinross, 21 May 2021

Summary of the accident

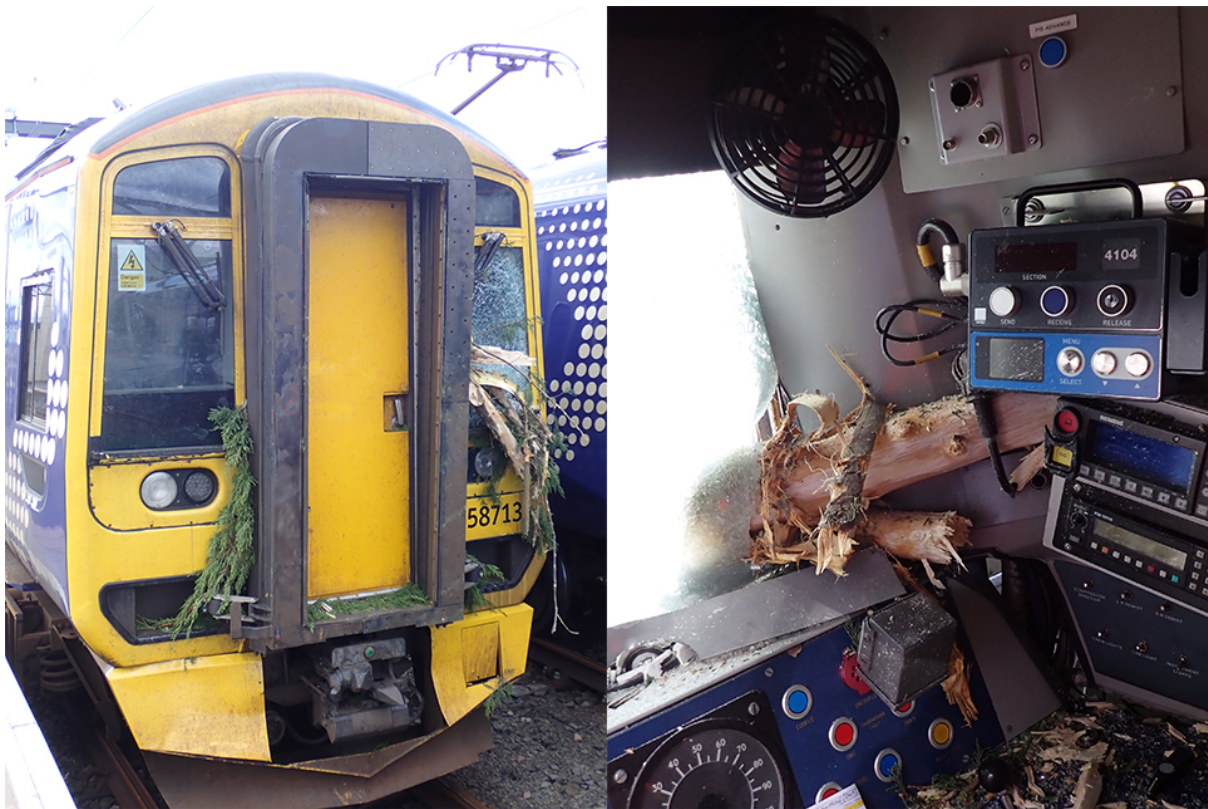
The train had been travelling at 74 mph (119 km/h) when the tree came into view. Although the driver applied the emergency brake, the train struck the tree seven seconds later. The tree penetrated the driving cab of the class 158 unit which formed the train, and the driver sustained injuries to his head and arms. The conductor and 28 passengers on board the train were unhurt. The driver's window and the interior of the cab were damaged, and the outer skin of two of the side windows of the train was broken.

Damage to the driving cab of the train

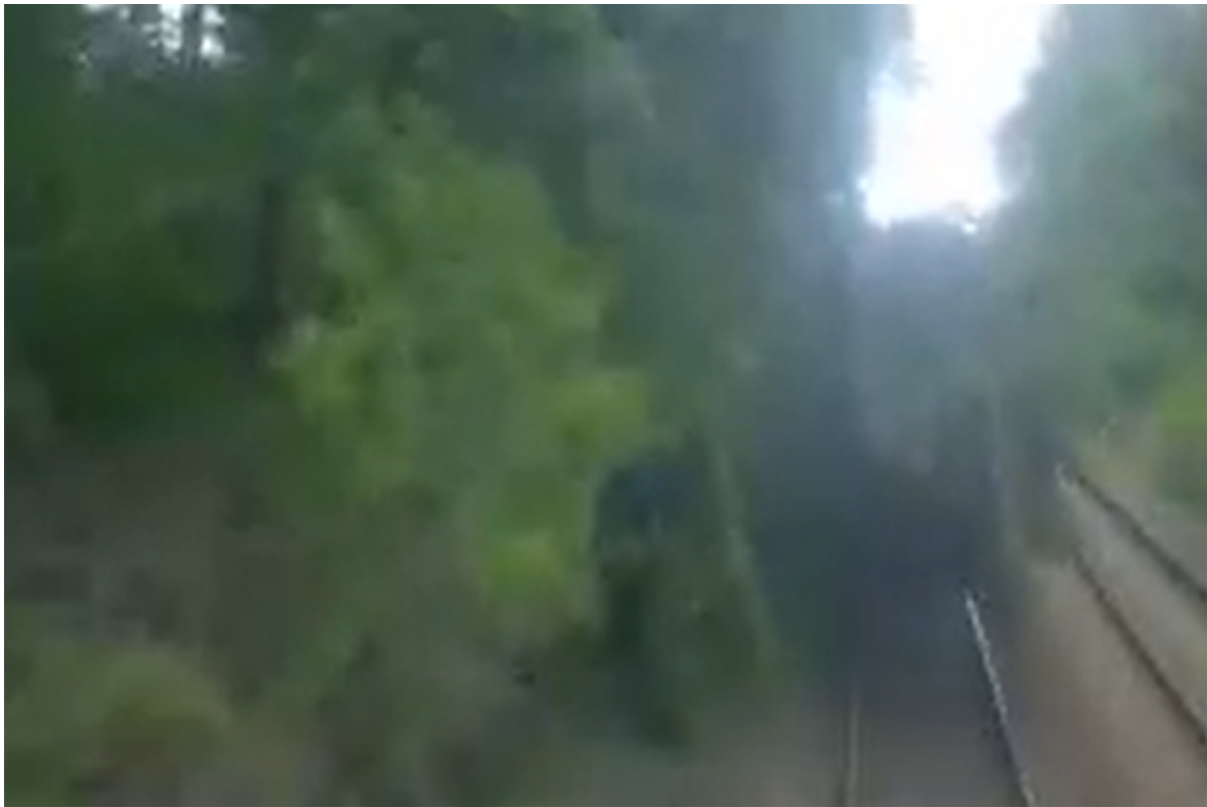
At around 16:47 hrs, train 2L71, the 16:39 hrs ScotRail service from Perth to Dundee, struck a fallen tree while travelling at 63 mph (101 km/h). The accident occurred near the village of Glencarse, on the section of line between Barnhill and Errol.

Image from the train's CCTV showing the fallen tree immediately before the accident

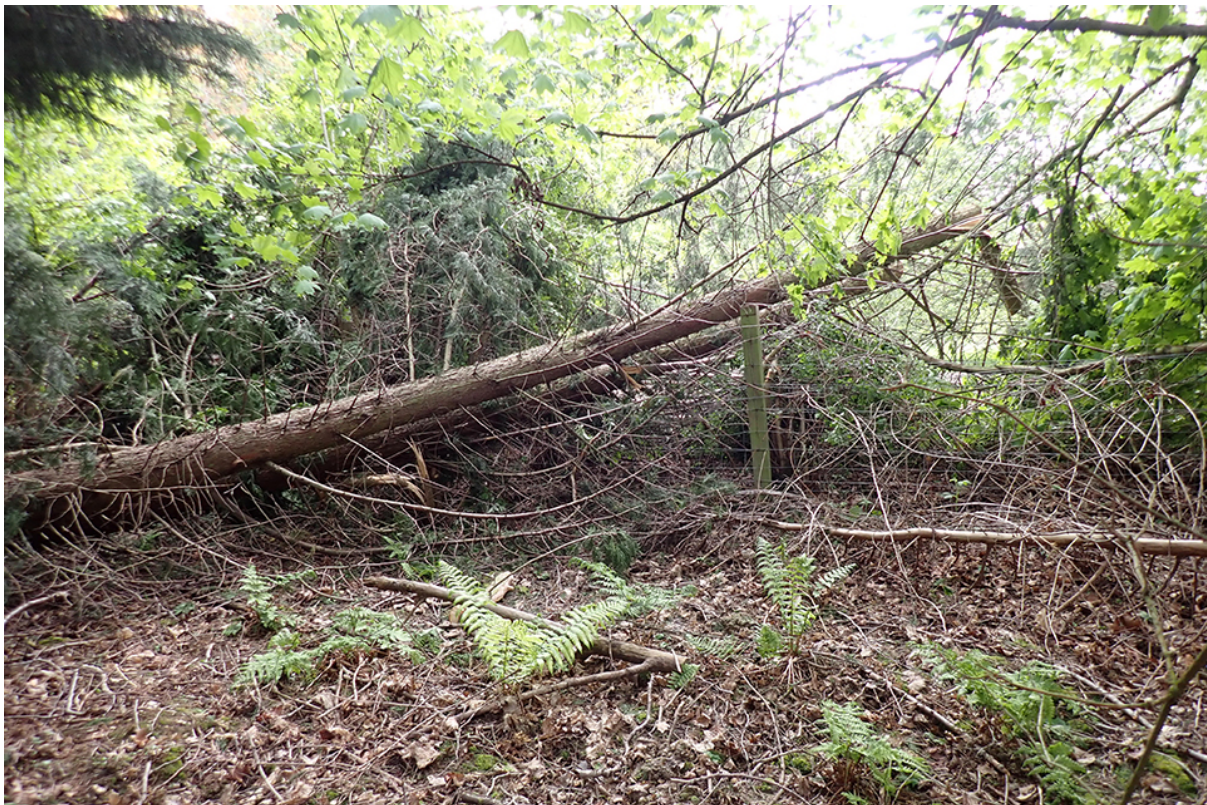
Examination of the remains of the tree, a Monterey Cypress, found that it had been growing from a base outside the railway boundary, about 11 metres from the nearest rail. The trunk of the tree had fallen some years before, and was mainly dead and rotten at the roots, but branches had grown up from the fallen trunk. These branches fell and obstructed the railway once their weight overpowered the restraining effect of the remains of the roots, and the trunk rotated as it lay on the ground. There was no evidence that the branches fell due to the direct effect of abnormal weather.

The remains of the fallen tree after the accident, viewed from outside the railway boundary fence, showing the branches which had grown from the fallen trunk and which eventually fell themselves

The base of the tree which fell was hidden from anyone on the railway side of the boundary fence by undergrowth. The portion of the tree that was visible above the fence would have appeared healthy, and it would have been very difficult for Network Rail staff to detect that it was at risk of falling, and it is not clear from the record of the inspection in September 2020 whether this particular tree was identified. Following the accident, Transport Scotland has instructed the company which operates the trunk road network on its behalf to inspect the area and do what is necessary to make the land safe, including the removal of any further trees that may be an issue.
