Collision between a locomotive and a passenger train at Grosmont, 21 September 2021

Summary of the accident

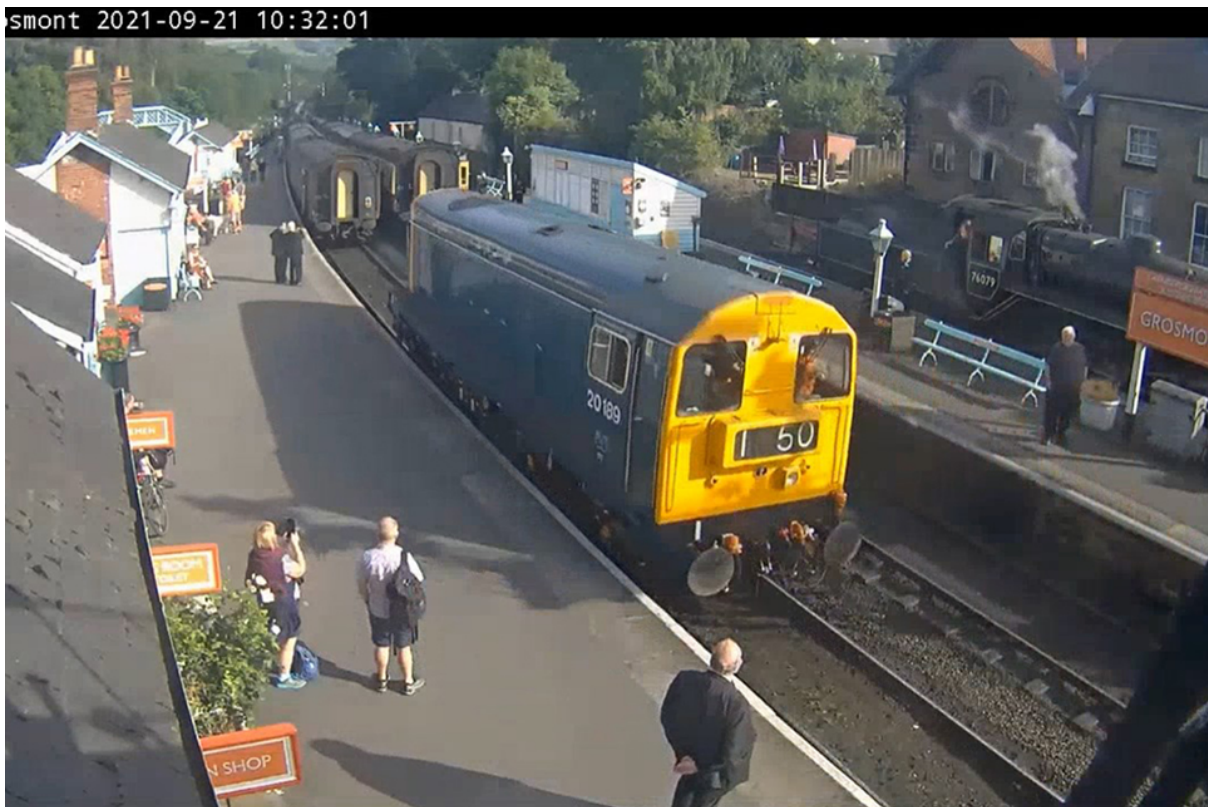
The locomotive entered platform two at about 10 mph (16 km/h) and was intended to stop in the section of unoccupied track behind the Whitby service. However, the locomotive collided with the rear of this train at about 5 mph (8 km/h).

The locomotive entering platform two, just before the collision (courtesy of the North Yorkshire Moors Railway)

The accident occurred because the locomotive was travelling too fast to be able to stop in the distance available when the stationary coaches ahead first came into the driver's view.

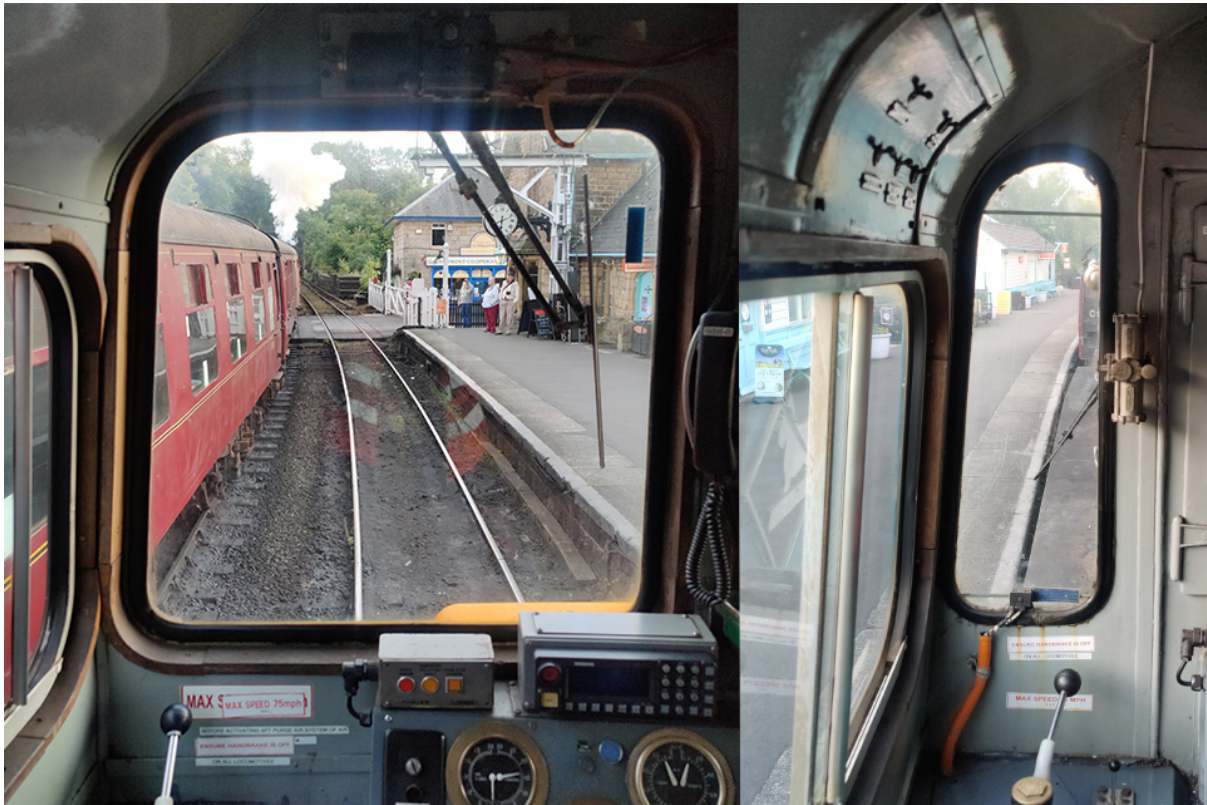
The class 20 locomotive, designed in the 1950s, is only fitted with a cab at one end. This means that a driver's visibility of the line ahead is much more restricted when the nose end is leading, with the driver having to look through a narrow window past the side of the locomotive, in a similar manner to a driver of a steam locomotive.

Driver view of the line ahead from cab-leading and cab-trailing driving positions

Following the accident, the driver of the train stated that, although he was aware of the train standing in platform two, he thought that it was further along the platform and that there was more space in which to bring his locomotive to a stop. It is also possible that the limited forward visibility compared to that from the class 25 and class 37 diesel locomotives, and the driver's unfamiliarity with driving this locomotive, affected his perception of the locomotive's speed and his decision making.

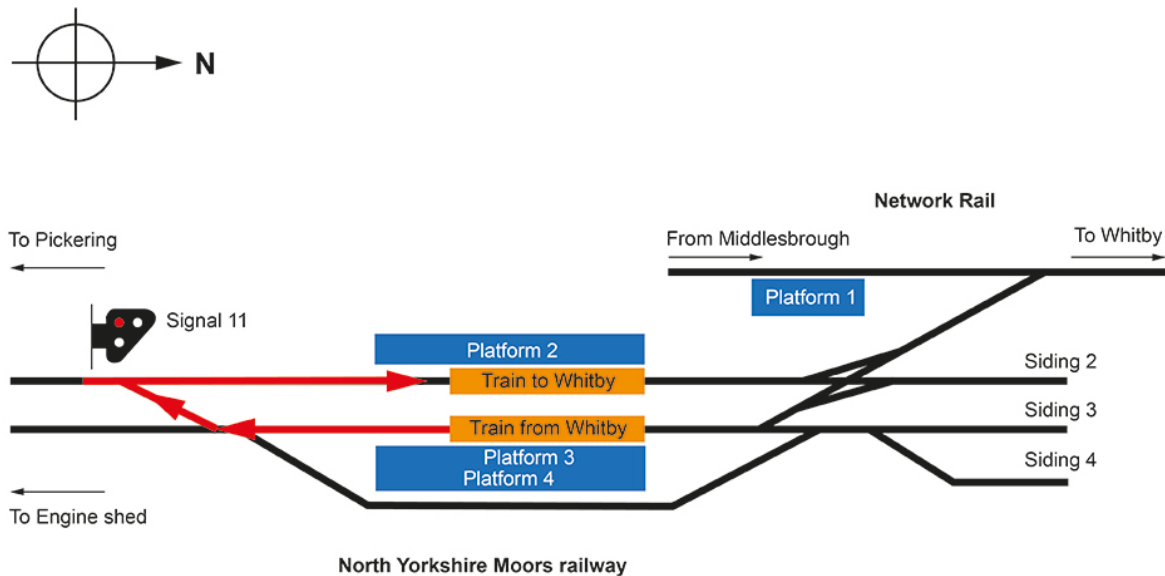
Details of the move resulting in the collision at Grosmont station

To carry out this move, the class 20 locomotive had to move forward over the crossover, behind signal 11, and then back through platform two. However, the move to siding two was blocked by the presence of the train waiting in platform two for departure to Whitby. The signaller and crew intended that the class 20 locomotive move from behind signal 11 into the free space in platform two, behind the Whitby-bound service. The locomotive would then wait there until the Whitby train departed, before moving to siding two.

The driver undertook the move from platform three to a position behind signal 11 with the locomotive's cab leading. He then changed driving desks and started the move back towards platform two, with the cab end trailing, once signal 11 had cleared. He accelerated the locomotive to around the 10mph (16 km/h) speed limit for the line. The initial part of this move was on straight track, with the driver's view of the line ahead limited by the body of the locomotive ahead of him. On approach to the platform, the line starts to curve to the right and the body of the locomotive further obscures the driver's view ahead. A reconstruction by RAIB of the approach and entry to the platform showed that the driver would only have been able to see the rear of the last coach of the train ahead when the front of the class 20 was approximately 16 metres from it.
