Rail Accident Investigation Branch

Rail Accident Report

**Derailment and fire involving a tanker train at
Llangennech, Carmarthenshire
26 August 2020**

Report 01/2022
January 2022

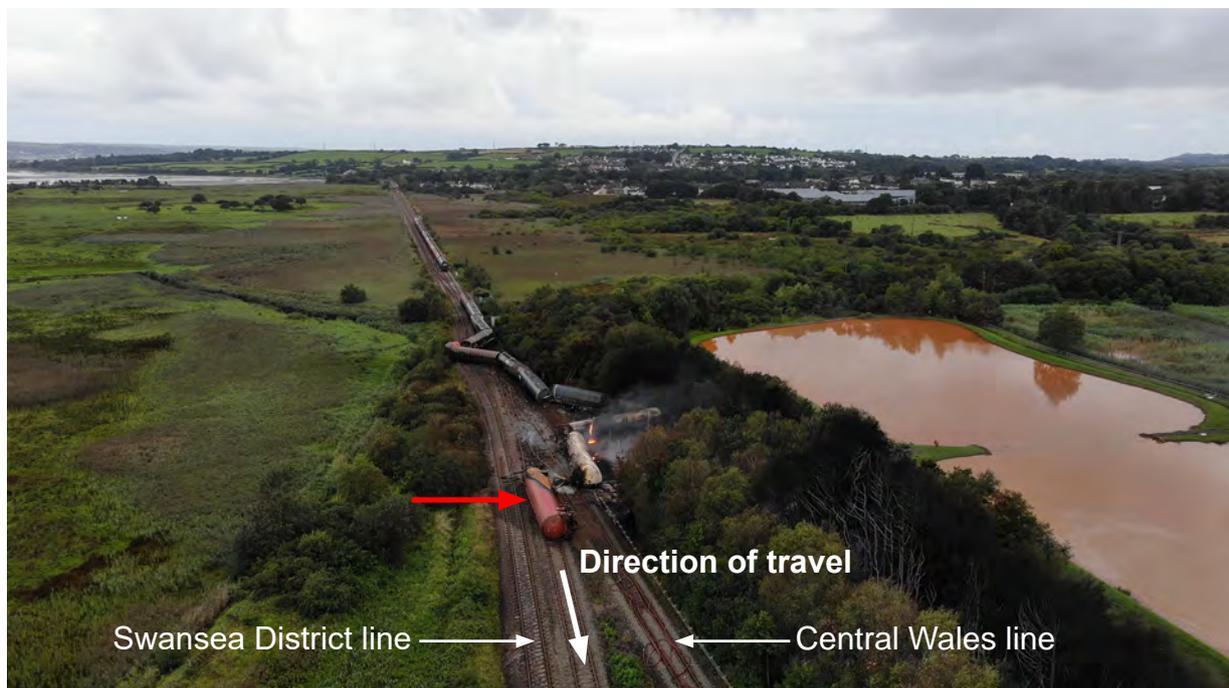
Figure 4: Image of the scene at Llangennech showing wagon GERS 89005 (red arrow). Please note the colour of the nearby water is not connected to the accident.

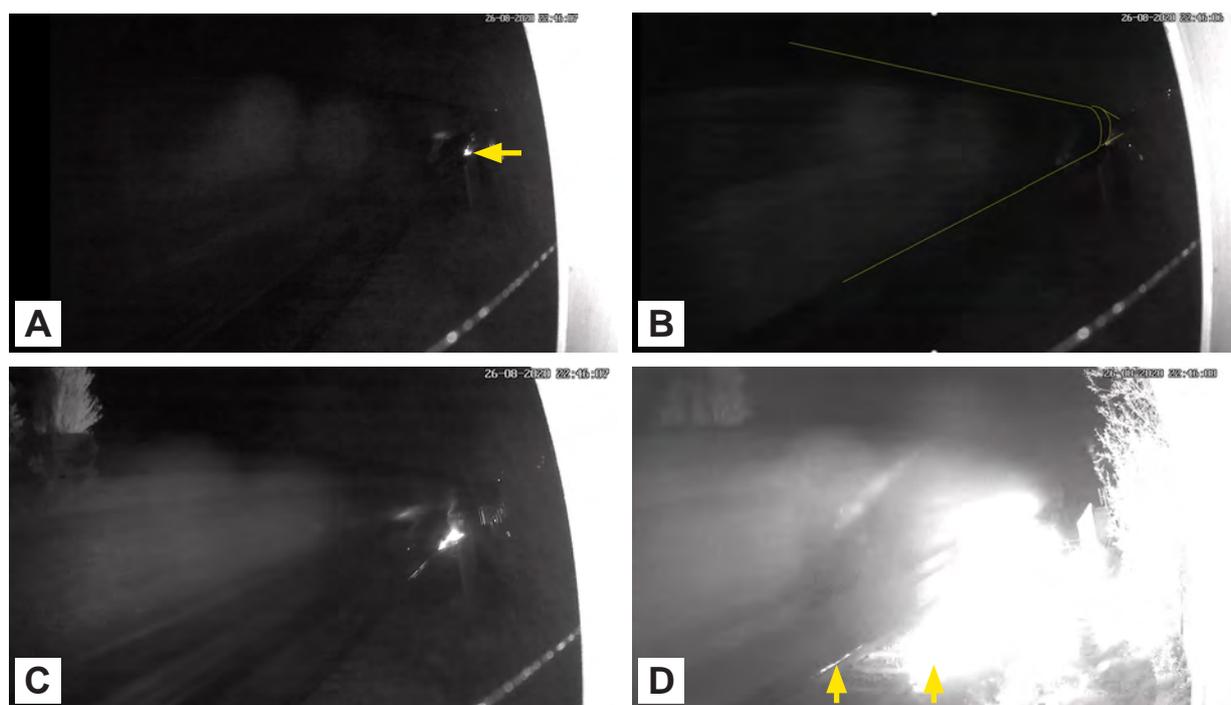
- 31 The train passed over Pen-y-bedd level crossing at 22:46 hrs. This crossing is approximately 11.5 miles (18 km) from Morlais Junction, 15 to 16 minutes running time at the speeds the train travelled at. CCTV footage from this level crossing shows that the front wheelset of wagon GERS 89005 was generating sparks when the train passed (figure 6). This can be an indication of a wheelset that is not rotating freely, or is completely locked.

Figure 6: CCTV images ((a) to (d)) showing train 6A11 and wagon GERS 89005 passing Pen-y-bedd AHBC showing sparks emanating from the left and right wheels on the front wheelset

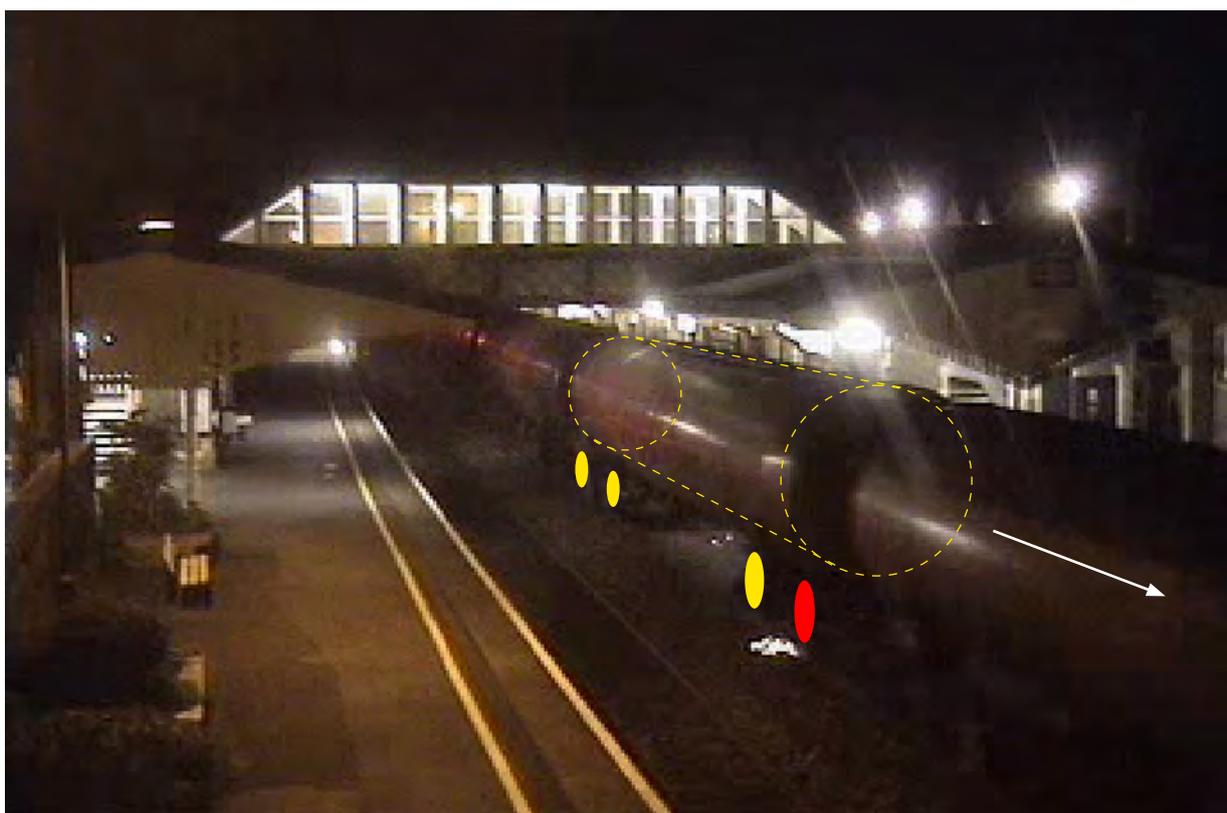
Figure 7: Station CCTV image showing train 6A11 passing through Llanelli station with sparks emanating from the front axle of wagon GERS 89005

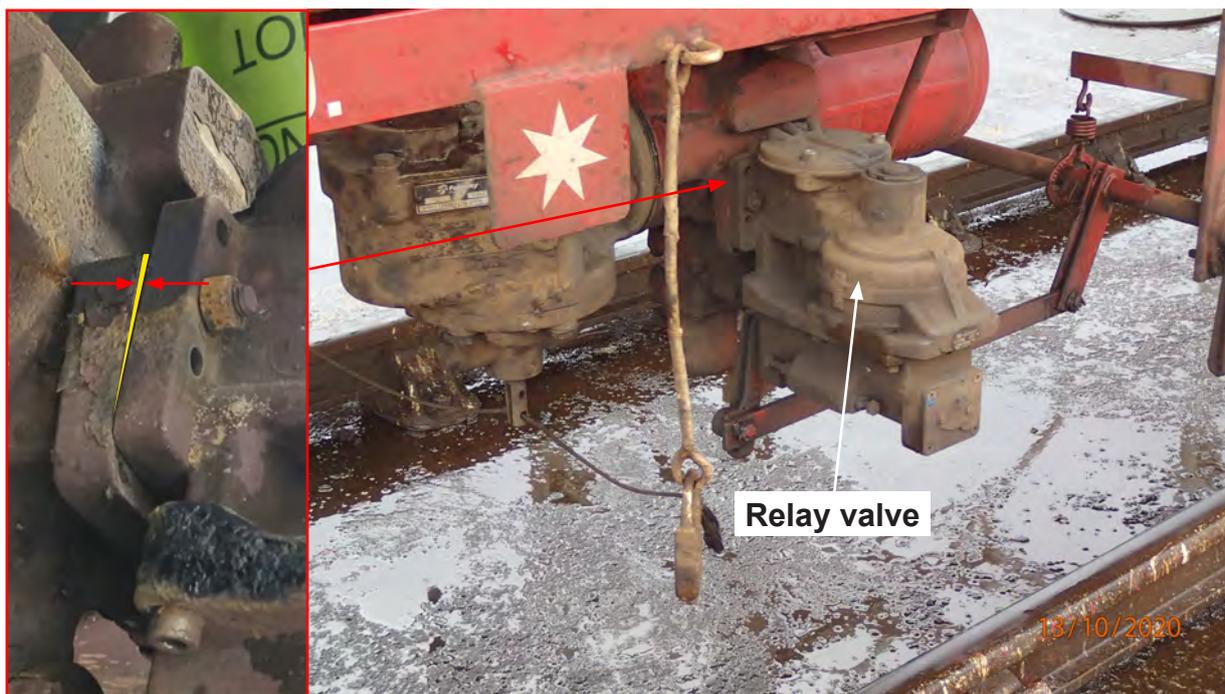
Figure 12: Image (main) showing the connection between the pipe bracket and the relay on a GF4-SS1 brake group with inset image showing the 1-2 mm gap (yellow segment) found between the pipe bracket and the relay valve on wagon GERS 89005

63 The derailment resulted in the brake group becoming detached from the wagon underframe, and it was also affected by the heat from the fire. On examination, the relay valve was observed to be loose on the pipe bracket. The nuts holding the relay valve in place were loose, and no washers were present. The mating faces of the relay valve and the pipe bracket had become separated by 1 to 2 mm. The mounting studs, which are screwed into threaded holes in the pipe bracket, were only ‘finger tight’ (figure 12).

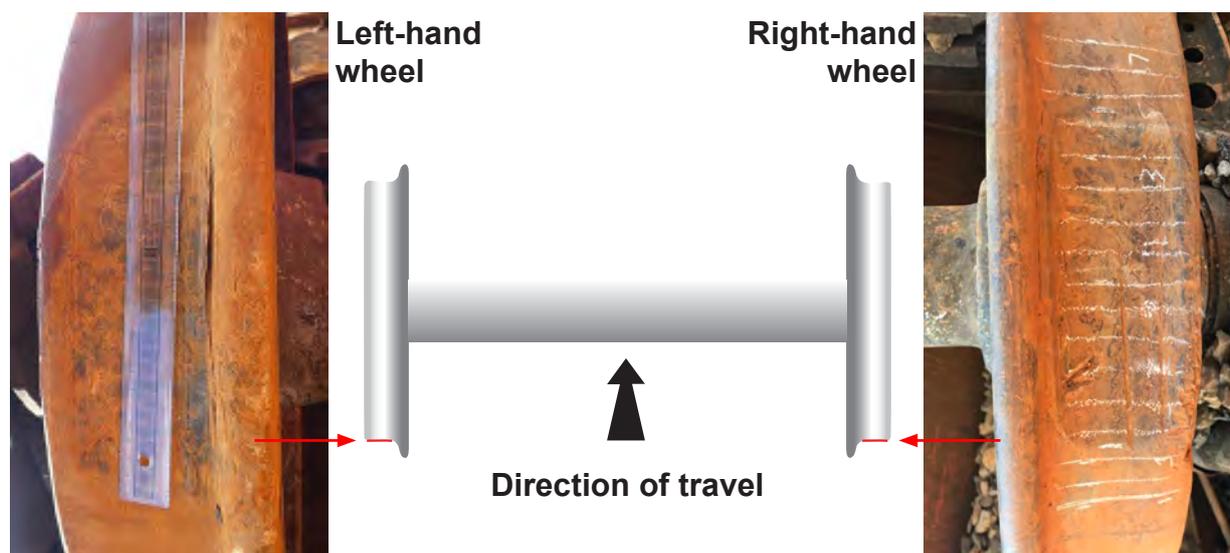
54 After the accident, the leading wheelset of wagon GERS 89005 was found to have developed a substantial flat area on the wheel treads and, as a consequence, there was a 'false flange' on the outside of the tread of each wheel, approximately 230 mm long and up to 15 mm deep (figures 13 and 14). The evidence from CCTV from Pen-y-bedd crossing and Llanelli station and the data from Pembrey HABD (see paragraphs 135 to 143) indicates that the leading wheelset was not rotating, and the other three wheelsets on this wagon were dragging (not rotating freely) when the train passed those recording devices. Score and burn marks were found on the railhead between Llangennech station and Morlais Junction. Railhead marks were also visible over the three miles (4.8 km) from Llandeilo Junction through to Llangennech level crossing where the marks appeared to change in shape, suggesting that wheels may have also been intermittently sliding and releasing.

Figure 13: Images showing the profile of the wheel and the damage (red line) that occurred to the left and right wheels on the leading axle of wagon GERS 89005

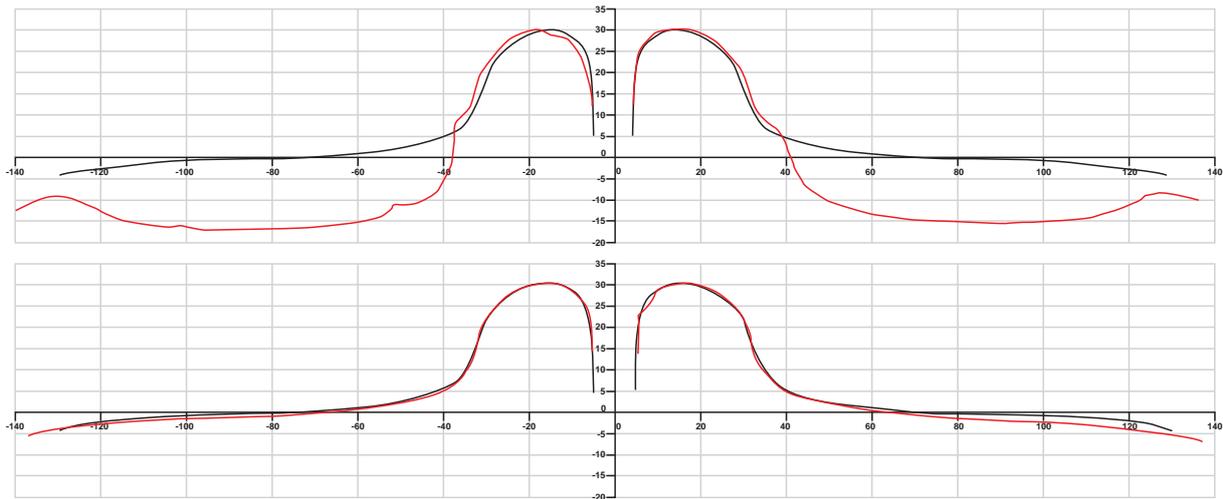
Figure 14: Diagrams showing the left (LHS) and right (RHS) wheel profiles (shown as black line) on the front axle (top) and rear axles (bottom) of wagon GERS 89005. The front axle (also shown as axle 15 on the HABD data on figure 29) also shows the depth (shown as a red line) of wear on the tread of the locked wheels. The treads on the rear axles (also shown as axles 16 to 18 on figure 29) show a lower depth of wear as these wheels were not locked although the brakes were dragging

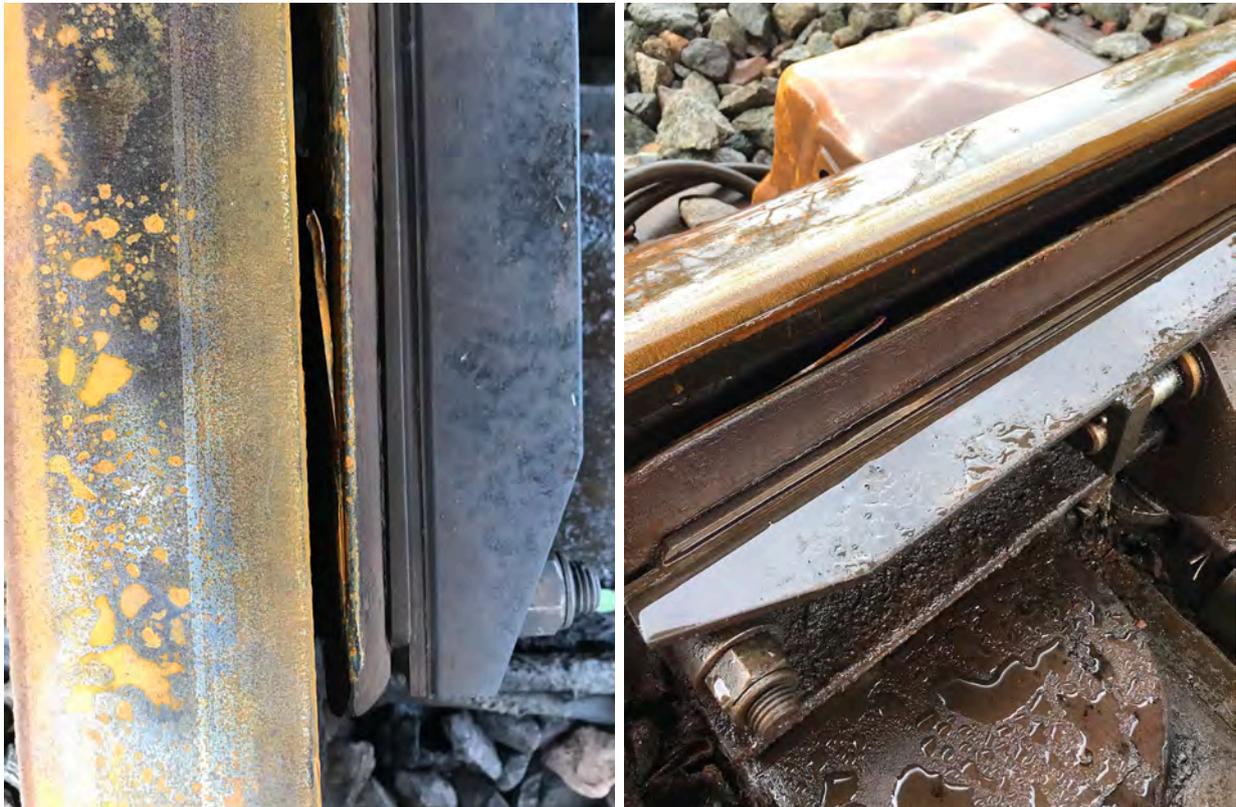
- 56 The point of derailment was identified from track marks and damage as being near the open end (the toe) of the switch rails of points 997A, which form part of a trailing crossover at Morlais Junction. As the third wagon traversed the trailing points, the false flange on the right-hand leading wheel rode along the inner face of the stock rail and caused the rail to rotate outwards towards the six-foot. The right-hand wheel then travelled along the web of the rail until it reached a fishplate, at which point the left-hand wheel climbed over the left-hand rail (figures 15 to 17).

Figure 17: Damage to the switch tip of points 997A

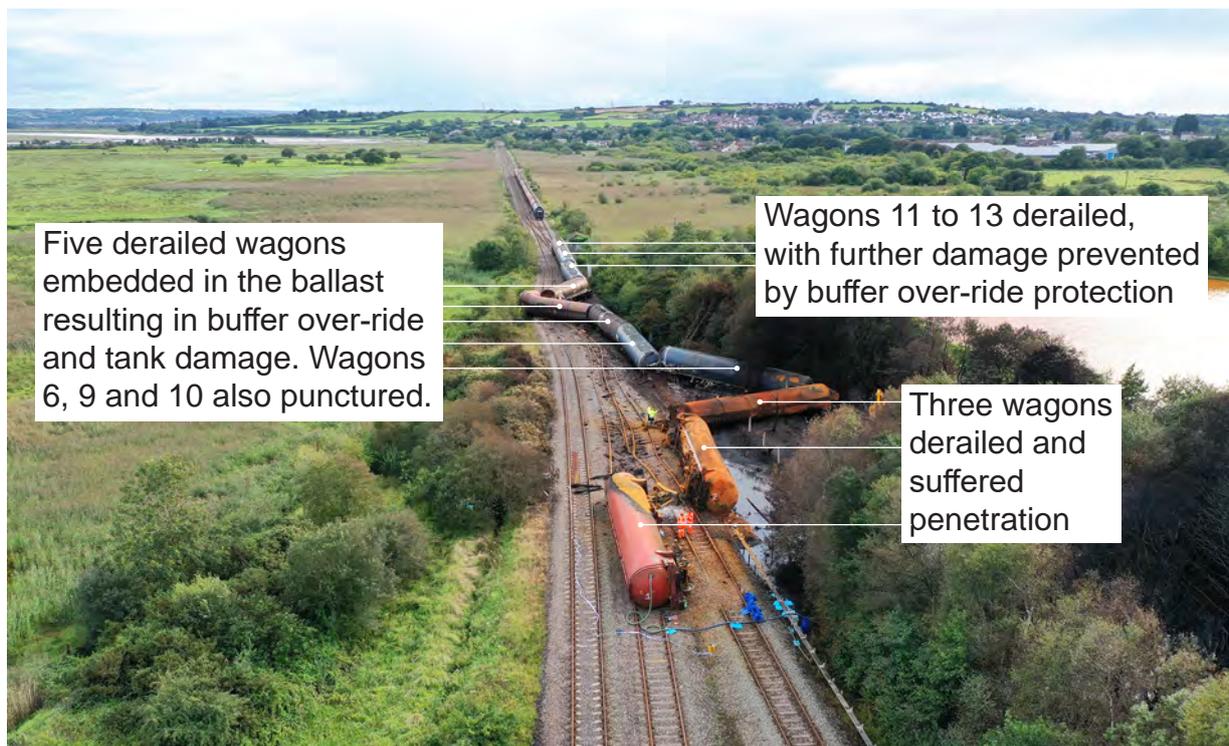
Five derailed wagons embedded in the ballast resulting in buffer over-ride and tank damage. Wagons 6, 9 and 10 also punctured.

Wagons 11 to 13 derailed, with further damage prevented by buffer over-ride protection

Figure 18: Aerial image of the accident site looking towards the rear of train 6A11(image courtesy of South Wales Fire and Rescue)

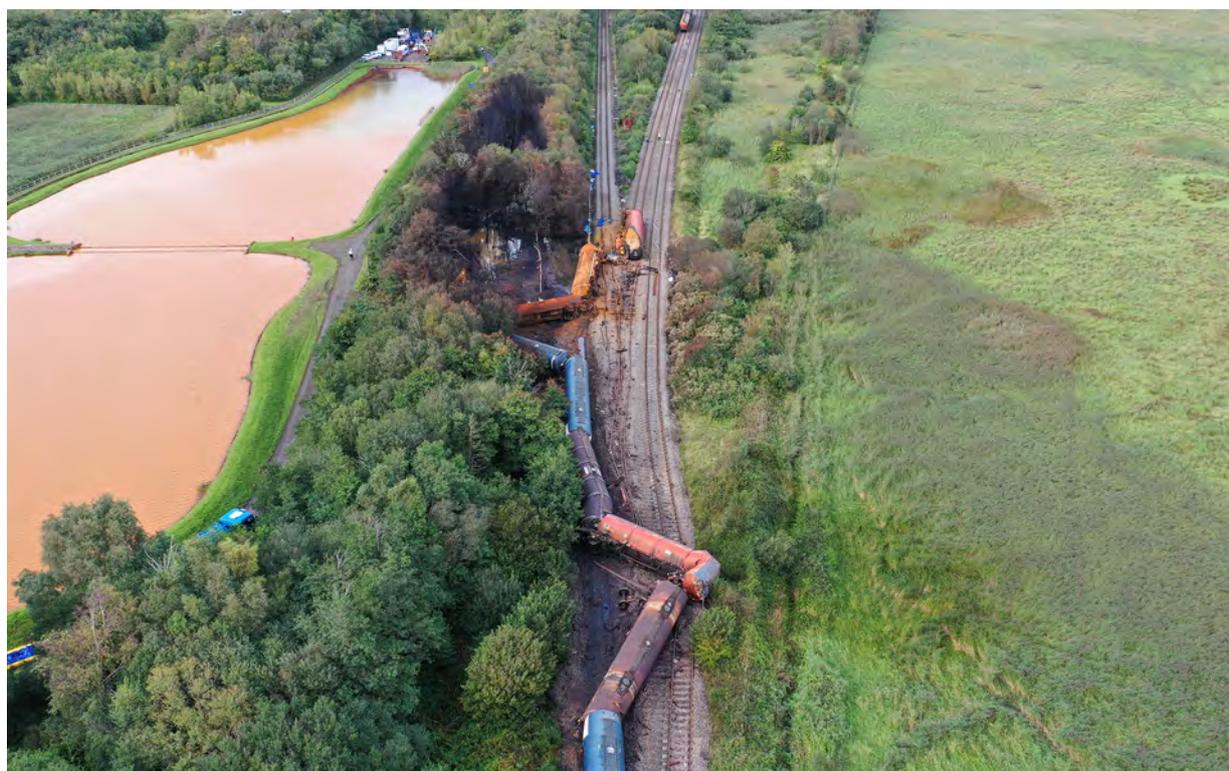
Figure 19: Aerial image of the accident site looking towards the front of train 6A11(image courtesy of South Wales Fire and Rescue)

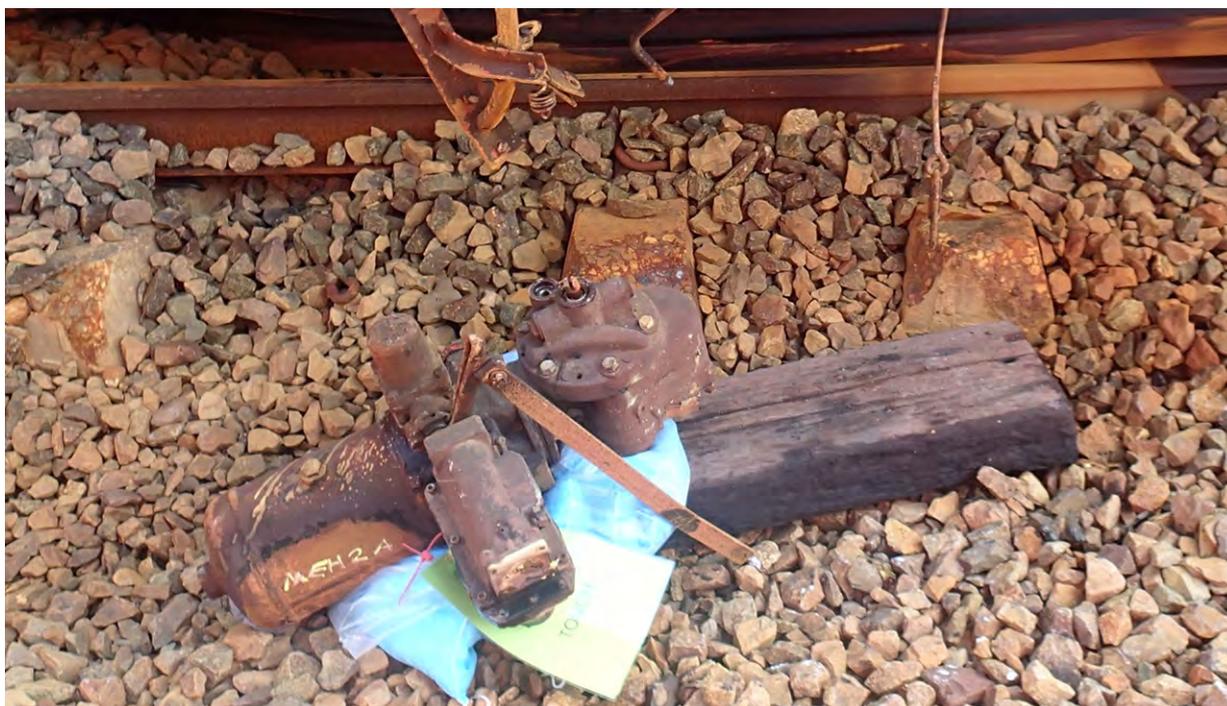
Figure 20: The brake group from Wagon GERS 89005 as found after the accident

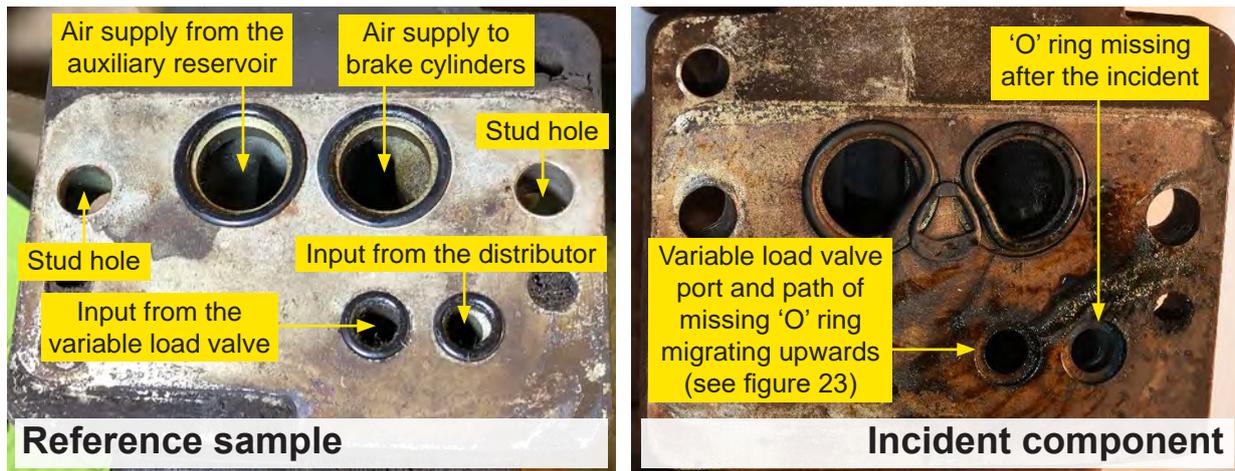
64 RAIB’s examination of the relay valve and pipe bracket mating faces found that one of the four ‘O’ rings which seal the air passages between the relay valve and the pipe bracket was missing (figures 21 to 23). The missing ‘O’ ring, one of the two smaller ‘O’ rings, was from the passage carrying the distributor output to the relay valve. It is not possible to be certain when this ‘O’ ring was lost. RAIB carried out reconstruction tests on the brake group (see paragraph 70), which suggested two possible scenarios. These are:

Figure 21: Image showing the correct 'O' ring locations of a reference sample (GERS 89014) in comparison to the incident wagon (GERS 89005)

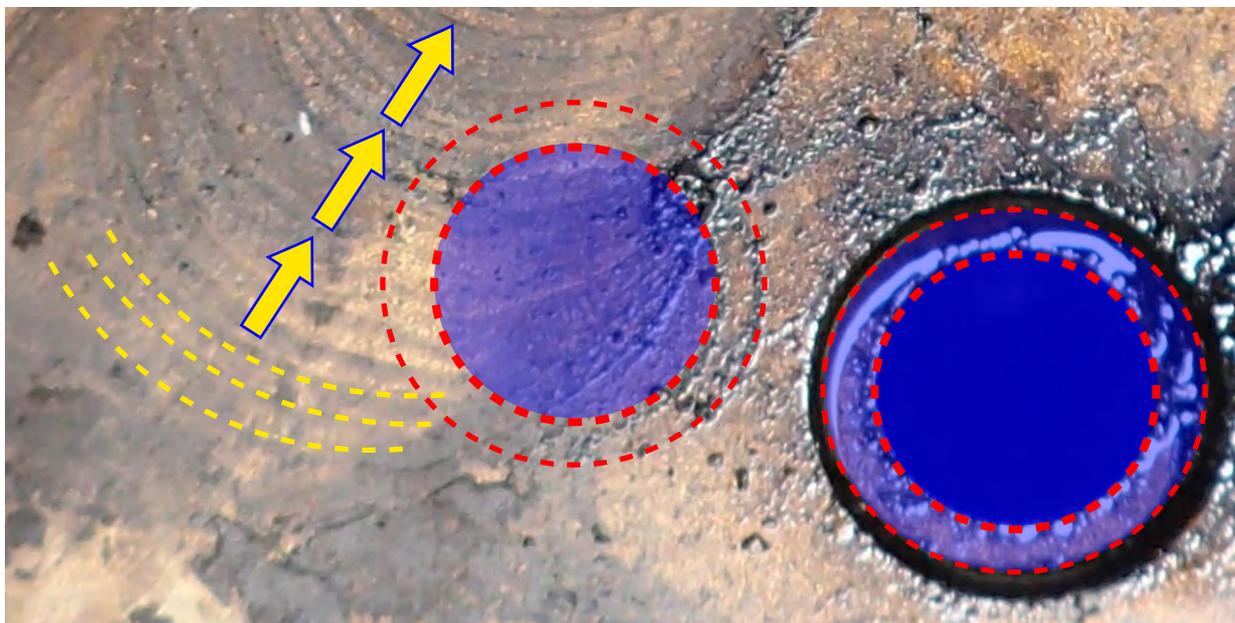
- 65 The other smaller 'O' ring, which seals the connection between the load sensing device and the relay valve, had migrated out of its recessed port (figures 22 and 23). Such migration would only have been possible if the relay valve was loose on the pipe bracket. The design of the two-stud mounting on the side of the pipe bracket is such that, if the relay valve becomes loose, a wedge-shaped gap develops between the mating faces, with a larger gap at the top than at the bottom. Contact trace marks found on the mating surfaces show the path the 'O' ring had taken as it migrated out of its recess. The 'O' ring had then become effectively 'sandwiched' between the two mating faces (figures 22 to 26).

Figure 22: Microscopic image showing the original location and a surface imprint on the mating face of the relay valve (red dotted lines) of what is believed to be an undamaged load sensing device 'O' ring. Also shown to the left (yellow dotted lines and arrows) are surface imprints of the same 'O' ring as it migrated up towards the auxiliary reservoir and brake cylinder ports (see figure 23)

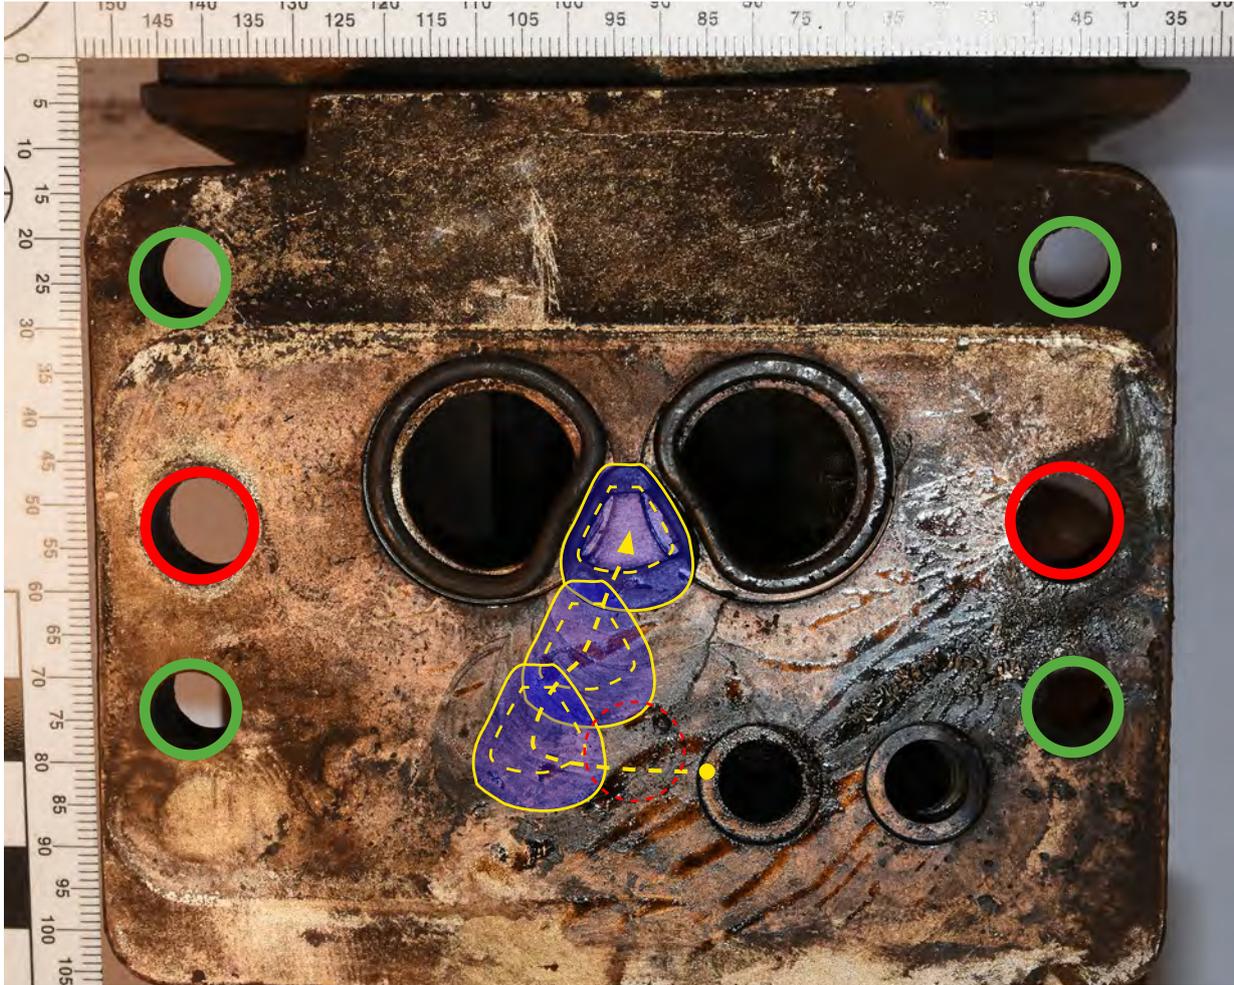
Figure 23: The relay valve mating face and what is believed to be the path taken by the variable load sensing device 'O' ring (yellow dashed line). Pre-1994 design incorporated four fixing points (green circles) and later design change to two fixing points (red circles)

- 66 As the wagon travelled, its motion led to movement of the mating faces relative to each other which caused the 'O' ring to migrate upwards. As the 'O' ring moved, it became flattened and deformed (figures 21 to 23), and came to rest wedged between the two larger 'O' rings which seal, respectively, the input from the auxiliary reservoir to the relay valve, and the output from the relay valve to the brake cylinders.
- 67 The three 'O' rings were found in the position shown in figure 23 when the assembly was dismantled after the accident. It was apparent that after the migrated small 'O' ring made contact with the two larger 'O' rings, all three became distorted. This resulted in the creation of a route for air to flow directly between the input and output ports of the relay valve, leading to uncommanded air pressure developing in the brake actuators.

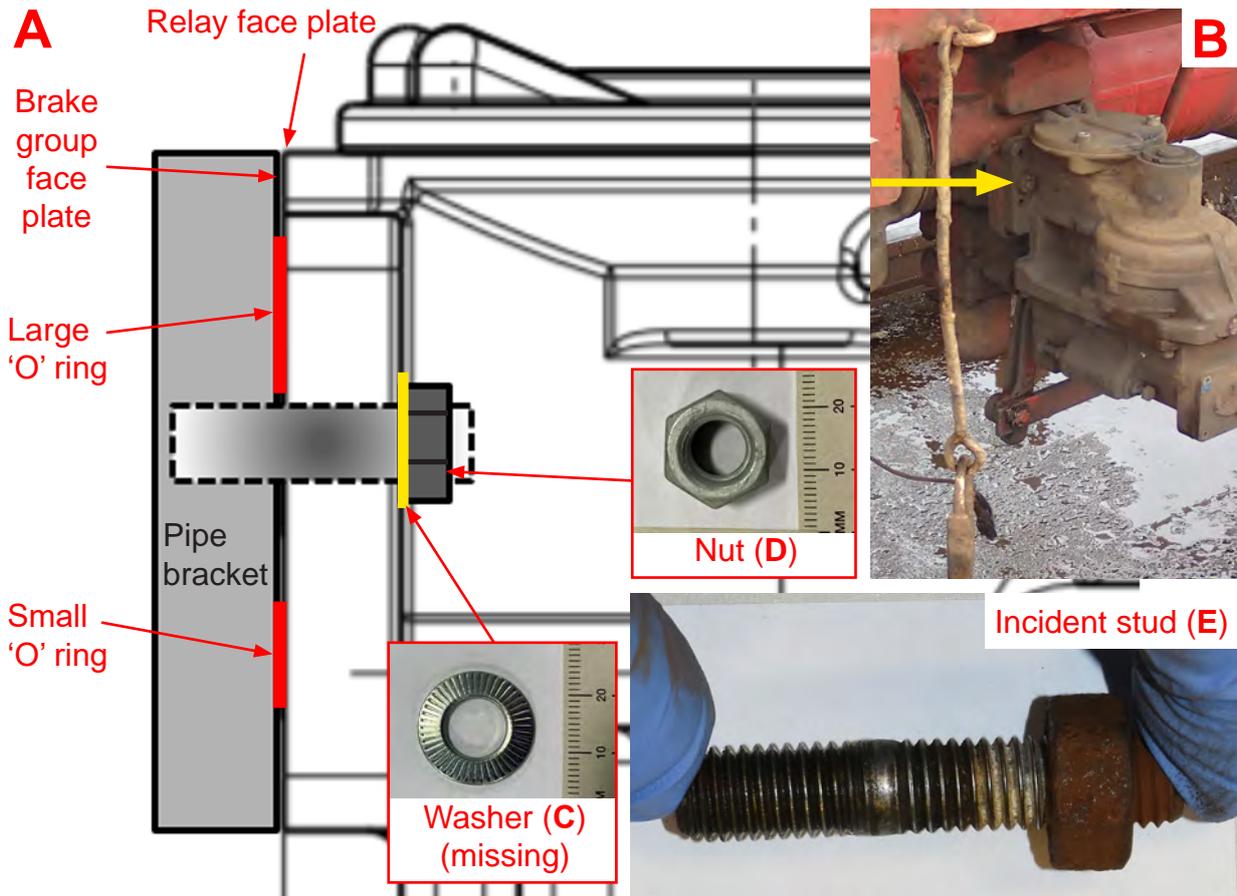
- If the two securing nuts are loose, the relay valve body can pivot on the studs, because of the clearance between the studs and the holes in the relay valve body. The tests confirmed that a loose relay valve can move with sufficient vigour to initiate a partial brake application, and to damage the internal surface of the mounting holes as found after the accident, thus providing an indication that the relay valve had pivoted on the studs (figure 24).

- The movement of the load sensing device port 'O' ring was the result of the pivoting action of the loose relay valve (figure 24). Reconstruction tests, in which the loose relay valve was manually moved to simulate the movement of the wagon, found that in this situation the smaller 'O' rings migrated out of their ports and also suffered distortion and damage.

Figure 24: Diagram (A) showing the position of the stud, nut and missing washer with inset image (B) showing the location of the mating faceplates. A washer (C), and nut (D) compared to one of two incident studs (E) attached (through corrosion) to the nut.

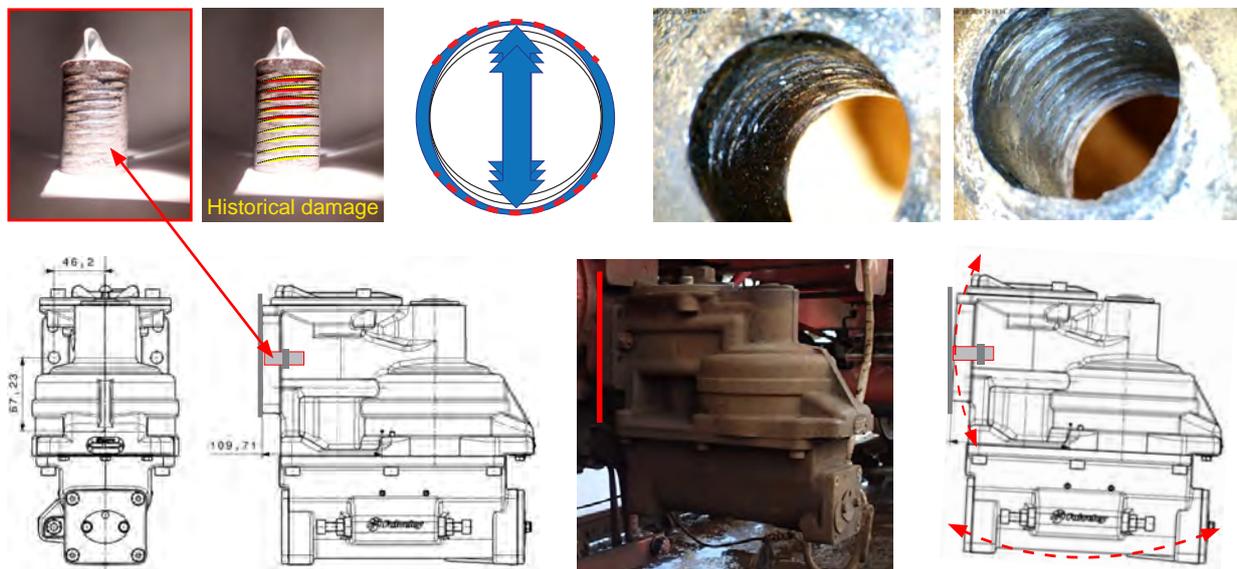
Figure 25: Images (top right and middle) showing the damaged surfaces of the internal bores of the mounting holes of the relay valve (bottom image and diagrams) as a result of the relay valve being loose and pivoting on the studs of the brake group. The inset image (top left) shows the castings taken from the bores for analysis of the marks which confirm that the relay was loose.

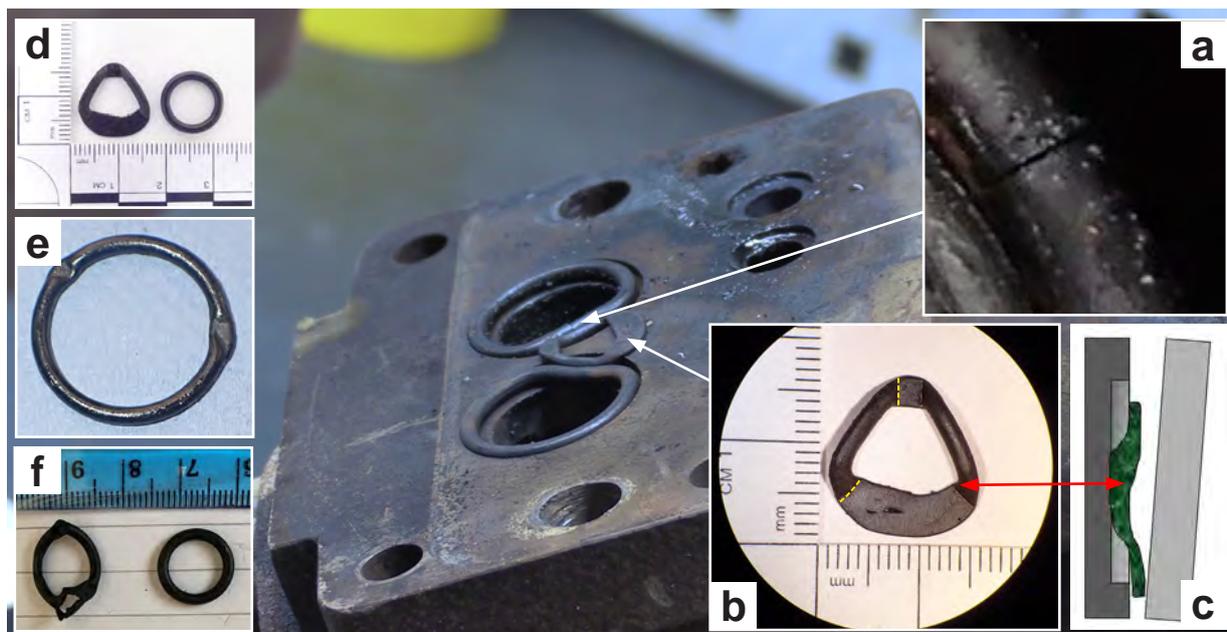
- The brake cylinder port 'O' ring had been deformed and had fractured. Analysis of the fracture surface showed this was not a deliberate cut, but was a fracture which may have been caused before or during the accident (figure 26).

- If a relay valve is loose such that the mating faces are about 0.5 mm apart, surface contamination, if present, can sometimes prevent the air pressure (4.3 to 5.0 bar) from exhausting to atmosphere, with no sound of escaping air being heard. During the tests, as the relay valve pivoted, brake pipe pressures were seen to fluctuate between 4.96 and 4.73 bar, and brake cylinder pressures fluctuated between 0.17 and 0.83 bar (figure 26).

Figure 26: Central image shows the as found location of the small load sensing device 'O' ring lodged between the auxiliary reservoir port and brake cylinder port with top right inset image (a) showing the fracture to the brake cylinder 'O' ring and bottom right images showing the damage and side view of the small 'O' ring (b) and (c). The top left-hand image (d) shows the damaged 'O' ring compared to a new reference sample. Images (e) and (f) show new reference sample 'O' rings used in reconstruction tests which showed similar damage after the mating faces of the relay valve and brake group became loose.

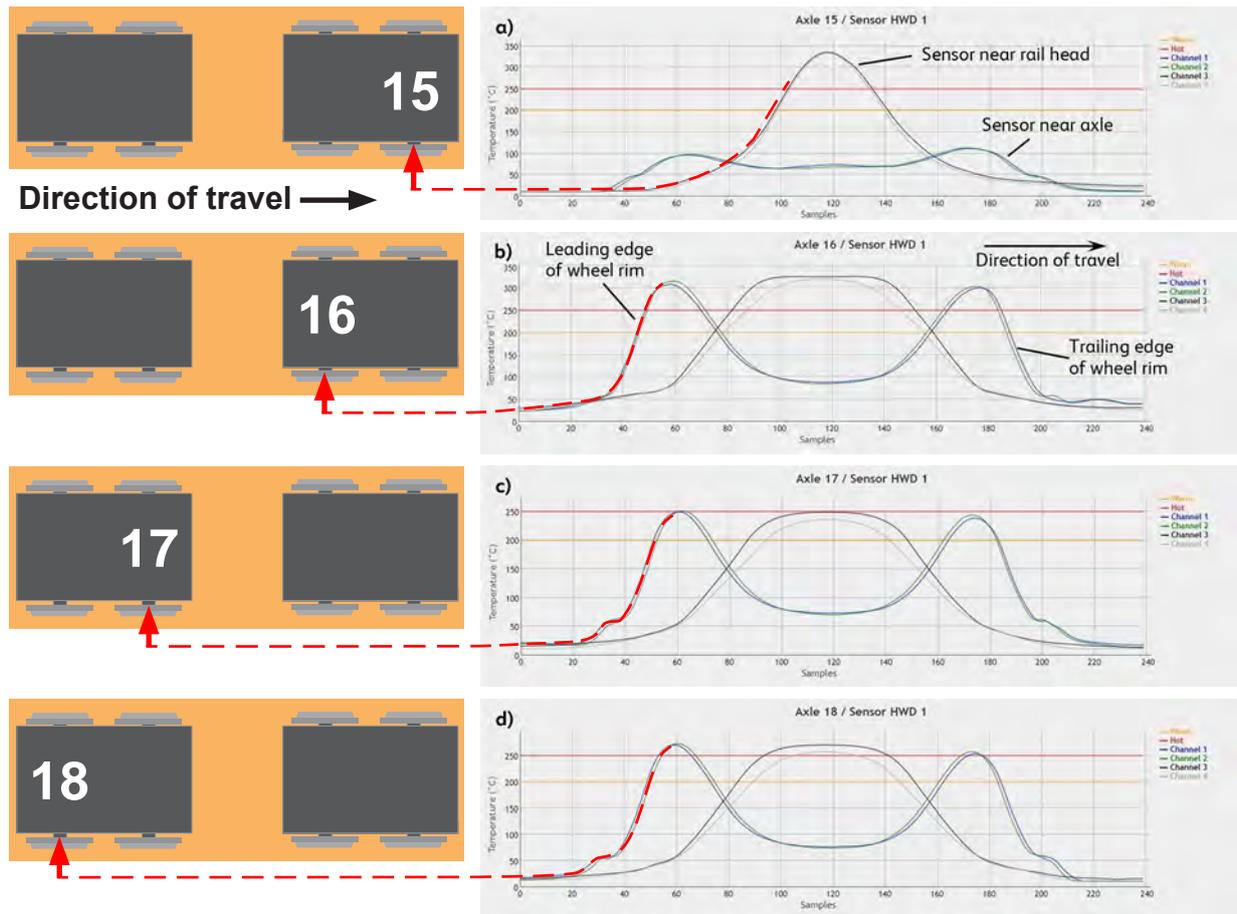
Figure 30: Recorded temperature curves from Pembrey HABD for train 6A11 on 26 August 2020, for the third wagon (axles 15 to 18). The curves for axle 15 (leading) are characteristic of a locked axle, while the curves for the other axles (16 to 18) show evidence of dragging brakes, in that high temperatures are recorded for the whole wheel, not just the tread (graphs courtesy of Network Rail)

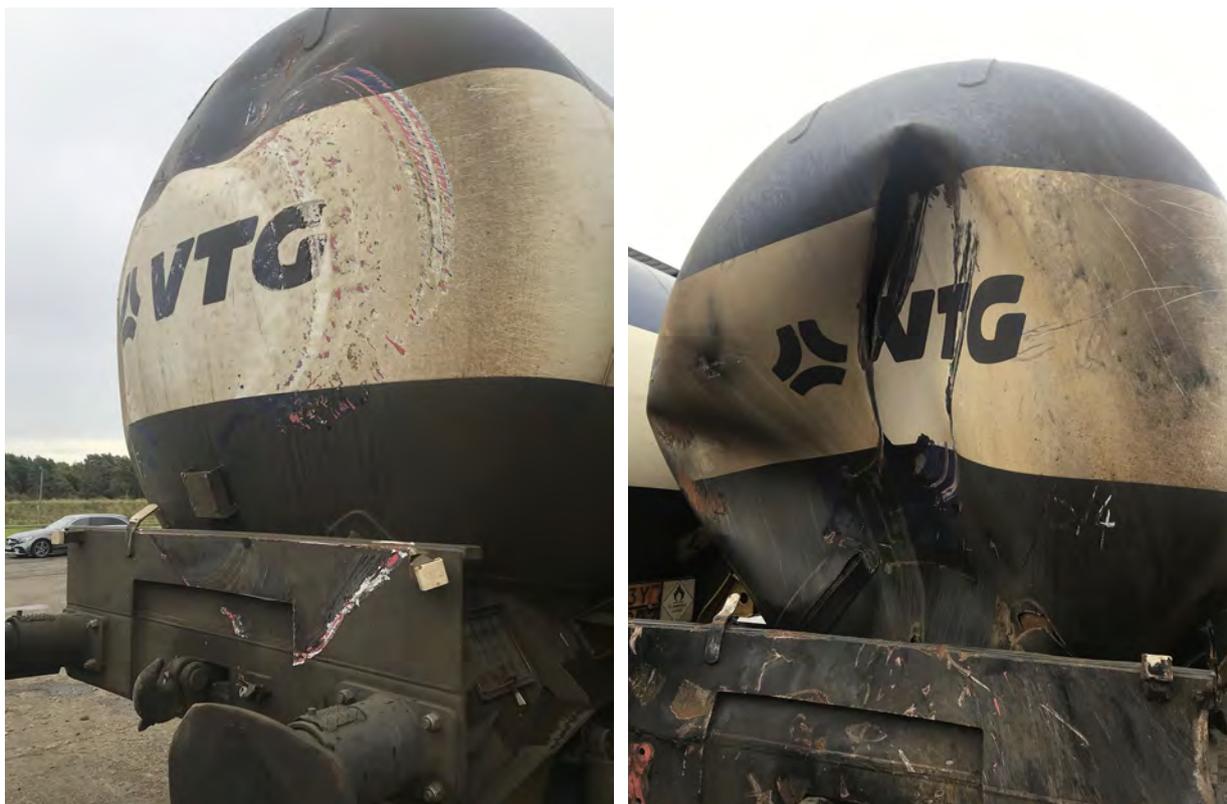
- 189 It was clear that the protective measures designed to reduce the likelihood of the tanks being punctured proved to be ineffective for those wagons subject to the greatest lateral and vertical movements. However, it is considered likely that these measures did provide protection to the tanks towards the middle and rear of the train (figure 31).

Figure 31: (left) VTG wagon (incident wagon 7) with raised buffer override protection beams which mitigated against further damage occurring and (right) wagon (incident wagon 6) that derailed, showing impact damage at high level where override protection could not prevent override and puncturing.

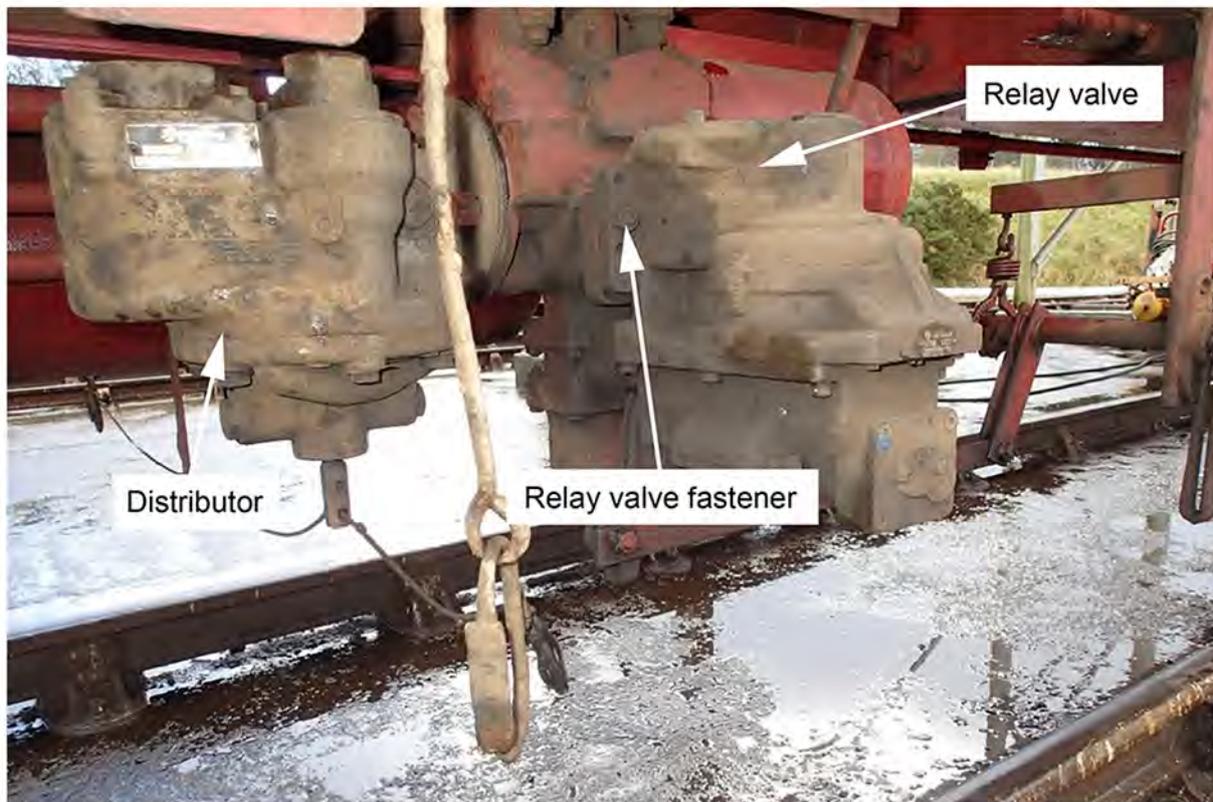
Examination of the brake group on the third wagon (TEA wagon GERS89005) found that the relay valve was loose on the pipe bracket. A sealing ring from one of the ports in the mating face had migrated to a position where it lodged between two other ports, distorted the sealing rings of those ports, and probably created a route for air to pass directly from the auxiliary reservoir to the wagon brake cylinder. This would have had the effect of applying the brakes on the wagon, producing the result described above.

Brake group on TEA wagon
