# Rail Accident Investigation: Interim Report

**Collision between passenger trains at Salisbury  
Tunnel Junction  
31 October 2021**

Report IR1/2022  
February 2022

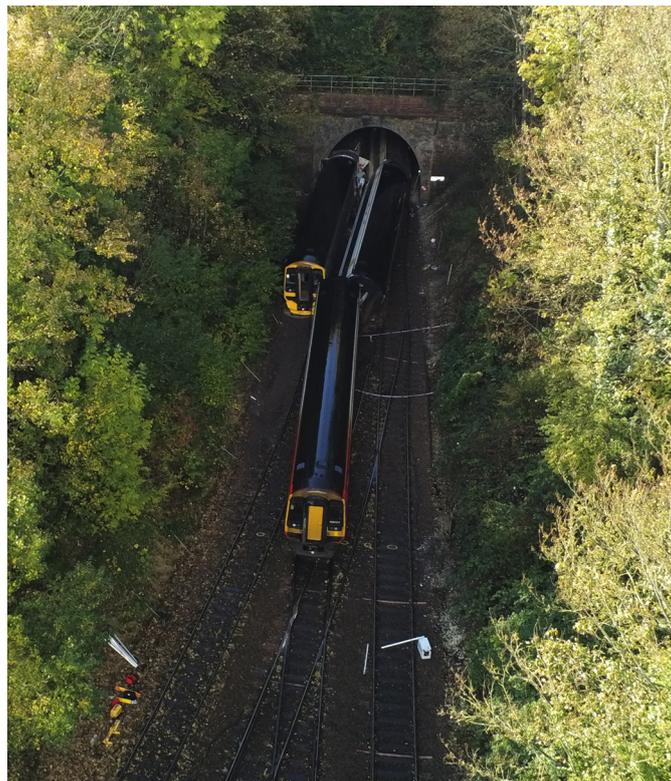
- 1 At around 18:43 hrs on 31 October 2021, train reporting number 1L53, the 17:20 hrs South Western Railway passenger service from London Waterloo to Honiton, collided with the side of train 1F30, the 17:08 hrs Great Western Railway passenger service from Portsmouth Harbour to Bristol Temple Meads. The collision took place at Salisbury Tunnel Junction, which is on the immediate approach to Fisherton tunnel, near Salisbury in Wiltshire.
- 2 The impact of the collision caused the front two coaches of train 1L53 and the rear two coaches of train 1F30 to derail. Both trains continued some distance into Fisherton tunnel following the collision, before they came to a stop. Thirteen passengers and one member of railway staff required treatment in hospital as a result of the accident, which also caused significant damage to the trains and railway infrastructure involved.

*Figure 1: Aerial view of the trains involved once they came to a stand following the collision, showing the junction and tunnel mouth*

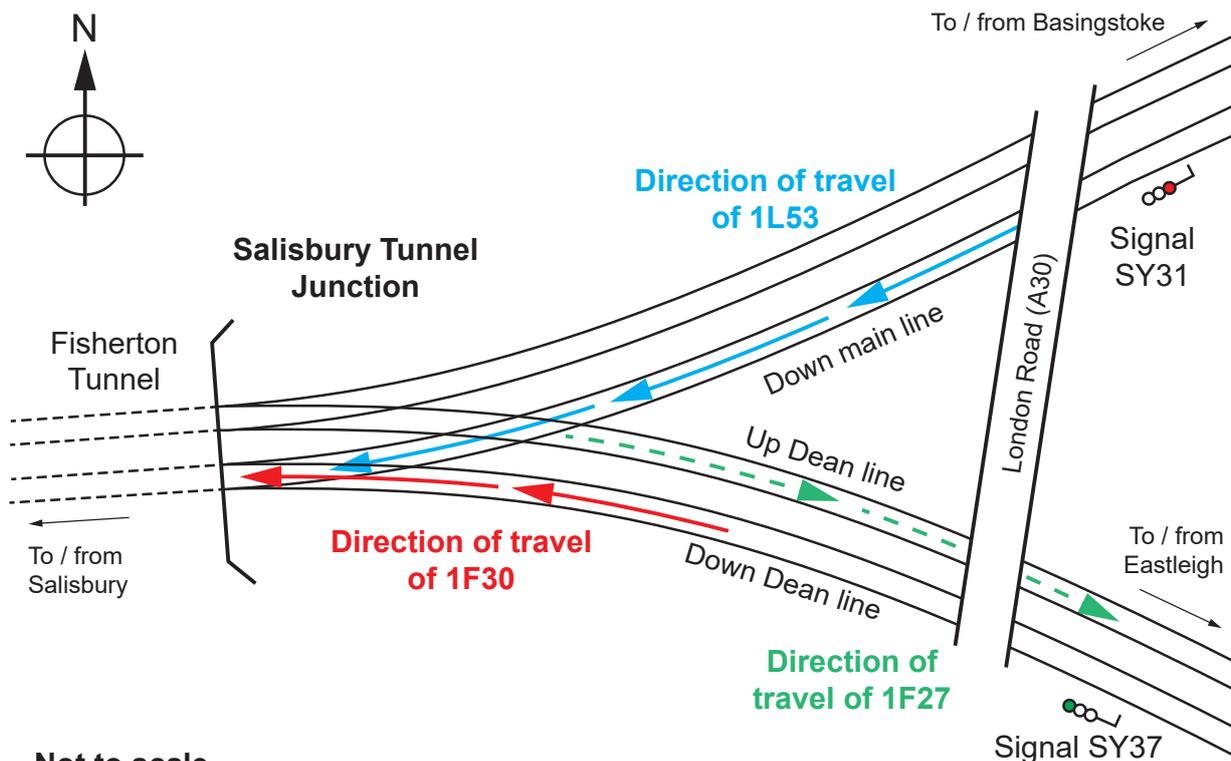
Figure 3: Diagram of location showing the approach of the trains involved in the collision

- 14 Signalling in the area is controlled from a signal box at Salisbury station. Signal SY31 protects the junction for trains approaching on the down main line. This is a three-aspect colour light signal, located around 191 metres from the point where the collision occurred. Before reaching signal SY31, trains approaching the junction on the down main line pass signal SY29R and signal SY29, which are respectively 3,314 metres and 978 metres from the point of collision.

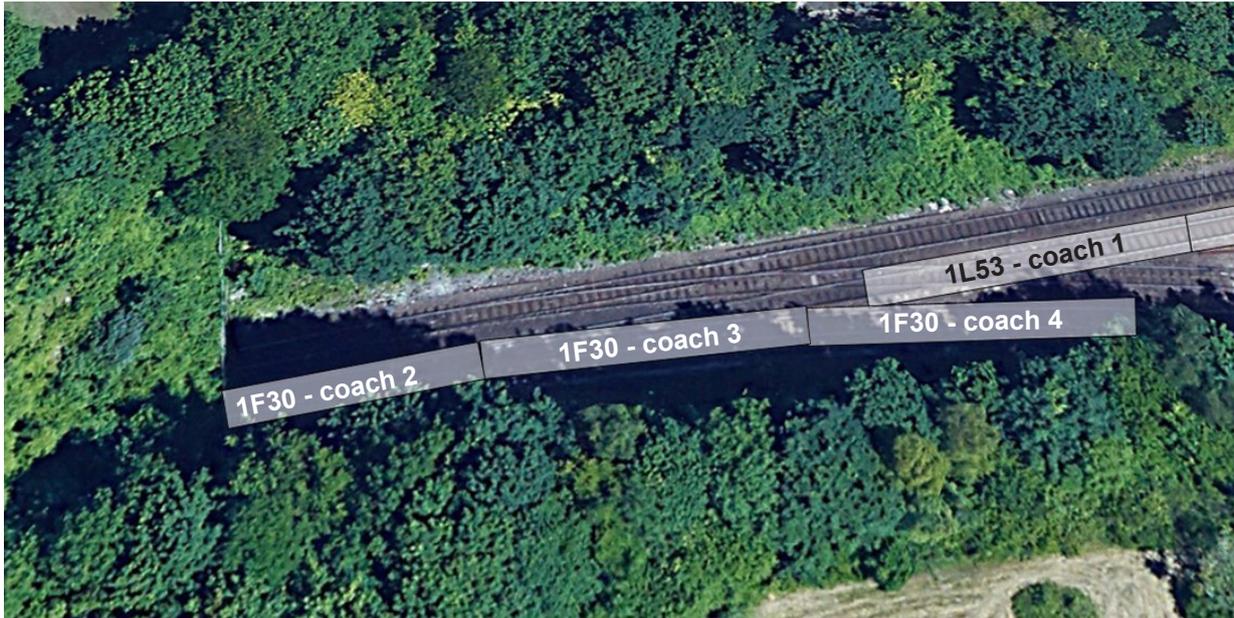
- 25 As a result of the collision, the coupling between the two DMUs which formed train 1F30 parted, and the leading two coaches, which were otherwise undamaged, came to a stop as their brakes applied automatically. The third vehicle of train 1F30 was derailed and forced to the left, against the tunnel wall. The last vehicle of this train was also derailed, and its front left corner struck the tunnel portal.

Figure 4: Estimated position of trains when they collided

- 26 Train 1L53 was travelling much faster than train 1F30, and the front corner of its leading vehicle first struck the leading end of the fourth coach of train 1F30, and then scraped along the side of the third coach until it stopped, tilted over to the right and inside the tunnel. The second coach of train 1L53 also derailed and tilted over to the right and came to rest immediately outside the tunnel, alongside the last coach of train 1F30. The last coach of train 1L53 was not derailed and remained upright.

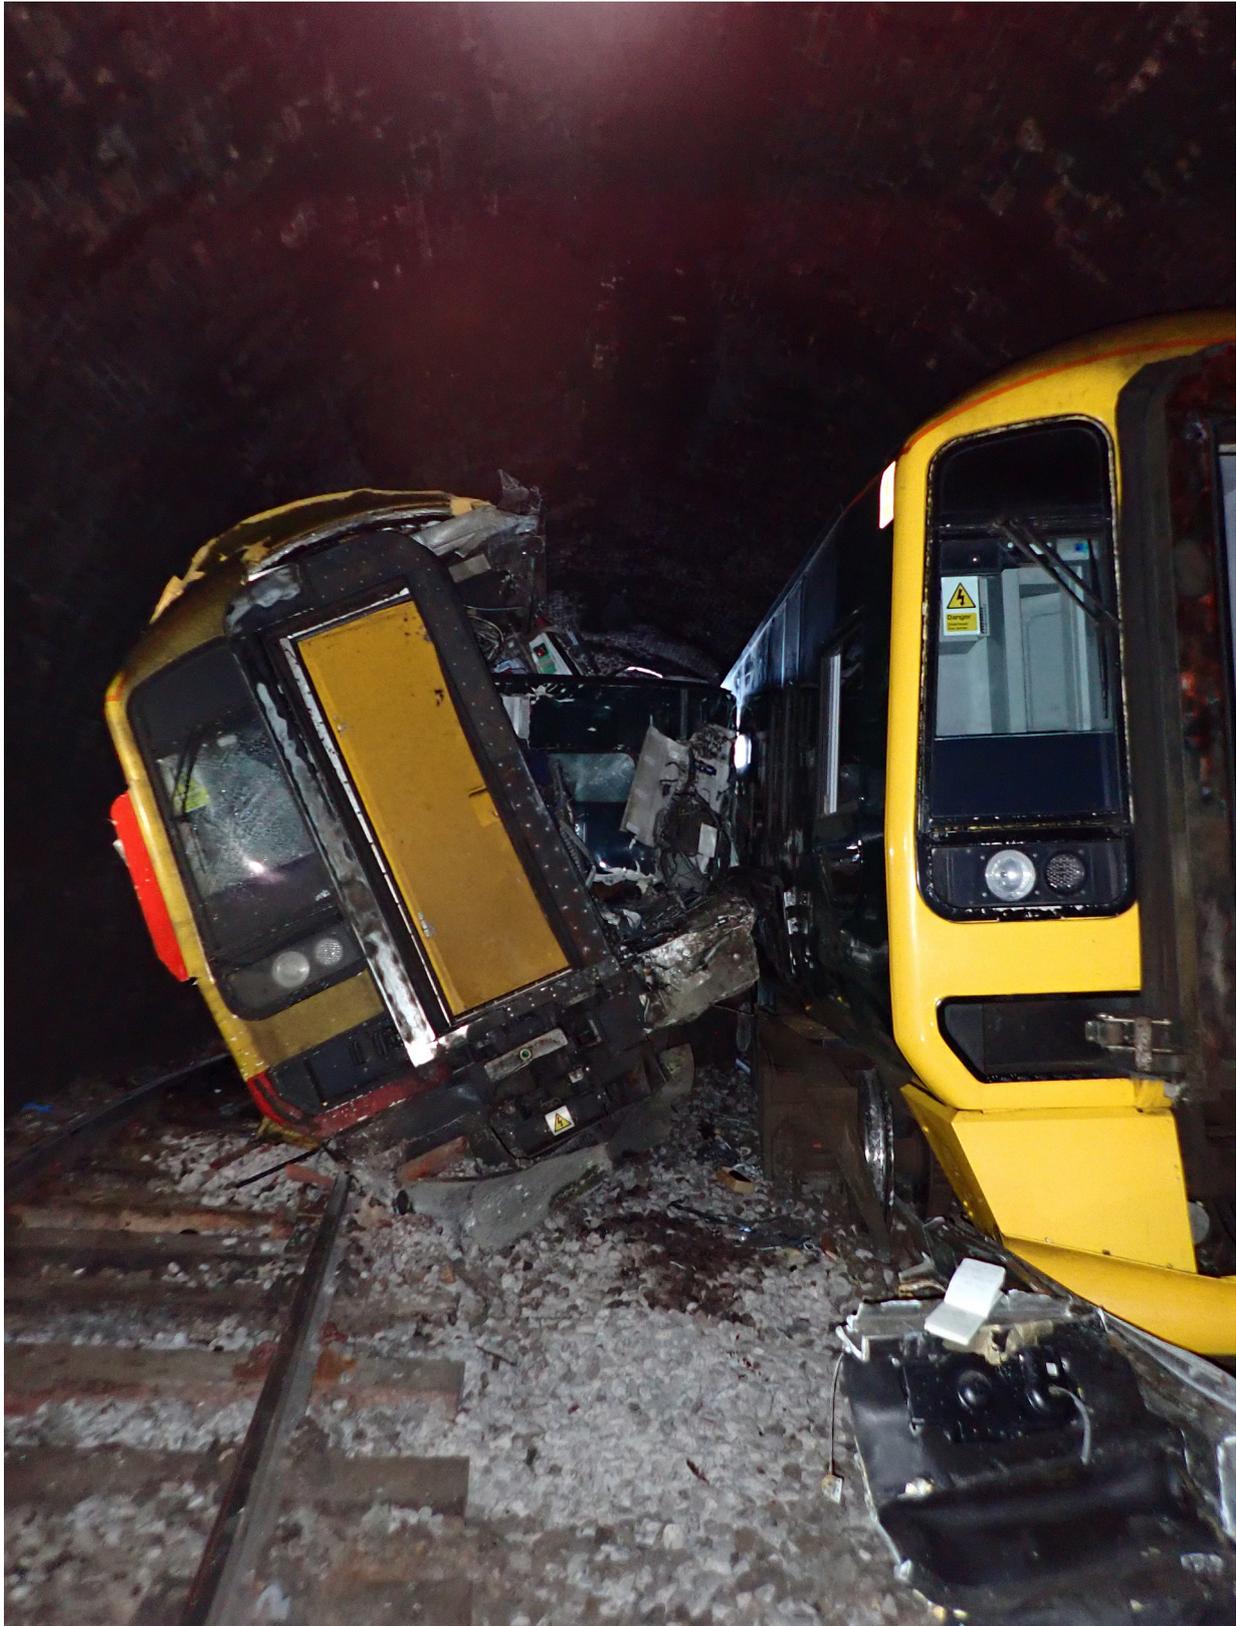
- 27 Witness evidence indicates that the driver of train 1L53 remained in the driving cab until he realised that he could do nothing more to prevent the collision. The impact occurred as he was attempting to leave the cab, when he was knocked unconscious and became trapped. The driver sustained serious injuries as a result of the collision and was subsequently freed from the cab by the emergency services.

*Figure 5: The scene inside the tunnel, showing the third coach of train 1F30 (right) and the leading coach of train 1L53 (left). Parts of the driving cab of train 1L53 have been cut away by the emergency services to release the trapped driver*

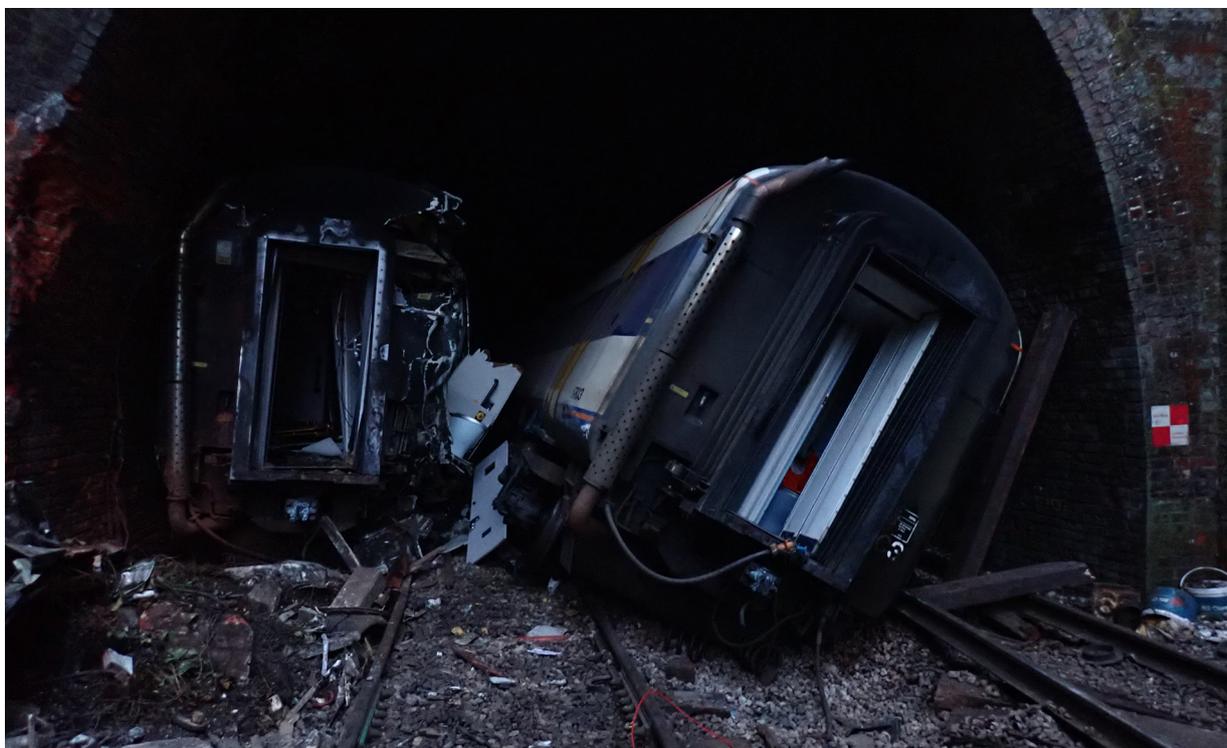
32 The accident caused extensive damage to both trains, the track and the interior of Fisherton tunnel. Recovery of the damaged vehicles began on 4 November and was completed on 7 November. Repair and reinstatement of the track and signalling was completed on 15 November, and services through the junction to Salisbury resumed on 16 November.

*Figure 6: The scene during recovery of the damaged vehicles, showing the rear of the third coach of train 1F30 (left) and the first coach of train 1L53 (right), after the removal of the vehicles that had been behind them*

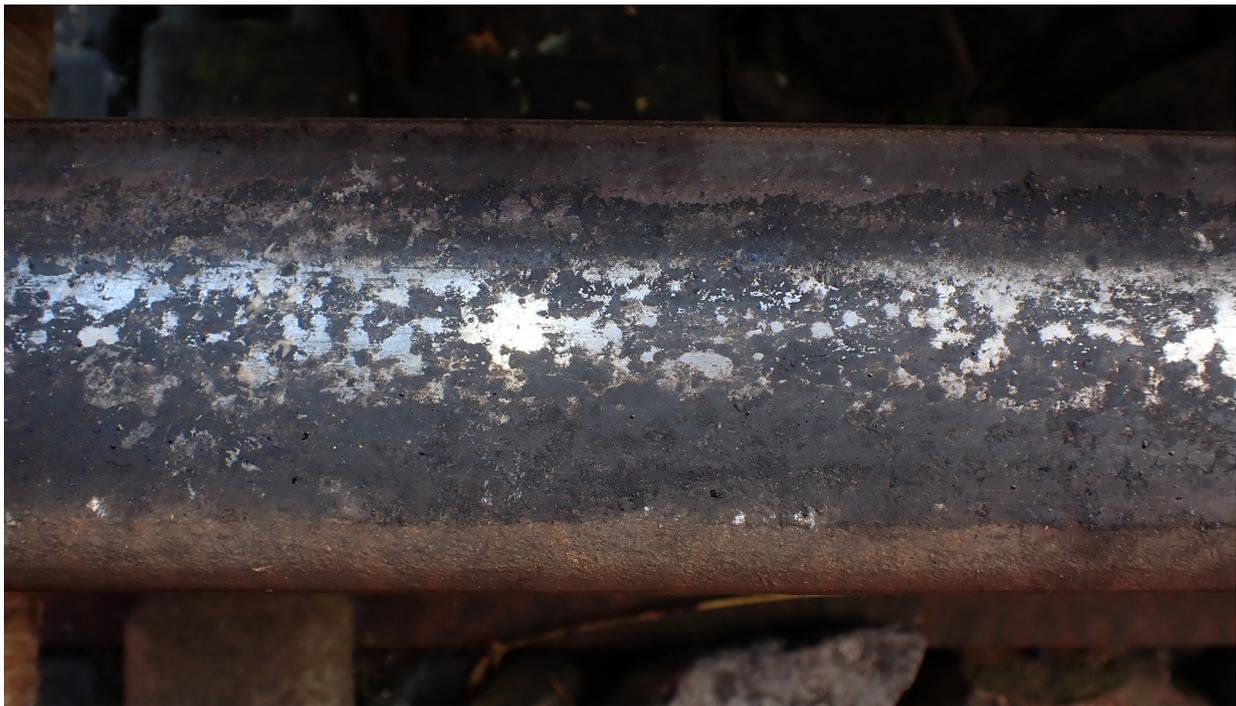
- 36 The railhead was found to be contaminated throughout the areas surveyed with a black deposit. This deposit consisted of leaf material which had been crushed under the wheels of passing trains and which is often associated with low adhesion conditions. Analysis showed that many areas had a medium or heavy level of contamination, and that the thickness of the leaf deposit was relatively consistent through each of the areas surveyed. It is likely that the rails were wet at the time of the accident. Wet values of the coefficient of friction measured as part of the post-accident survey were found to be between 0.2 and 0.02, suggesting that there was low friction between the wheels and the railhead. The average rate of deceleration of train 1L53 suggests adhesion levels closer to the 0.02 value were prevalent at the time of the accident. Samples taken from the area around signal SY29 and between there and the junction showed that the deposits were smeared and flaky and typical of the sort of contamination layers which exist after train wheels have slid over them.

*Figure 8: Railhead contamination on the down main line near signal SY29R*

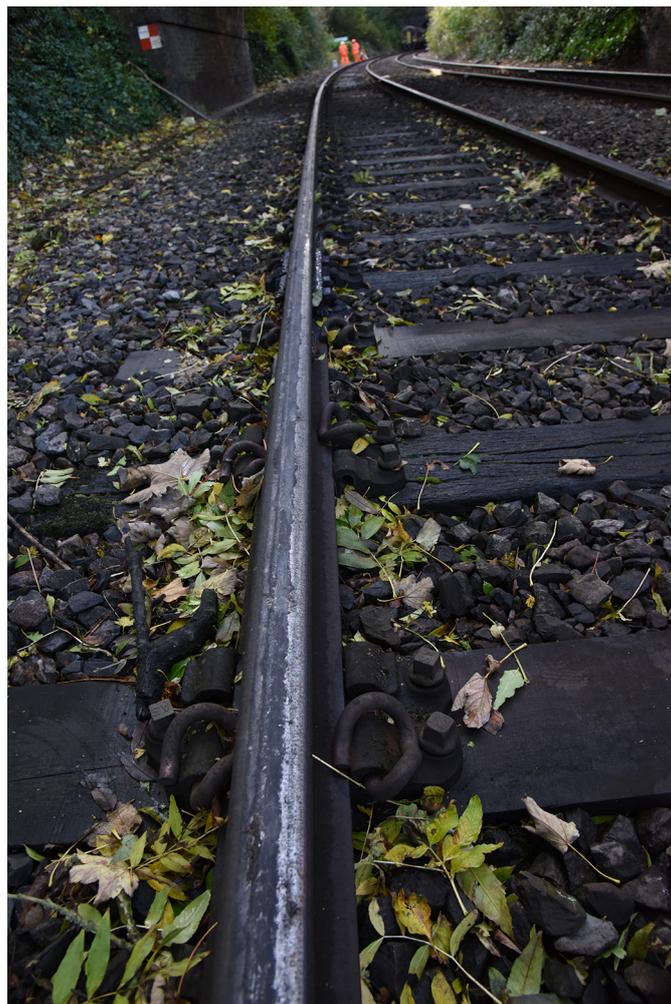
*Figure 9: The down main line near SY31 signal, showing railhead contamination (image courtesy of British Transport Police)*
