Rail Accident Investigation Branch

## **Derailment of a passenger train at Carmont, Aberdeenshire 12 August 2020**

02/2022 Synopsis  
v2 January 2024

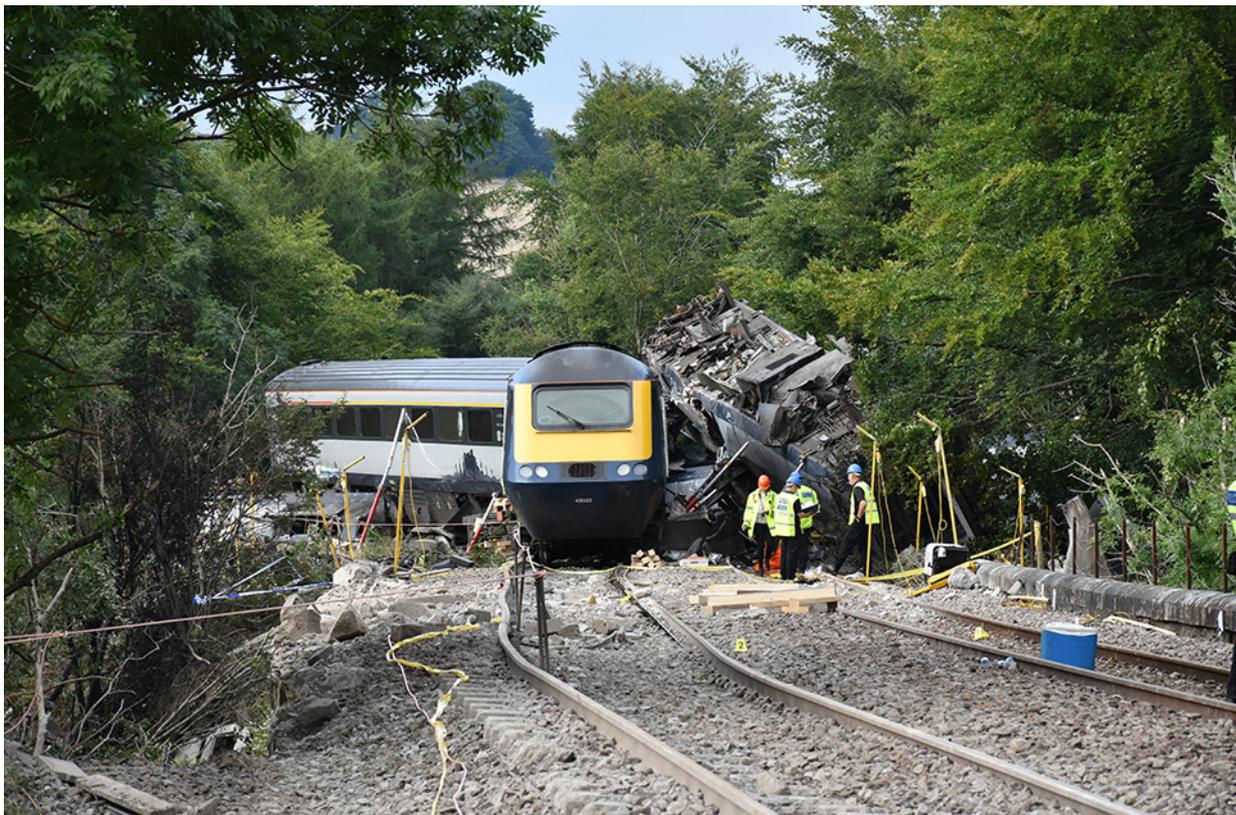
- S2 Train 1T08 was travelling at 73 mph (117 km/h), just below the normal speed for the line concerned. The collision caused the train to derail and deviate to the left, before striking a bridge parapet which caused the vehicles to scatter. Tragically, three people died as a result of the accident:

*The aftermath of the accident (image taken on 13 August 2020)*

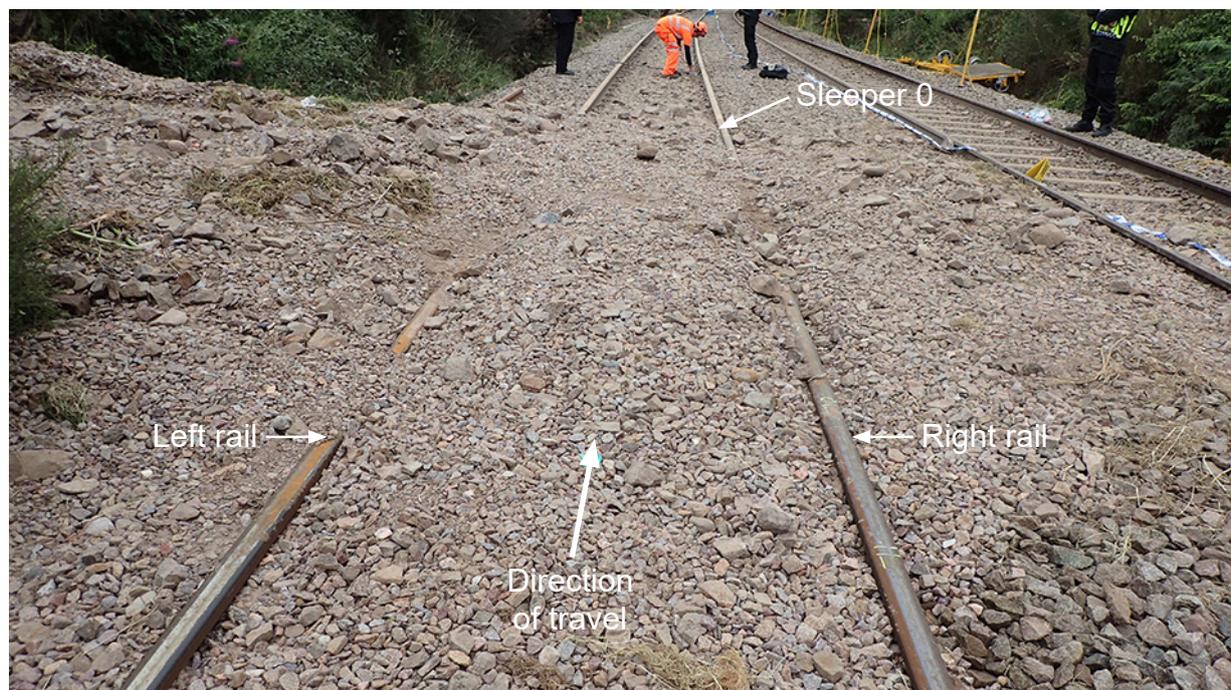
- S4 Train 1T08 derailed because it struck debris washed out from a 15 metre length of steeply sloping drainage trench. This is evidenced by CCTV images from the train, grooves cut through the debris, the absence of derailment marks on the track on the approach to the debris and marks indicating that the leading wheelset had derailed immediately after the debris field.
- S5 The debris mainly comprised gravel with some cobbles and covered the down line for a length of about 10 metres. Estimates made by RAIB after the derailment indicate the maximum depth of debris on the left and right railheads was probably around 170 mm and 135 mm respectively before the train ran through it.

*Washout debris covering the track*

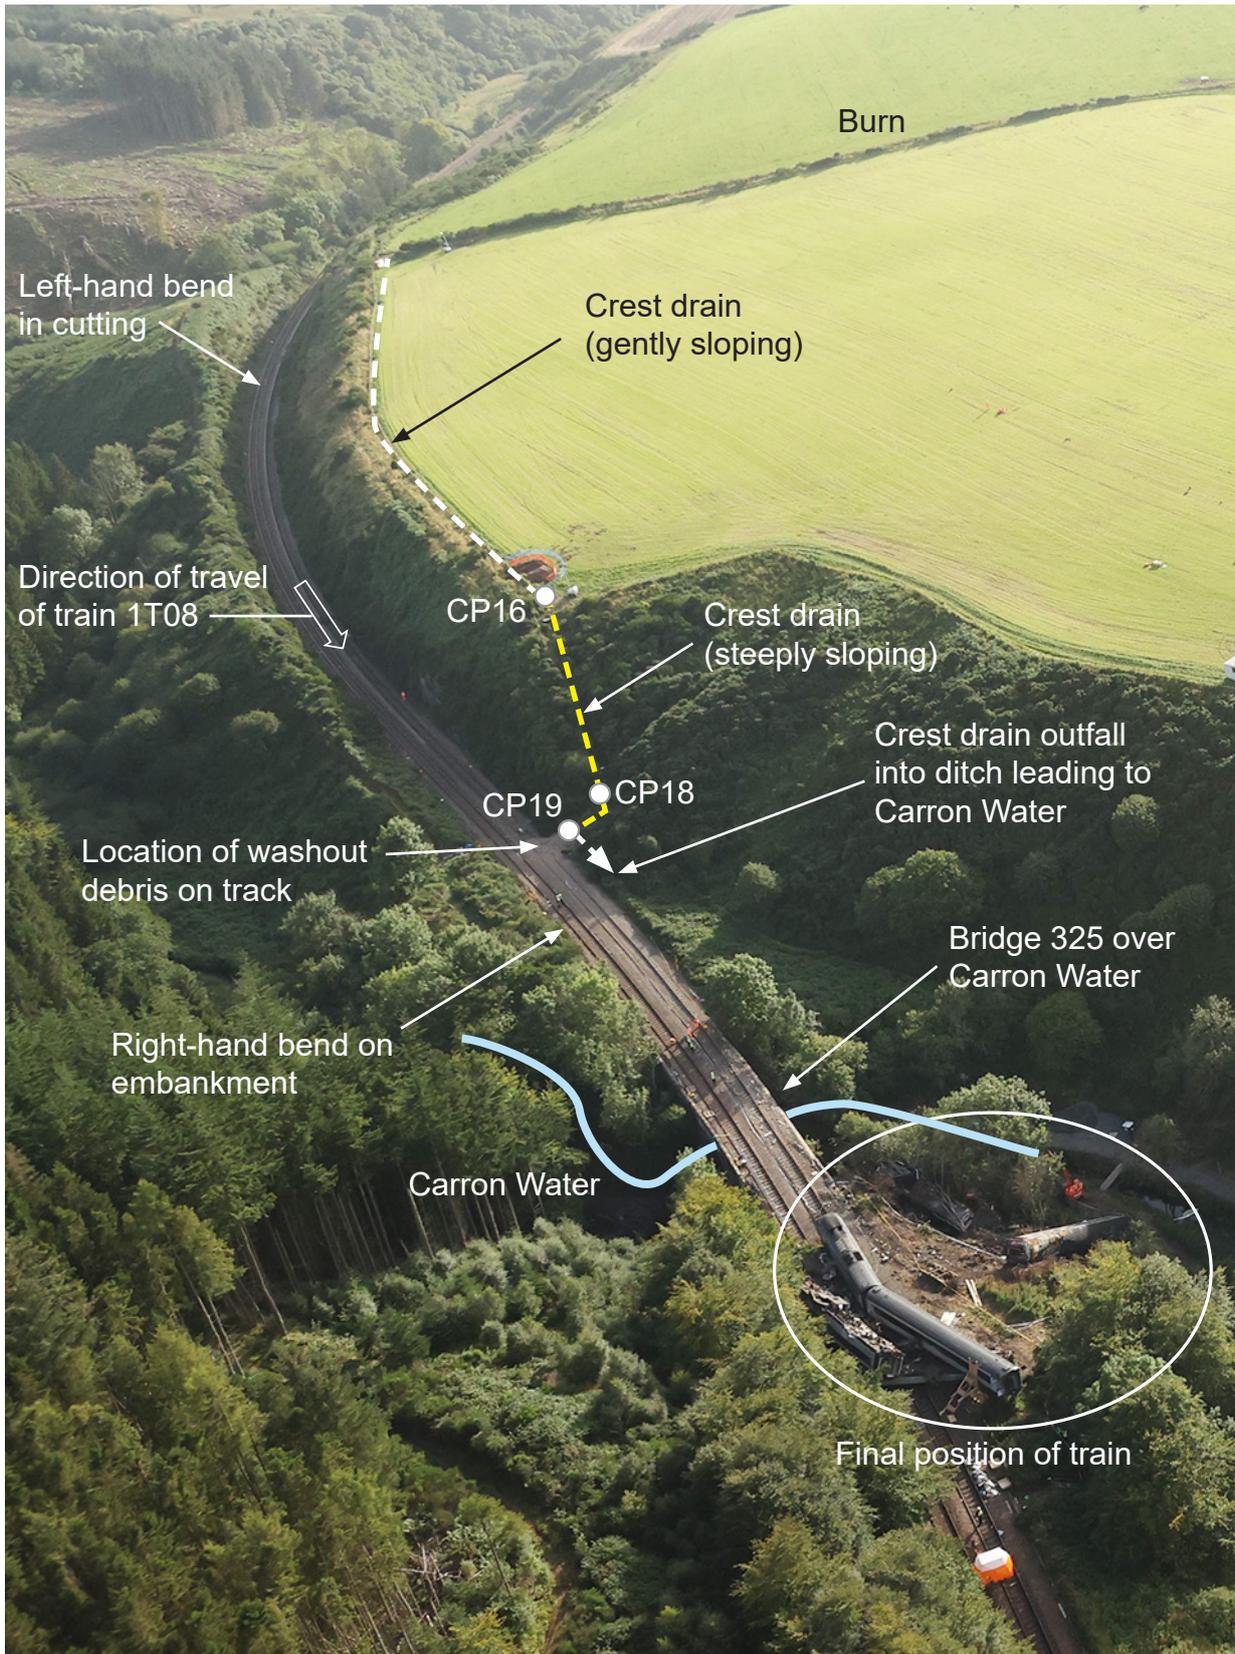
S12 The trench which contained the drainage pipe was filled with gravel (mainly between 20 mm and 40 mm in size) in accordance with normal practice for french drains. However, the use of this gravel in such a steeply sloping trench increased the likelihood of it being washed away should the water reach the drain as a concentrated flow.

Overview of the drainage system (locations marked 'CP' are catchpits) (Network Rail)

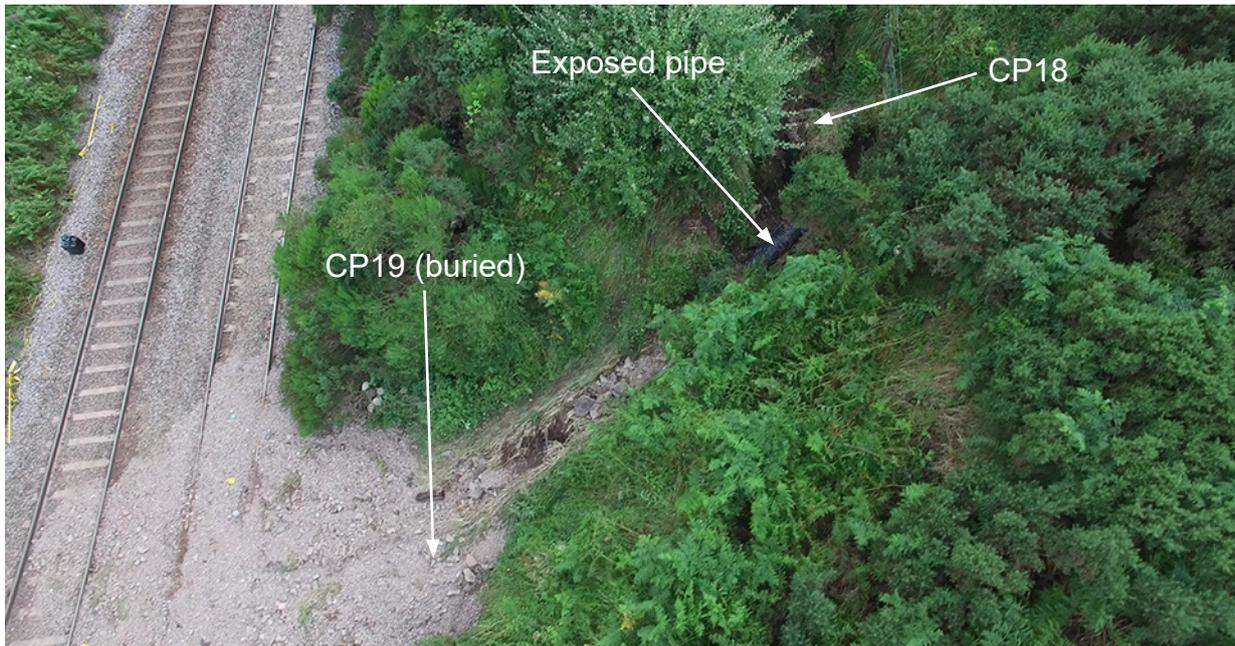
S8 The source of the debris that caused the derailment at Carmont was a 'french drain' and the ground immediately surrounding it. This drain had been installed during 2011 and 2012 (the 2011/12 drain) as part of a wider scheme to address a known problem with the stability of the earthworks in this locality. This drain comprised a 450 millimetre (approximately 18 inch) diameter perforated pipe buried in a gravel-filled trench which ran for 306 metres along the edge of a field at the top of a slope that ran down to the railway. The drain then sloped down relatively steeply (at an inclination of 1 in 3) for 53 metres to track level. Catchpits (access chambers, sometimes called manholes) were provided at intervals along the pipe to allow inspection and maintenance of the pipe.

*The washout (locations marked 'CP' are catchpits)*

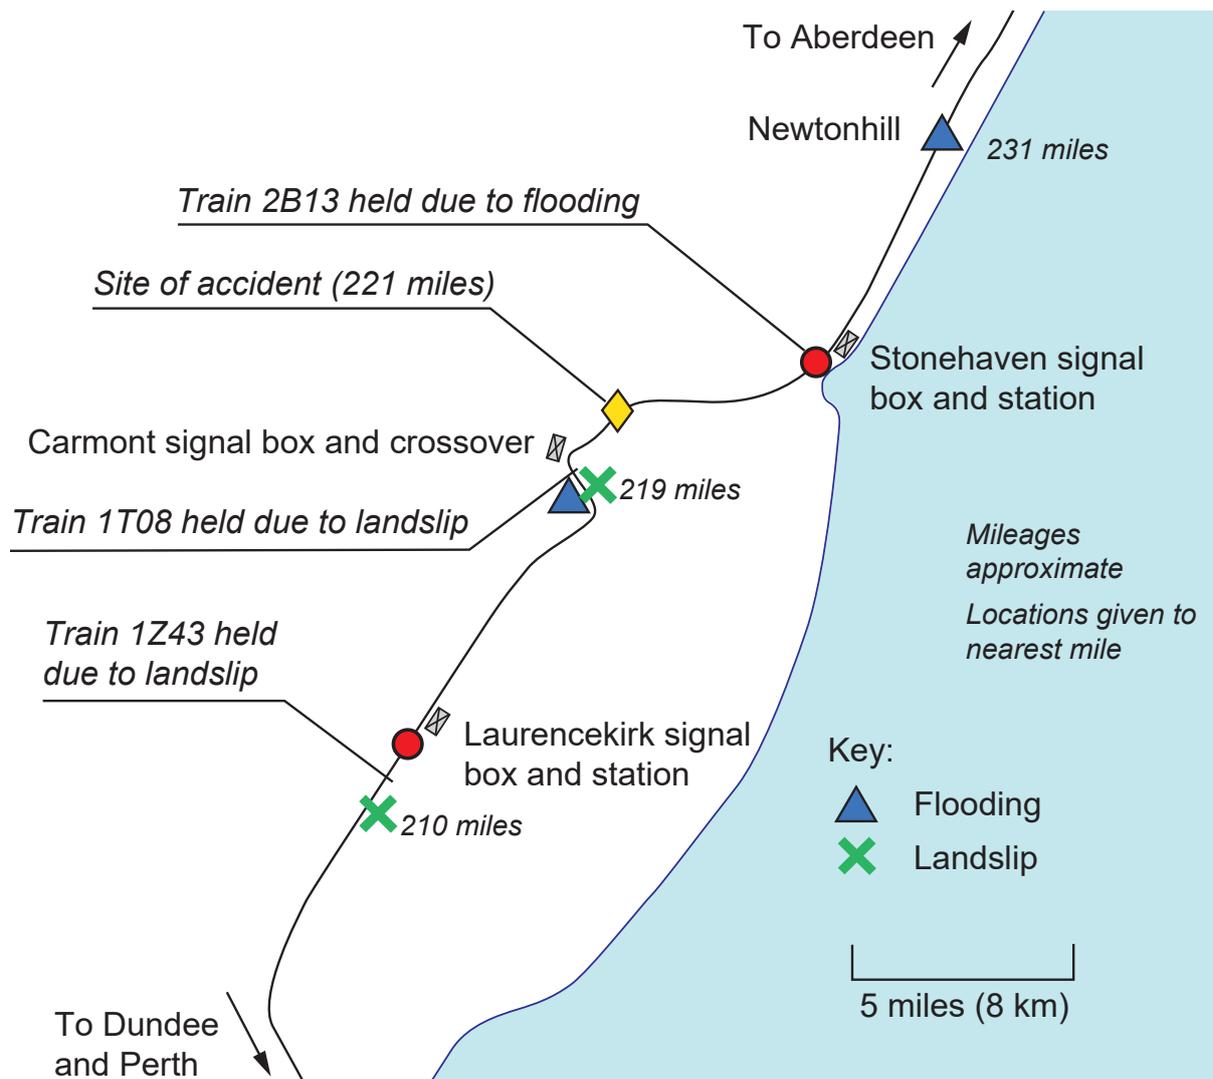
S37 RAIB found evidence that the Scotland route control team was under severe workload pressure on the morning of 12 August 2020, because of the volume of concurrent weather-related events in Scotland (such as the canal breach at Polmont). However, despite the severe nature of the disruption to Scotland's railway infrastructure, no additional resource had been obtained for the control room and the senior management 'gold command' structure had not been established to relieve the pressure on the controllers.

Train positions and known infrastructure failures around Carmont at 09:00 hrs on 12 August 2020

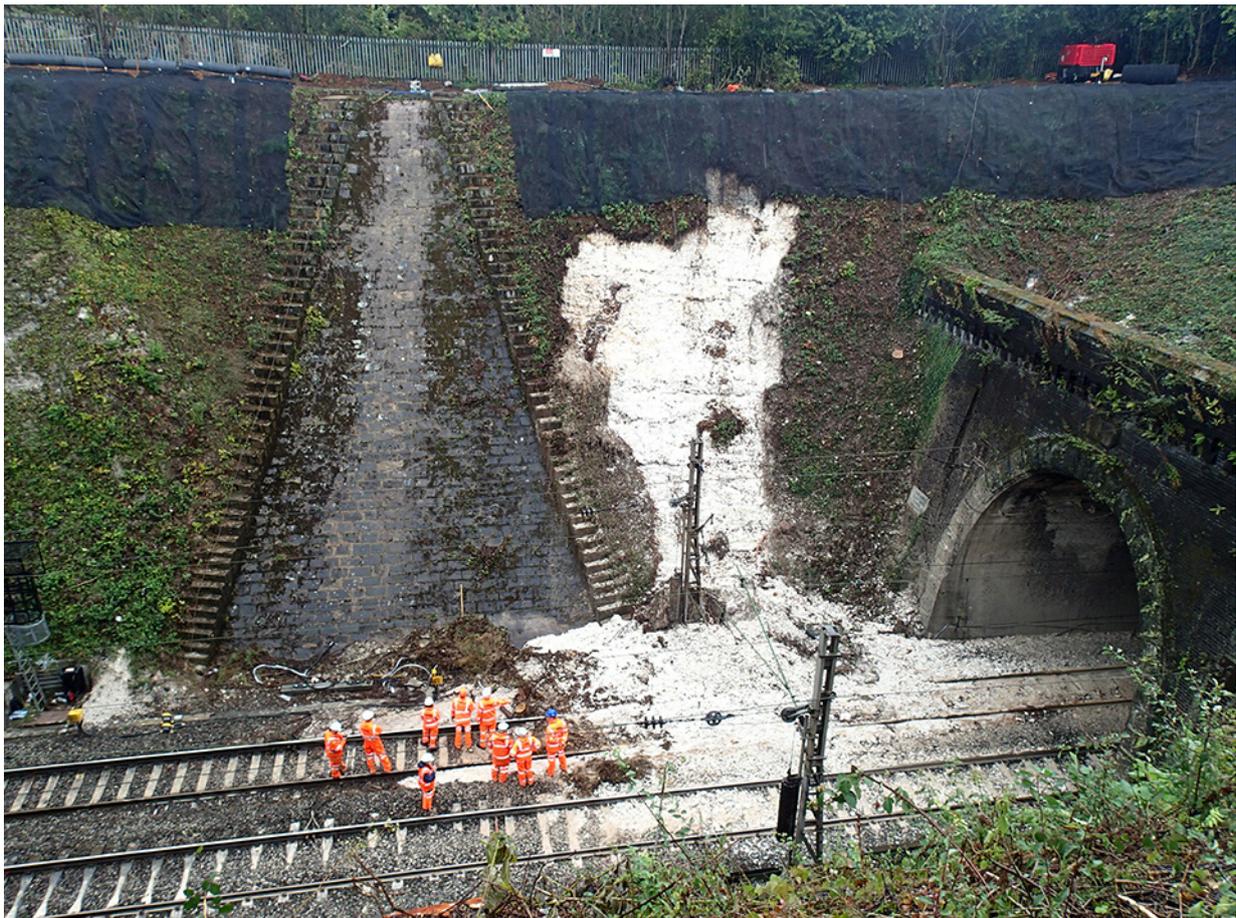
S58 Network Rail and RAIB concerns were heightened by the landslip just outside the portal of Watford tunnel, Hertfordshire, in September 2016 that caused the derailment of a train and a subsequent glancing blow, inside the tunnel, between the derailed train and a train on the opposite track. Discussions at the meeting of Network Rail's executive committee and the company's Safety, Health and Environment committee in November 2016 covered a range of issues, including:

*The landslide at Watford tunnel, September 2016*

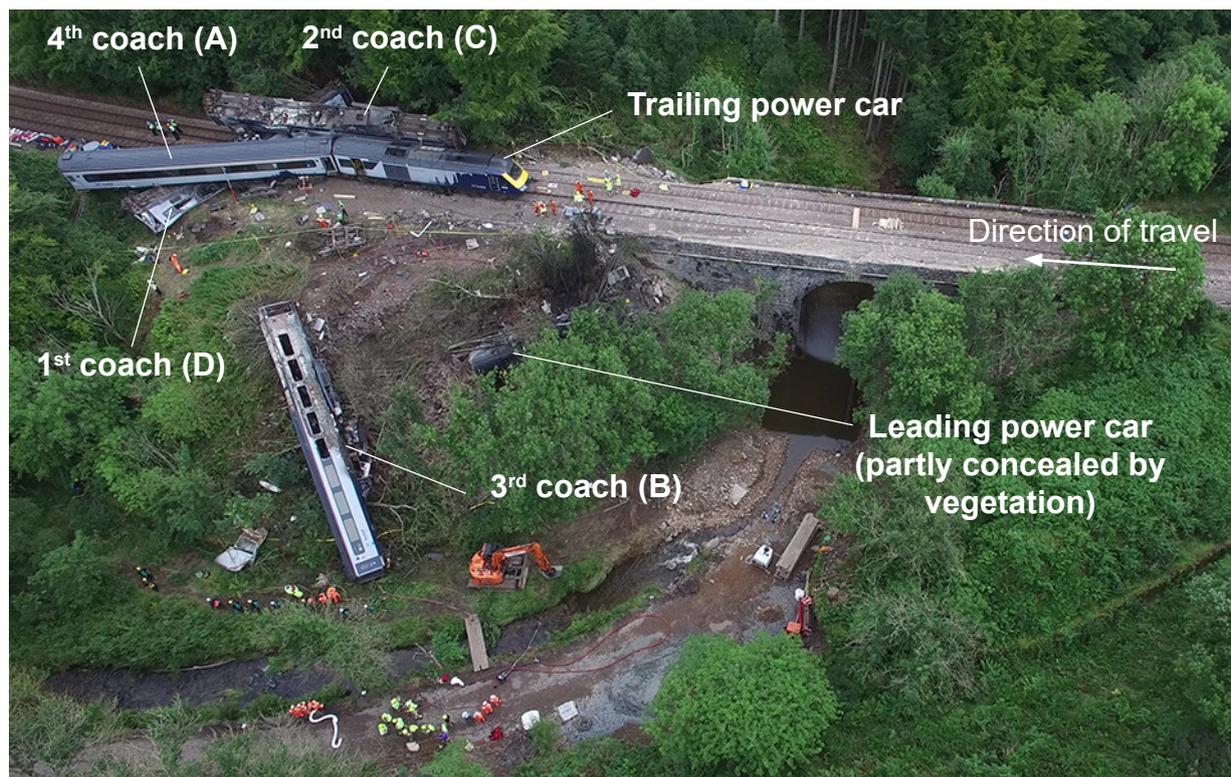
*The derailed train*

S62 The marks found on the track are consistent with the leading left-hand wheel of the leading power car being lifted up by debris between the wheel and rail and displaced to the left across the head of the rail before falling off the track entirely. At the same time the right-hand wheel dropped into the space between the two rails.

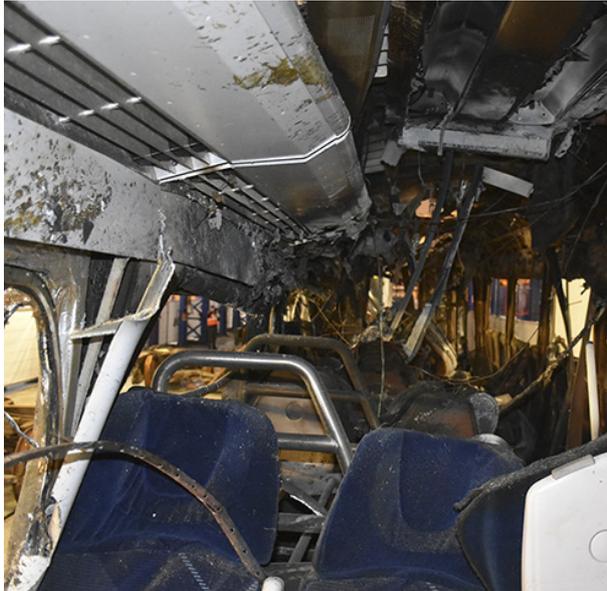
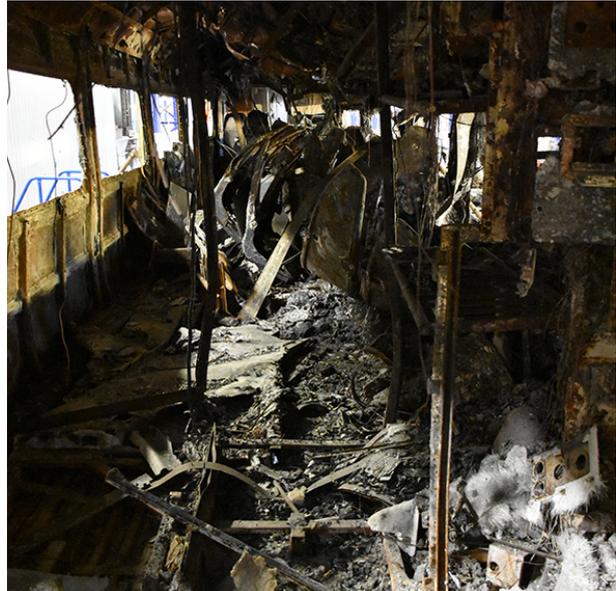
S81 The fire in the third coach originated in the batteries beneath the floor of the coach and almost certainly was caused by an electrical fault that arose due to the extent of damage to the underframe of the coach. The subsequent spread of the fire was a consequence of the coach coming to rest on its right-hand side on the slope, with its trailing end uppermost. This orientation meant that the fire naturally extended across the underframe and grew towards the trailing end of the coach. A rectangular hole in the floor on the left-hand side, designed to allow air from the air conditioning system into the passenger compartment, was the likely route of the fire into the coach's interior.

*Fire damage in the third coach*
