Rail Accident Report

**Derailment of a passenger train at Carmont,
Aberdeenshire
12 August 2020**

Report 02/2022
v2 January 2024

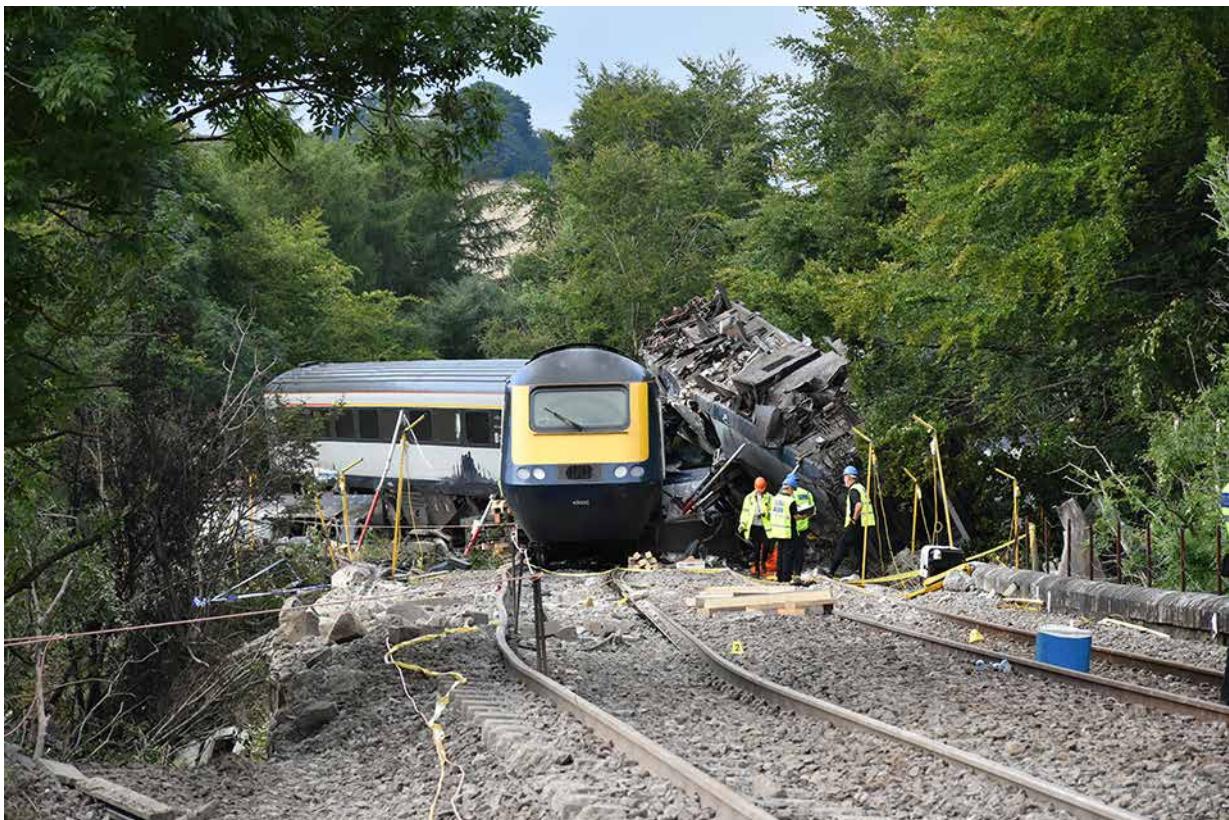
The aftermath of the accident (image taken on 13 August 2020)

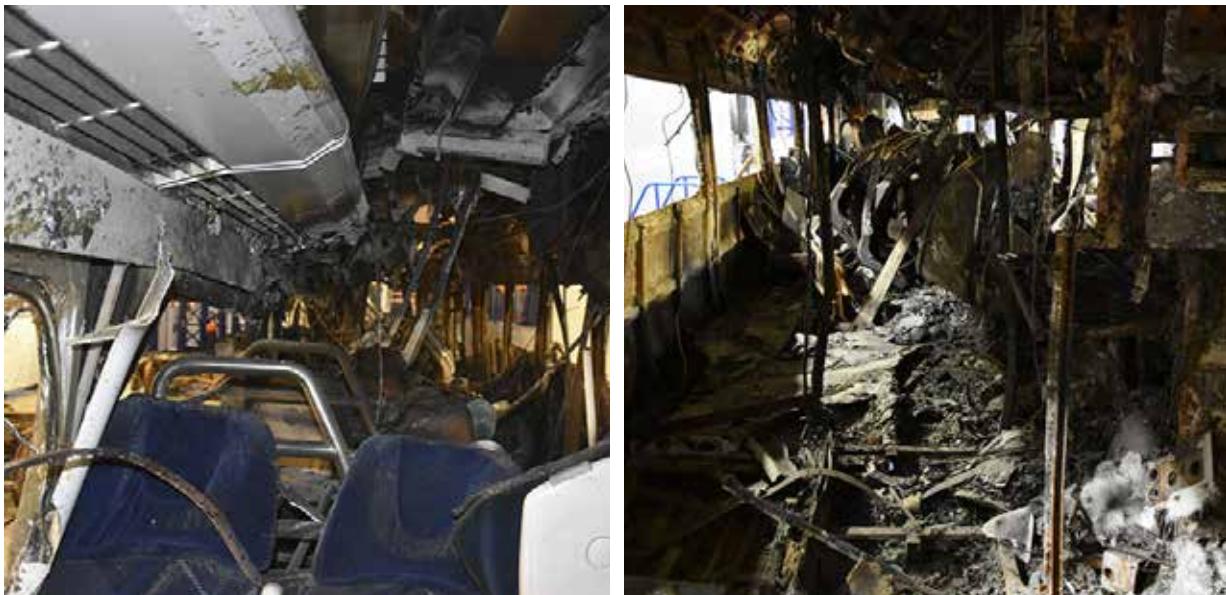
Fire damage in the third coach

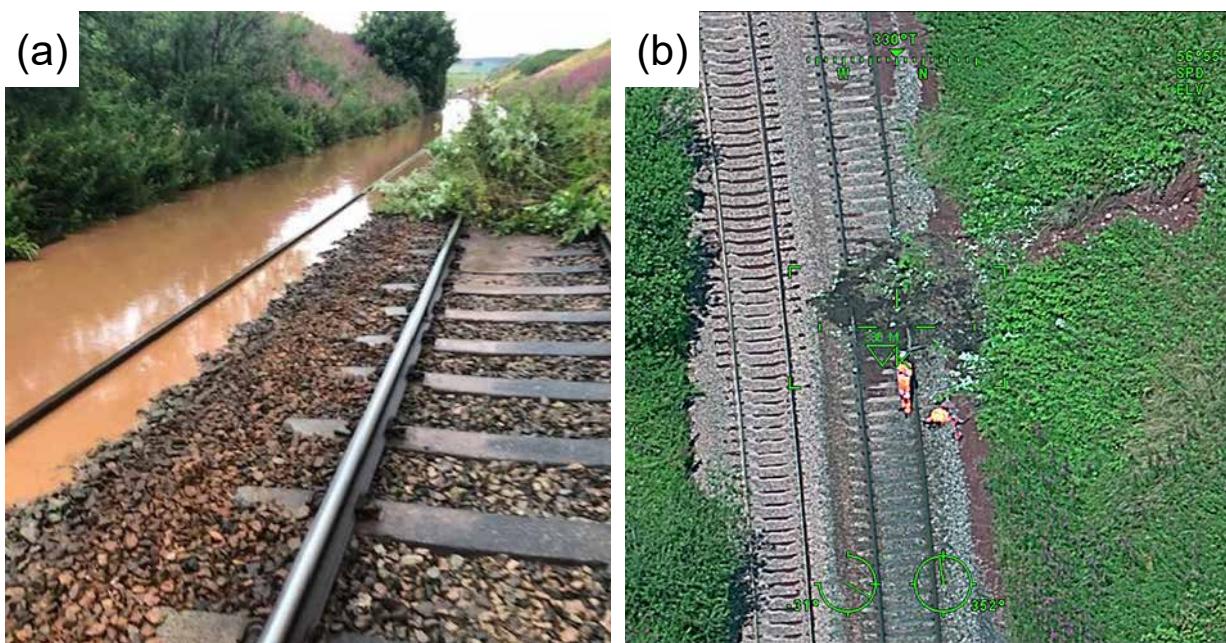
Figure 15: Landslip blocking the up line 1.6 km (1 mile) south of Carmont signal box near Ironies Bridge (a) at around 08:50 hrs on 12 August 2020 when the down line was also flooded, and (b) at around 11:00 hrs on 12 August 2020 after flooding had receded (Network Rail)

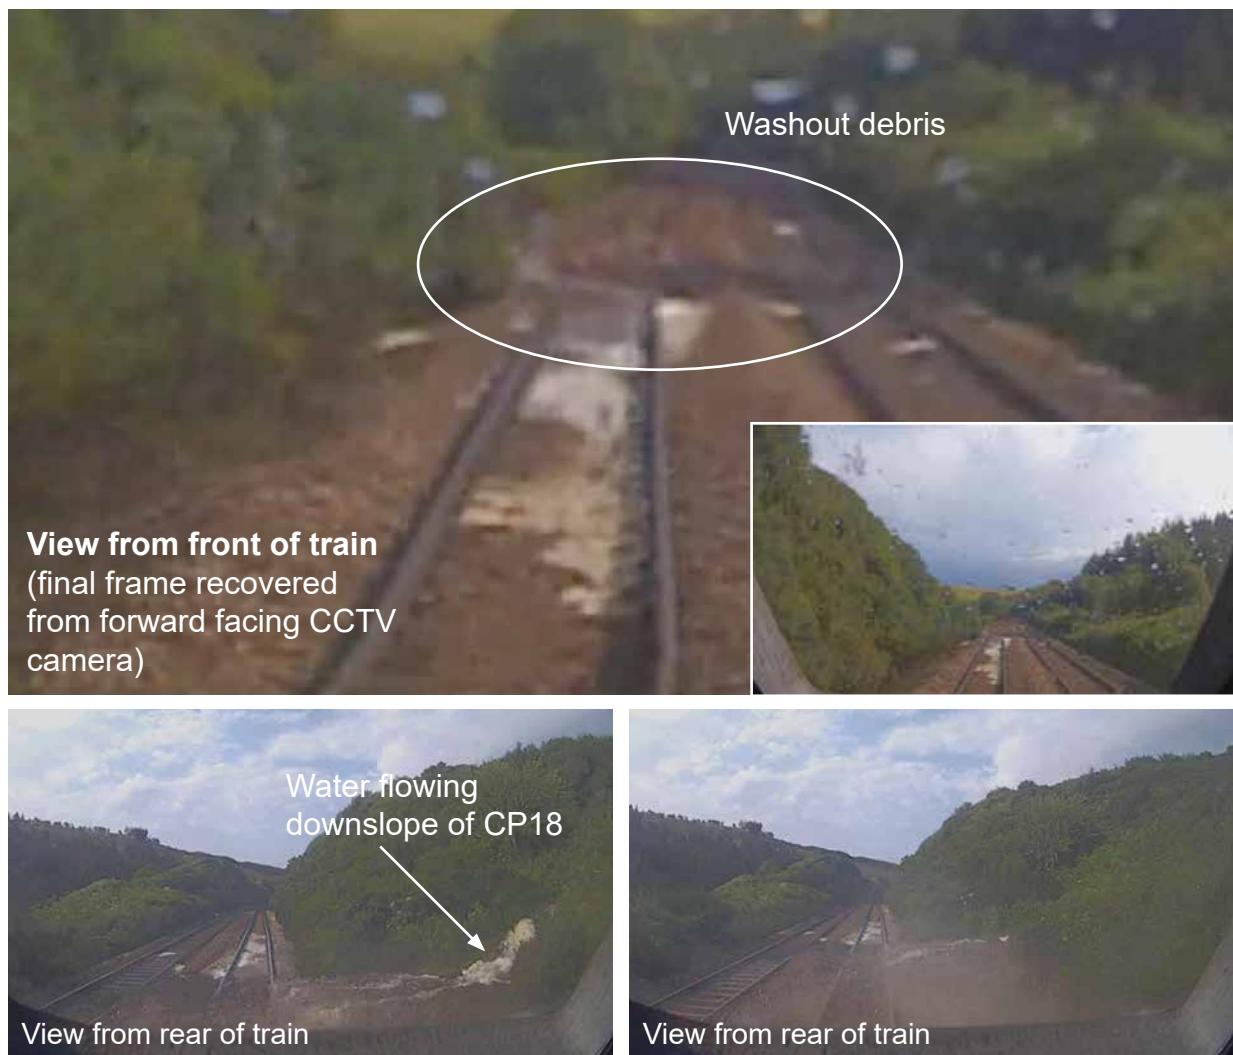
Figure 21: CCTV images from train 1T08 showing the washout (ScotRail)

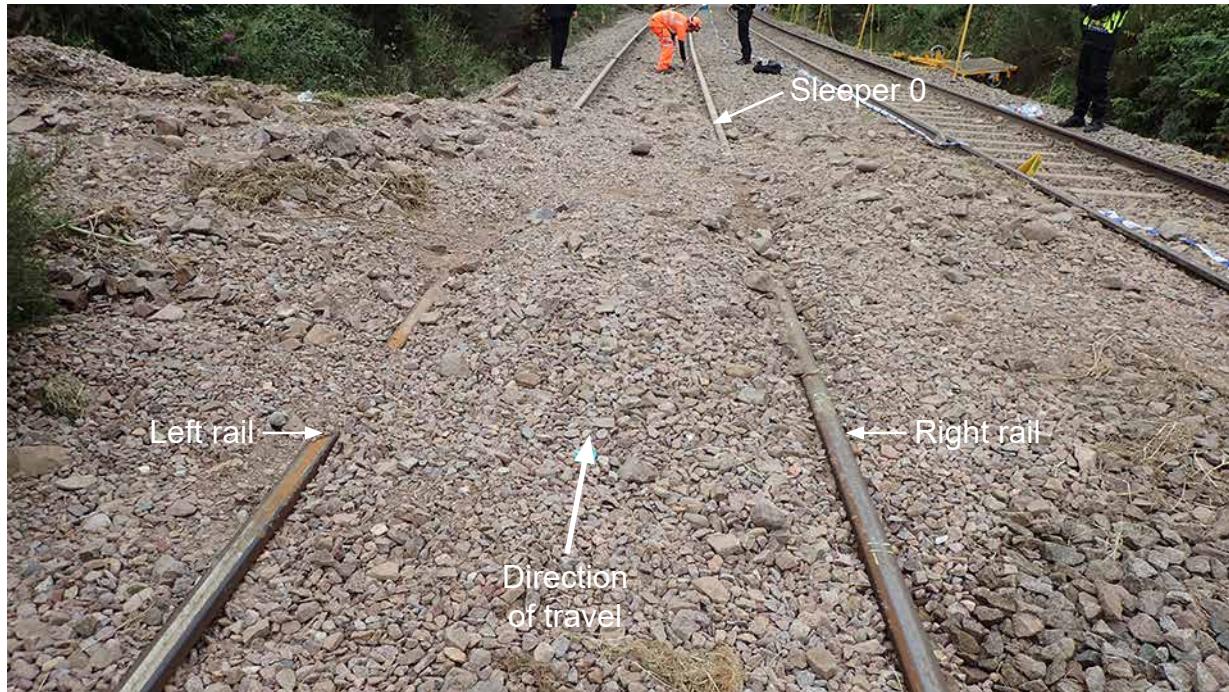
S62 The marks found on the track are consistent with the leading left-hand wheel of the leading power car being lifted up by debris between the wheel and rail and displaced to the left across the head of the rail before falling off the track entirely. At the same time the right-hand wheel dropped into the space between the two rails.

Figure 22: Washout debris covering the track and point of derailment at sleeper 0. Grooves cut by the wheels of train 1T08 through the debris are visible

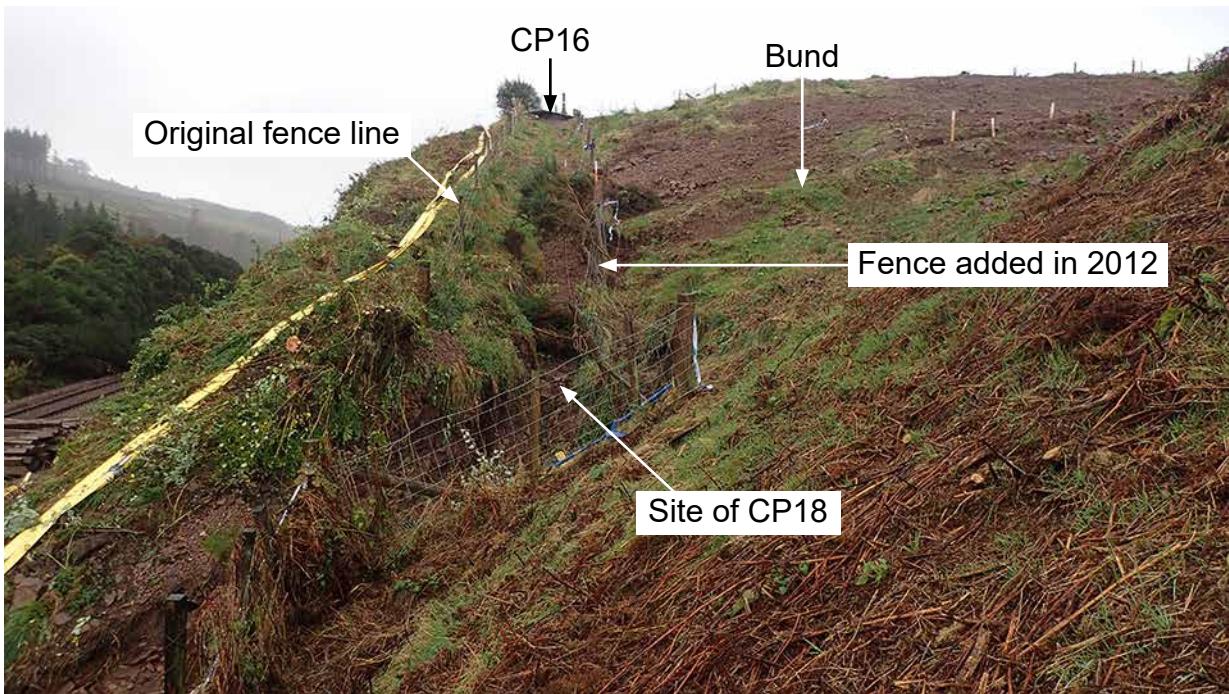
Figure 36: Funnel area post-accident after clearance of vegetation and removal of CP18

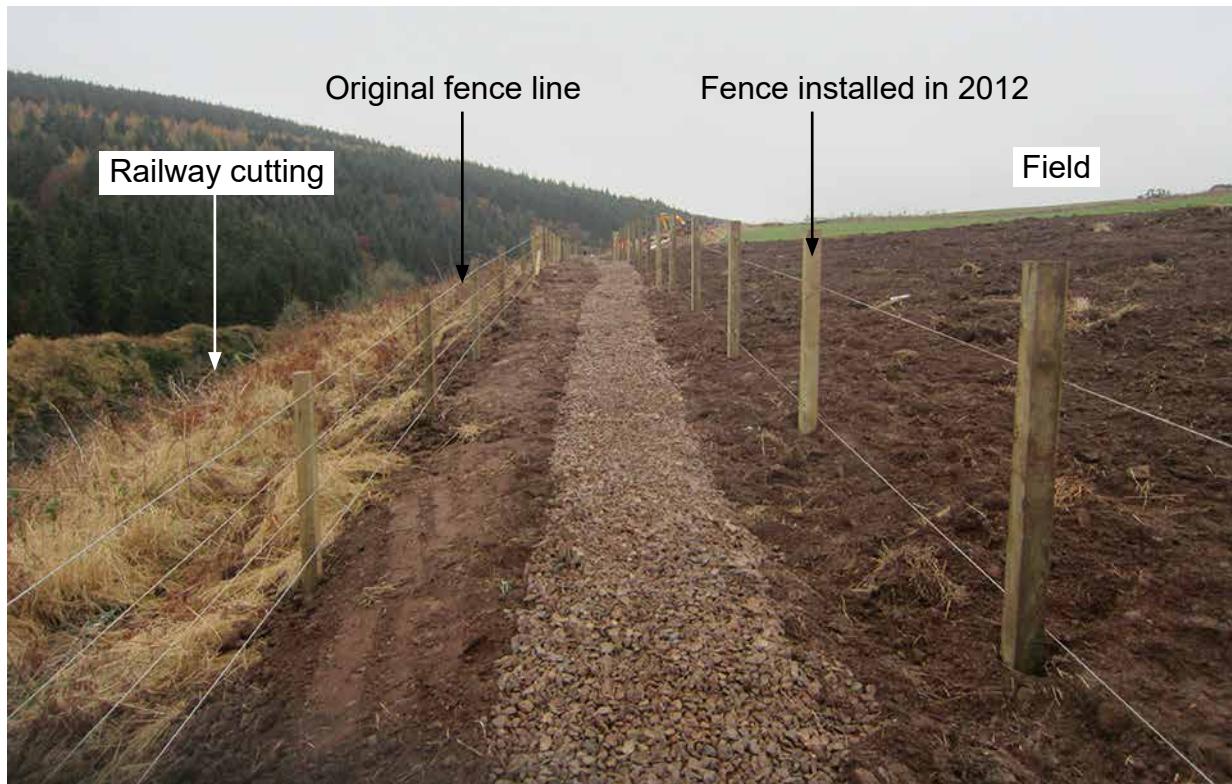
Figure 45: Drain shortly after completion in late 2012 showing section between CP11 and CP16 looking south (Network Rail)

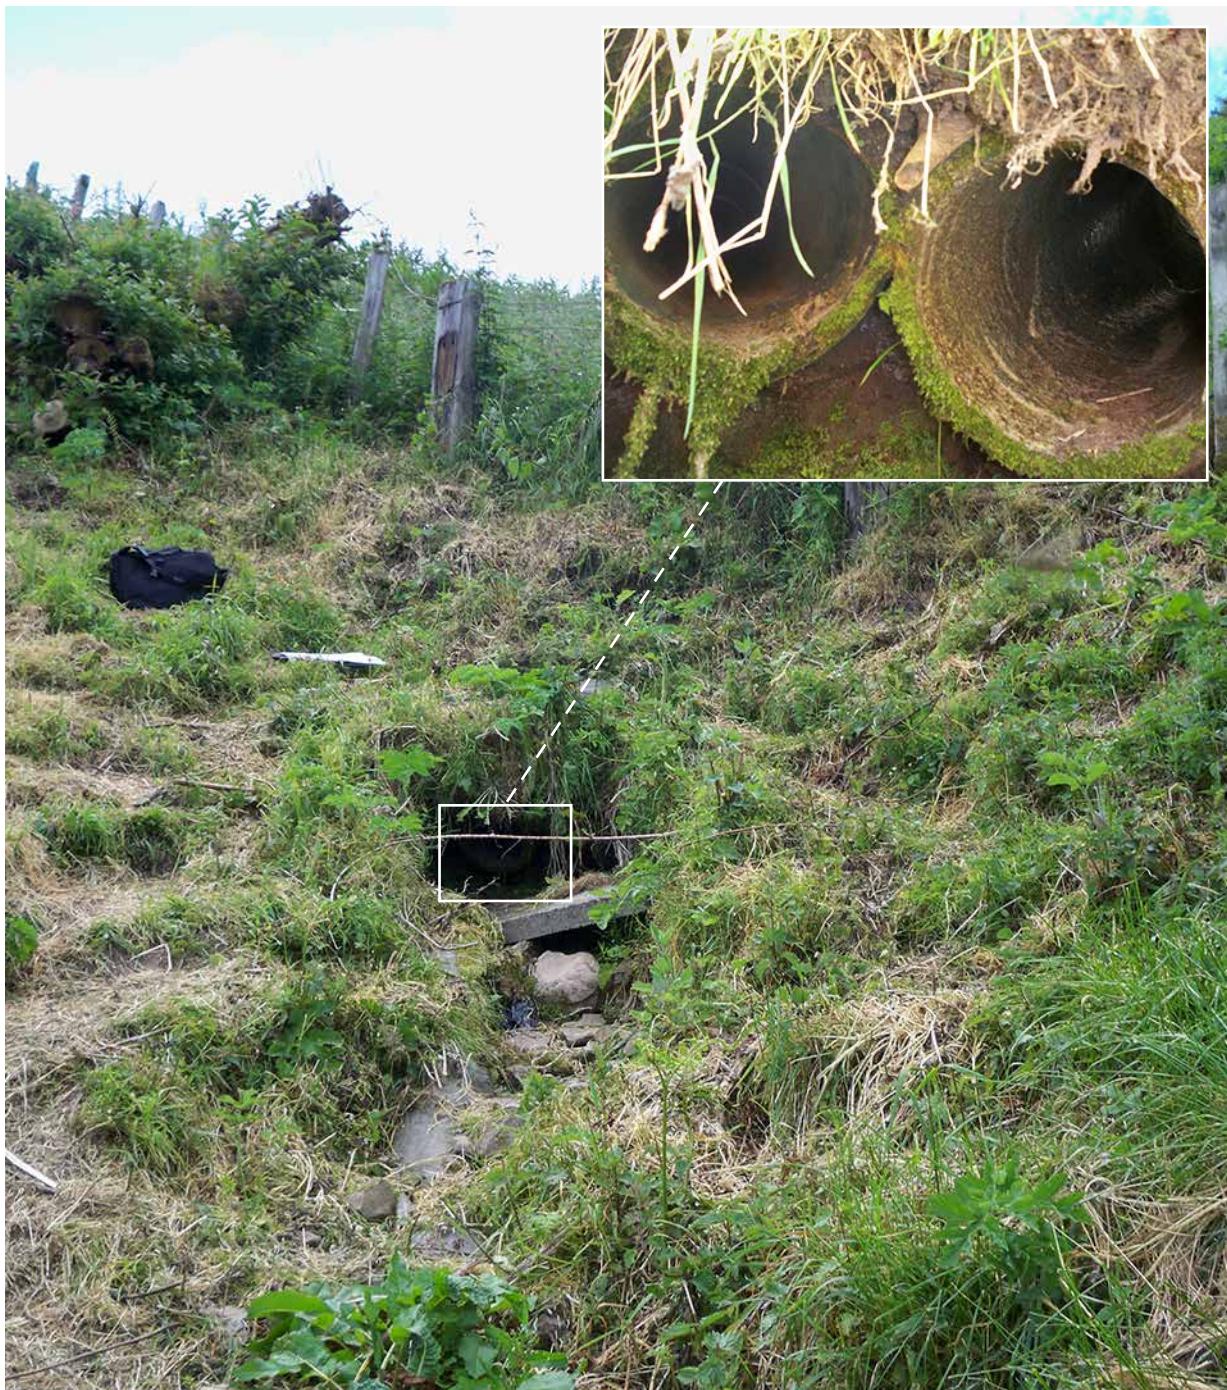
Figure 48: Pipes entering channel in pre-2010 drainage system at as-designed position of CP18 (Arup, June 2010). Inferred that left-hand pipe is from historic crest drain and right-hand pipe from pre-2010 drainage ditch as shown on figure 32

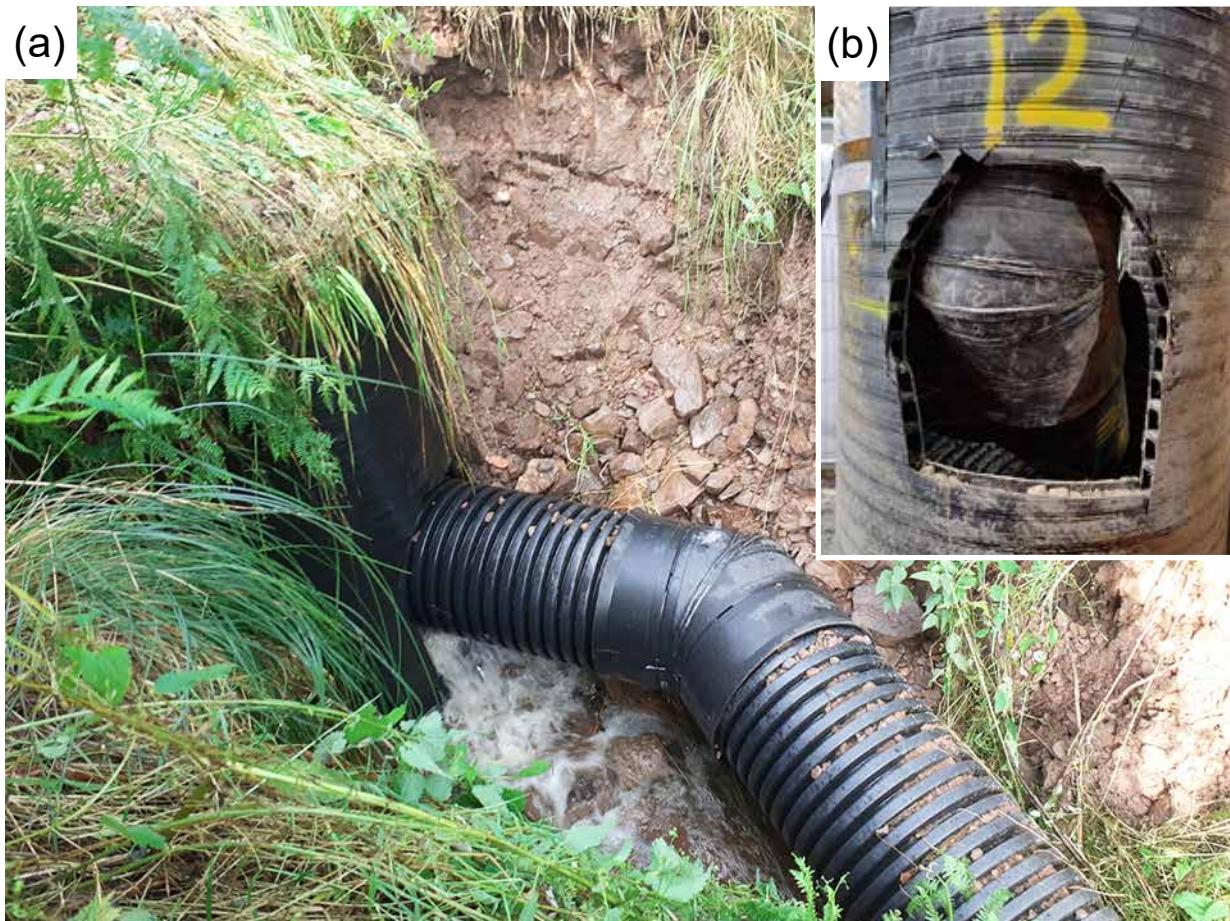
150 At CP18, the enlarged hole on the downslope side of the catchpit was significantly bigger than required to accommodate the drainage pipe. AECOM's analysis concluded that, until surface water flow caused washout of the gravel, escape of water through the gap between the pipe and the enlarged hole would have been constrained by gravel restricting the amount of outflow and by the damming effect of the locally dug fill (figure 30). This would have led to a build-up of water in the gravel sufficient to force the escaping water to re-enter the pipe through the pipe perforations, with no water escaping to the surface. This would not have caused a washout, although it had the potential to trigger a washout if surface water flows over the drain were just less than needed to cause a washout. The washout upslope of CP18 demonstrates that surface flows were sufficient to cause a washout without the assistance of water escaping from around the drainage pipe.

Figure 51: Downstream face of CP18 showing enlarged hole (a) on 12 August 2020 (Story Contracting), and (b) after removal (Note: a loose section of pipe has been subsequently placed inside the catchpit)

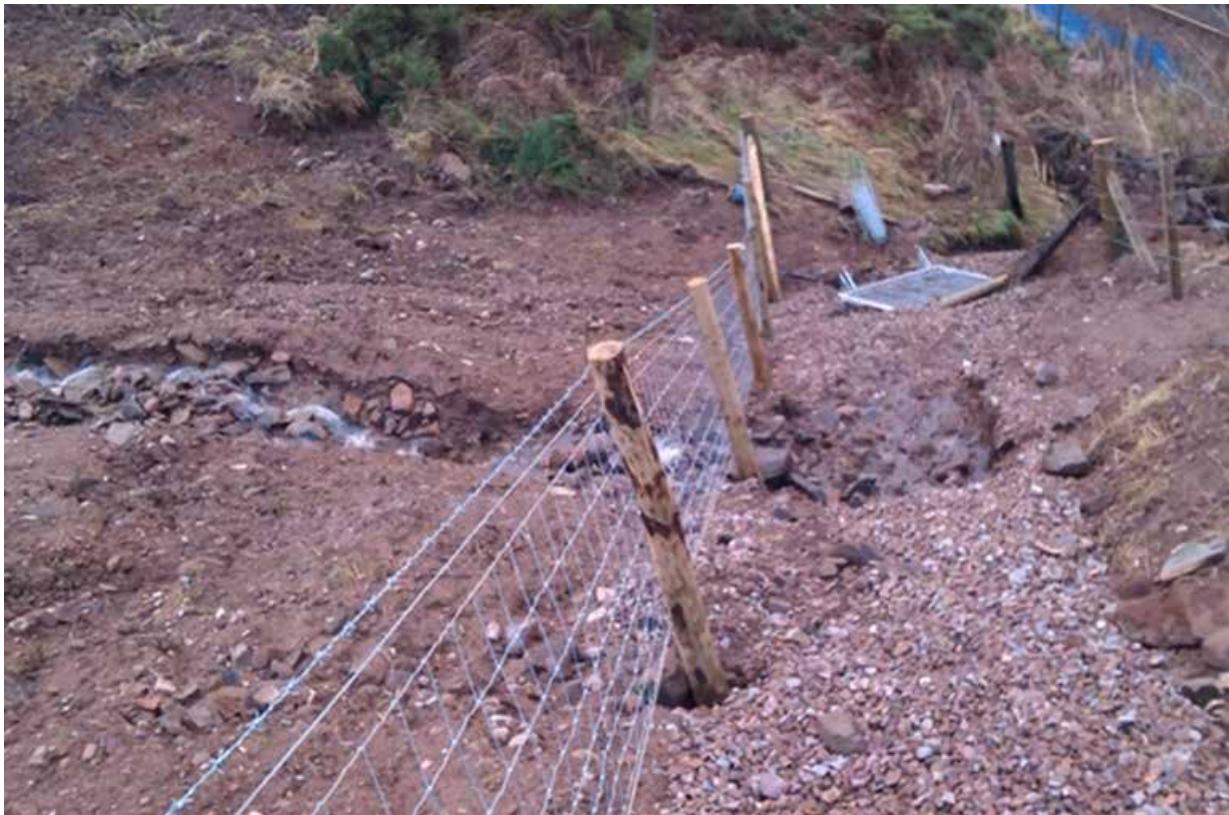
- S21 In December 2012, shortly after the drain was completed, but before the associated fencing work was finished, the landowner visited the sloping section of drain following a period of heavy rain. During this visit, he took a photograph of the steeply sloping section of drain upslope of catchpit 18 showing water flowing from a side channel and slight erosion to the gravel surface of the 2011/12 drain. The landowner stated that he passed this photograph to Carillion or Network Rail. No evidence has been found relating to receipt of the image or action being taken in response to it. It is likely that this erosion was visible when Network Rail and Carillion staff inspected the site in March 2013.

- S22 It is very unlikely that the slight erosion of the gravel surface would have been immediately recognised as a precursor to a sudden washout affecting railway safety. However, this was clear evidence of a problem requiring action such as repair, monitoring and/or reference to the drain designer. This was a missed opportunity to recognise the effect of the bund on water flows.

Figure 52: Surface of drain looking towards CP18 and railway in December 2012, before completion of the fencing (landowner)

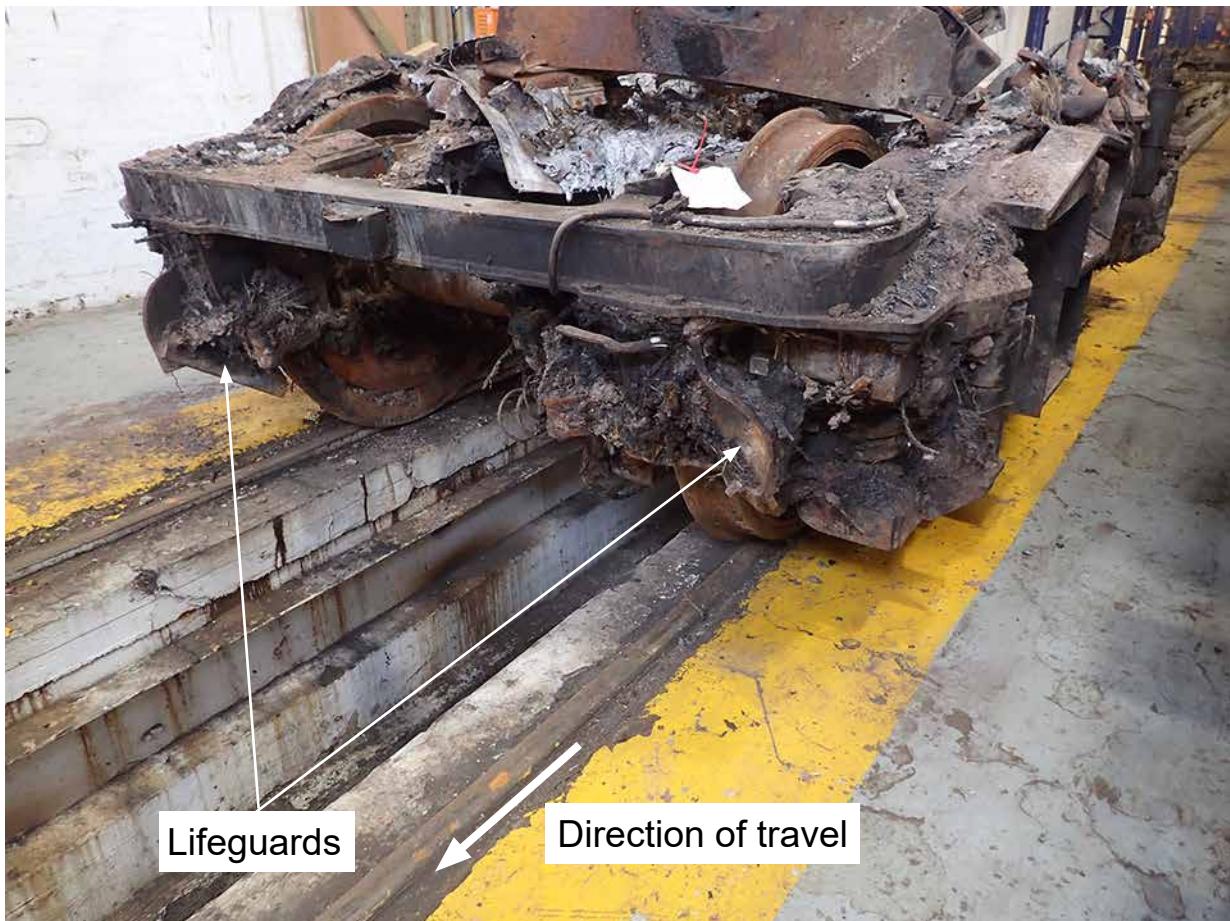
Figure 60: Damaged lifeguards on the leading bogie of the leading power car

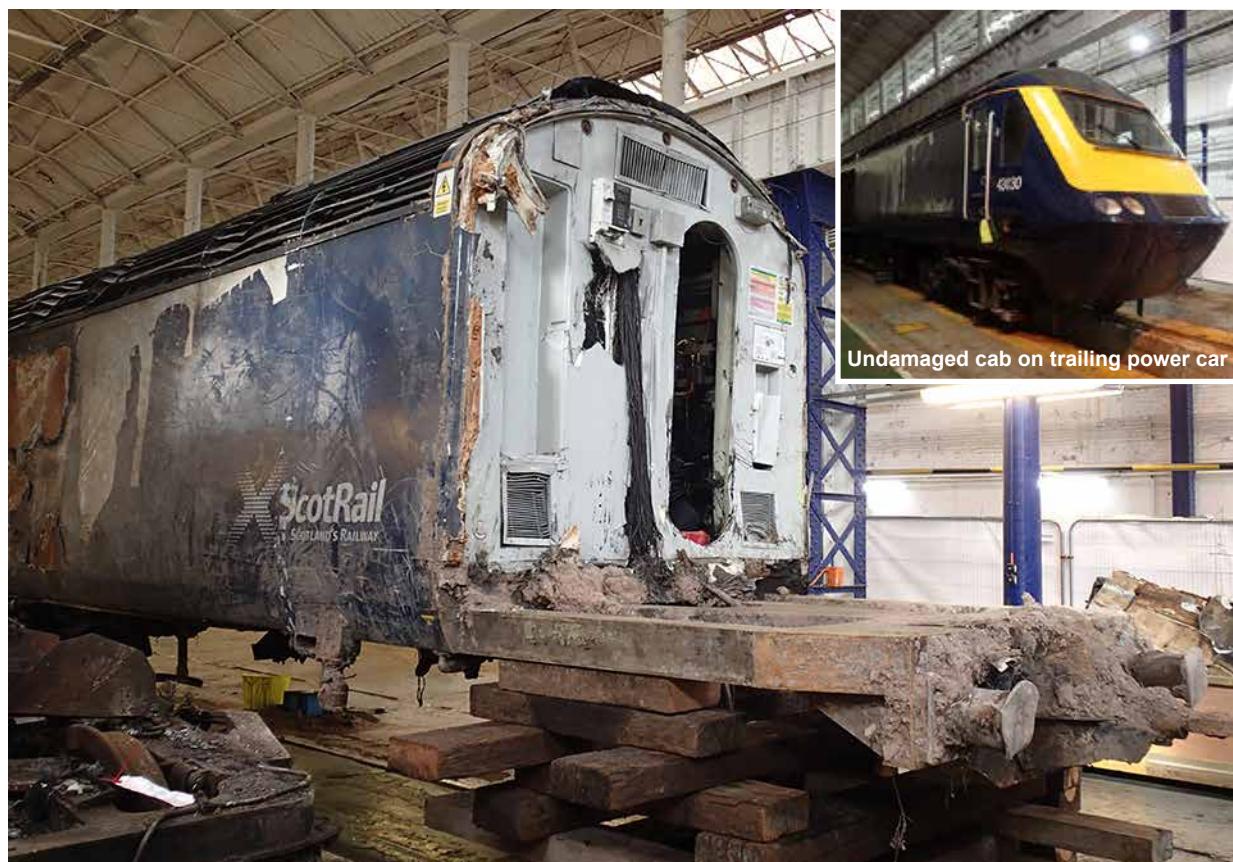
Figure 72: Front of leading power car (cab became detached during accident)

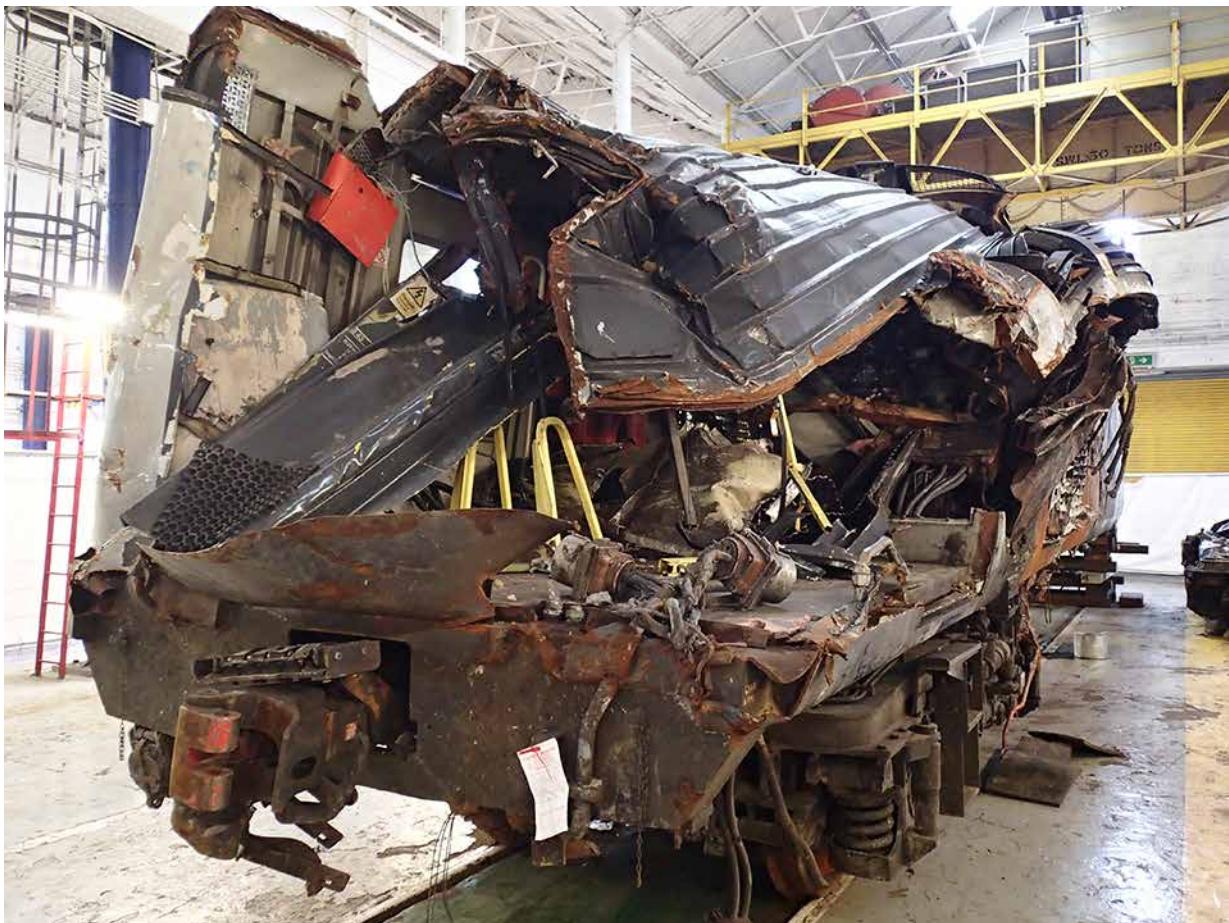
Figure 73: Damage to rear of leading power car

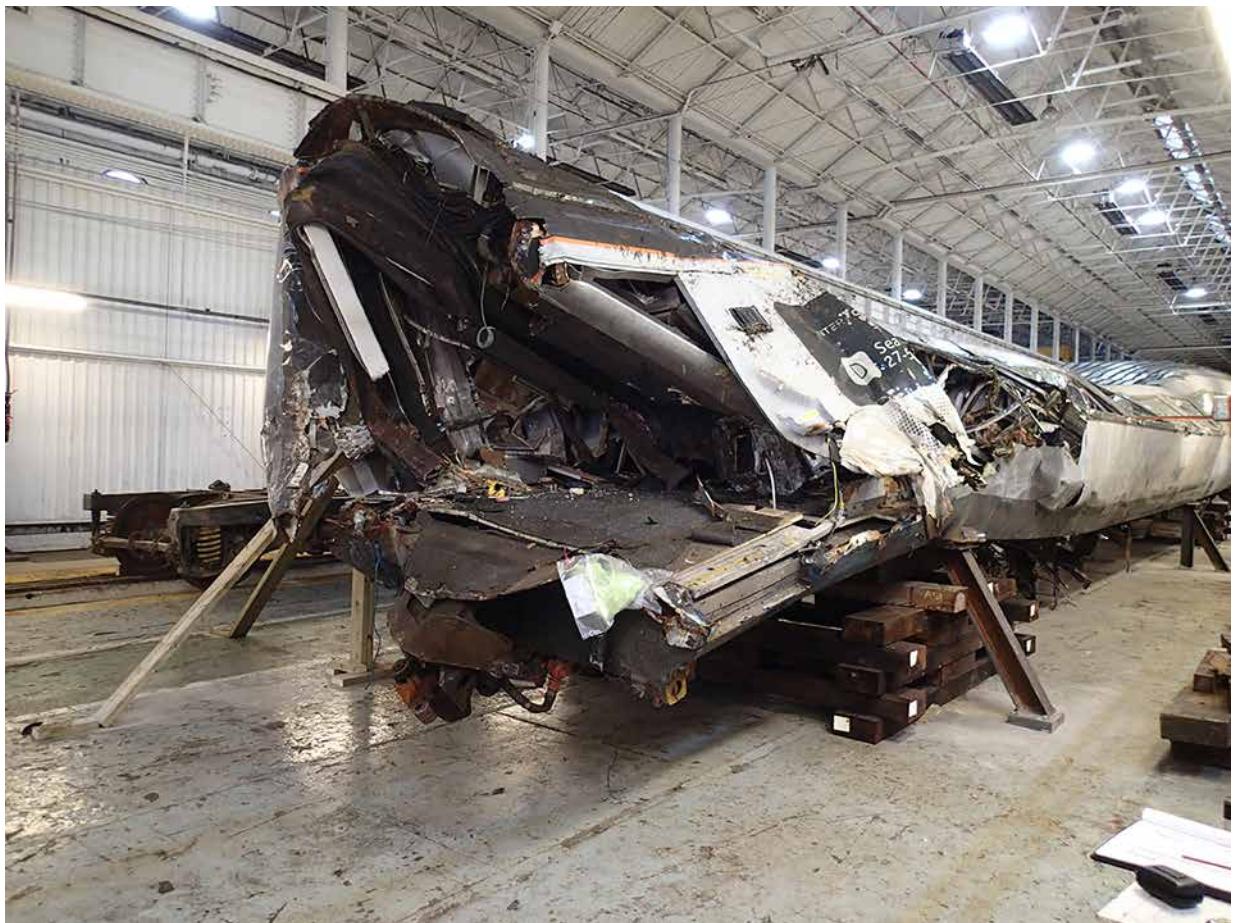
Figure 74: Damage to leading end of coach D

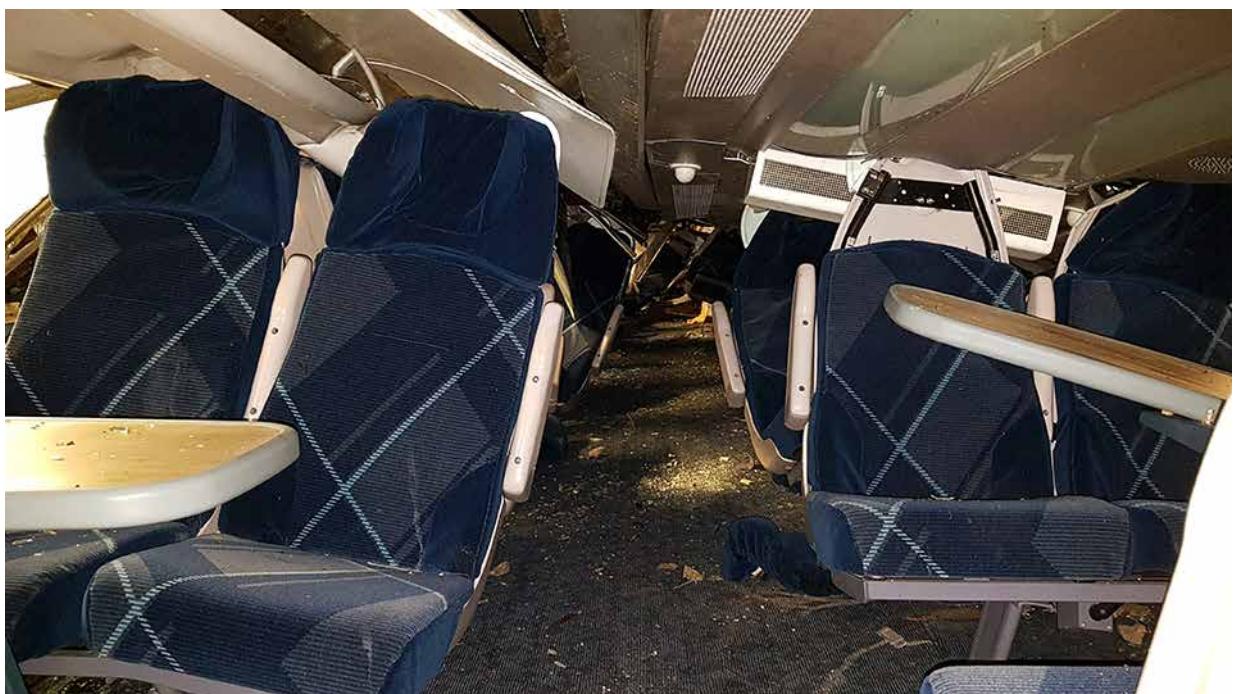
Figure 75: Interior damage at leading end of coach D

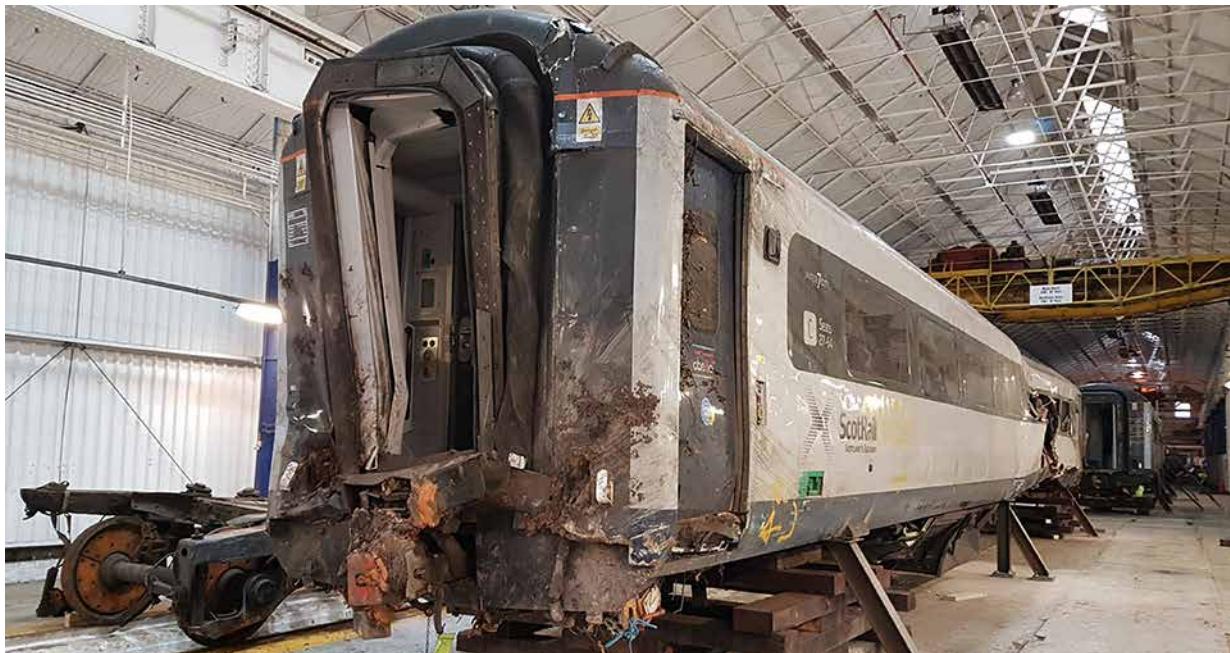
Figure 76: Leading end of coach C

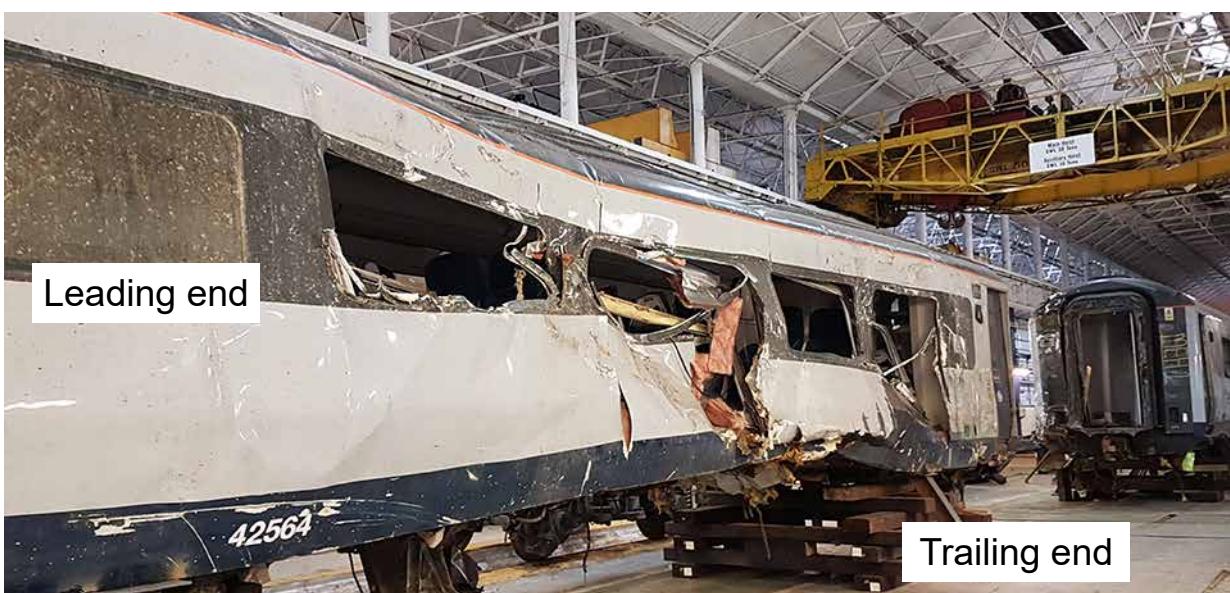
Figure 77: Penetration damage at trailing end of coach C (left side)

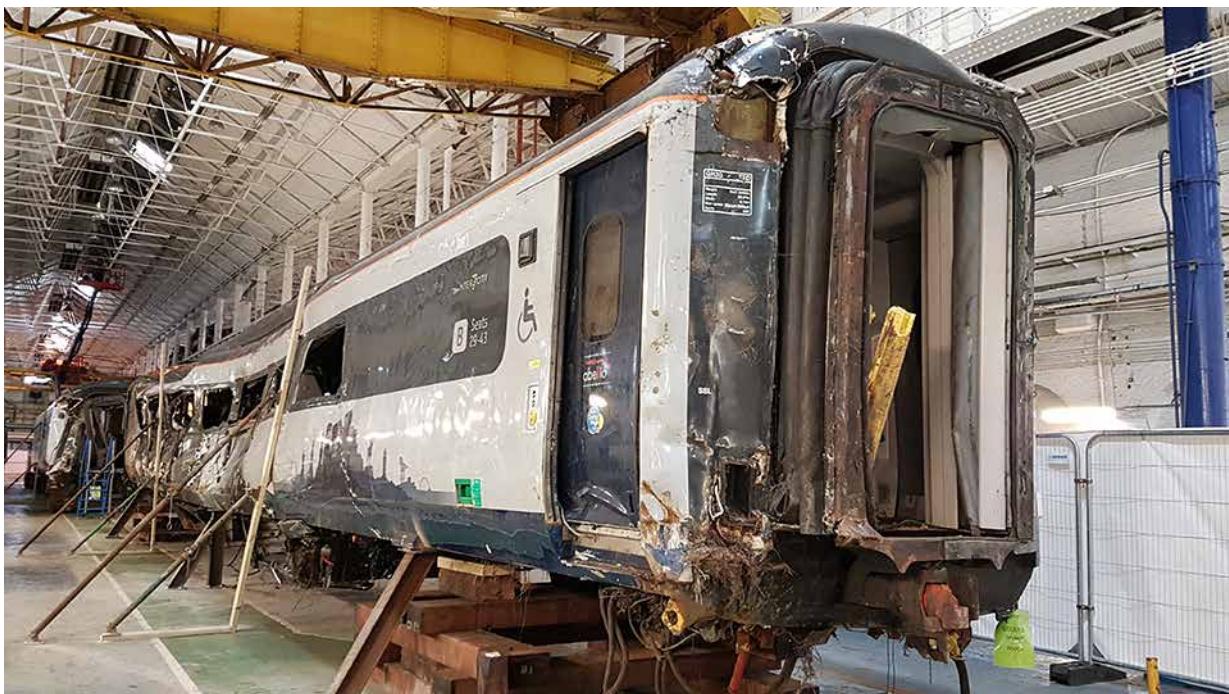
Figure 78: Damage to leading end and right side of coach B

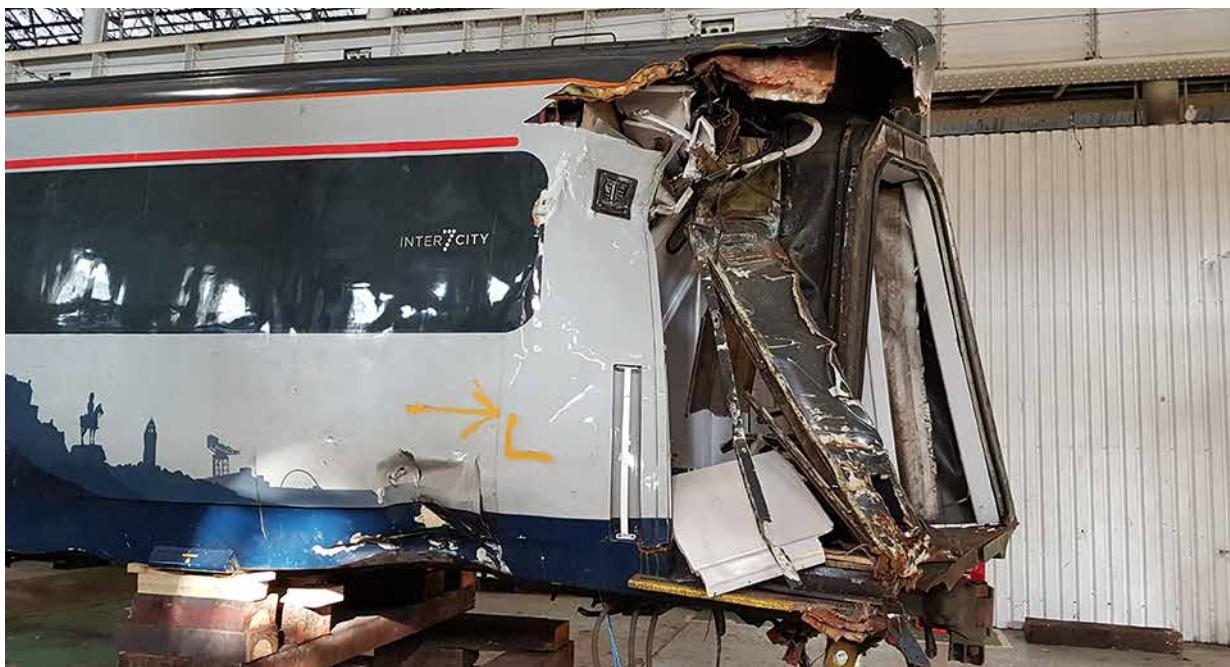
Figure 79: Damage to leading end of coach A

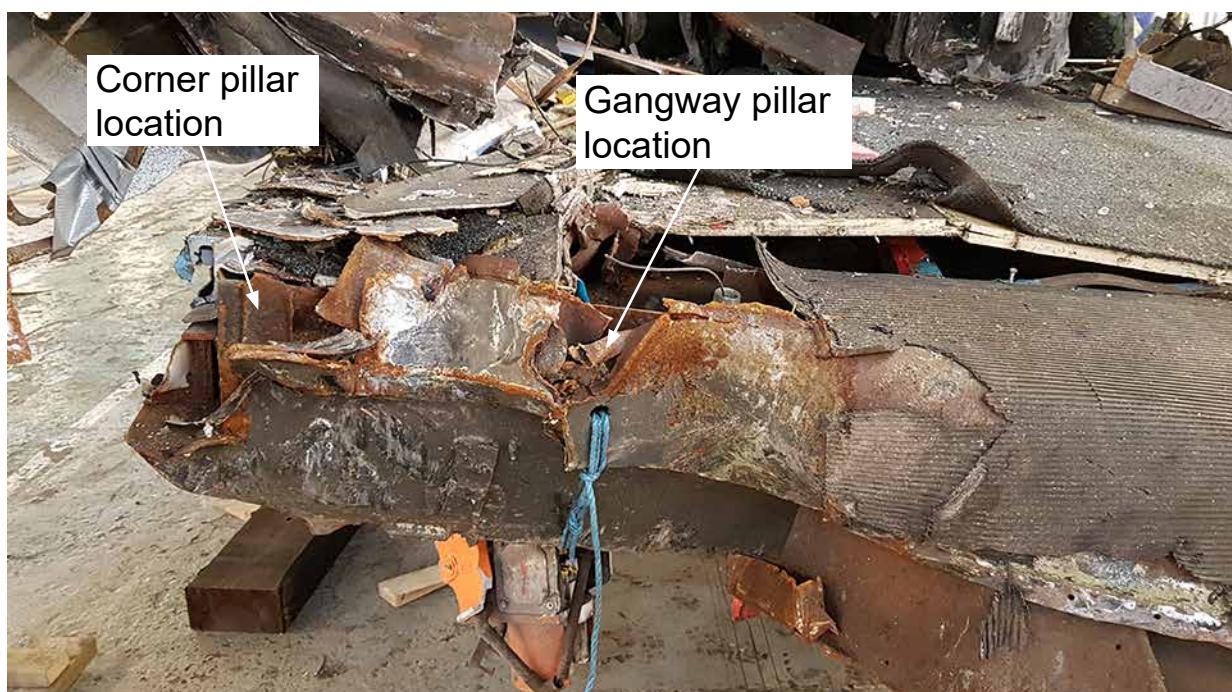
Figure 80: Corrosion on coach D at leading right-hand side of underframe at pillar locations

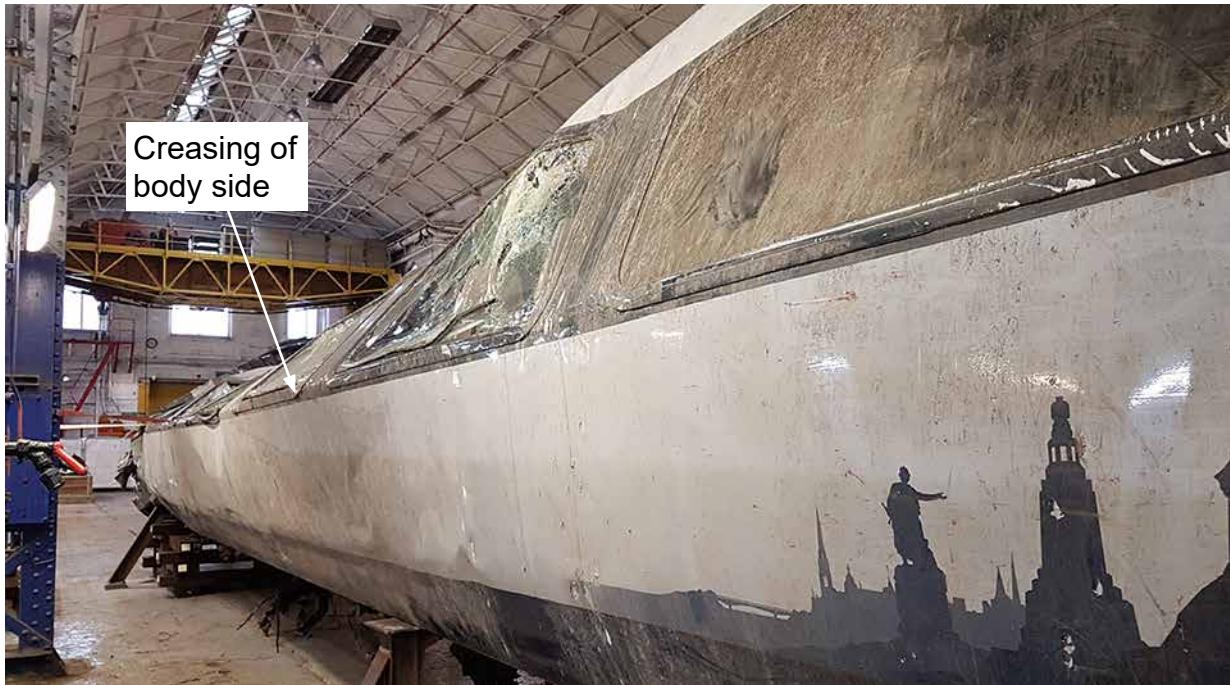
Figure 81: Creasing along left-hand bodyside of coach D
