Rail Accident Report

**Derailment of a passenger train at Carmont,
Aberdeenshire
12 August 2020**

Report 02/2022
v2 January 2024

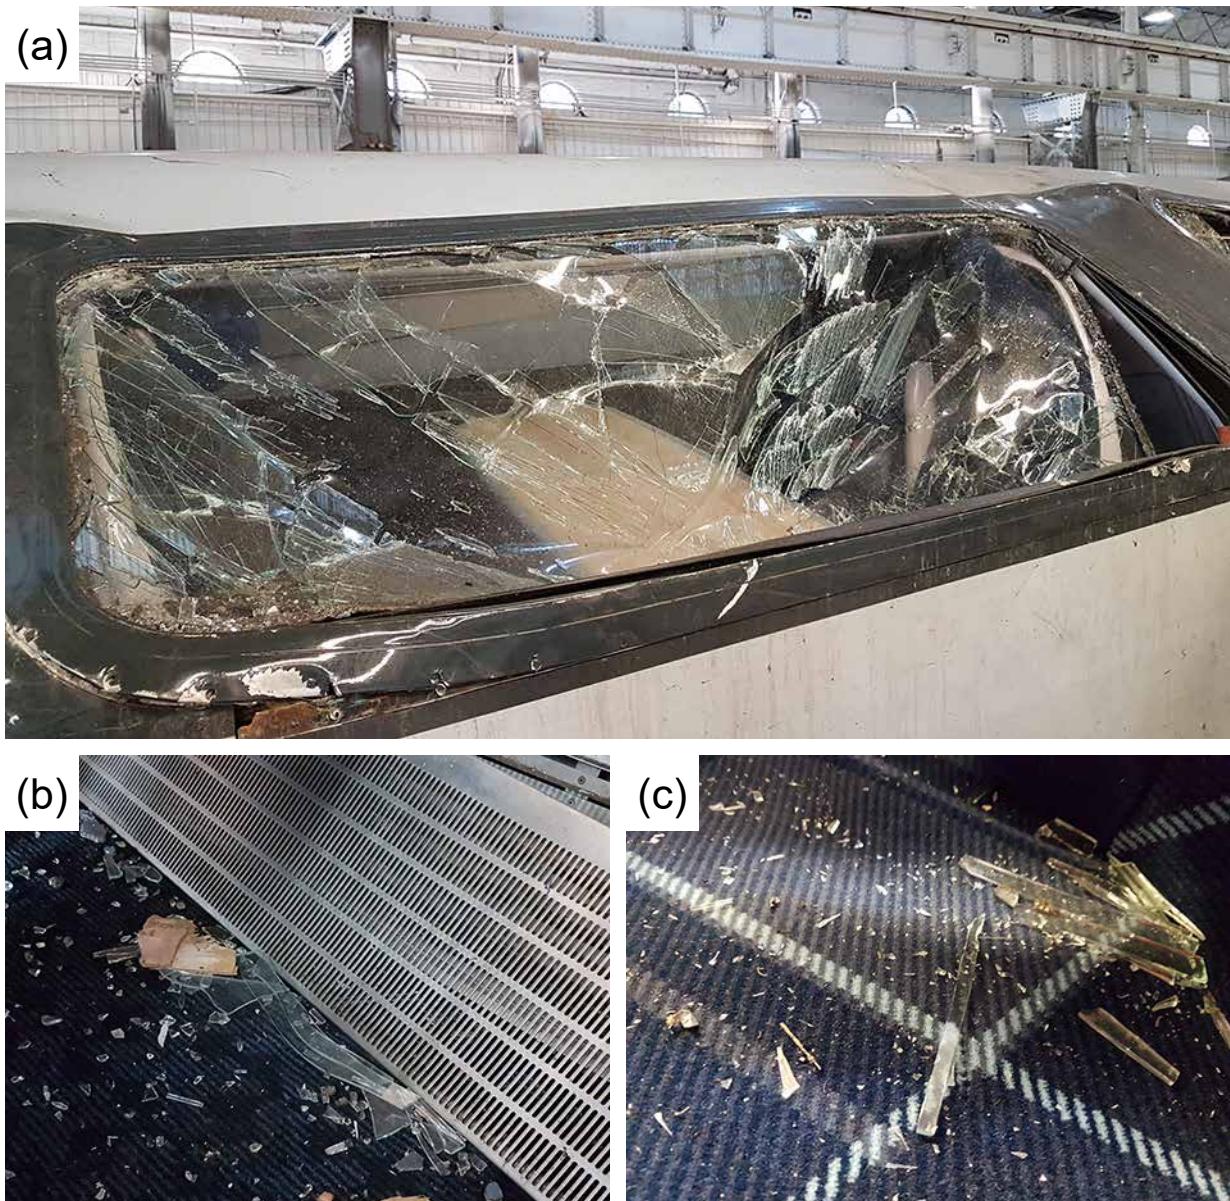
- c) Of the 61 main bodyside windows on the passenger coaches, 22 windows were found to be completely broken through (that is, there was no glass left to provide passenger containment) during a post-accident inspection. Most of the windows that were completely broken through were in areas that had suffered significant bodyside damage, or had failed due to the fire that broke out in the third coach. Examination of the interior of the leading coach showed that many large shards of glass had become detached from the inner laminated pane of the window. Both passengers who survived the accident in the leading coach suffered laceration injuries which may have been caused by these pieces of broken glass.

Figure 85: A broken window on coach D with remnants of inner laminated pane (a), ingress of large shards on the floor (b) and on a seat (c)

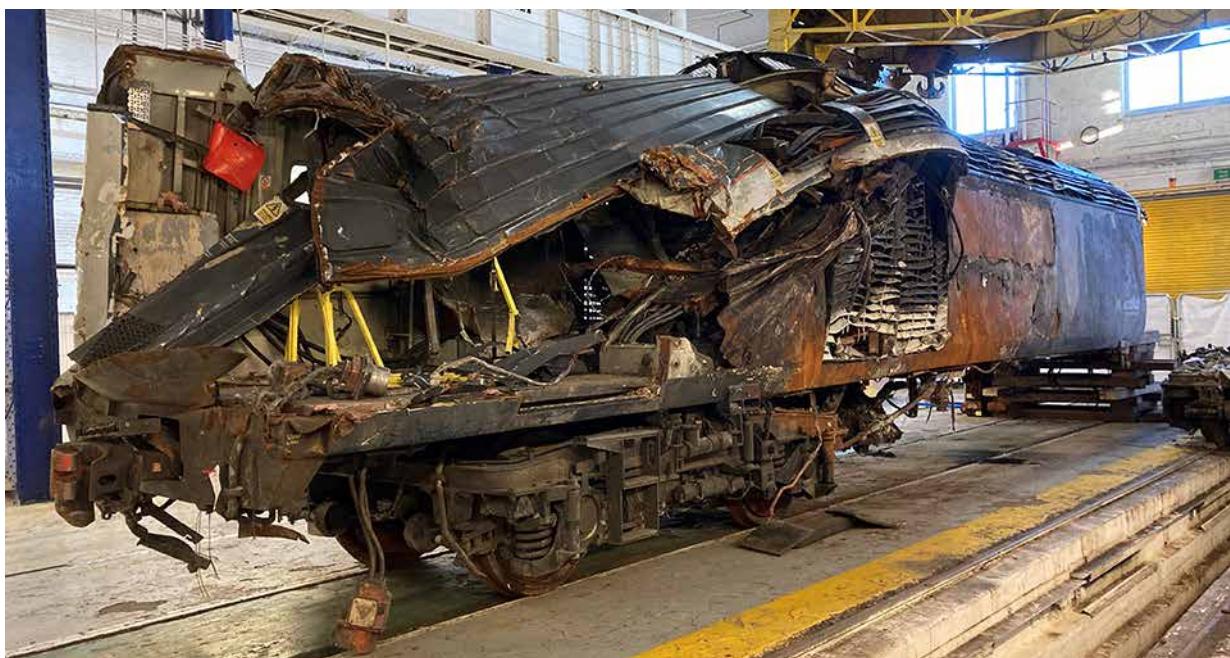
Figure 87: Fire-damaged leading power car

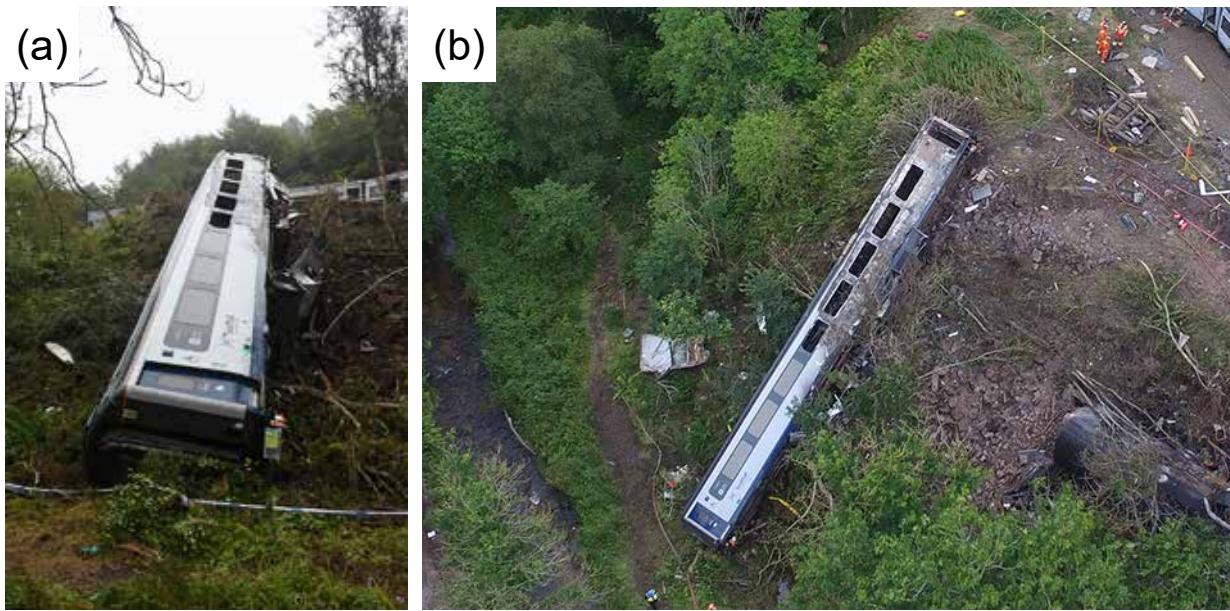
Figure 91: Coach B showing fire damage viewed (a) from bottom of embankment and (b) from overhead

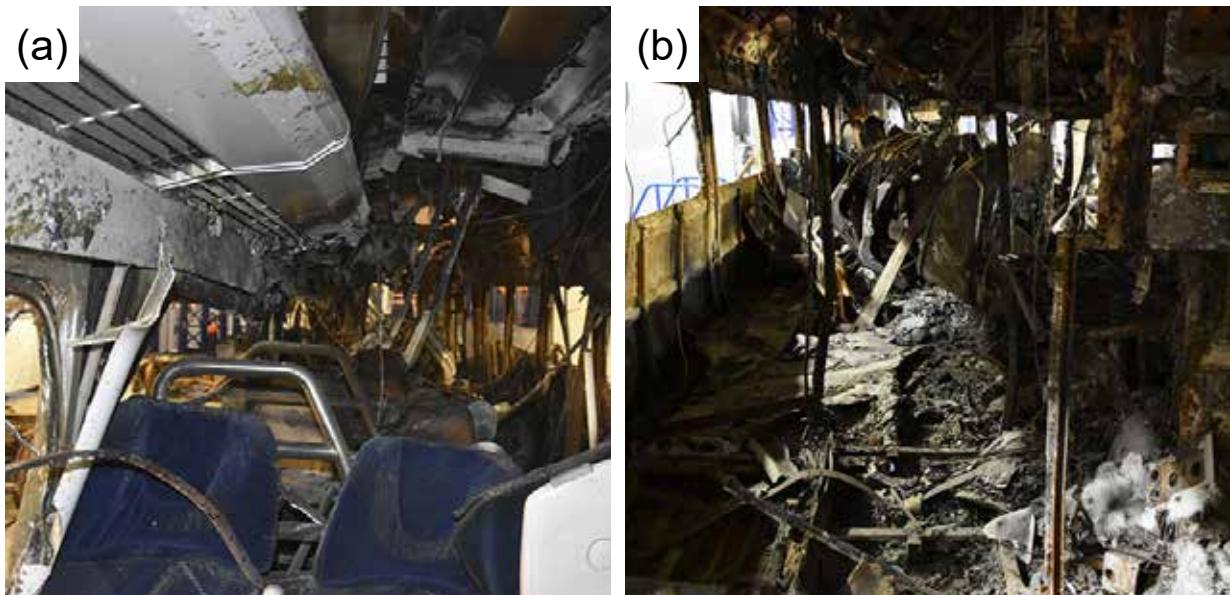
Figure 92: Coach B interior without fire damage at leading end (a) and fire damaged at trailing end (b)

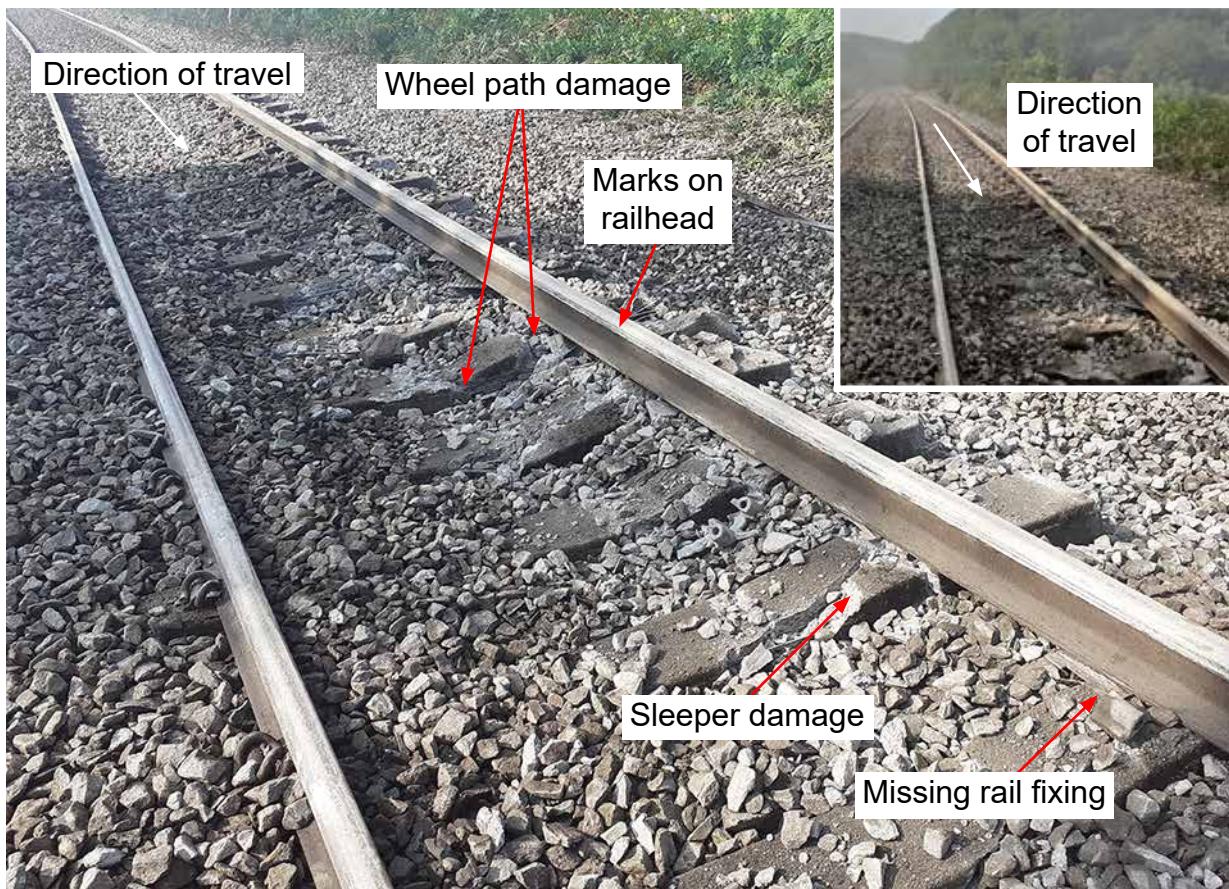
Figure F.1: Track damage looking south from sleeper 80 back towards washout location at 10:35 hrs on 12 August 2020 (Story Contracting)

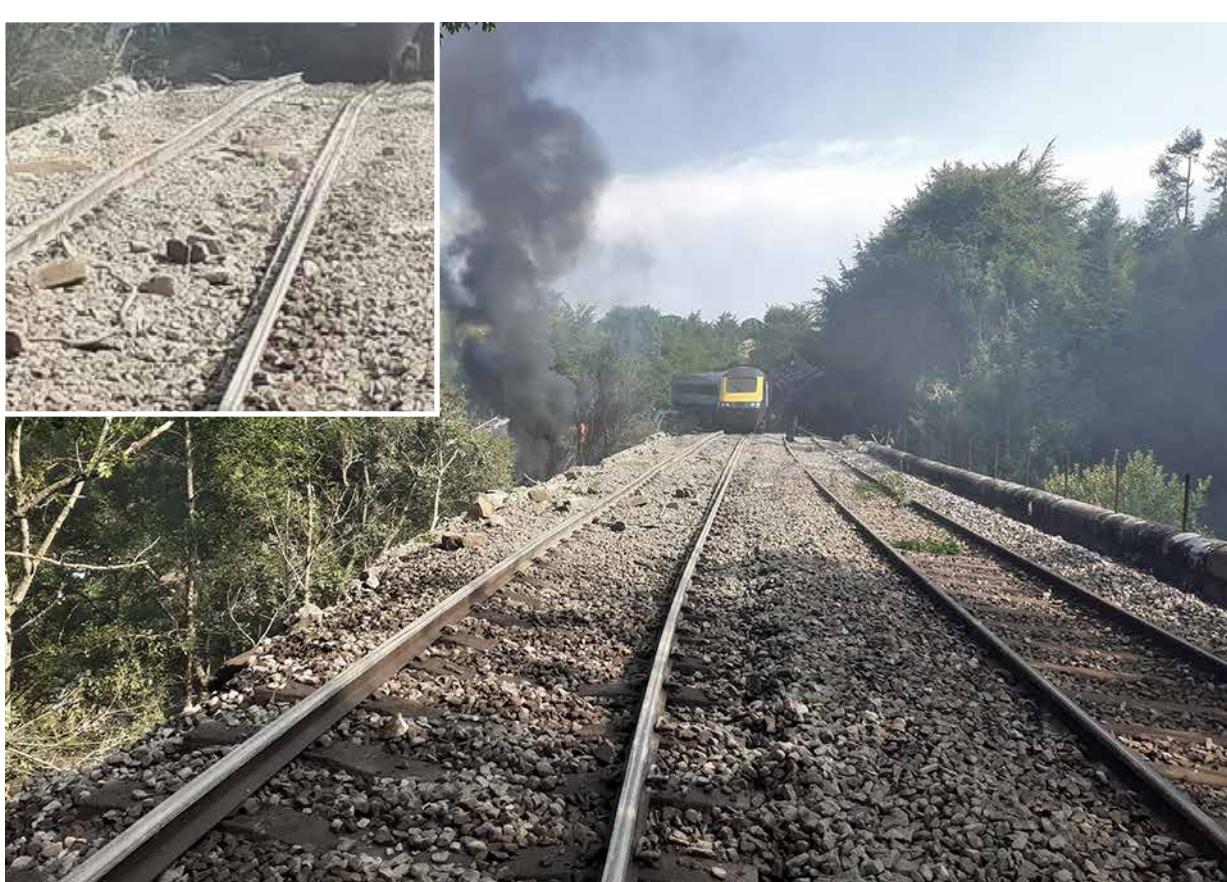
Figure F.2: Track damage across bridge 325 at 10:35 hrs on 12 August 2020 (Story Contracting)

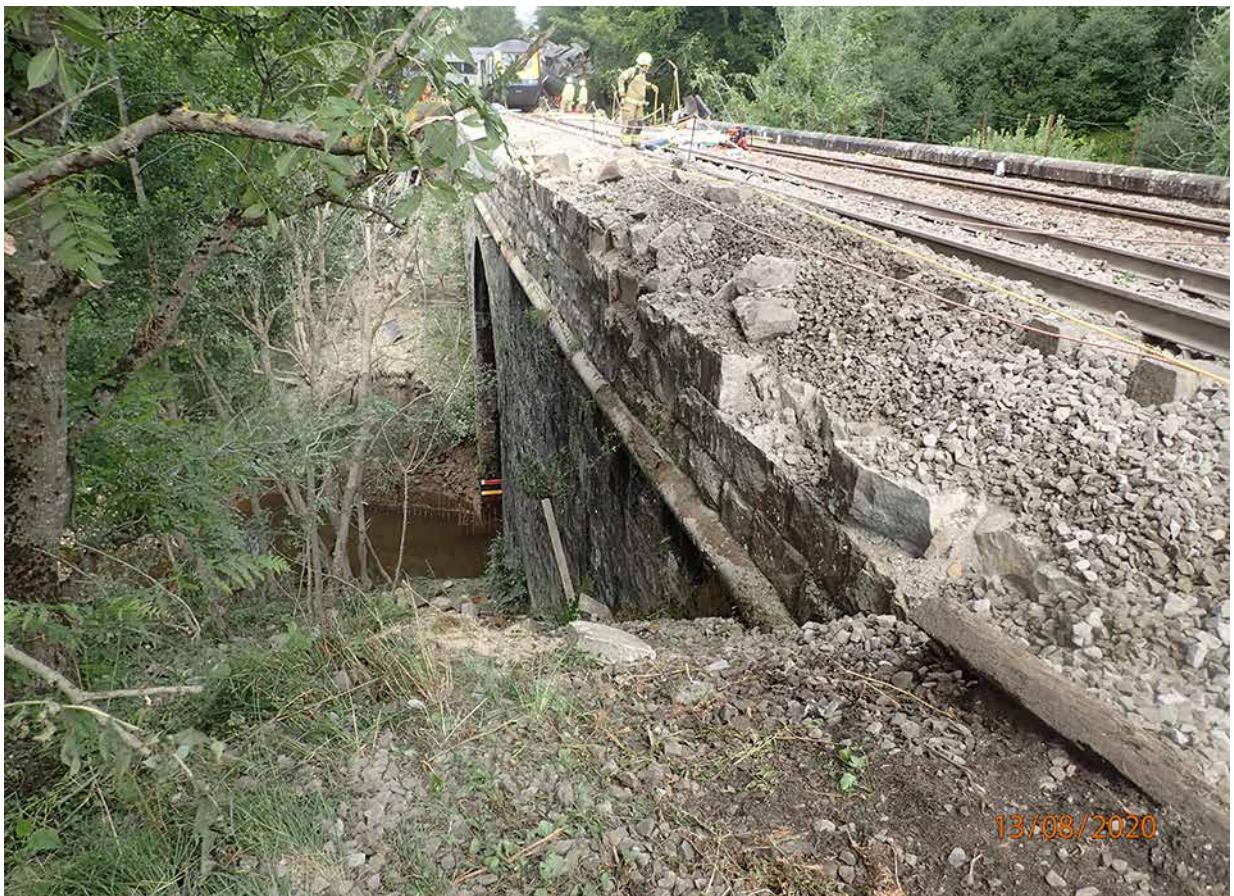
Figure F.5: Down-side parapet looking north showing damage to the parapet end

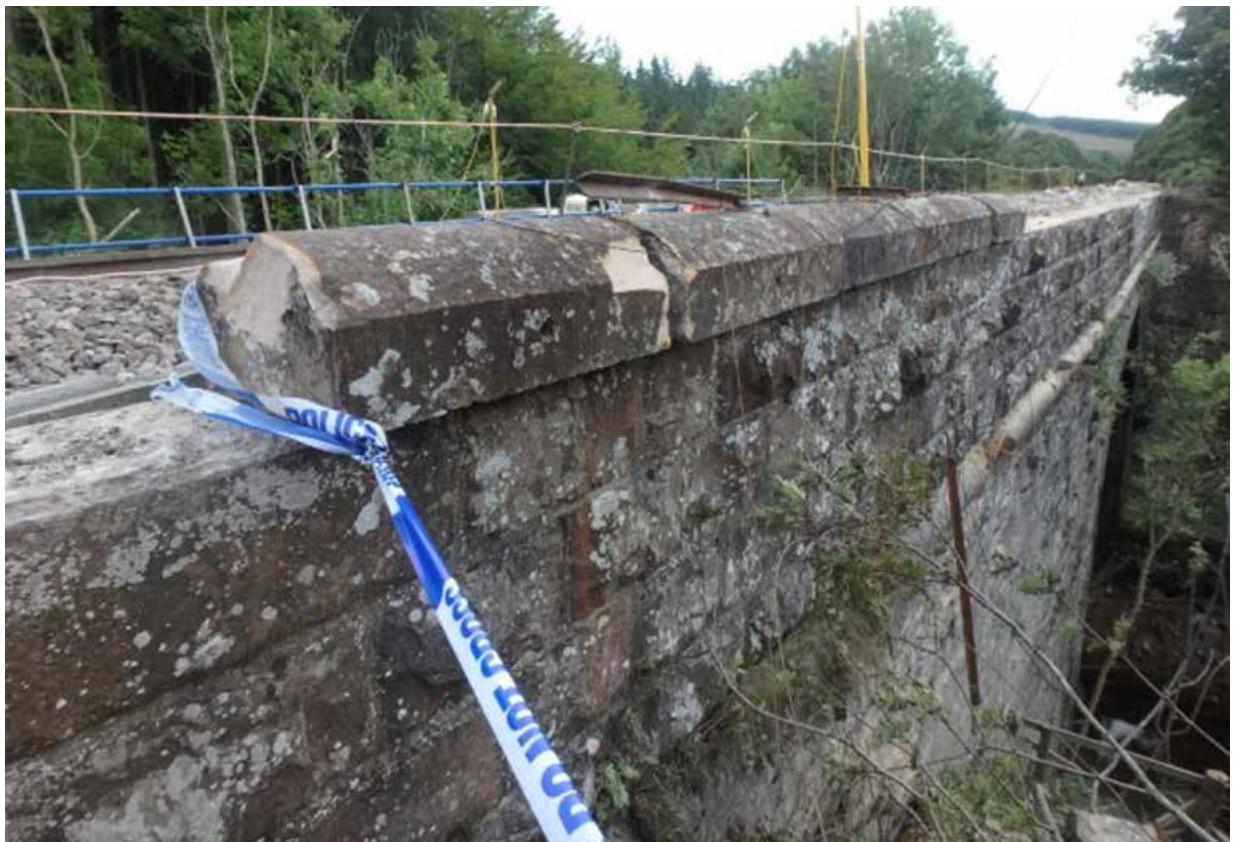
Figure F.6: Down-side parapet looking south showing remaining coping stones (Amey)

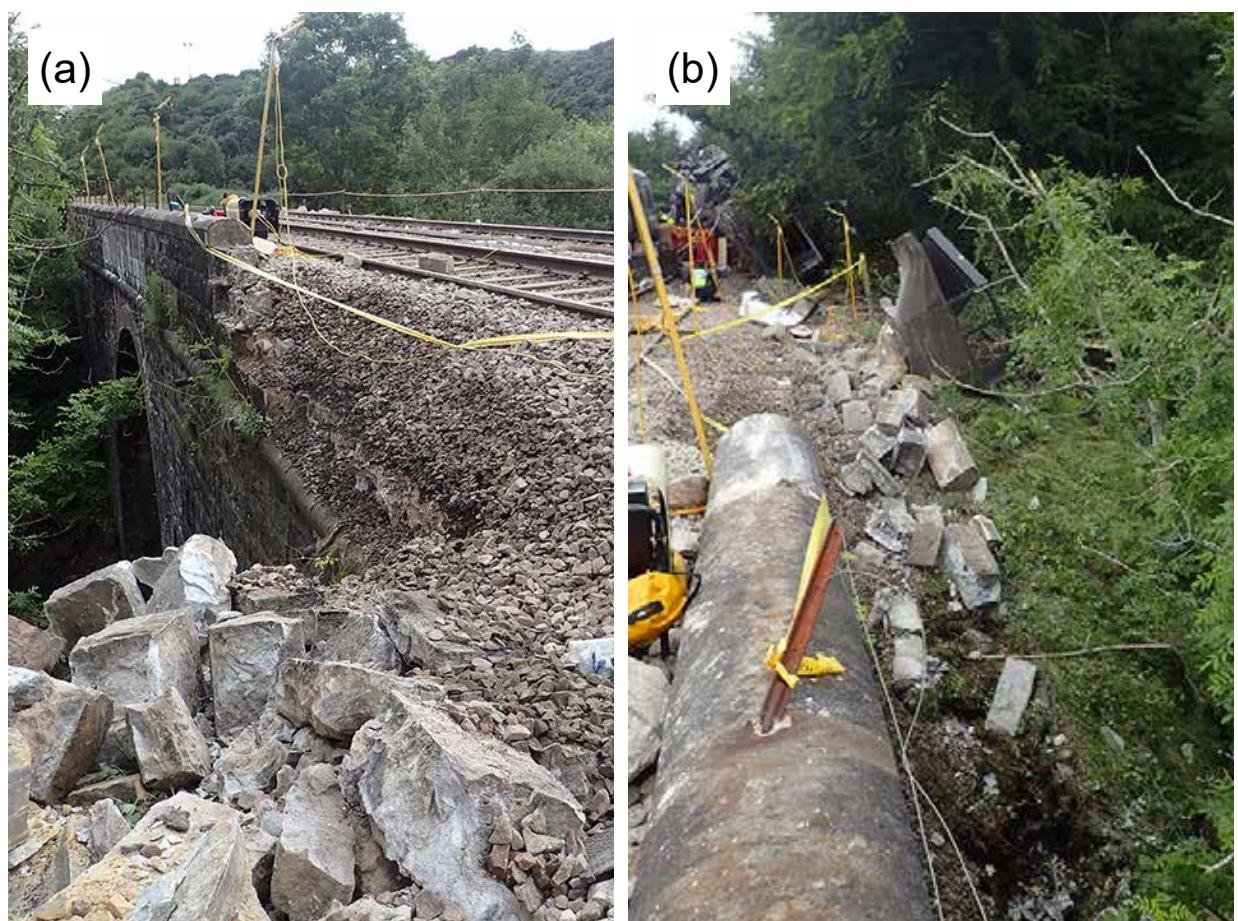
Figure F.8: Up-side parapet damage (a) looking south and (b) looking north

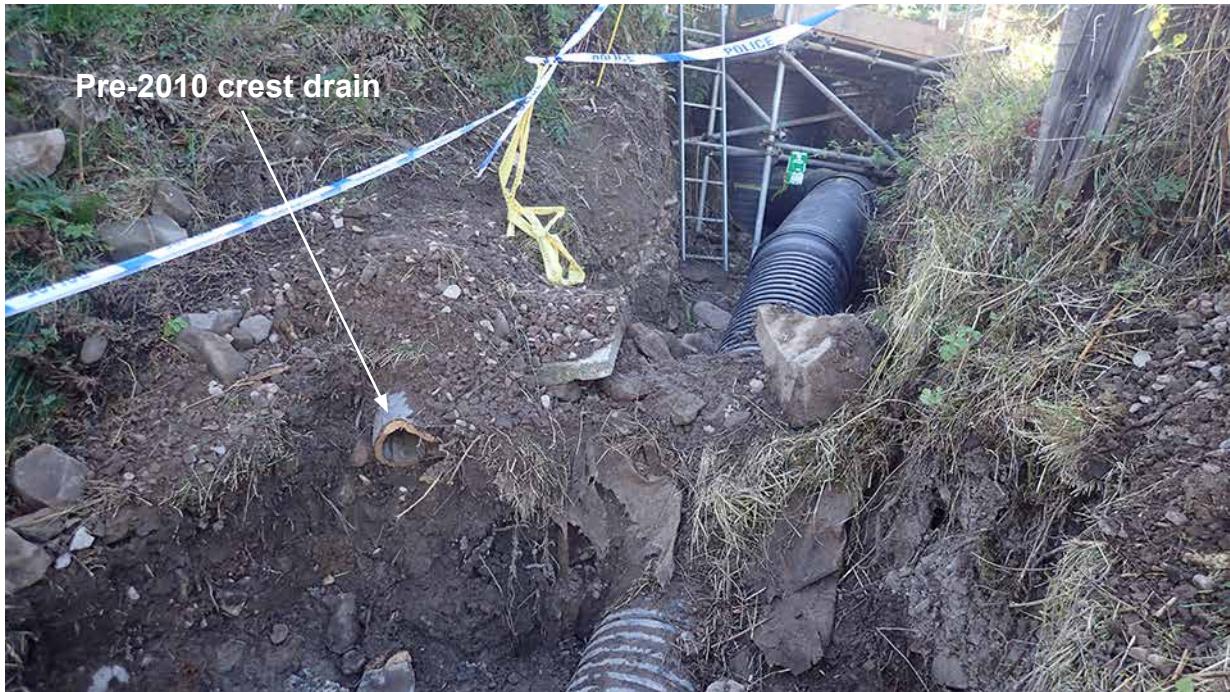
Figure G.4: Image looking upslope from near CP19 towards CP18 showing damaged end of pre-2010 crest drain close to the as-designed position of CP18. Photograph taken during post-accident investigations with scaffolding over as-built position of CP18 visible in background

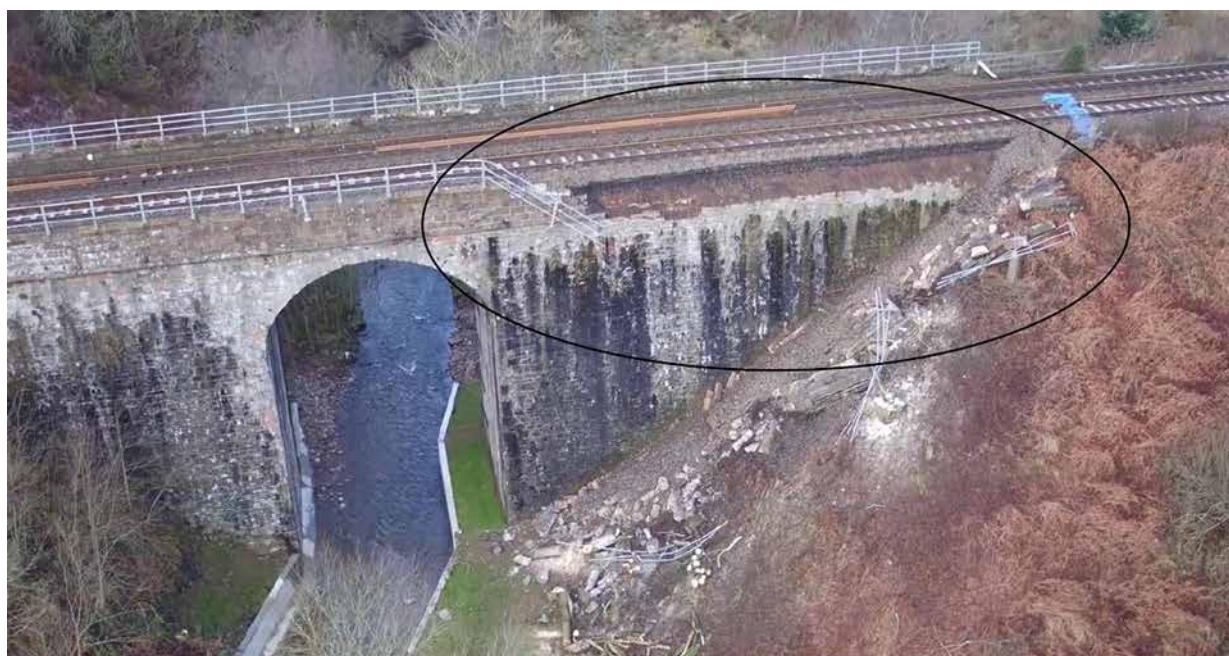
Figure M.1: South-east corner of bridge 328 following the failure of part of its parapet wall on 15 January 2021 (Network Rail)
