AAIB Bulletin

5/2022

Aircraft Type and Registration:	Silent 2 Electro, G-CIRK	
No & Type of Engines:	1 FES electric motor	
Year of Manufacture:	2013 (Serial no: 2054)	
Date & Time (UTC):	23 April 2021 at 1305 hrs	
Location:	Wormingford Airfield, Colchester, Essex	
Type of Flight:	Private	
Persons on Board:	Crew - 1	Passengers - None
Injuries:	Crew - 1 (Serious)	Passengers - N/A
Nature of Damage:	Aircraft destroyed	
Commander's Licence:	Light Aircraft Pilot's Licence (Sailplanes)	
Commander's Age:	71 years	
Commander's Flying Experience:	295 hours (of which 55 were on type) Last 90 days - 13 hours Last 28 days - 13 hours	
Information Source:	AAIB Field Investigation

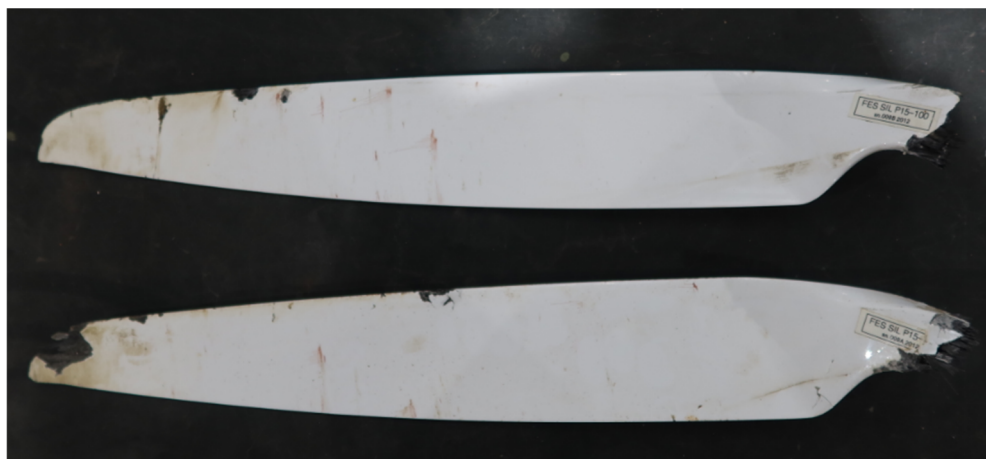
The electric motor was too severely damaged to test, but the separated propeller blades indicated that the motor was rotating at impact. As well as the root damage, the propeller blades had leading edge nicks and one blade had tip damage (Figure 9).

Figure 9
Propeller blade damage

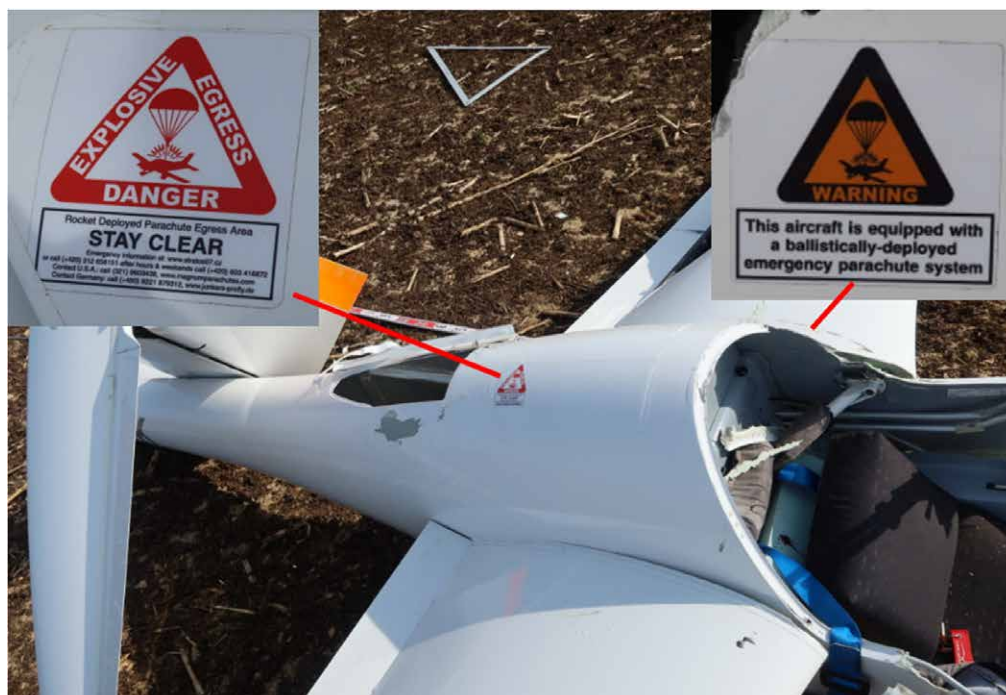
Two placards were affixed to the fuselage aft of the cockpit to warn people about the hazards from the rocket and parachute (Figure 14). These placards conformed to the requirements in ASTM F2316-12²⁸. They did not conform to the placard requirements in BCAR Section S²⁹, sub-section K on 'Microlight Parachute Recovery Systems', which require the 'DANGER' placard to be larger than that specified in ASTM F2316-12³⁰, and which also require a double offset black and yellow chequered line to surround the parachute and rocket exit area (Figure 15). As an SSDR the Silent 2 Electro is not required to meet BCAR Section S; however, the CAA published Skywise article SW2021/91³¹ on 29 April 2021 which stated that: 'The CAA strongly recommends that owners of SSDRs fitted with a BPRS comply with the requirements of BCAR Section S, Sub-Section K, to clearly identify the presence of the BPRS to emergency services and first responders in the event of an accident.'

Figure 14
BPRS placards on G-CIRK

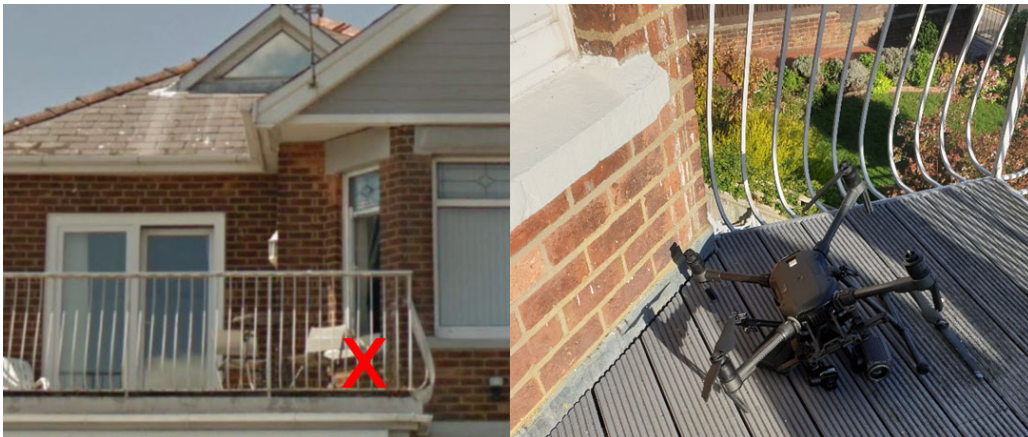
The pilot and observer packed their kit and drove to the last location of the aircraft shown on the map display. When they arrived in the area of the last position, the controllers regained communication with the aircraft and displayed its GPS coordinates. They found the aircraft on a first-floor balcony of a house (Figure 2). There was no one at the front of the property but there was light foot traffic along the path by the lake, about 30 m from the aircraft's location. The aircraft's right leg had snapped at the mounting bracket, three propeller blades had shattered, and one propeller had detached but was located next to the aircraft.

Accident site location and damage to UA

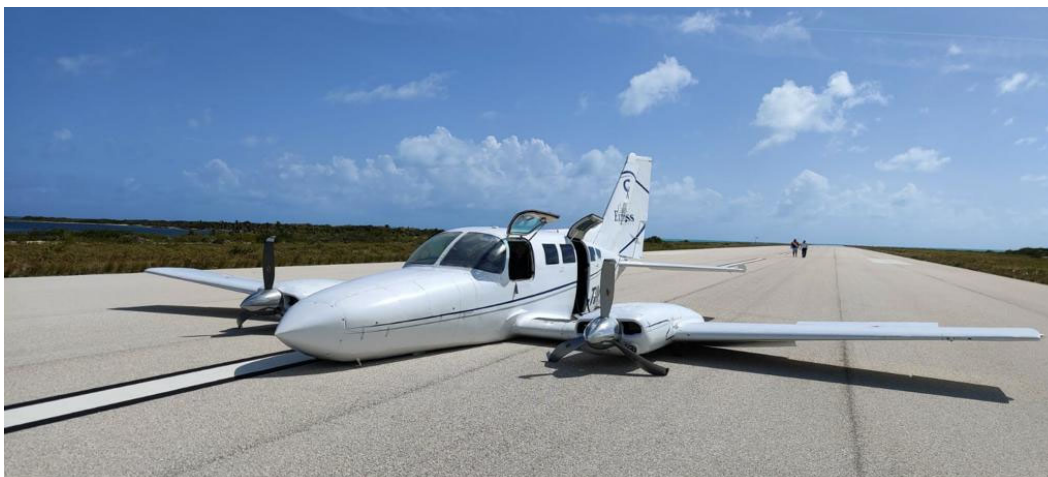
The aircraft sustained extensive damage to its flaps, propellers and underside, and both engines were shock-loaded.

Figure 1
VQ-TIN after landing

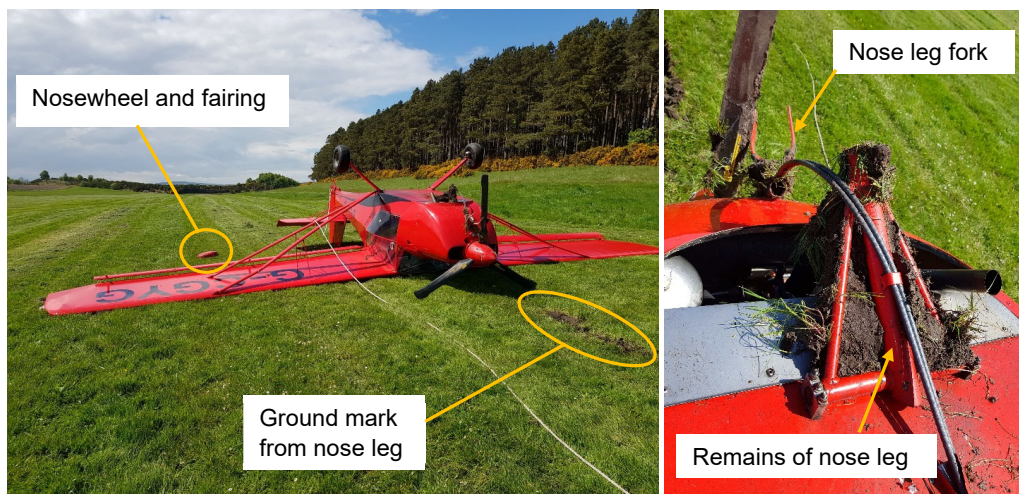
The aircraft pitched over onto its roof and, right, the snapped nose leg

The nose leg was bent downwards from its fitted orientation and had snapped at the point where the shock absorber bracket had been welded to the upper surface of the nose leg. Examination of the leg and the fracture surfaces showed that it failed in overload.

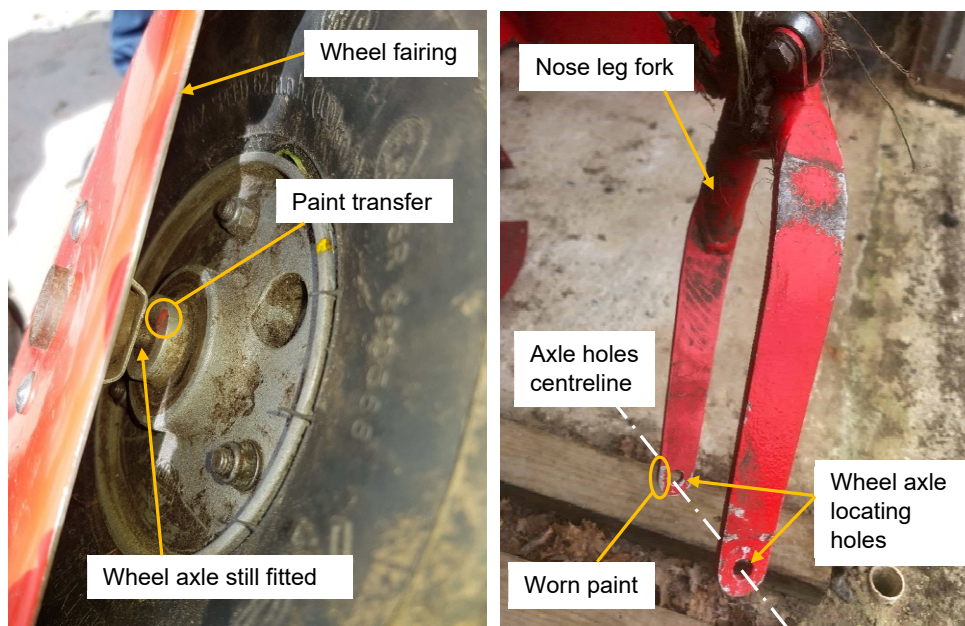
Nosewheel and fairing showing paint transfer and nose leg fork showing paint wear

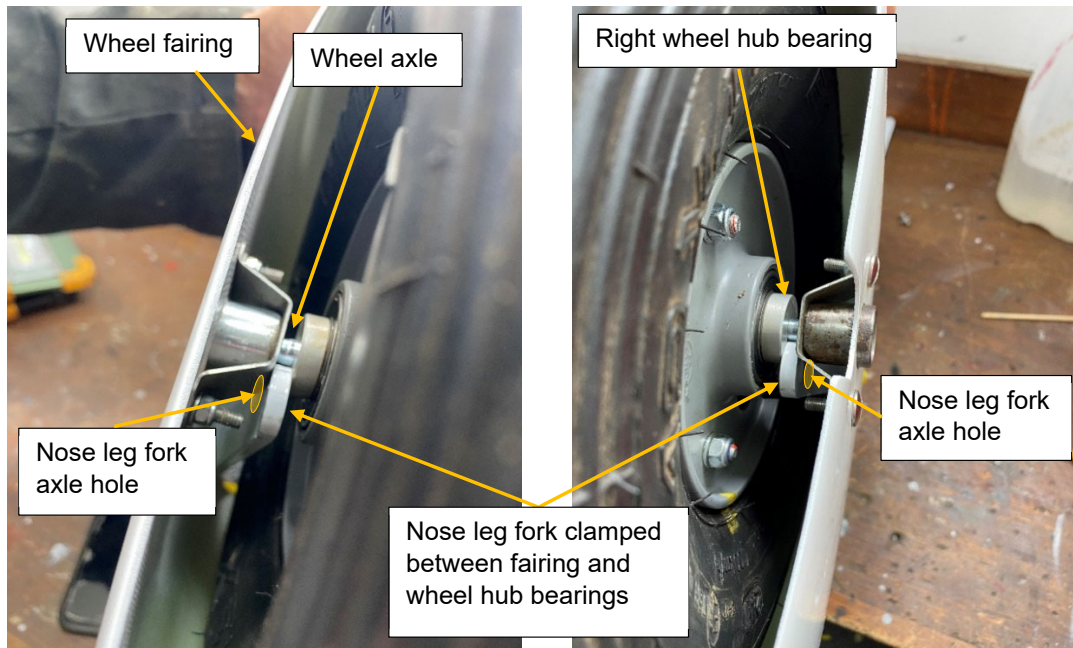
Figure 5 shows the axle not routed through the nose leg fork. Instead, the nose leg fork is clamped between the wheel hub bearings and the fairing.

Nose leg fork clamped between the fairing and left and right hub bearings but with the wheel axle not routed through the nose leg fork axle holes

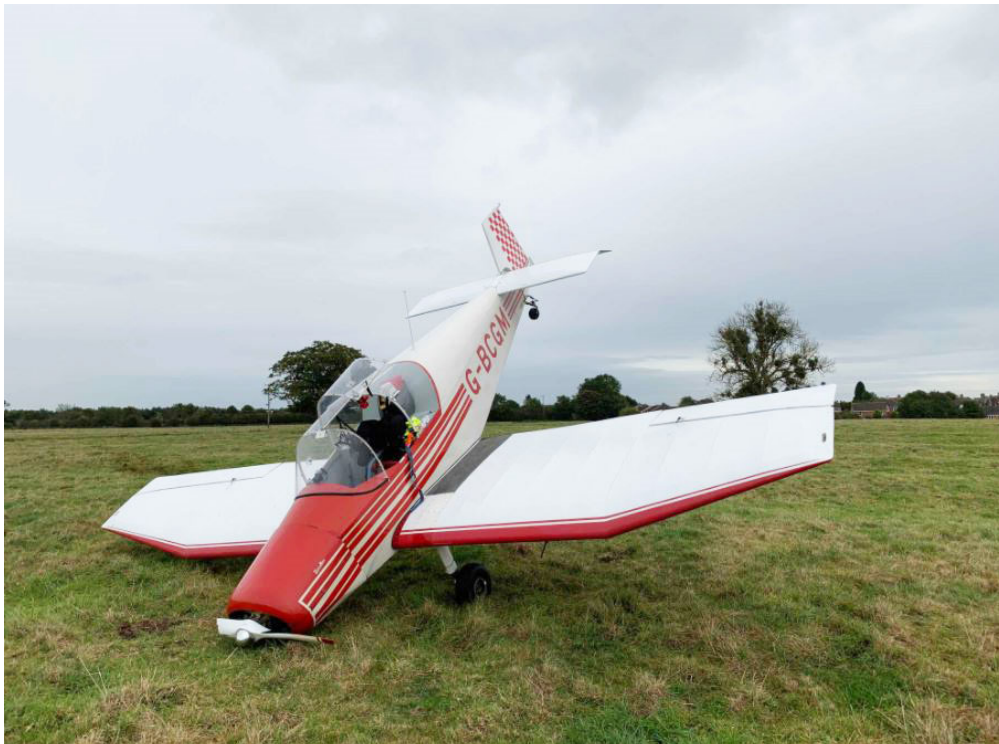
the right landing gear leg dug into the ground (Figure 1). The pilot was not injured and was able to vacate the aircraft without difficulty.

G-BCGM following the forced landing

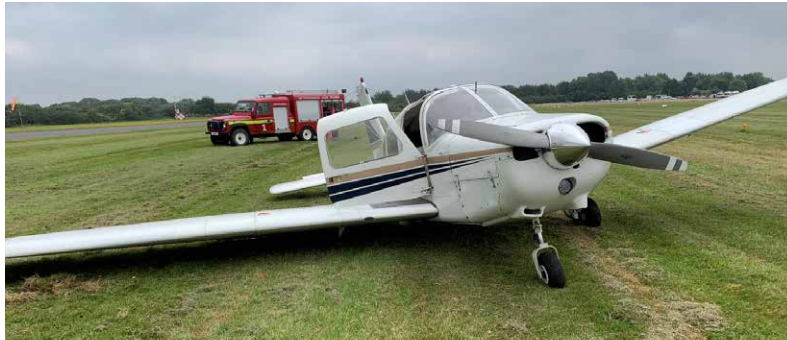
Figure 1
G-BRBA after the accident

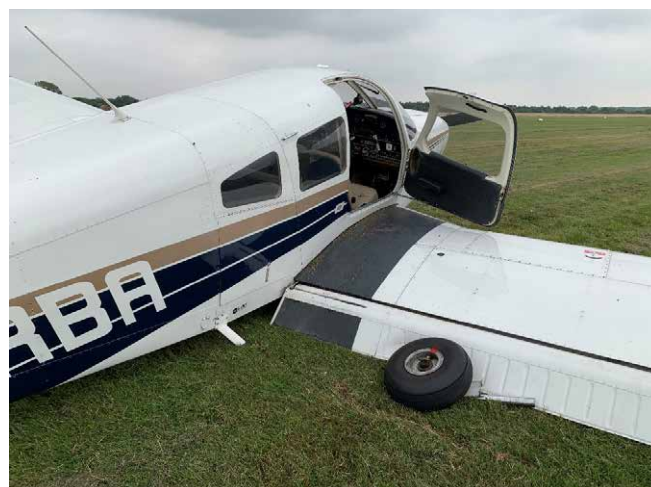
Inspection of the aircraft showed that the lower section of the right landing gear oleo had come out of the upper cylinder. The wheel assembly had remained attached to the aircraft by the flexible brake hose. The assembly had become wedged on the back of the right-wing flap (Figure 2 and 3). Abrasion on the brake calliper showed that as the aircraft landed and the right wing dropped, the aircraft slid on the underside of the wedged wheel assembly. The remaining upper portion of the landing gear oleo was undamaged and did not appear to have contacted the runway.

Figure 2
Right wheel assembly and lower portion of the oleo wedged on the flap

The right flap was damaged where the wheel assembly had become wedged on the flap. There were also puncher marks on the underside of the wing where the loose wheel assembly had been flailing below the wing.

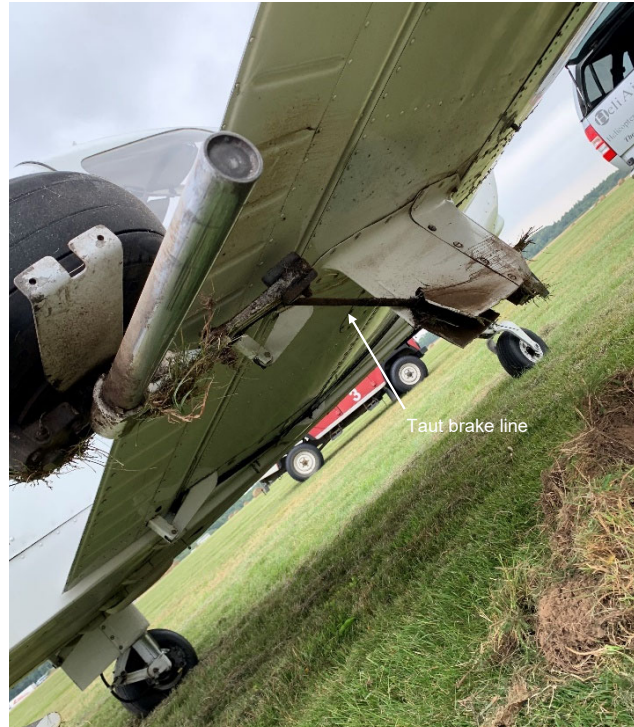
Right wheel assembly viewed when the wing was lifted after the accident, showing the taut brake line

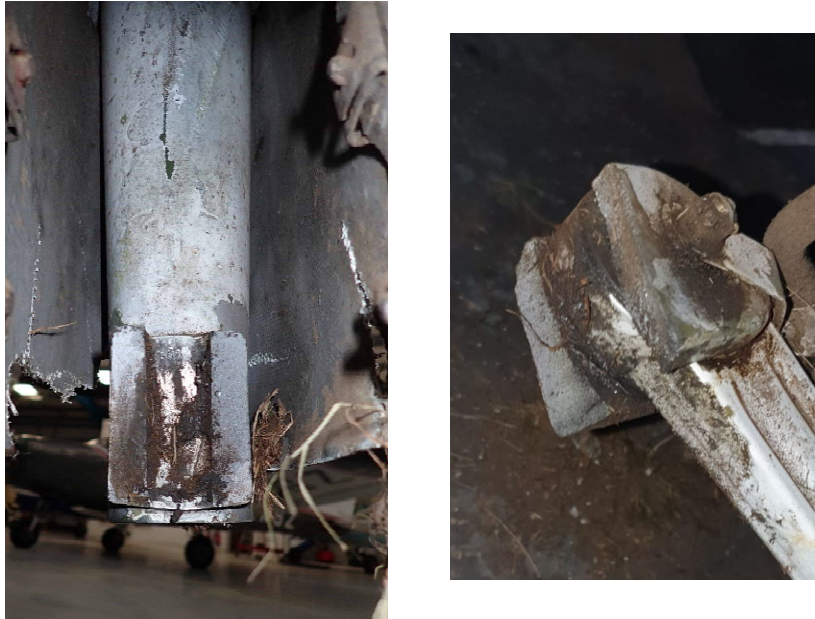
Right landing gear assembly showed the failed upper torque link attachment lugs

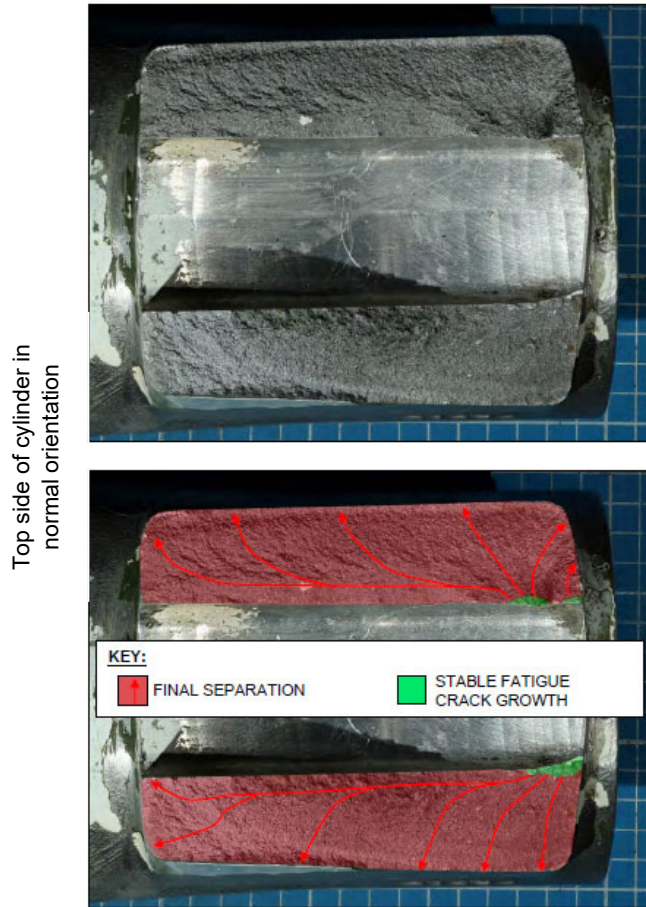
SB 1131A required an inspection by liquid penetrant if cracks could not be seen with a magnifying glass. Aluminium alloy castings typically have a degree of porosity. Surface breaking porosity often produces a degree of background fluorescence during dye penetrant inspection. In some cases, it can be difficult to differentiate such porosity from very small cracks. The inspections are conducted with the component on the aircraft which can also make it harder to see very small cracks.

Fracture surface on the landing gear upper cylinder

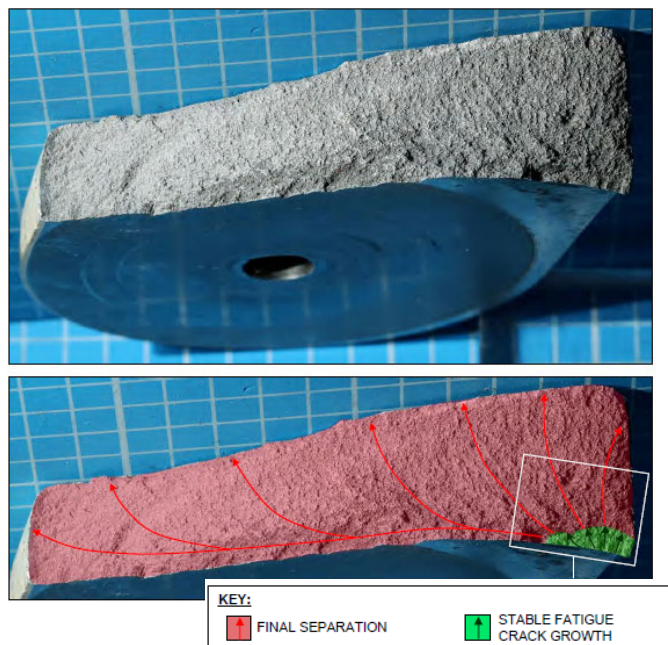
View of the left lug (similar cracks were found on the right lug)

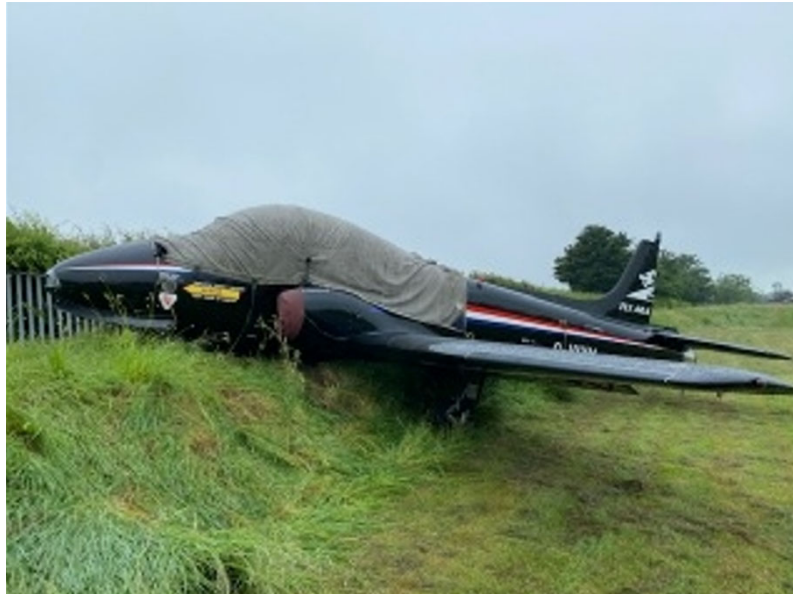
Figure 1
G-VIVM final position

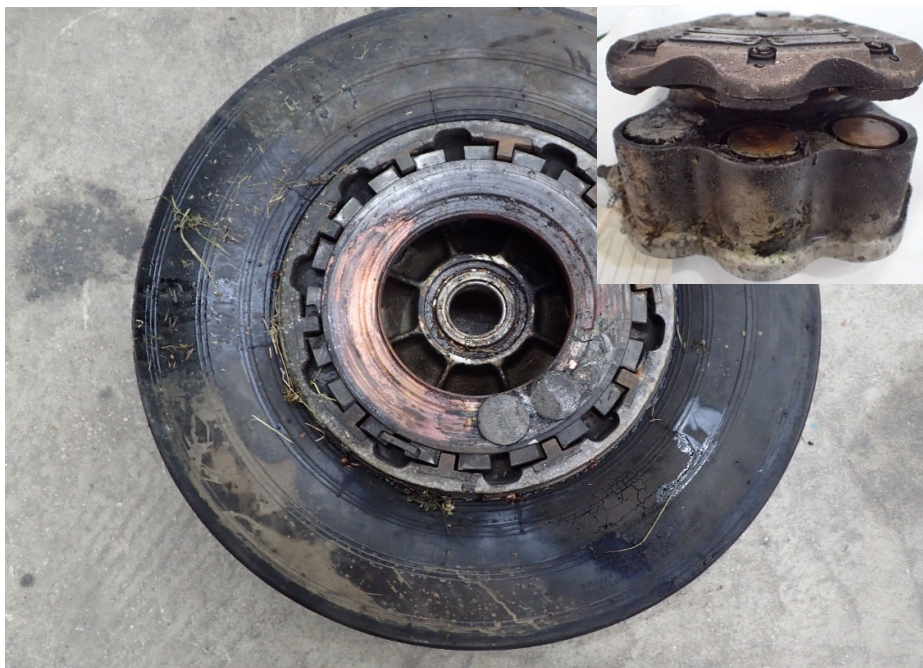
On the right wheel, two of the floating friction pads had fused to the disc and one was absent. Two pads found in the grass close to the left landing gear exhibited heavy wear; the third was absent. The recovered floating friction pads were not evenly worn across the entire surface area, but measured thickness ranged from 3.71 mm – 5.80 mm. This compared to a thickness of 16.05 mm for a new floating friction pad.

Right main landing gear wheel and brake disc.
Inset shows brake calliper and pistons

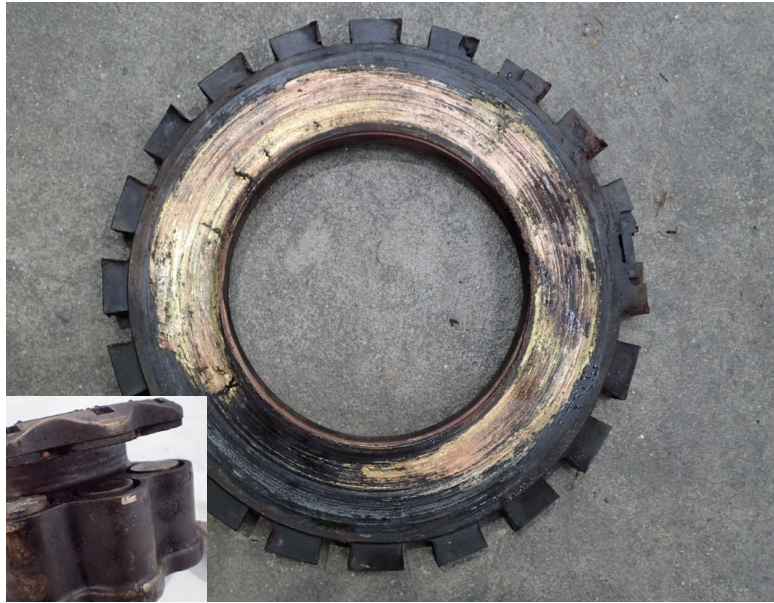
Left main landing gear brake disc.
Inset shows brake calliper and pistons
