Passenger trapped in doors and dragged at Wood Street station, north-east London, 14 January 2022

Summary of the incident

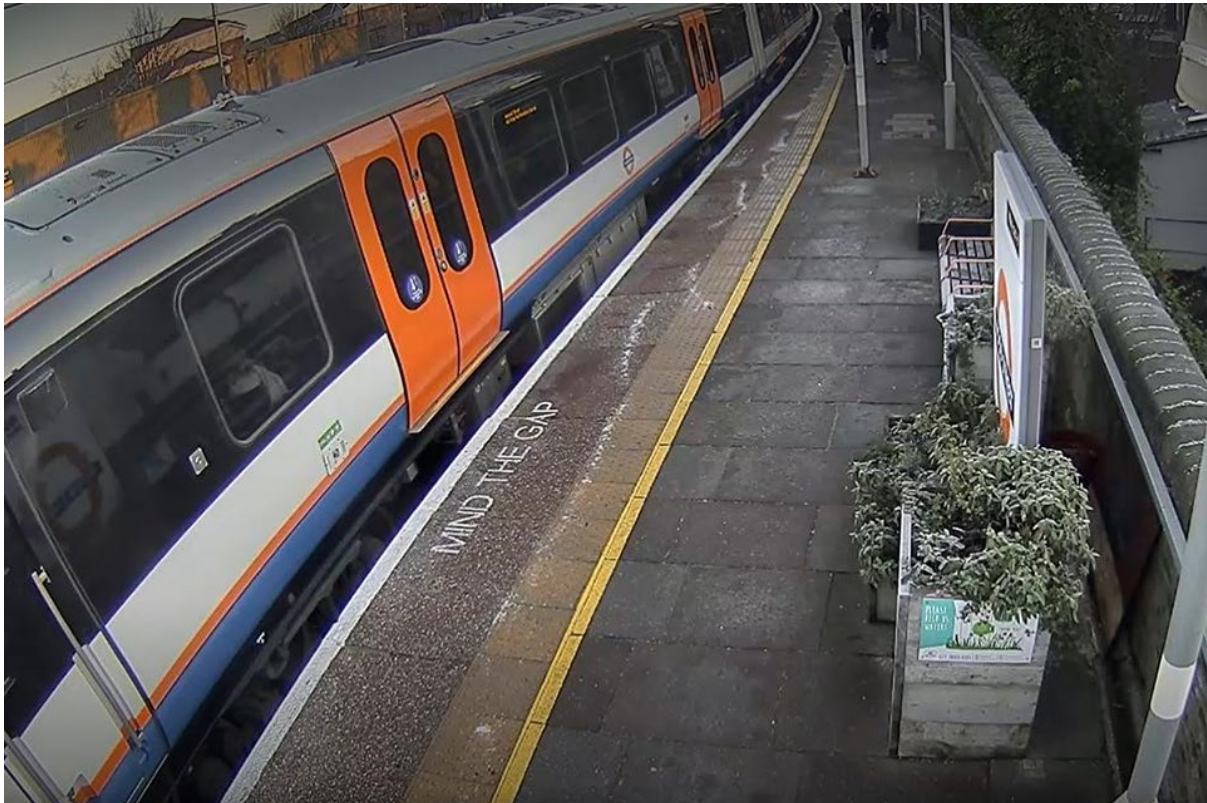
Platform CCTV from Wood Street station shows that the passenger involved in the incident had initially got out of the rear door of the fifth car after the train arrived at Wood Street station. She then attempted to board the train again using the rear doors of the fourth car, after the door closing sequence had begun. As she attempted to board the train, the passenger placed her hand between the closing doors. After the doors closed, the passenger was left standing next to the train, with her hand trapped between the closed doors. The train then started to depart from the platform with the passenger's hand still trapped in the doors.

The train stopped after it had travelled for around 20 metres along the platform, having reached a maximum speed of 7.6 mph (12 km/h). After the train stopped, the passenger was able to free her hand from the doors. It was reported to RAIB that the passenger did not sustain any injuries and that she left the station after speaking to the train driver.

CCTV showing the train and platform involved (courtesy of Arriva Rail London)

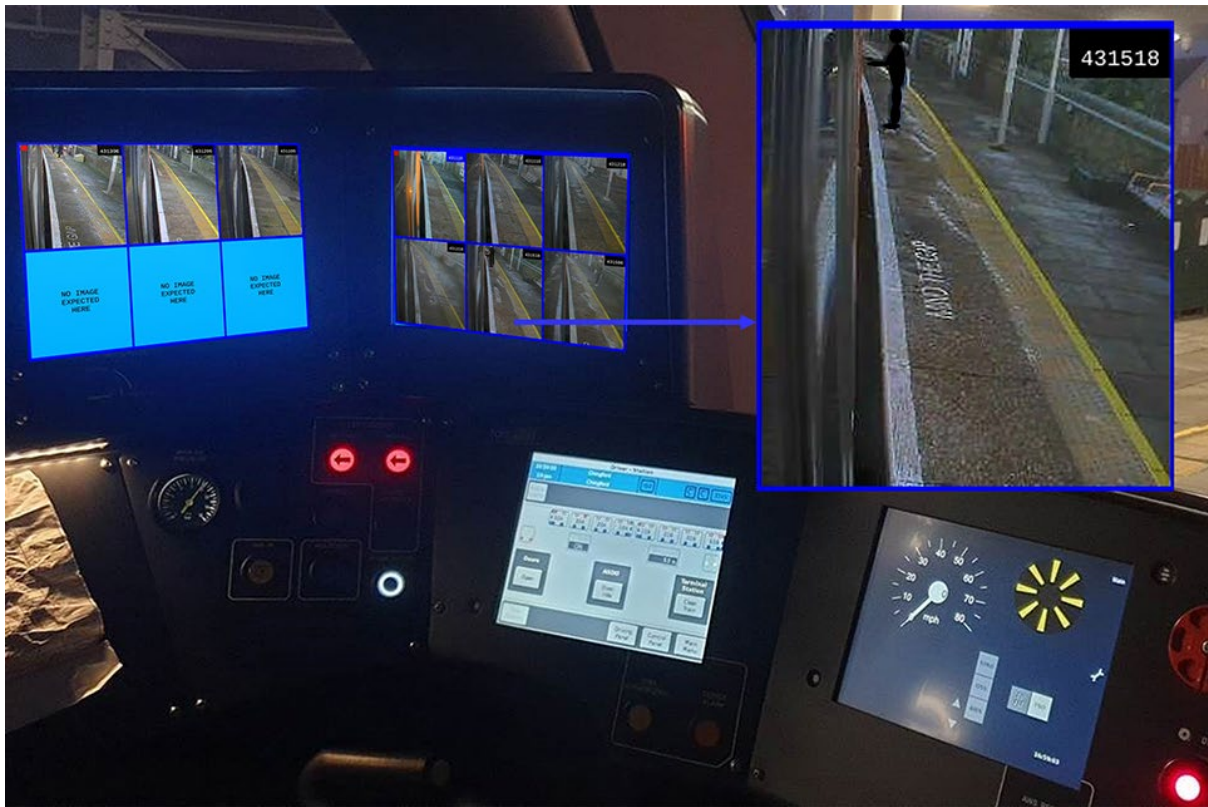
This incident occurred because the driver did not appreciate that the passenger was in an unsafe position when he made the decision that it was safe to start the train. The driver stated that, although he had seen that the passenger was close to the side of the train before starting the train, he was unaware that she was trapped in the doors and believed that she was pressing the 'door open' button to try and board the train.

Reconstruction of the driver's in-cab screen using images from the incident CCTV at the moment that door interlock was obtained (the passenger's image has been obscured for publication)

During this incident, the train driver reported that, after the doors closed, he checked that he had obtained door interlock. He then looked at his in-cab CCTV monitors and saw that a passenger was close to the side of the train. The driver believed that this passenger was pressing the 'door open' button to try and board the train. The driver then started the train. Once he observed on the monitors that the passenger was continuing to move alongside the train, he brought the train to a stand. The driver stated that an emergency egress device was activated on a door on the opposite side of the train to the platform as he did this.

The driver later stated that he did not believe that the passenger could have been trapped in the doors when he started the train, because he had obtained door interlock. This suggests that the driver was, in these circumstances, using the interlock to indicate whether it was safe to start the train.
