## **Interim report on the investigation of the accidental release of the suspended fishing gear on board the beam trawler *Cornishman* (PZ512), resulting in one fatality, approximately 55 nautical miles south-west of the Isles of Scilly on 6 February 2021**

*The aim of this interim report is to inform owners and skippers of UK beam trawlers and scallop dredgers of the circumstances of the accident and MAIB's initial findings. A full report will be published when the investigation is complete. The information contained in this interim report is based on investigations to date. Readers are cautioned that new evidence may become available that might alter the circumstances as depicted in this report.*

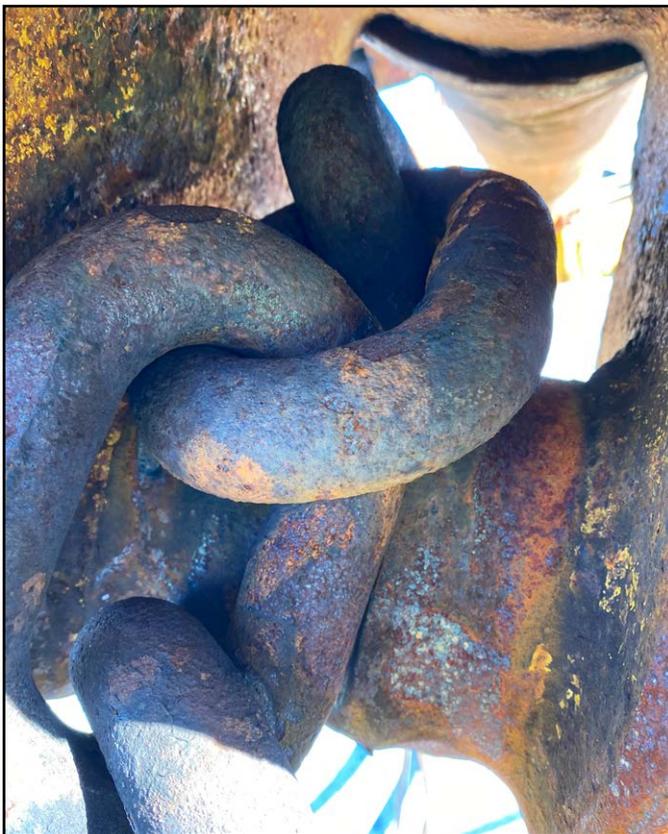
The ongoing MAIB investigation found that a chain link in the port fishing gear quick-release mechanism had failed, causing the trawl beam to fall. The 32mm chain link had fractured at the point where it went over a fixed steel pin at the derrick head. The investigation also identified that the derrick head pin was badly worn. A photograph (**Figure 1**) taken shortly after the accident shows the same mechanism on the starboard side derrick head.

**Figure 1:** Starboard side derrick head quick-release mechanism

The practice of passing lifting chains over fixed pins introduces complex loadings on the chain links. This makes it very difficult to calculate the tensile strength of the arrangement and makes it more susceptible to failure. It is therefore imperative in the short-term that these types of release mechanisms and derrick head pins are subject to regular inspection and replaced at the earliest sign of wear.

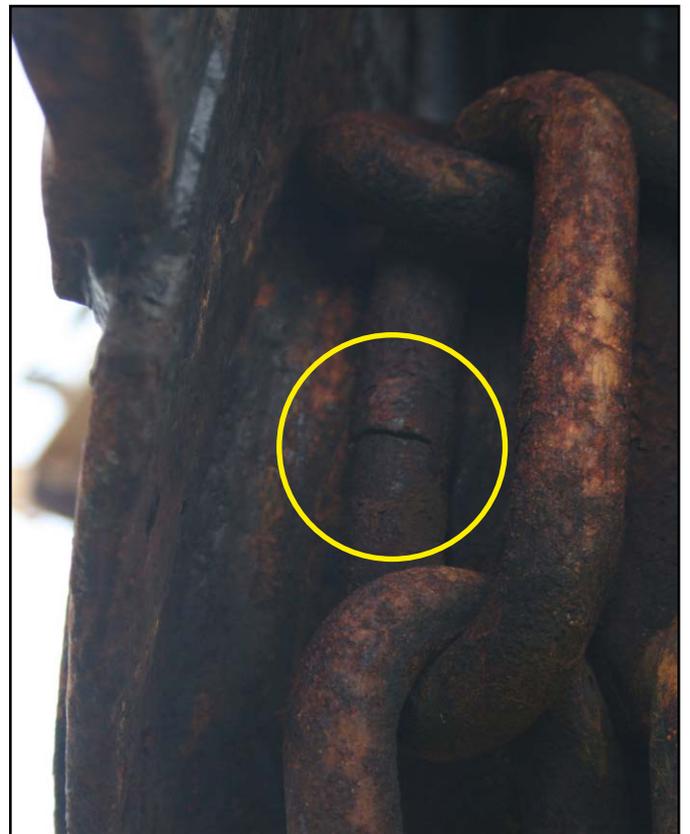
The arrangement of a chain passing over a fixed pin is used for quick-release mechanisms on board many beam trawlers and scallop dredgers that operate in the UK. Similar chain failures have led to fishing gear collapsing on other vessels and chain fractures have been identified during vessel inspections (**Figure 2**).

**Figure 2:** Chain fracture discovered during inspection of a quick-release mechanism on another vessel
