Rail Accident Investigation Branch

Rail Accident Report

**Track worker struck by a train near Surbiton station, south-west London
9 February 2021**

Report 05/2022
May 2022

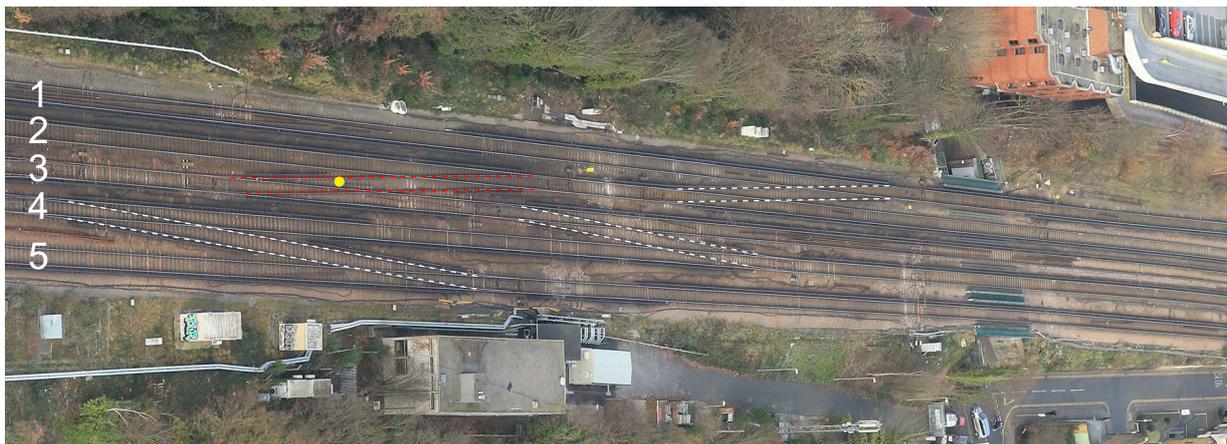
Figure 3: Example of four of the crossover lines (shown by dashed lines, with the crossover where the accident occurred shown with red dashed lines) on the country side of Surbiton station. Line 1 is the up slow, line 2 is the up fast, line 3 is the down fast, line 4 is the down slow and line 5 is the Down Hampton Court. The approximate position of the COSS is shown by the yellow circle (image courtesy of Network Rail).

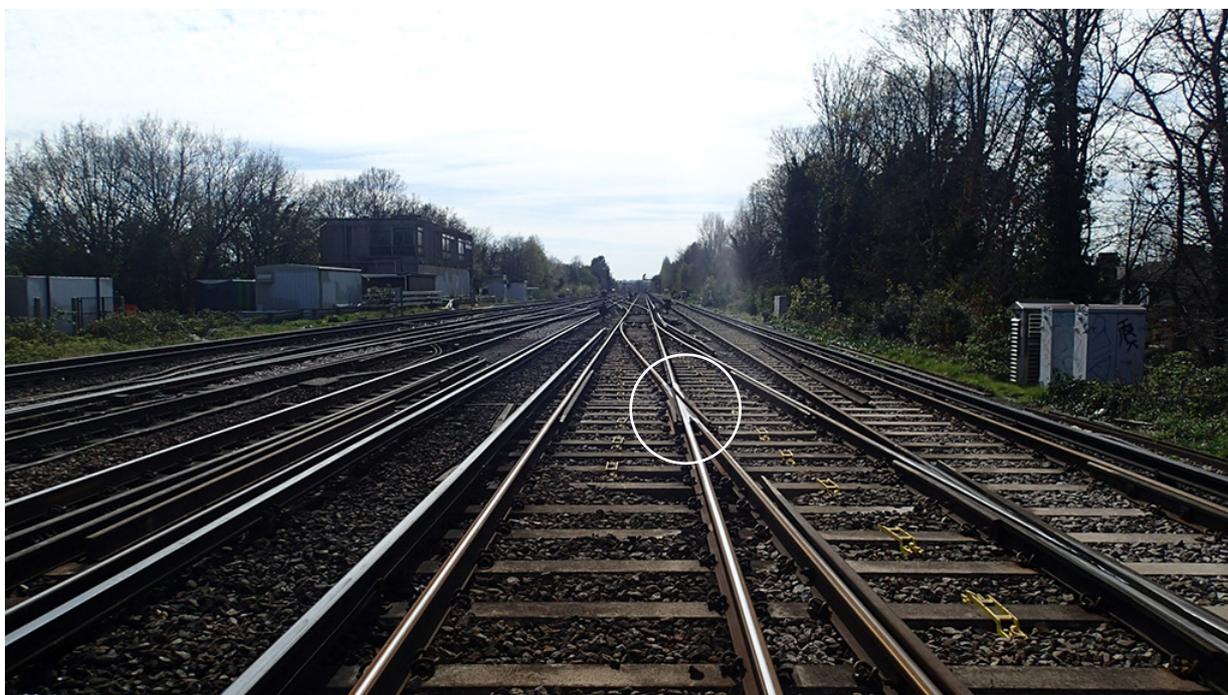
Figure 4: One end of a crossover, with the crossing ringed

65 The layout of the rails at the junction probably meant the COSS did not realise he was walking in the crossover and possibly also caused him to unintentionally move further towards the down fast line.

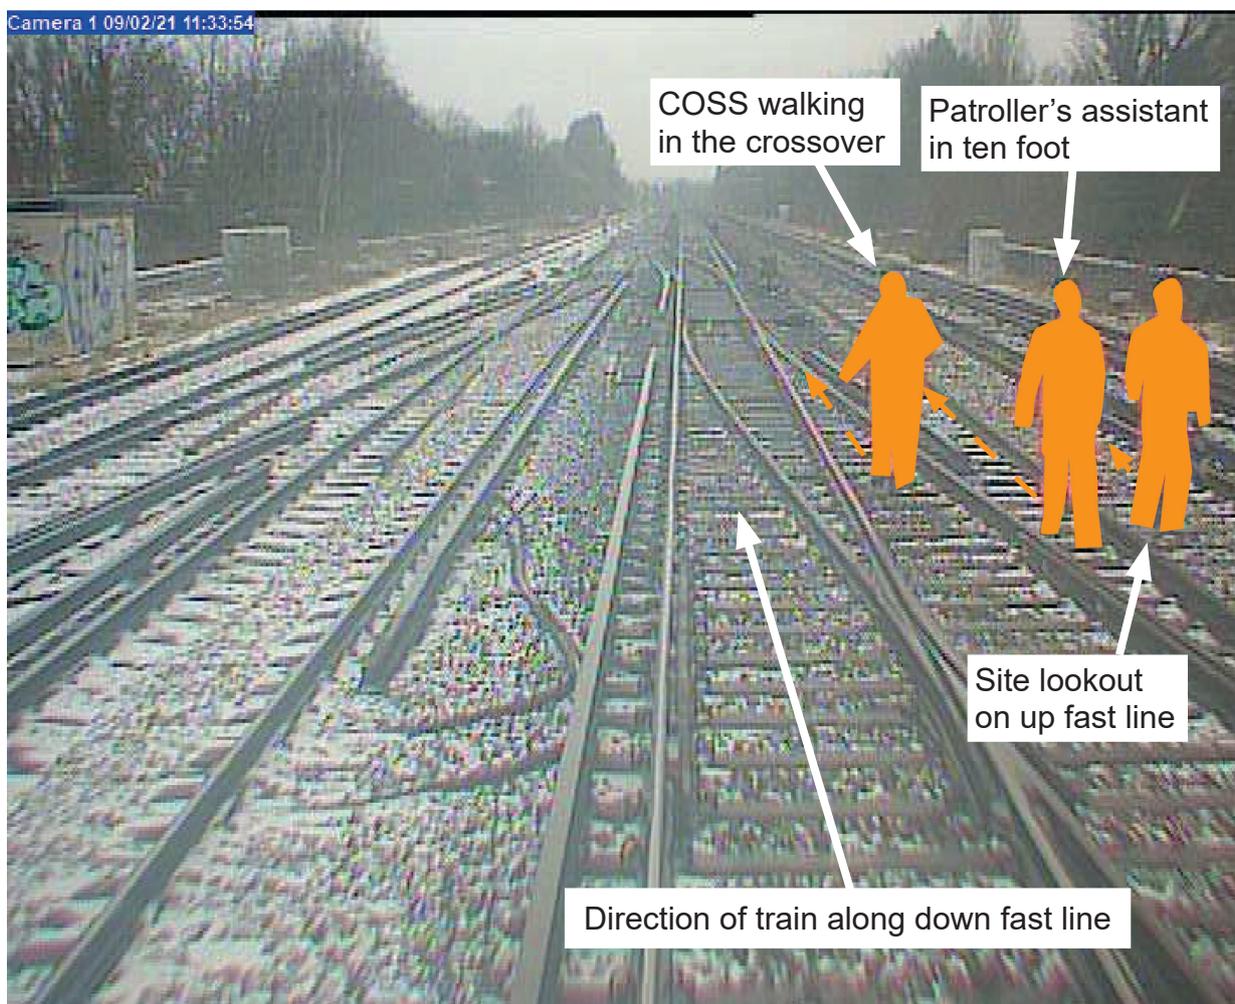
- 31 However, the COSS had stepped out of the four-foot² (the space between the running rails) of the up fast line and was walking in the crossover between the up fast and down fast lines. Witness evidence suggests that the COSS would not normally have chosen to walk in the crossover but would instead usually remain within the four-foot of the up fast line. The patroller's assistant was also walking to the left of the up fast line, in the space between the up fast and down fast, known as the ten-foot, while the site lookout remained in the four-foot of the up fast line. FFCCTV from train 1L29 shows the group walking along the track and not looking back towards the approaching train (figure 5).

Figure 5: FFCCTV image from train 1L29 showing positions of the group just before the accident. The group have their backs to the approaching train (image courtesy of South Western Railway).

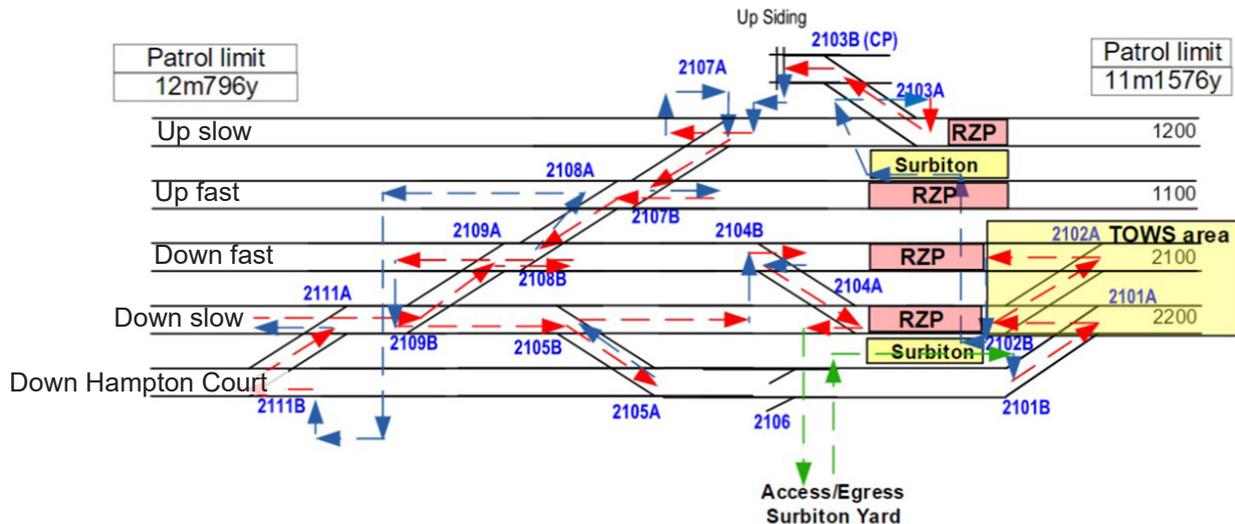
70 Once the inspection of the crossovers on the up side¹² of the railway was complete, issue 2 of the patrol diagram, dated December 2019 (figure 6) required the group to walk in single file in the up fast line to reach the point where they were to cross to the down side of the railway (‘walking’ is shown on the patrol diagram as a blue dashed arrow and ‘inspecting’ is shown as a red dashed arrow). However, only the site lookout was walking in the up fast line.

Figure 6: The patrol diagram for the Surbiton area

- 71 Issue 1 of the patrol diagram had shown that, after inspection of the up fast to down fast crossover, the group were to return to the up cess and walk back to Surbiton station to use the station footbridge to get to the down side of the railway. Once on the down side, the group were then required to walk in the down cess to reach the point where the inspection of the crossovers on the down lines could commence. However, it was identified by the TME that staff were not walking back to the station because of the time taken to complete the patrol, and so he revised the patrol diagram to issue 2, which now required the group to walk in the up fast line to reach the point where they would cross to the down side of the railway. This reflected how staff were actually walking during the patrol and a belief that it is safer not to walk with backs to traffic.
