Rail Accident Investigation Branch

Rail Accident Report

**Near miss between a rail grinding train and
an empty passenger train at Sileby Junction,
Leicestershire
5 May 2021**

Report 06/2022
July 2022

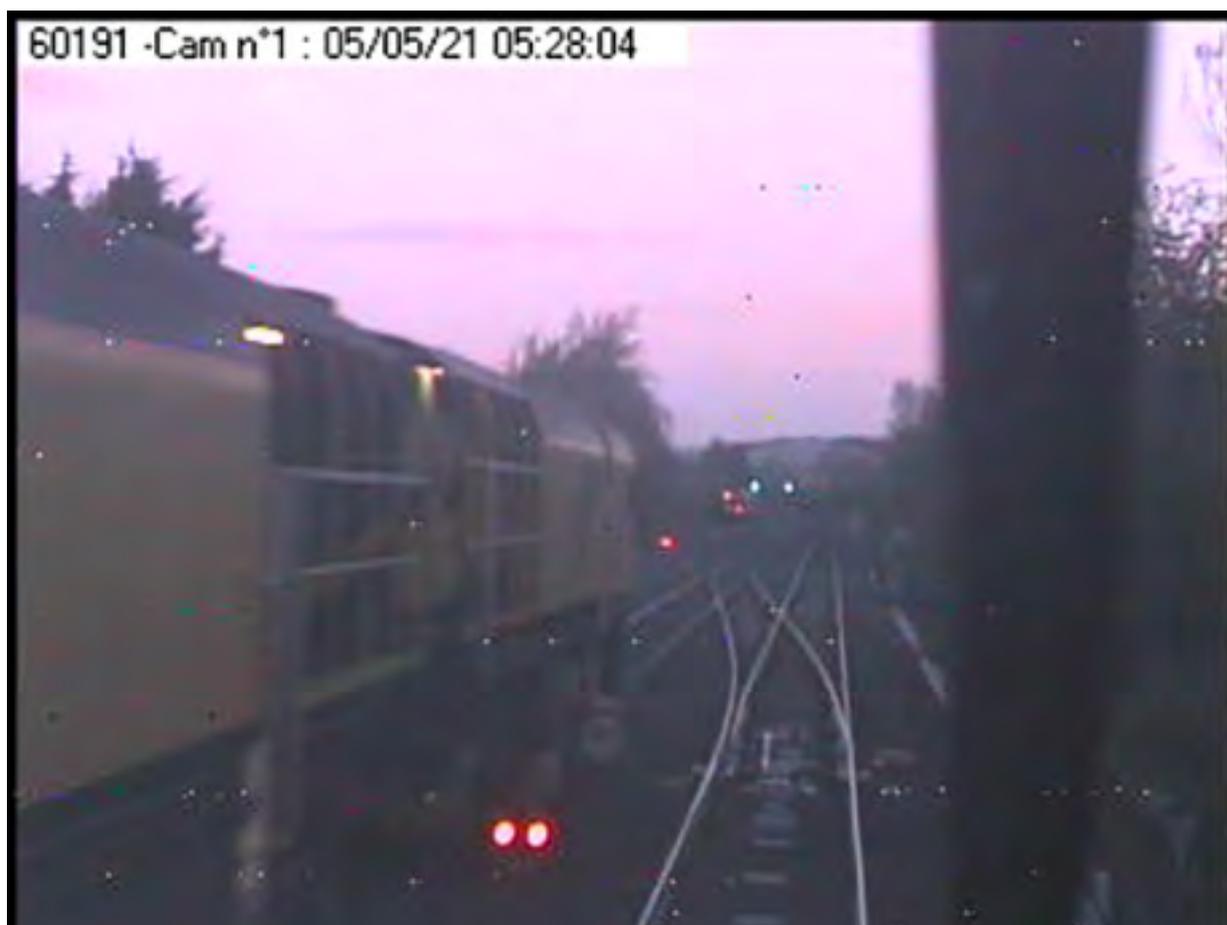
- 3 At about 05:29 hrs on Wednesday 5 May 2021, a train made up of machines used for reprofiling (grinding) rails passed signal LR477 at danger (showing a red aspect) on the down slow line at Sileby Junction, between Leicester and Loughborough (figure 1). This resulted in a near miss with an empty passenger train travelling in the opposite direction that had cleared the junction less than 10 seconds before the rail grinding train reached it (figure 2).

Figure 2: Still image from the rearward facing closed-circuit television (CCTV) of train 5P01 having just crossed over from the up fast line to the up slow line, across the path of train 6Z08; image shows the leading end of rail grinding train 6Z08 (left) shortly before it came to a stop on the down slow line (East Midlands Railway)

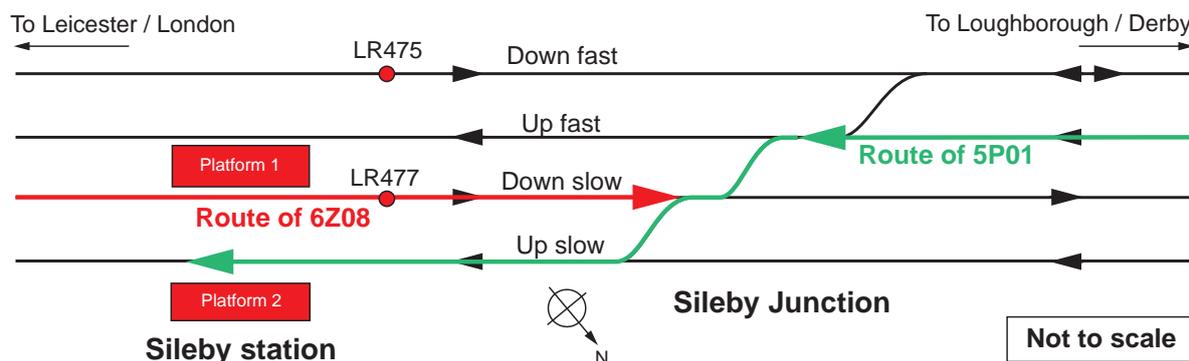
Figure 3: Track layout at Sileby Junction

- 7 Sileby Junction is located at 107 miles from London St Pancras station on the Midland Main Line, about 0.4 miles (0.6 km) north of Sileby station. The junction consists of a series of three crossovers, where trains can change tracks between the up and down fast lines, and the up and down slow lines (figure 3).
- 8 The maximum permitted speed on the down slow line at this location is 65 mph (105 km/h); this was increased from 50 mph (80 km/h) in 2010. There is a slight falling gradient of 1 in 508 for about one kilometre on the approach to signal LR477.

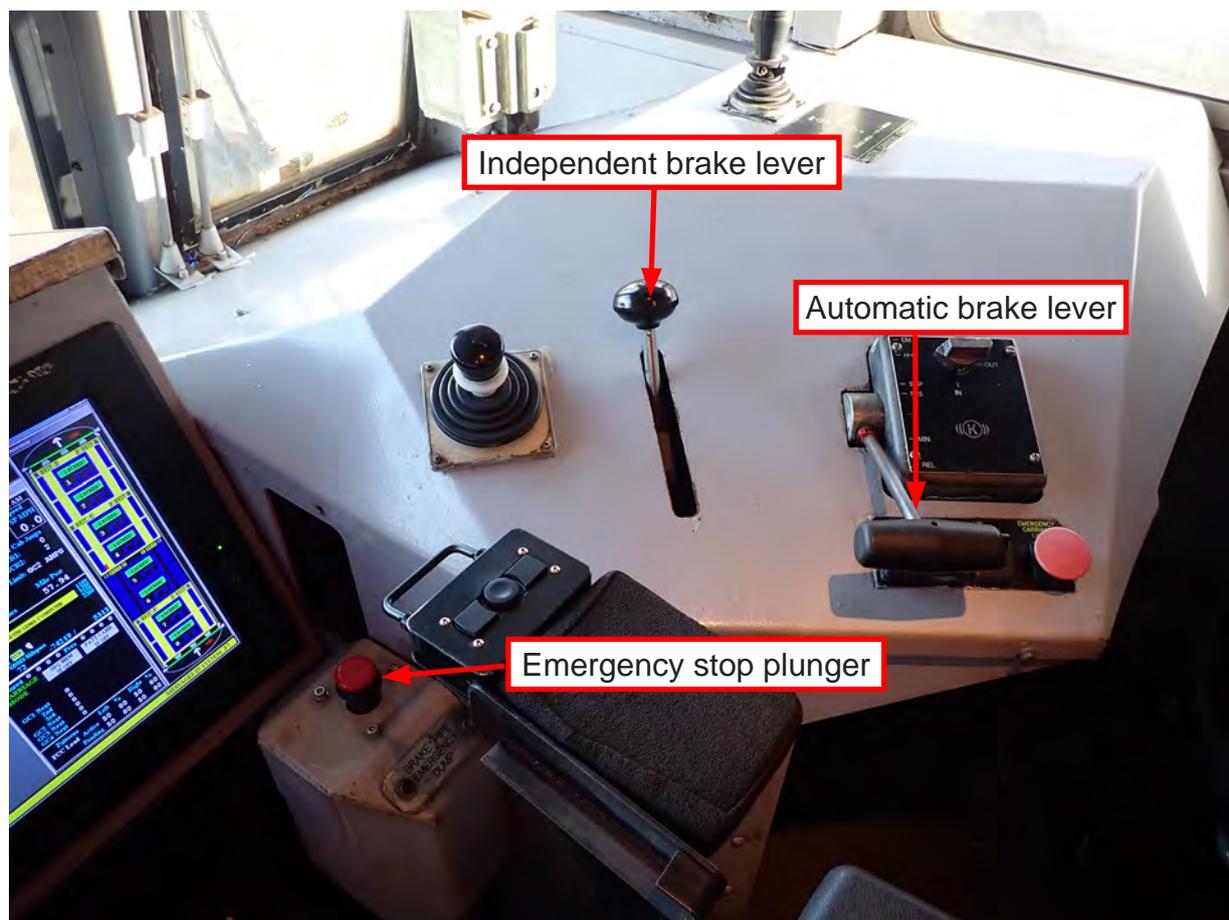
Figure 5: Driver's braking controls for the rail grinding machine. These controls are situated to the right-hand side of the driving seat.

- 15 Machine C2101 is fitted with two braking systems (see figure 5). The first is a conventional 'automatic' braking system, which controls brake cylinder pressures on all the machines via the brake pipe.¹ The automatic brake applies uniform brake cylinder pressure throughout the train; as such, it is used when travelling at higher speeds outside possessions. The second system is an 'independent' (or 'direct') brake, which rapidly changes brake cylinder pressure independently of the brake pipe. The independent brake operates more quickly than the automatic brake but, consequently, can result in the wheels sliding on the rails and being damaged as a result. Therefore, the independent brake should only be used when travelling below 20 mph (32 km/h). It is primarily for controlling speed during grinding work.

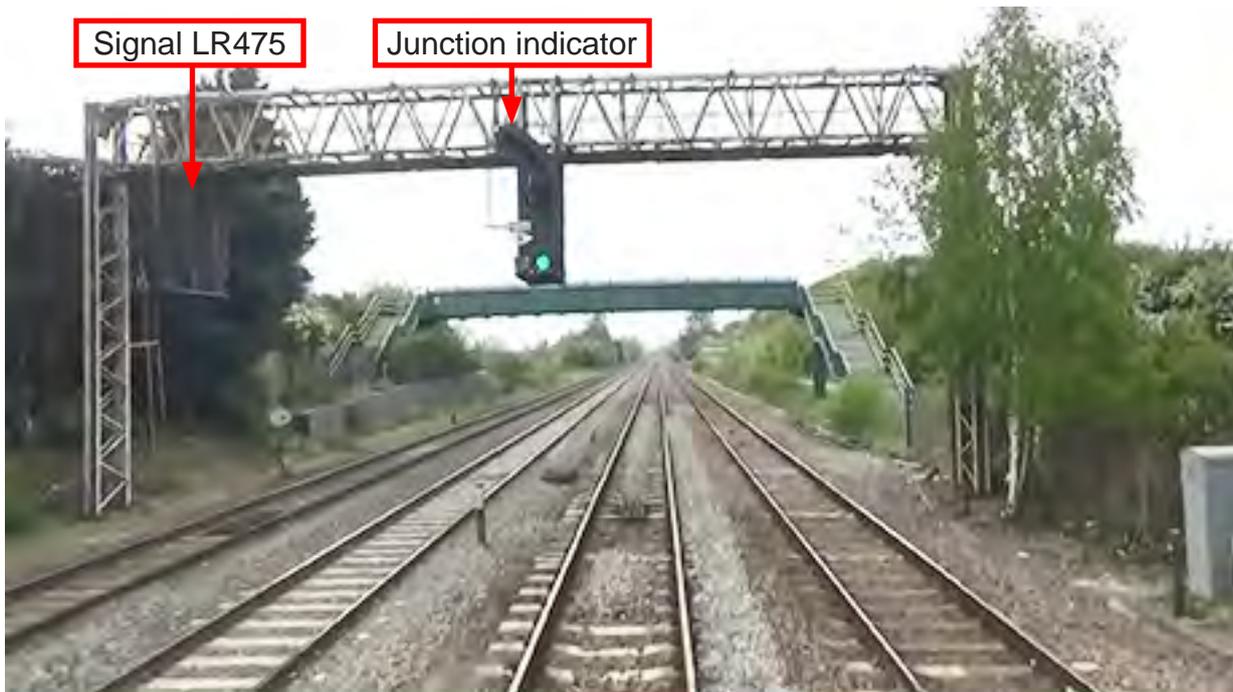
Figure 6: Signal LR477 (Colas Rail UK)

- 22 Signal LR477 is a three-aspect colour light signal with a junction indicator³ (which is lit for trains taking the left-hand crossover at Sileby Junction), located at 106 miles 1278 yards on the down slow line. The signal is controlled by the signaller to protect movements across Sileby Junction. The signal is mounted 5.1 metres above the running line on an overhead gantry (figure 6). Also mounted on the same gantry is signal LR475 for the down fast line, parallel and to the left of signal LR477.

- 23 On the approach to signal LR477, there is a slight left-hand curve before the track straightens through Sileby station, which itself is around 160 metres on the approach to signal LR477. A post-incident signal sighting committee convened by Network Rail determined that the signal was first visible from 450 metres on the approach.

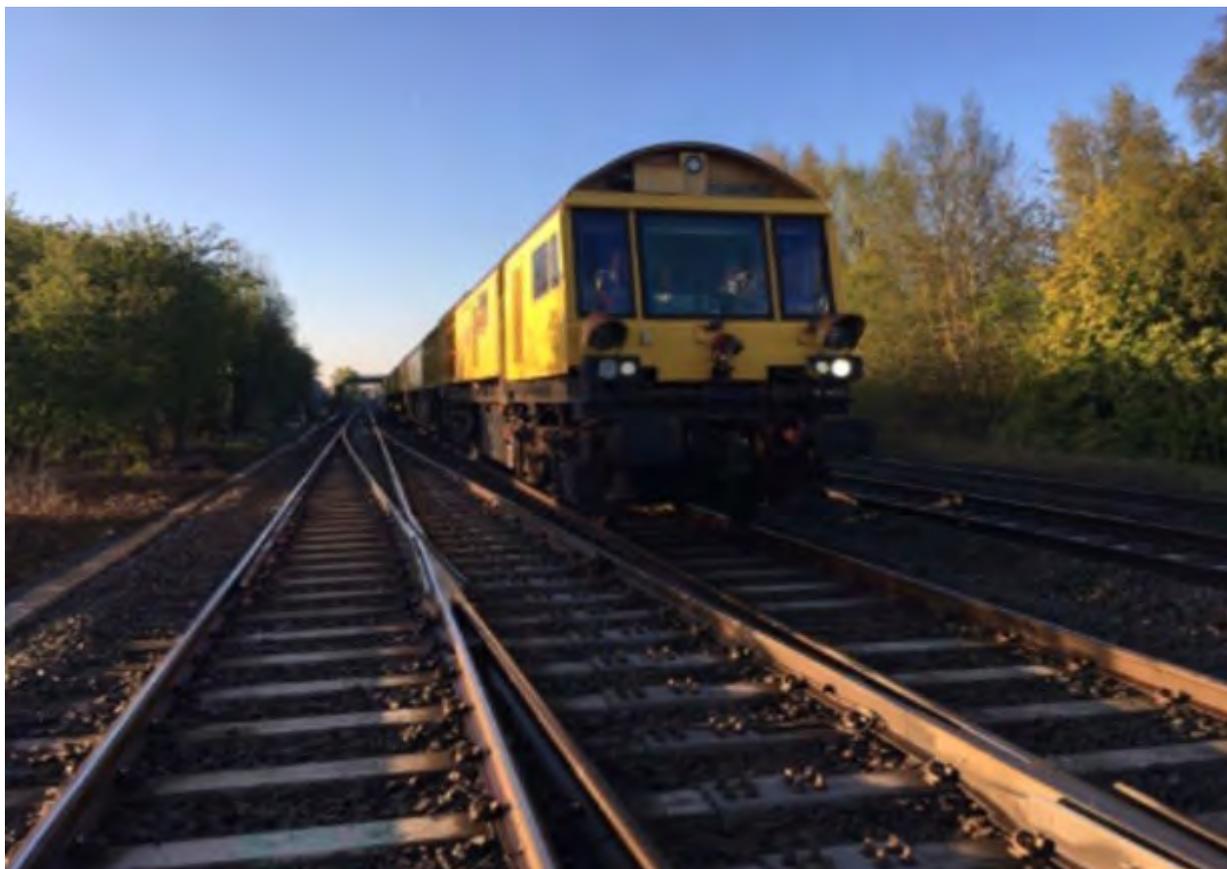
- 40 Train 6Z08 passed signal LR477 at danger at 05:29:24 hrs, while travelling at 40 mph (64 km/h). At this point, the front of train 5P01 had just traversed from the up fast onto the down slow line, before continuing its movement onto the up slow line. About 20 seconds later, the rear end of train 5P01 cleared the junction, just before train 6Z08 reached the conflict point (figure 3). Train 6Z08 stopped after a further 10 seconds, having travelled around 340 metres beyond the signal (figure 7).

Figure 7: Stopping point of the train after the incident, showing the crossover used by train 5P01 from the down slow to the up slow line (Network Rail)
