AAIB Bulletin

8/2022

Aircraft Type and Registration:	DA 40 NG, G-CTSB
No & Type of Engines:	1 Austro E4-A piston engine
Year of Manufacture:	2015 (Serial no: 40.N283)
Date & Time (UTC):	12 December 2020 at 0926 hrs
Location:	Cranfield Airport, Bedfordshire
Type of Flight:	Aerial Work
Persons on Board:	Crew - 1 Passengers - None
Injuries:	Crew - 1 (Serious) Passengers - N/A
Nature of Damage:	Aircraft destroyed
Commander's Licence:	Commercial Pilot's Licence
Commander's Age:	23 years
Commander's Flying Experience:	1,229 hours (of which 779 were on type) Last 90 days - 70 hours Last 28 days - 33 hours
Information Source:	AAIB Field Investigation

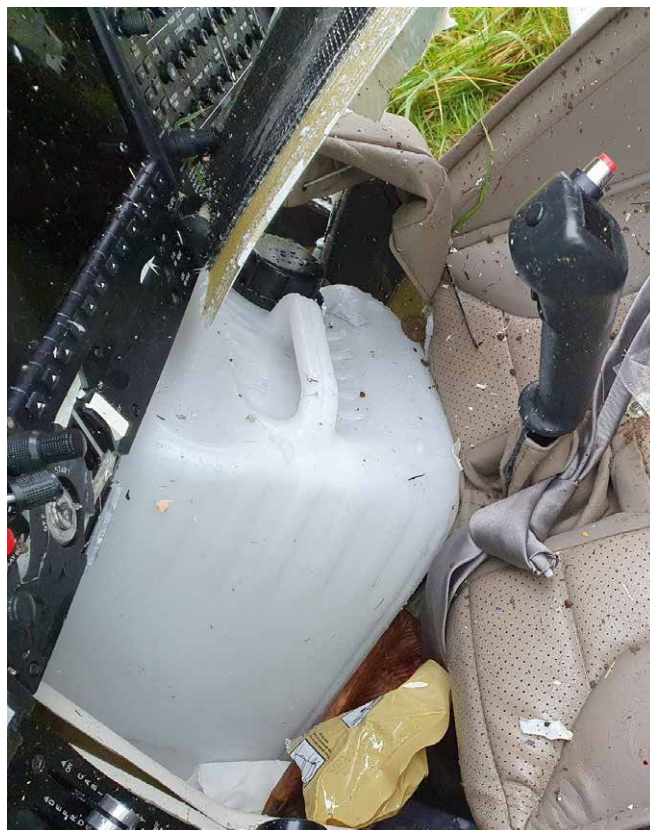
Figure 2

Images of the aircraft taken after the accident show the de-icing fluid container positioned in the footwell of the front right seat (Figure 2). Once removed, this container was found to have been punctured on the lower part of its forward face (as found) and on the base adjacent to the forward face damage (Figure 3).

Container as found in wreckage (used with permission)

These features indicate that the container had been positioned in the footwell in an upright position prior to the accident. The damage is consistent with the container moving forward during the accident, into the seat rudder pedal adjustment rail. This led initially to the forward face of the container being breached, followed by damage to the base of the container as it rode up over the rudder pedal adjustment rail. A scuff mark (Figure 4) was also identified on the top left surface of the container. This indicated that the container moved underneath the instrument panel during the impact sequence, providing additional confirmation that the container was upright during the accident, as the top surface would not have been scuffed if the container was laid either horizontally, or at an angle.

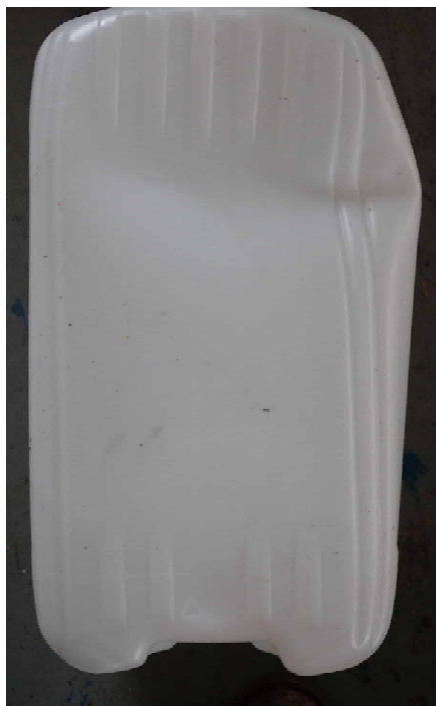
Figure 5

Another container recovered from the accident site was found to have damage consistent with it being positioned on the front right seat. A crease along the front face of the container and damage to the right side of the instrument panel combing suggested that the container was forced against the combing during the impact sequence (Figures 5 and 6).

Crease in container

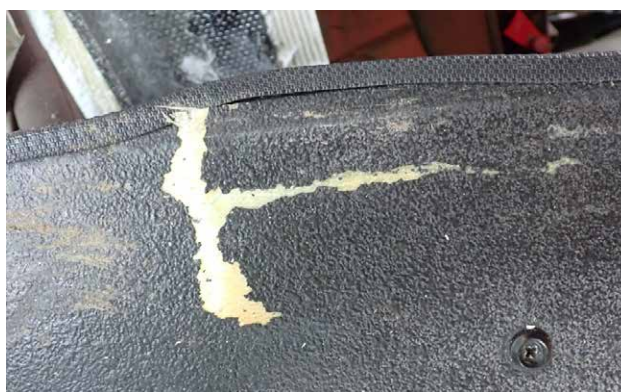
Figure 6

Damage to right instrument panel combing

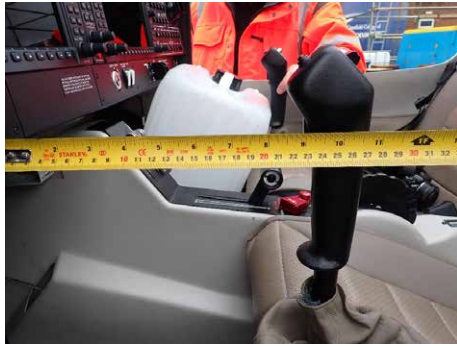
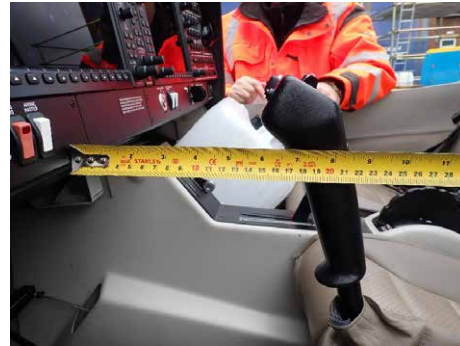
Figure 7

The AAIB inspected another DA 40 aircraft with the same cockpit layout to determine whether, with a container in this position, there would have been any control restrictions. The elevators were placed in their neutral position and the distance from the left control stick to the edge of the instrument panel measured (approximately 188 mm). A further measurement was then made with the control stick moved fully forwards (approximately 126 mm). A surviving undamaged container was then positioned upright in the right footwell and the control stick moved as far forward as possible. This resulted in the base of the stick contacting the container with the stick being approximately 230 mm from the instrument panel. The position of the container was adjusted, placing it at an angle by moving the base into the footwell as far forward as possible until it contacted the rudder pedal adjustment rail. The stick was then moved as far forwards as possible and, again, it contacted the container. The distance between the stick and instrument panel was approximately 172 mm. The results are shown in Figure 7.

Container upright

Container at an angle

This demonstrated that with the container in the upright position the control stick could not be moved forward of the control neutral point, and only slightly forward of the neutral point with the container lying at an angle with its base as far forward as possible (Figure 8).

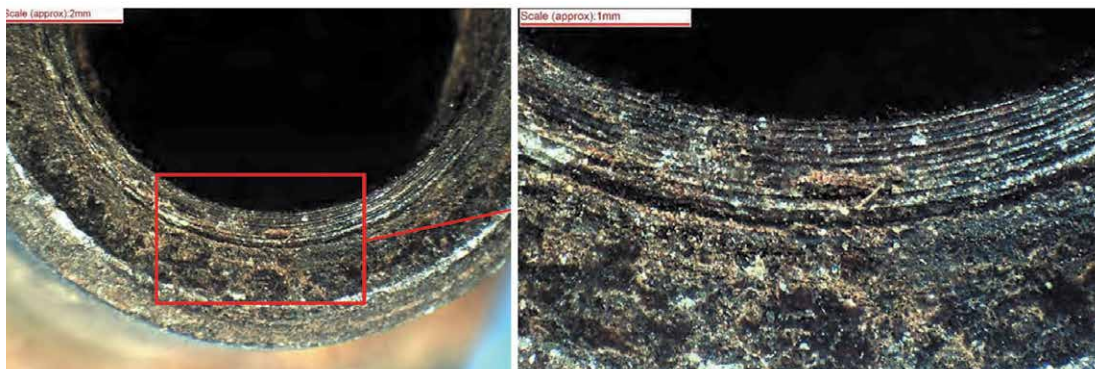
Figure 6

There was evidence on two of the threaded inserts of a circular imprint and helical machining marks on the surface on the non-flanged end, ie the end adjacent to the propeller (Figure 6). It was considered possible that these imprints were a result of the shank of the bolt having been pressed into the insert. This situation is called 'shanking', where the bolt is tightened to the specified torque but the pre-load tension in the bolt is lower than specified. Insufficient pre-load is a common cause of fatigue failure of threaded fasteners.

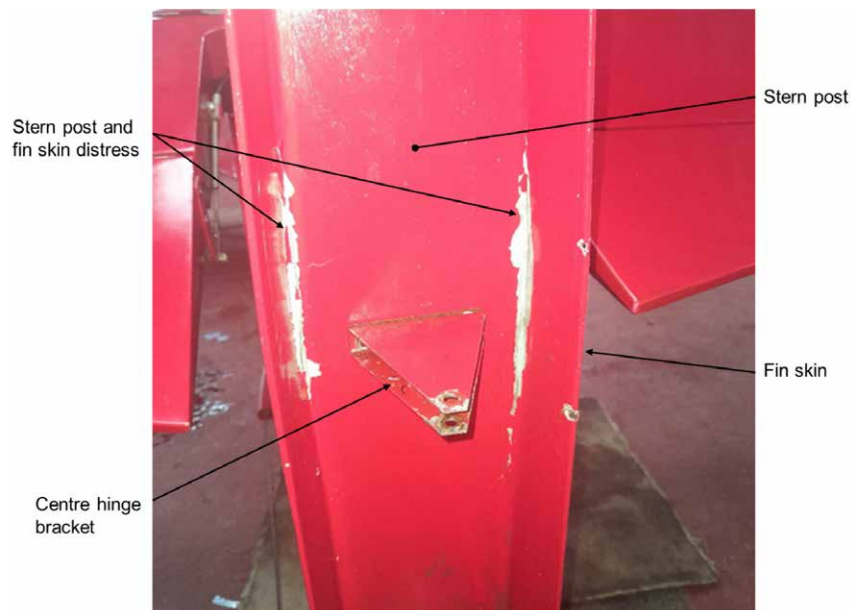
Figure 3

Distress between the fin skin and stern post both sides of the centre hinge

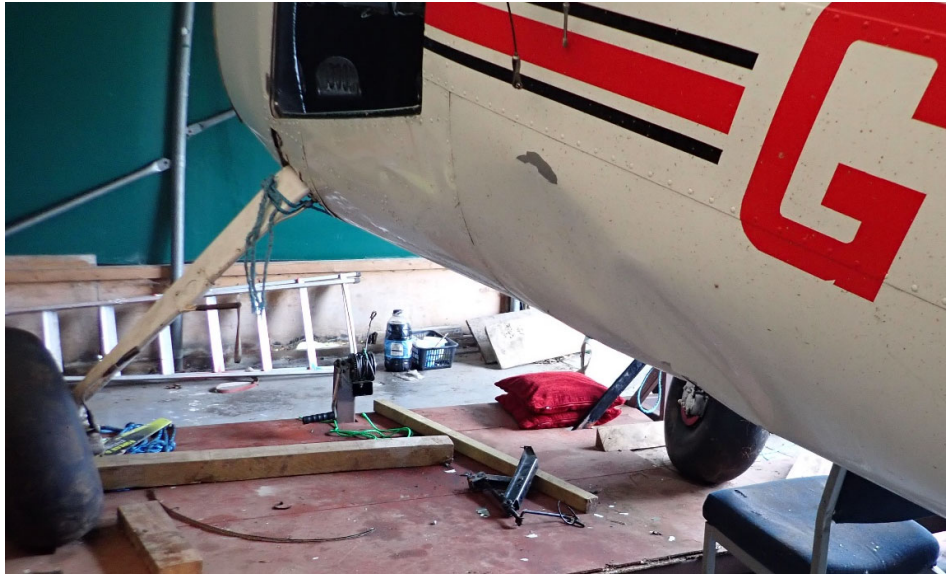
Figure 2
G-OVFM fuselage buckling

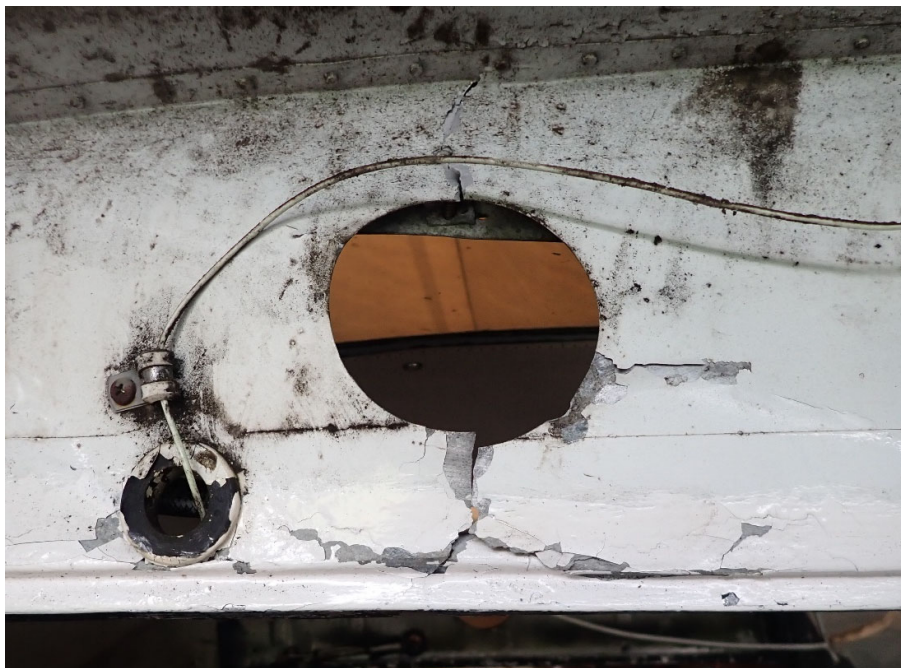
Figure 3
G-OVFM cracking of right wing root
