Train collision with fallen tree and derailment near Balderton, Cheshire, 26 November 2021

Summary of the accident

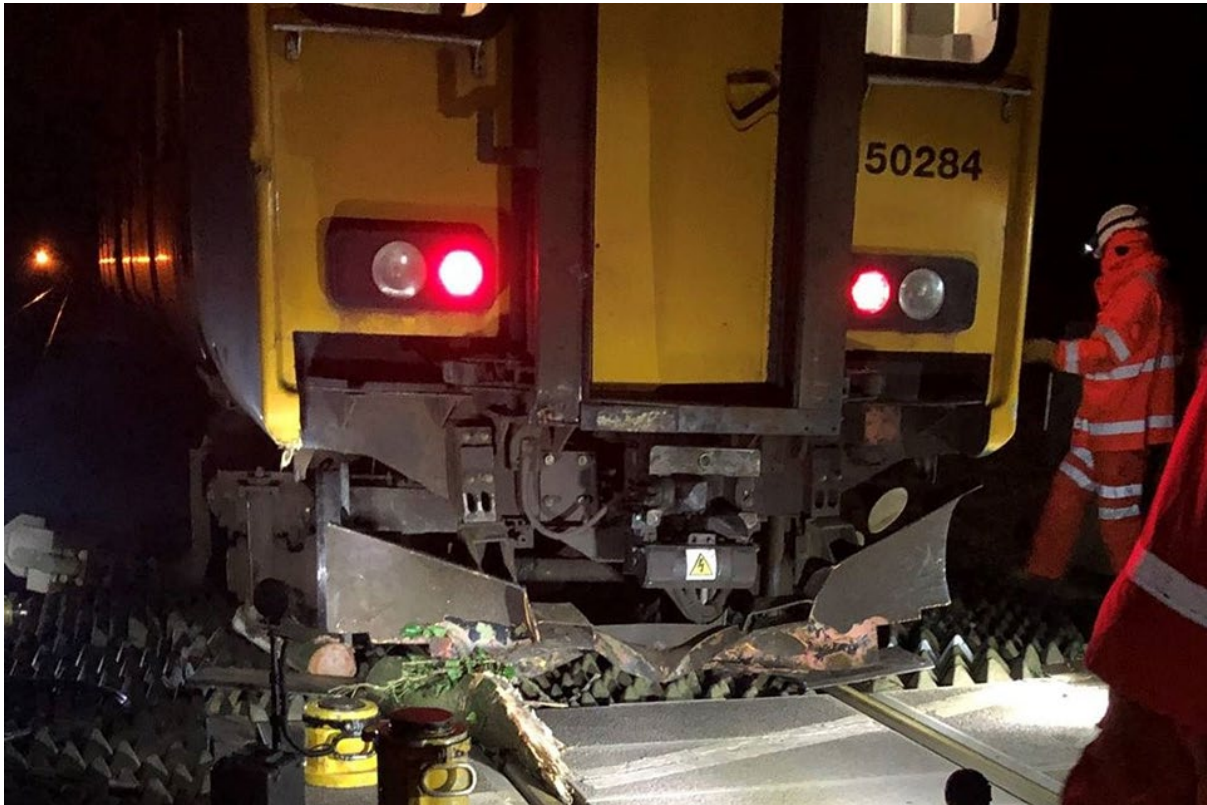
At about 23:13 hrs on Friday 26 November 2021, an empty passenger train collided with part of a fallen tree while travelling at 46 mph (74 km/h). The train involved, reporting number 5D77, consisted of a class 150 diesel multiple unit which was being operated by Transport for Wales between Wrexham General and Chester. The collision caused the leading axle of the train to derail. There were no injuries, but minor damage was caused to the train and to local signalling equipment.

The derailed train following the collision (image courtesy of Network Rail)

The derailment occurred on the down Wrexham line, in a tree-covered cutting about 68 metres beyond the exit of Balderton tunnel. The tree that fell across the railway was an ash tree, with a trunk around 0.5 metres in diameter. This had been growing just beyond the crest of the cutting, about 9 metres from the railway track and about 0.5 metres outside the railway boundary fence.

After the accident, Network Rail staff inspected the remains of the tree which caused the derailment and found that it had been in 'apparent good health' before it fell. This inspection concluded that the cause of the tree falling was 'extremely high wind speeds' coming from an unusual direction.

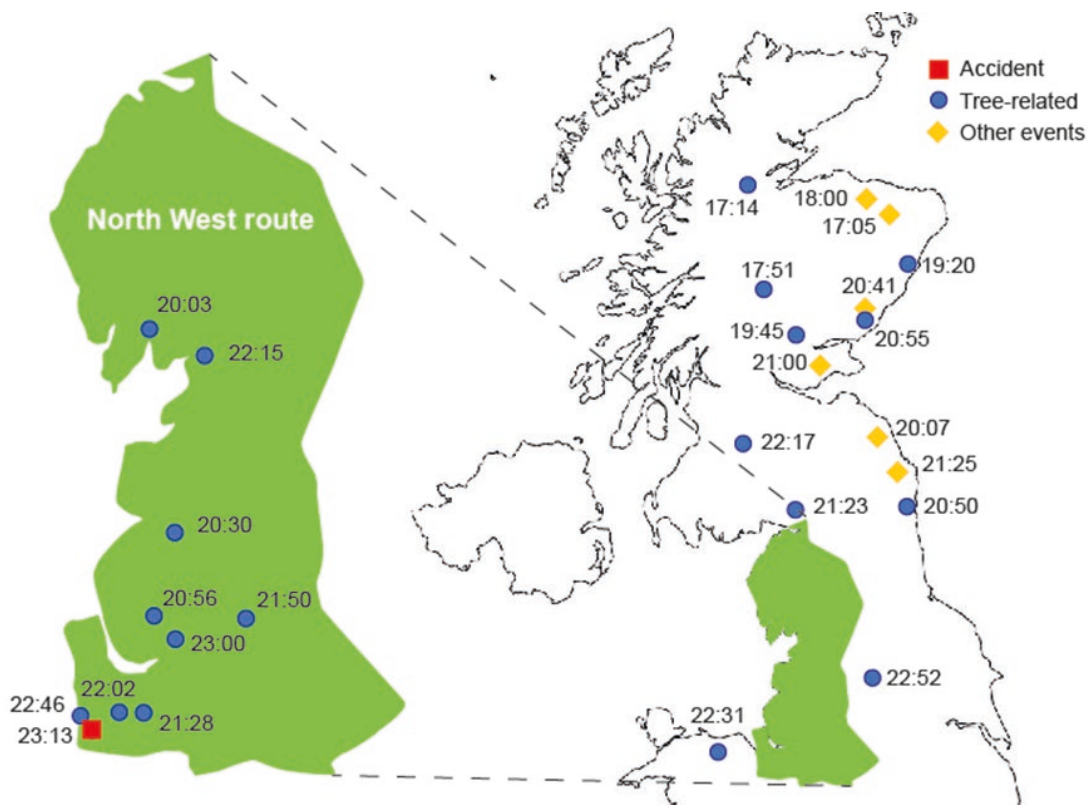
Storm Arwen had caused serious disruption on Network Rail infrastructure before the derailment of 5D77 at around 23:13 hrs. By this time, nineteen events involving falling trees had been reported on Network Rail infrastructure, including nine within the North West route. Before this derailment, North West route control staff were monitoring these events and had considered whether to apply BESRs. They decided against this, as they believed the incidents were mostly minor and manageable.

Weather-related incidents on 26 November 2021, with time reported, as recorded in Network Rail national log. Some incidents are not recorded on this log.
