Rail Accident Investigation Branch

Rail Accident Report

Collision between a tram and a cyclist, near Audenshaw tram stop, Manchester 1 September 2021

Report 08/2022
August 2022

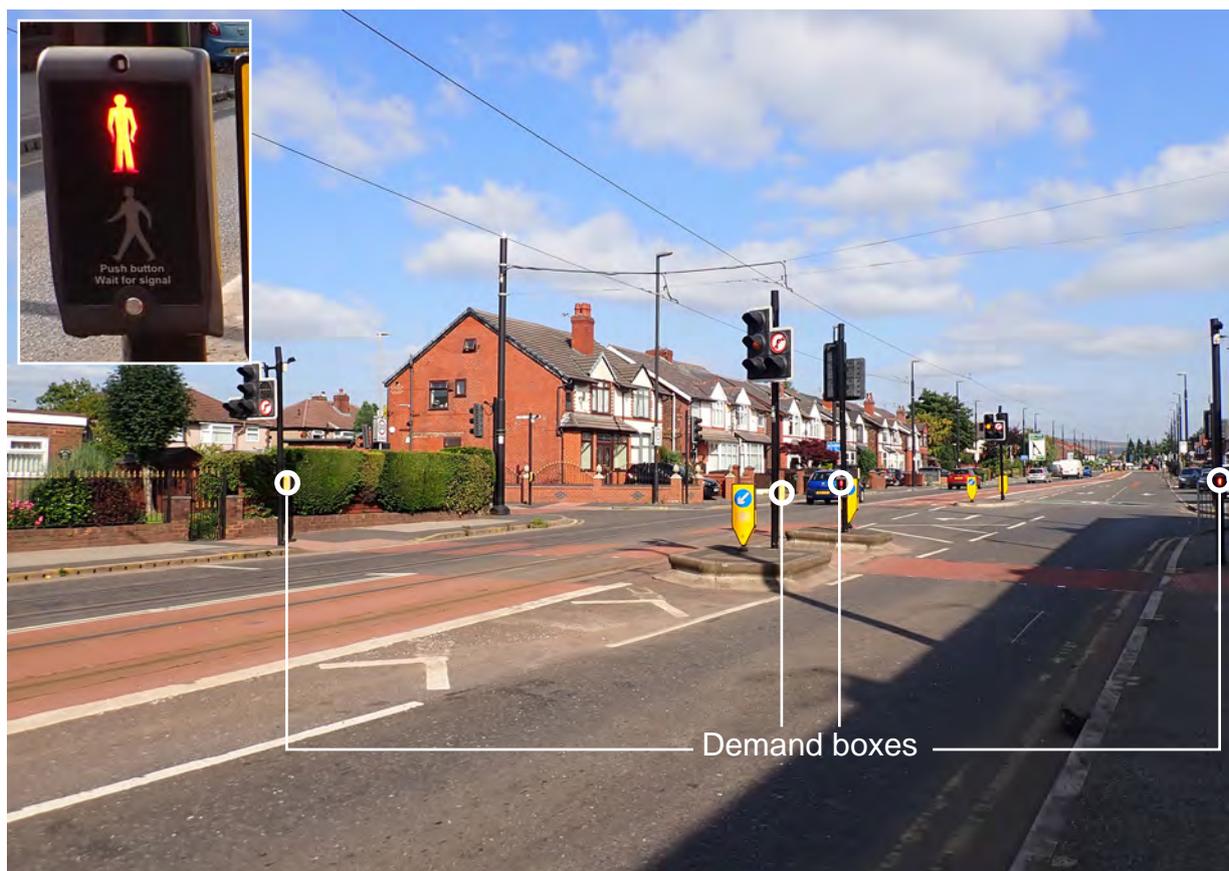
Figure 4: general view of the Puffin crossing across Droylsden Road (looking east), with (inset) demand box showing 'red standing man' indication

- 11 Although a mid-carriageway pedestrian refuge exists, the Puffin crossing covers the entire carriageway of Droylsden Road as a single crossing. Operating the demand button on either side of the crossing will cause road (and tram) signals to change, stopping traffic from both directions so that an individual may cross the complete width of Droylsden Road.

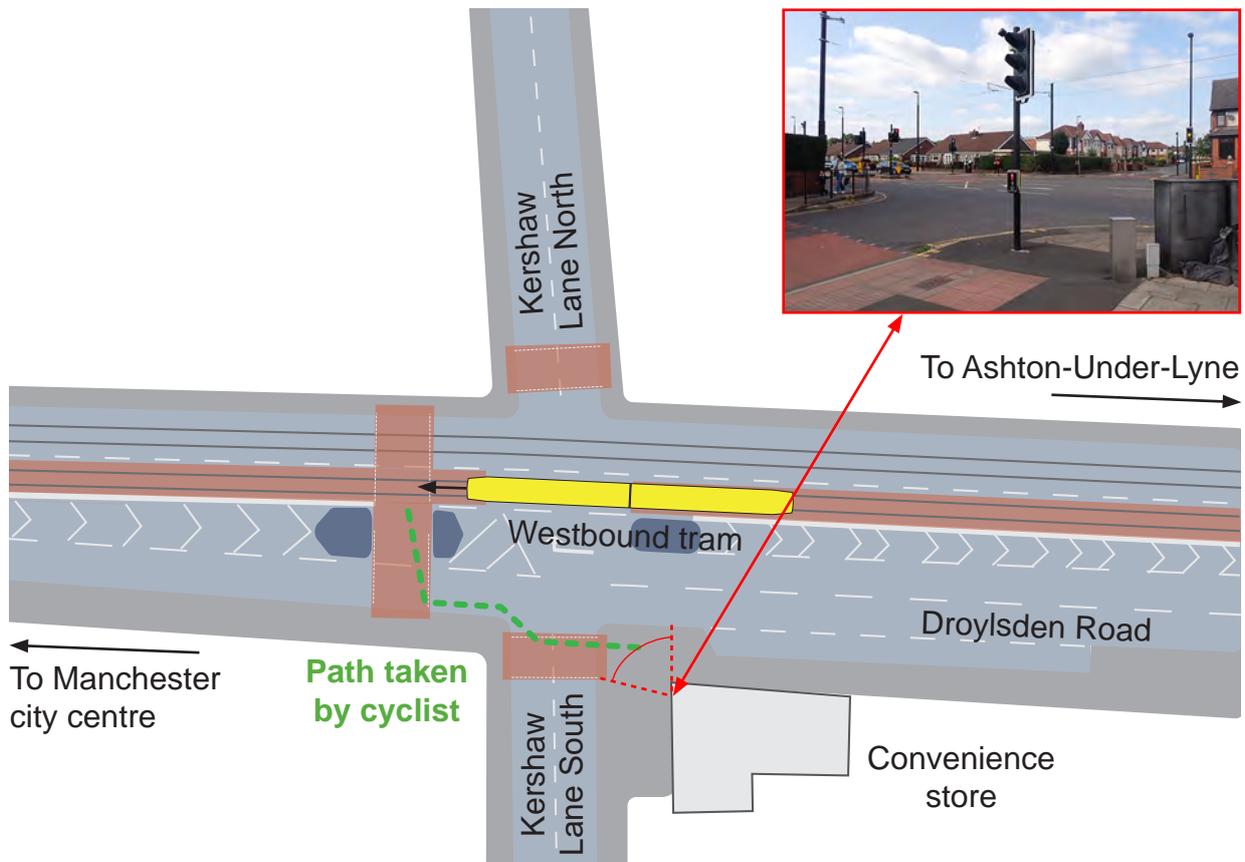
- 29 After leaving the shop, the cyclist mounted his bicycle, crossed the southern leg of Kershaw Lane, and then moved around the road side of the pavement fencing (figure 5) at the south-west corner of the junction with Droylsden Road. The cyclist then crossed Droylsden Road as far as the mid-carriageway pedestrian refuge. CCTV shows that he arrived there at 19:25:31 hrs.

Figure 5: the crossing and the path taken by the cyclist to the mid-carriageway refuge

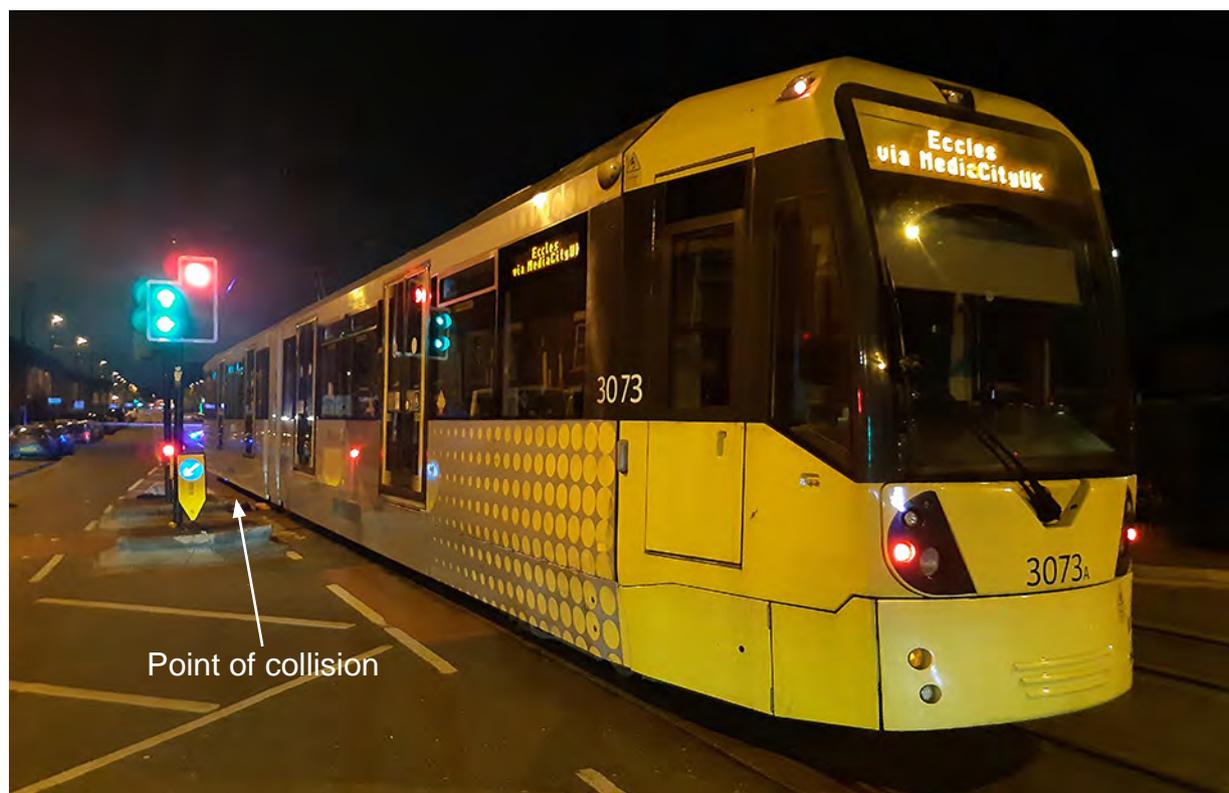
Figure 6: The tram, stopped after the accident. The point of the collision is indicated

- 33 The cyclist was knocked from his bicycle and fell partly under the left-hand side of the tram. He was found alongside the tram, with his legs in the vicinity of the tram's centre bogie, which was in line with the pedestrian refuge by the time the tram came to a stop. There was no evidence that the cyclist interacted with the tram's underrun protector, which is located immediately in front of the leading wheels of the tram. This indicates that the cyclist fell to the left of the tram's bogies and wheels.

- 34 It is possible that the high containment kerb (figures 4 and 6) around the pedestrian refuge may have deflected the cyclist towards the tram after the collision. Marks were found on the kerb after the accident showing evidence of contacts, but it cannot be determined exactly what effect the presence of the kerb had on the outcome of the collision.

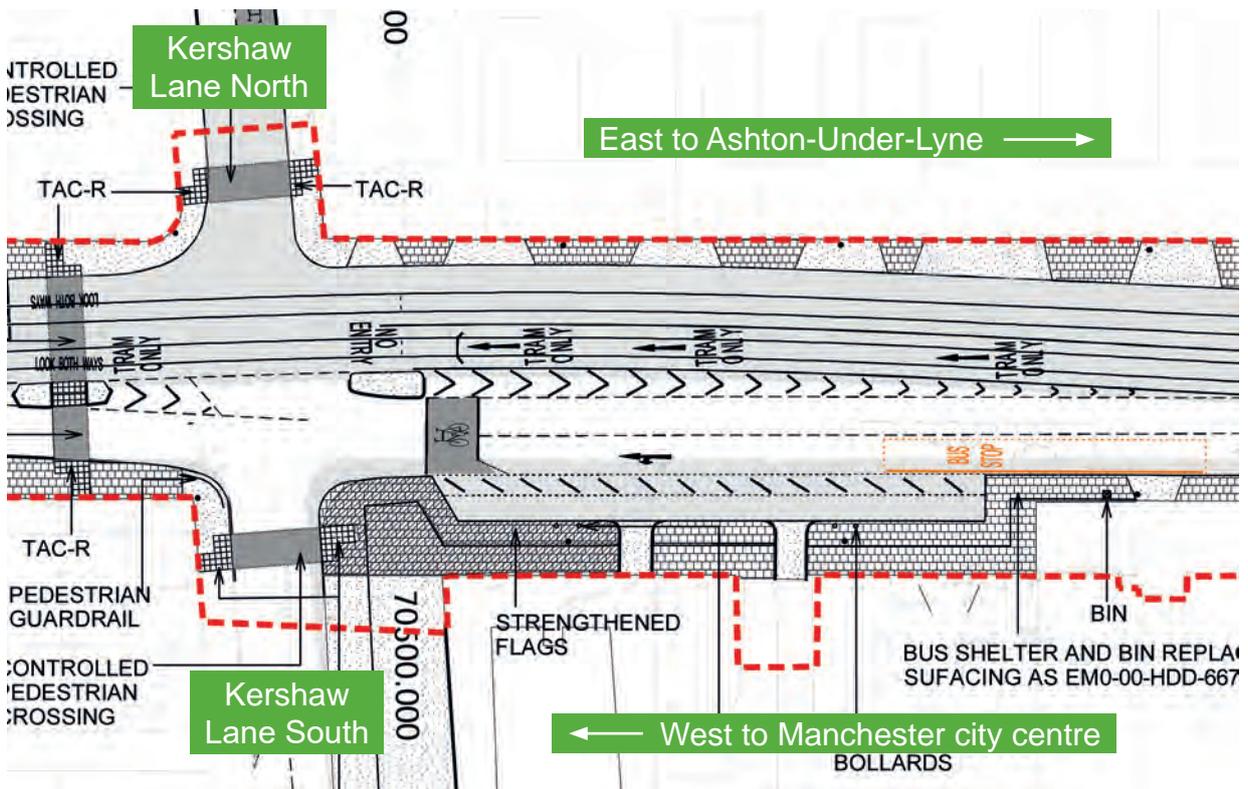
- 66 This initial design had the advantage of placing a controlled crossing at the location of the likely 'desire line' for pedestrians crossing to and from the convenience store and other businesses at the eastern side of the junction (paragraph 61). However, problems associated with the needs of property owners in the vicinity were encountered with the layout. For these reasons, this initial design was rejected. Design work then progressed with the intent of providing a controlled crossing (on Droylsden Road) solely across the western leg of the junction. By June 2010, MPT's detailed design had progressed to a point where it included the pedestrian refuge in its final position, to the south of both tram tracks. It was this configuration which was ultimately constructed, and which existed at the time of the accident (figure 12).

Figure 12: June 2010 design (courtesy of TfGM/MPT)

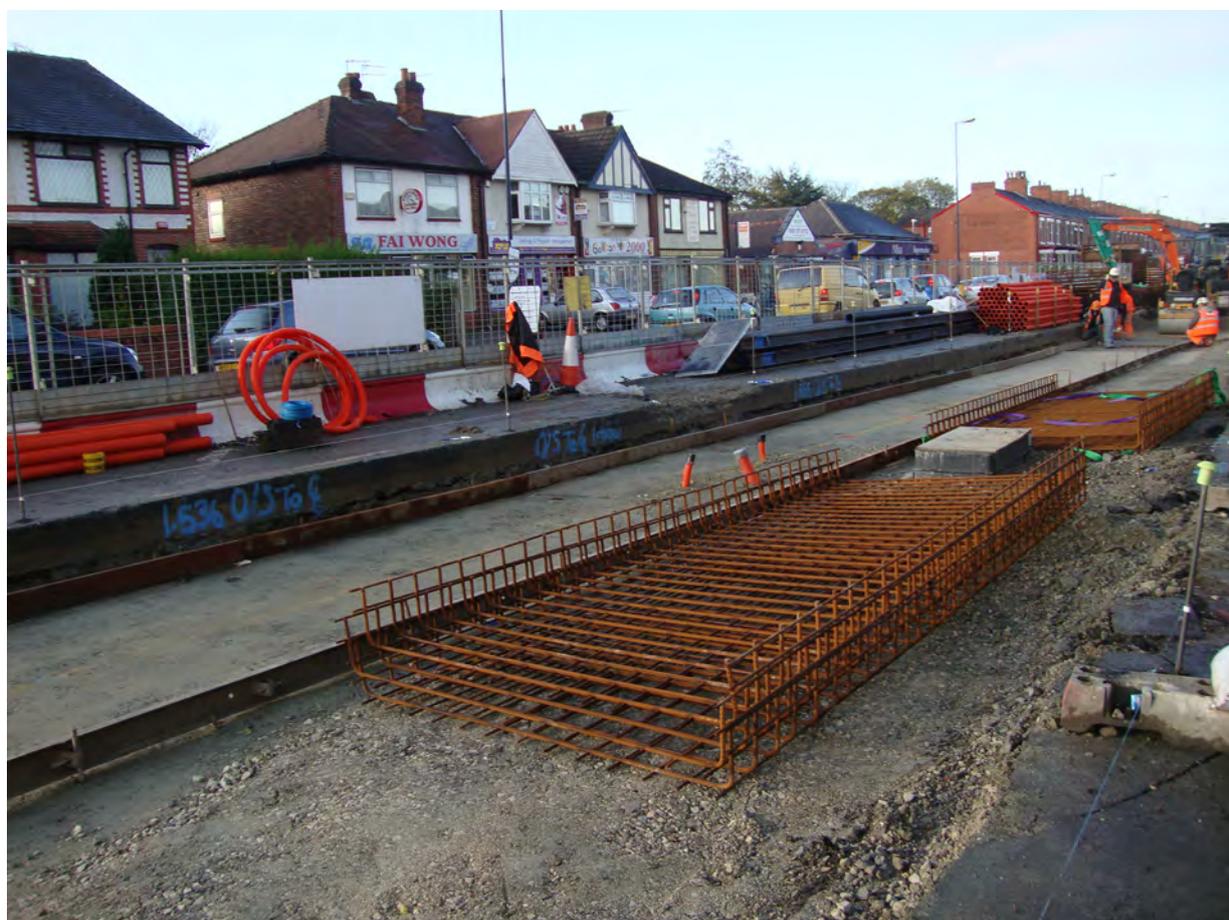
- setting off from a stand
- when entering a curve
- when a vehicle is blocking the track.

- 70 Construction of the tramway took place during 2011 and 2012. The basic track foundations were completed by November 2011 (figure 14), and the tramway works area around the location of the accident were substantially completed by the end of 2012. The East Manchester Line was opened from central Manchester to Droylsden in February 2013, and from Droylsden, past the location of the accident, to Ashton-under-Lyne in October 2013.

Figure 14: Construction work on Droylsden Road in November 2011. The location of the accident is at the right of the image (courtesy of TfGM)

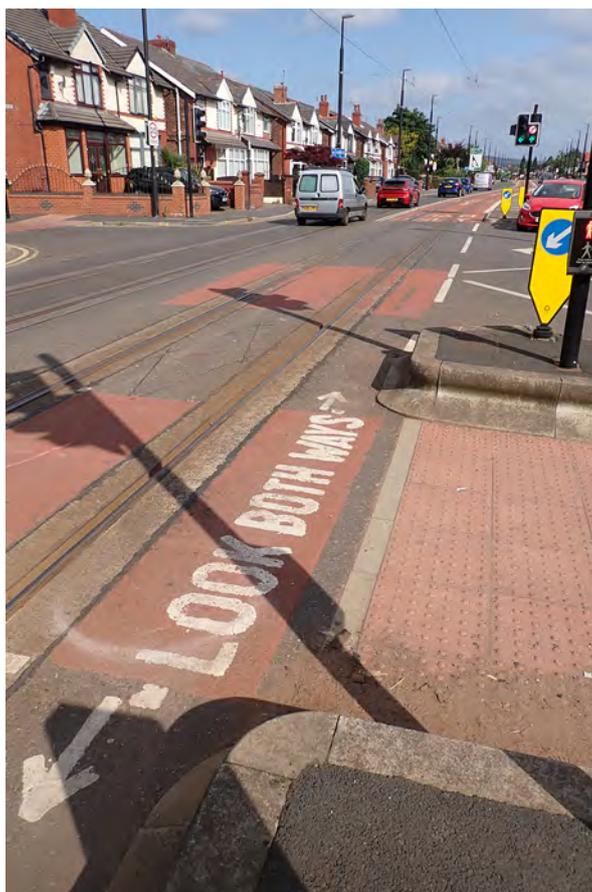
Figure 15: 'Look Both Ways' markings painted onto the road surface

The ‘look both ways’ markings were laid as recommended, and were found to be in place on the day of the accident (figure 15). However, the recommended markings to the south of the island were not in place. RAIB has been advised that these markings were never laid.

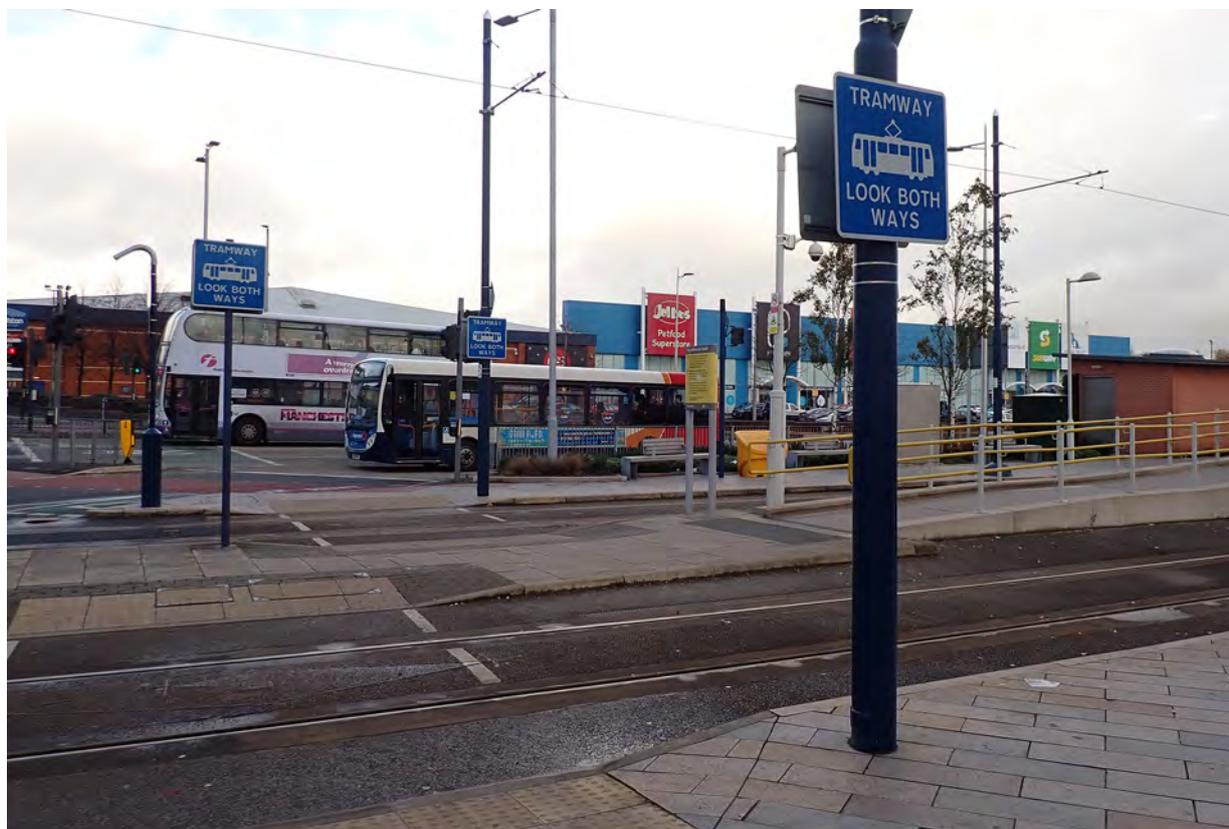
The improvements suggested in the review all apply to the western side of the crossing. This suggests that the review had identified that the same risk was present at the crossing on the western side of the junction. The road markings were also noted by the stage 3 RSA (paragraph 126) and were implemented at the accident location. However, diagram 963.3 signage was not provided.

137 Section 10.3 of Chapter 3 of the TSM documents the 'Diagram 963.3' signage (figure 16). Neither TSRGD nor the TSM mandate the use of these signs at locations such as the site of the accident; they equally do not prohibit the use of such signage.

Figure 16: Diagram 963.3 signage in place elsewhere on the Metrolink network
