Interim report on the investigation of the fire and subsequent loss of power on board the roll-on/roll-off cargo ship *Finnmaster* in Hull, England on 19 September 2021

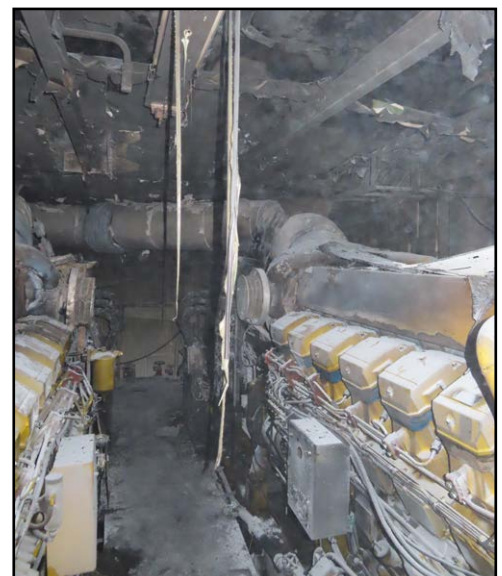
At 2013¹ on 19 September 2021, a fire broke out in the auxiliary engine room on board the Finland registered roll-on/roll-off cargo ship *Finnmaster* during departure manoeuvres in King George Dock, Hull. The fire ignited on one of the auxiliary engines and caused significant damage to the equipment and systems within the compartment (**Figure 1**), resulting in a total loss of electrical power. The emergency diesel generator started but was unable to supply power to the onboard emergency systems. The loss of power resulted in the vessel drifting until tugs mobilised and assisted it alongside.

Figure 1: The auxiliary engine room following the fire

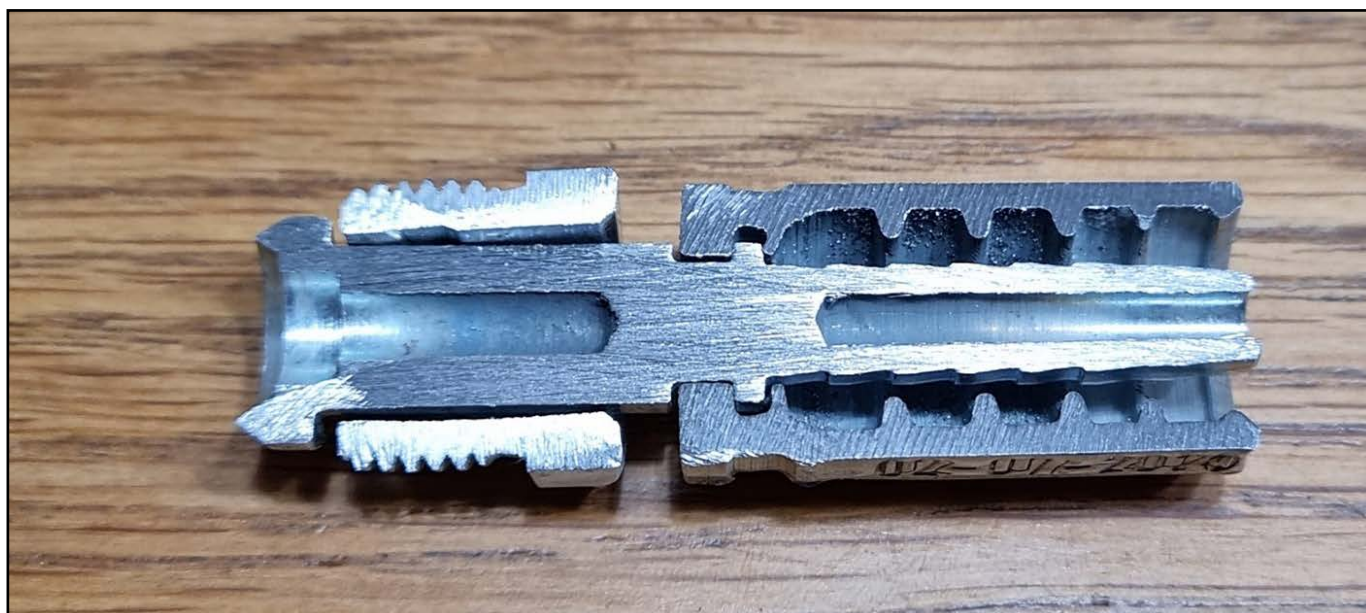
The initial investigation identified that the partial discharge of the CO₂ fire extinguishing system was because one of the pilot hose couplings had not been fully bored (**Figure 2**) while it was being manufactured, resulting in one of the pilot hose assemblies being completely blocked. The same manufacturing defect was found in two other hose couplings in the vessel's cargo hold CO₂ pilot line system. Testing of the auxiliary engine room's CO₂ system also identified several coupling leaks in the pilot lines.

Following the accident, tests conducted on the high-pressure CO₂ fire extinguishing systems on board the other vessels in the fleet operated by *Finnmaster*'s owner, Finnlines Plc, identified two similar blocked pilot hose couplings on another vessel.

Figure 2: Section through blocked CO₂ pilot hose coupling showing incomplete bore through the stem

In March 2022, the MAIB issued a safety bulletin (SB1/2022²) highlighting the risk that high-pressure CO₂ fire extinguishing systems on ships fitted with the affected hose assemblies may not correctly operate in an emergency. The safety bulletin included a recommendation to companies identified as having been supplied with the affected pilot hose assemblies to take immediate remedial action to identify and rectify any blocked assemblies and pilot system leaks on potentially affected CO₂ systems. The safety bulletin also included recommendations to the company that supplied the affected hose assemblies to amend its purchasing and quality control procedures, and to promulgate the safety bulletin to customers that were supplied with the affected hose assemblies.
