Rail Accident Report

Collision between a train and agricultural equipment at Kisby user worked crossing, Cambridgeshire 19 August 2021

Report 12/2022
October 2022

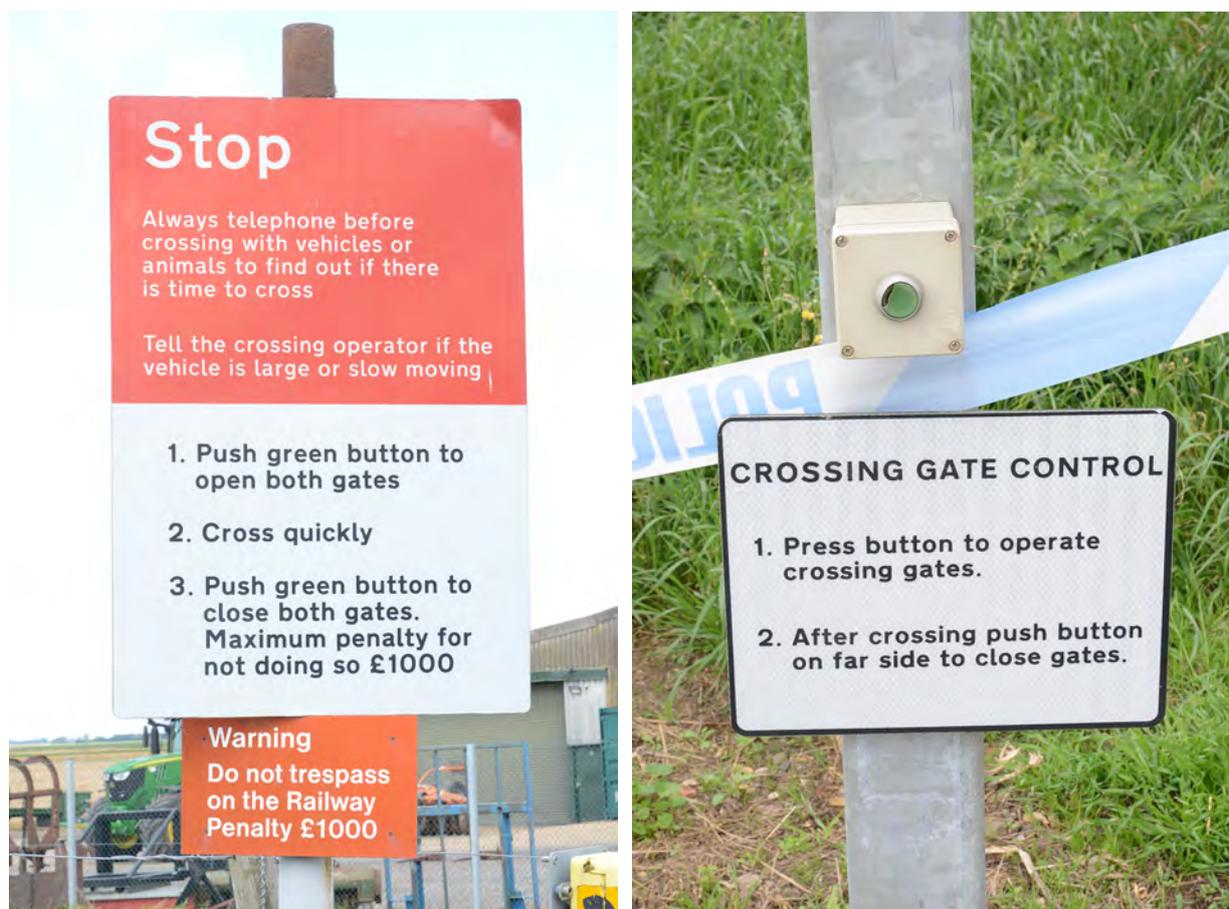
- 14 Signs on each approach to the crossing (figure 5) present instructions to users with vehicles and animals. These signs are a variant of the standardised design for a UWC(T), as set out in the Private Crossings (Signs and Barriers) Regulations 1996.

Figure 5: Level crossing signs provided at Kisby level crossing.

- 50 Although RAIB recognises that there are shortcomings in the signage at Kisby and similar level crossings, there is insufficient evidence to treat this as a causal factor in this accident because tractor driver 1 did not read the signs before using the crossing. Signage issues are addressed separately at paragraph 87.

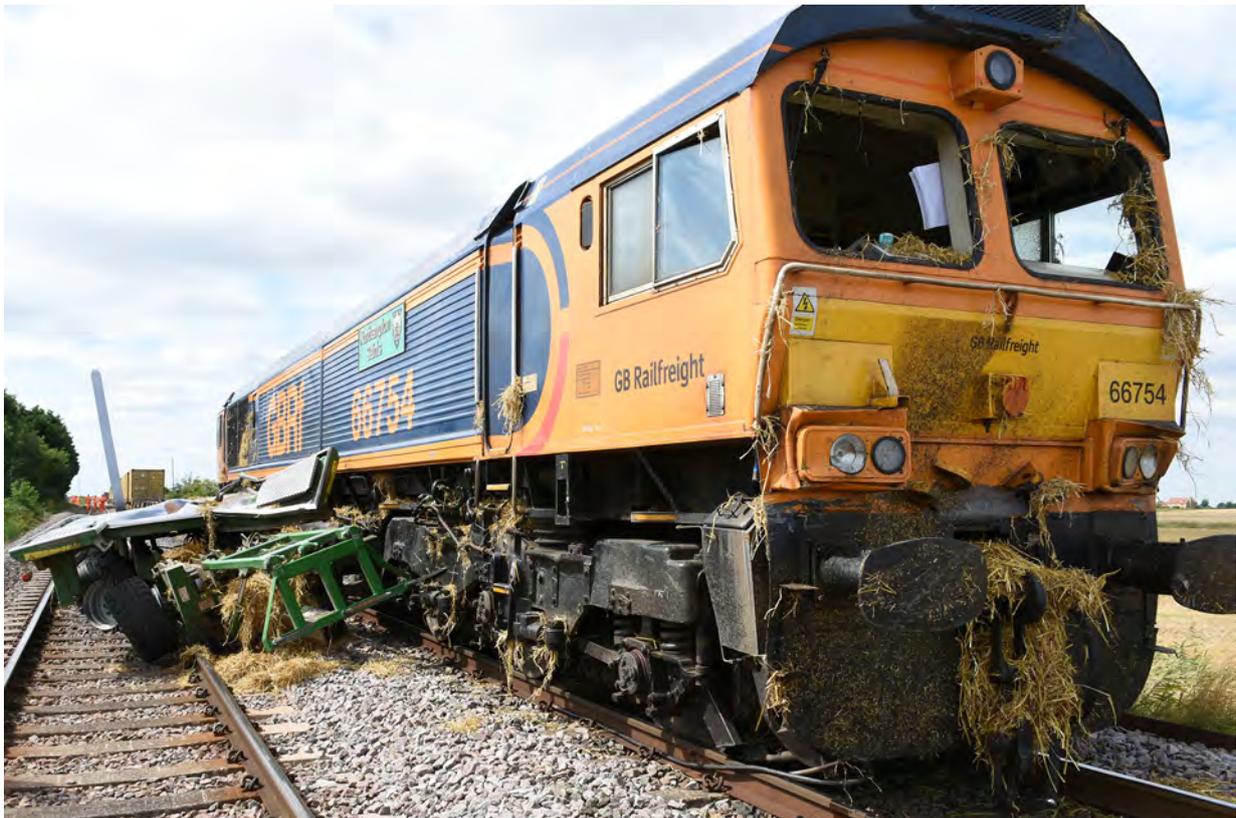
¹ A level crossing where the barriers or gates are operated by the user.

Figure 7: Damage to the front of the class 66 locomotive.

- 41 The locomotive sustained damage to the front and side, including damage to the leading wheelset, windscreens and in-cab equipment. The derailed FWA wagon sustained damage to its wheels, braking system and drawbars. The headstocks⁵ of the FWA wagons forming the front and rear units of the FWA triple-set were also damaged.

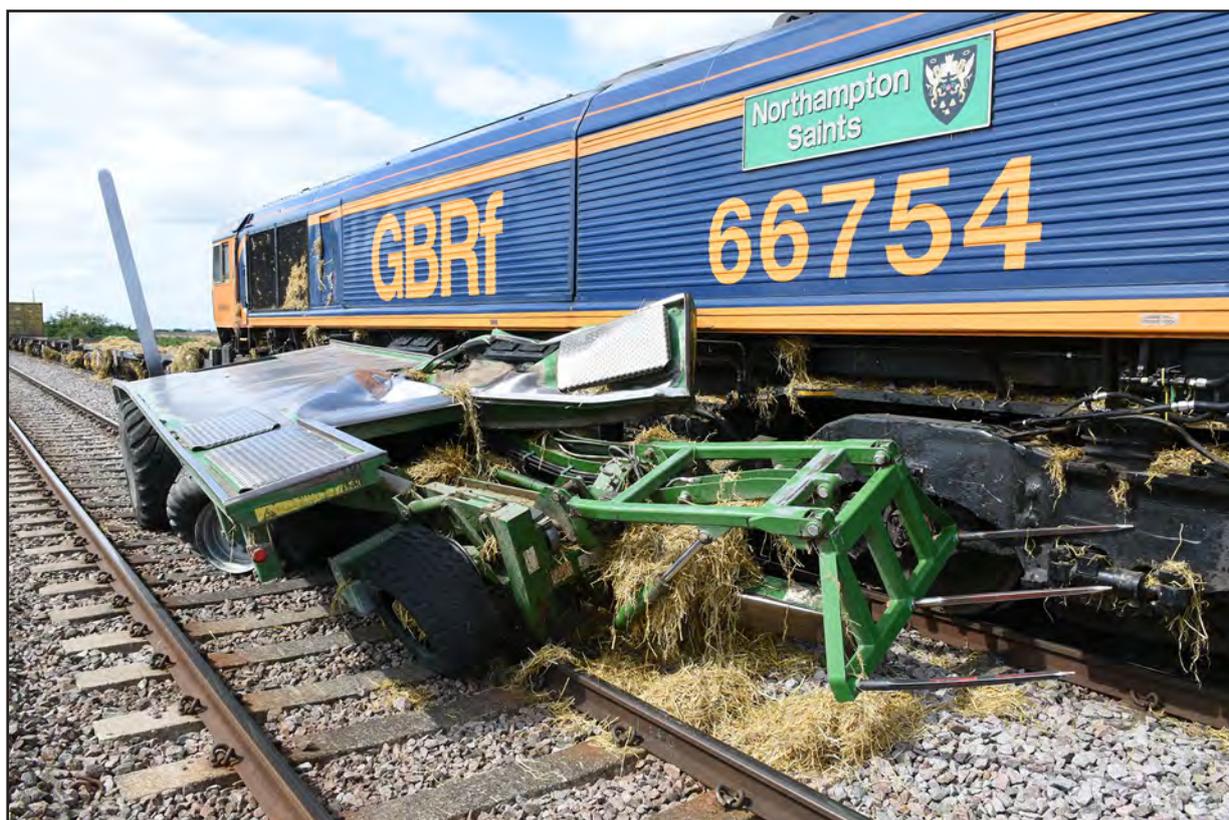
- 35 At the point of impact, the leading wheelset of the locomotive lifted off the rails, landing around two metres beyond the level crossing deck. This wheelset then ran derailed along the sleepers for a distance of 780 metres, until the train stopped.
- 36 All wheels on the sixteenth wagon in the train derailed around 220 metres before the crossing, their approximate location when the locomotive struck the tractor. They then ran derailed until the train stopped. The wagon which derailed was the middle unit of a semi-permanently coupled³ triple-set of FWA wagons.
- 37 The bale chaser rotated through 90 degrees and became entangled with the locomotive. It was dragged along the railway until the train stopped (figure 8).

Figure 8: The bale chaser entangled with the class 66 locomotive.

- 42 The bale chaser was separated from the tractor and damaged beyond economic repair. A combine harvester parked adjacent to the crossing was also damaged by flying debris. The tractor remained at the crossing during the accident and was undamaged.
- 43 Both lines were closed to rail traffic until 24 August, five days after the accident.

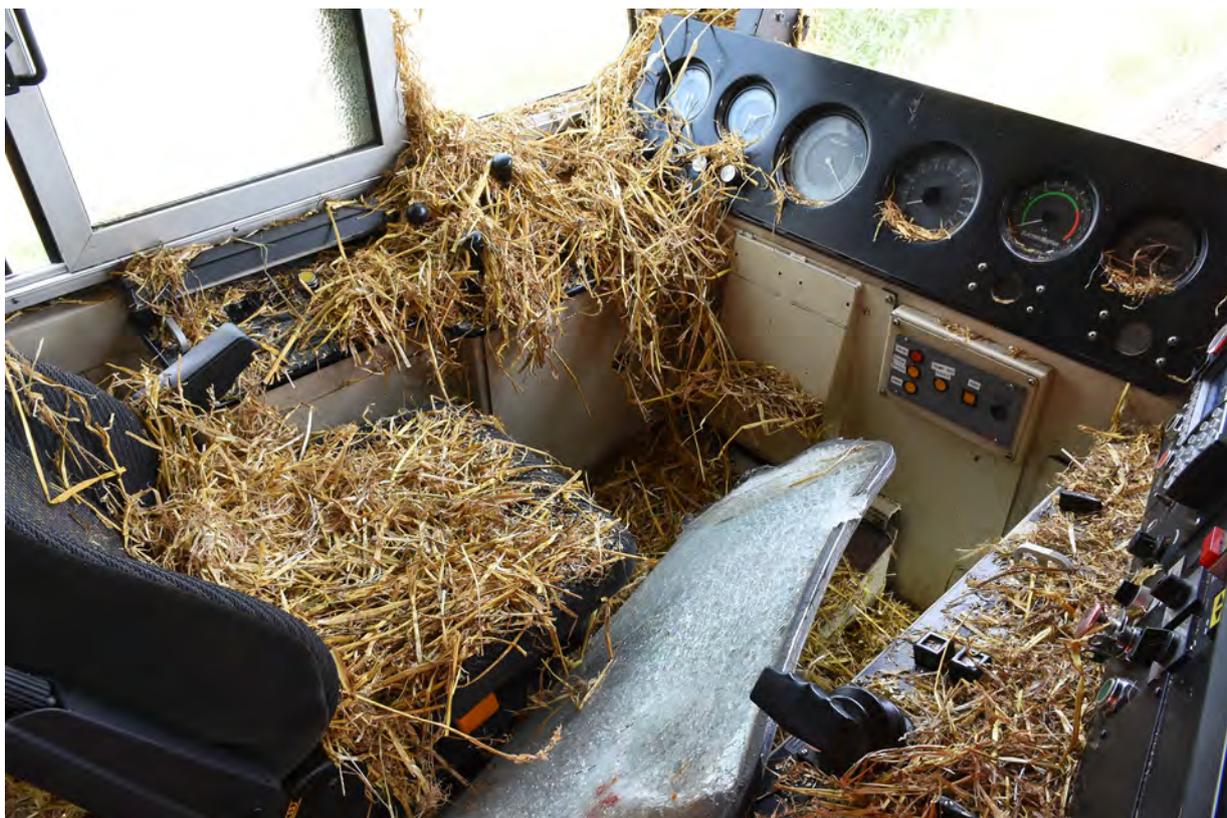
89 Both of the locomotive's front windscreens were pushed into the cab on impact with the bale chaser.

- 90 The impact with the bale chaser resulted in both of the locomotive's front windscreens, each with a mass of about 50 kilograms, being pushed into the cab, along with some straw. This resulted in damage to cab equipment. It is likely that this would also have caused serious injury to the train driver had he remained in his seat during the collision rather than moving towards the corridor entrance at the rear of the cab (figure 9).

Figure 9: Driver's side of class 66 cab after the accident.

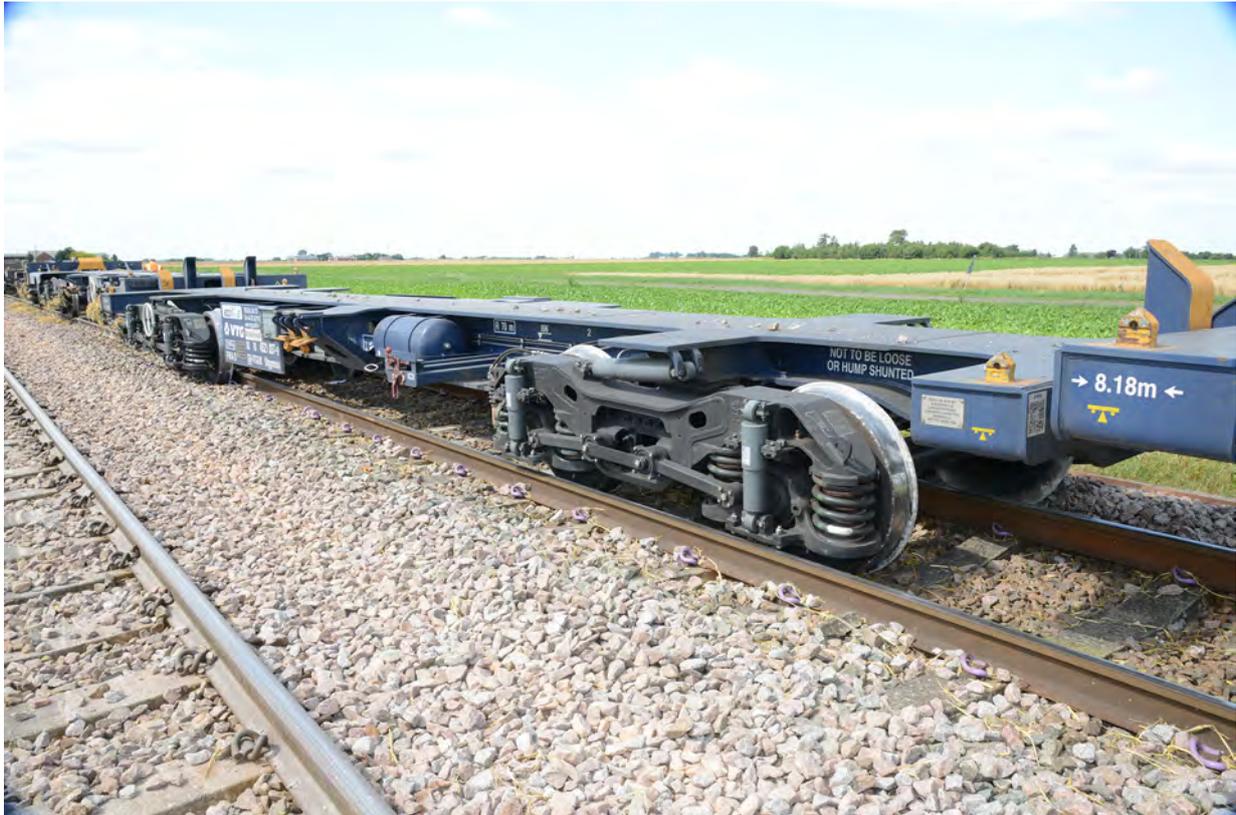
94 RAIB is considering the mechanism which caused this wagon to derail as part of its investigation into the derailment of a similar FWA wagon approaching London Gateway on 24 December 2021. It is not considered further in this report.

Figure 10: Derailed FWA wagon after the accident.
