AAIB Bulletin

1/2023

Published 12 January 2023

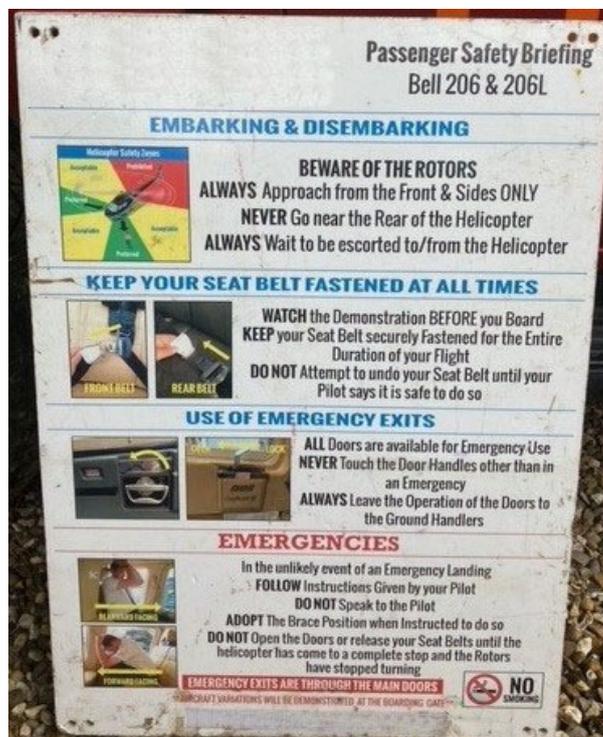
Figure 2

During the site set-up cows escaped on to the site from an adjacent field and needed to be removed and secured. The site set-up was then running late, and passengers were arriving and parking in incorrect locations. The sign was secured with two plastic cable ties on the top corners when normally it would be secured with plastic cable ties on all four corners. The sign measured 800 mm x 575 mm x 10 mm and weighed 2 kg (Figure 2).

Sign that became detached (Image used with permission)

A sign was not secured properly because the ground crew were distracted and under time pressure. During a landing, the combination of downwash and wind caused the sign to detach and strike a waiting passenger who suffered minor injuries.

The operator issued a flying staff instruction that required the sign to be secured with two cable ties on each corner and ordered metal lanyards to secure the sign in future (Figure 4).

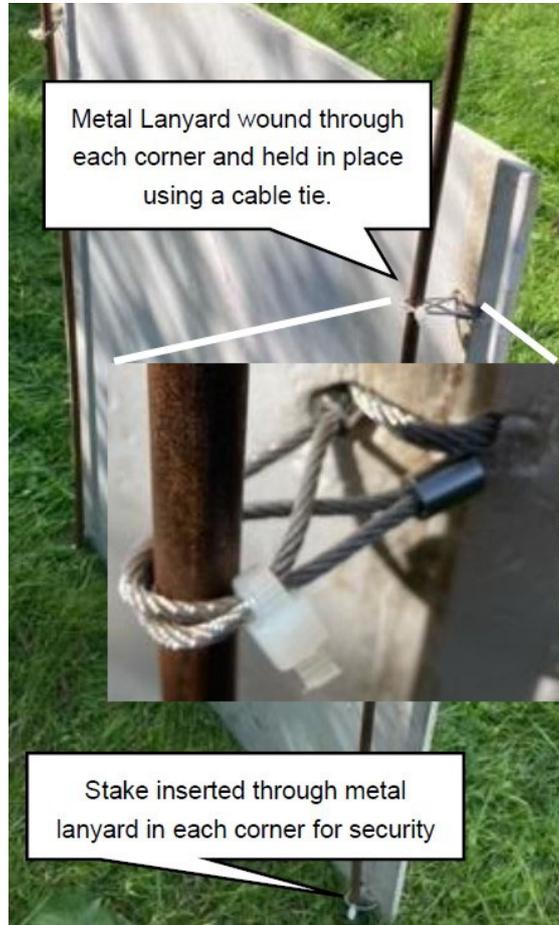
Figure 4

New method of securing the sign (Image used with permission)

The flying staff instruction also required the ground team leader to check the safety of the site before the first flight of the day and before each start of the helicopter engine.

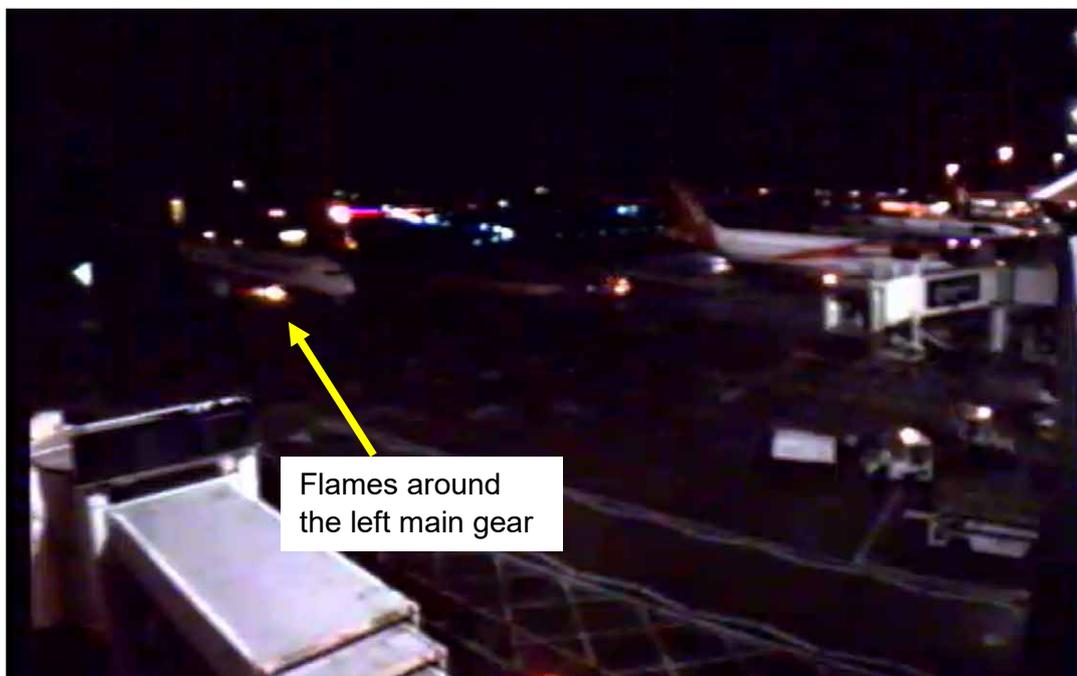
Figure 1

CCTV images showed that the fire started as the aircraft turned left from the apron towards the gate (Figure 1).

Still from CCTV showing a fire around the left main gear as the aircraft turned onto the stand (reproduced with permission)

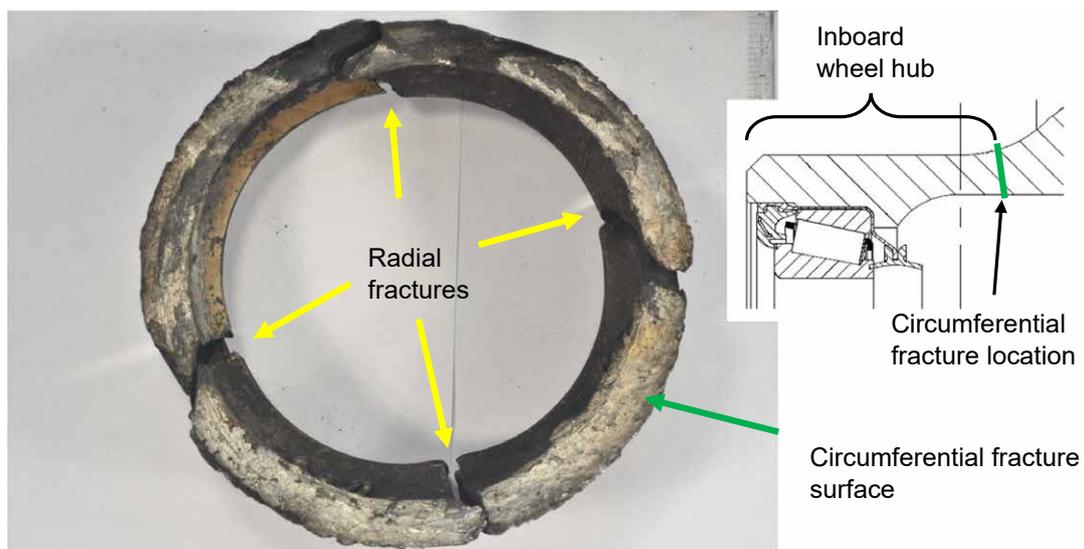
Figure 3

The wheel and brake manufacturer subsequently identified that the inboard wheel hub had fractured radially in four locations; they also identified a circumferential crack around the hub (Figure 3).

Inboard wheel half fragments showing the location of the circumferential and four radial fractures (reproduced with permission)

Three of the four radial fractures and the circumferential fracture were all consistent with overload. A fatigue crack was identified on one of the fracture surfaces, which originated at a corrosion pit located on the lead-in chamfer of the inner wheel half bearing bore (Figure 4). A number of other fatigue cracks, all originating from corrosion pits, were also found in the bore.

The wheel manufacturer has developed an ultrasonic inspection to assess the condition of the internal bore of the wheel hub to identify the presence of cracks originating at the lead in chamfer of the bearing bore.

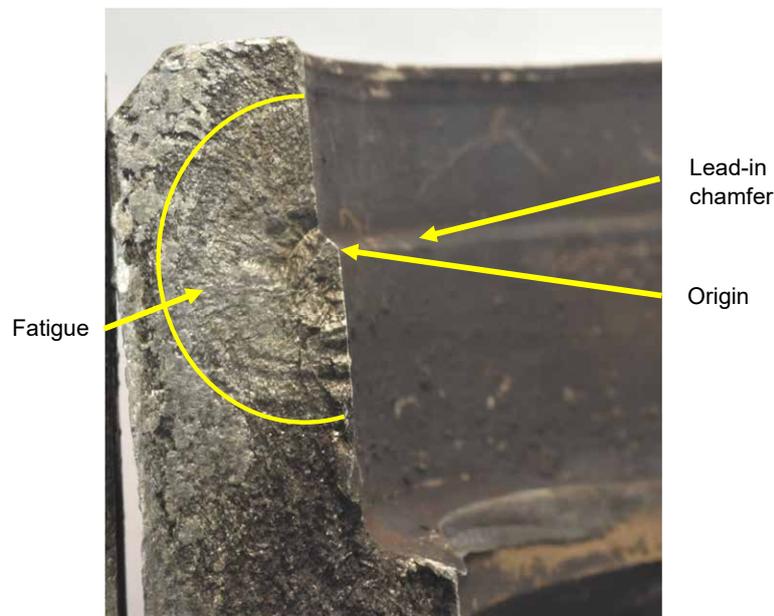
Figure 4

The fatigue crack originated from a corrosion pit in the wheel hub. Following this occurrence, the wheel manufacturer developed an ultrasonic inspection technique to identify cracks in this location on the hub and the operator has incorporated the new inspection into their maintenance programme.

Radial fracture surface with area of fatigue highlighted (reproduced with permission)

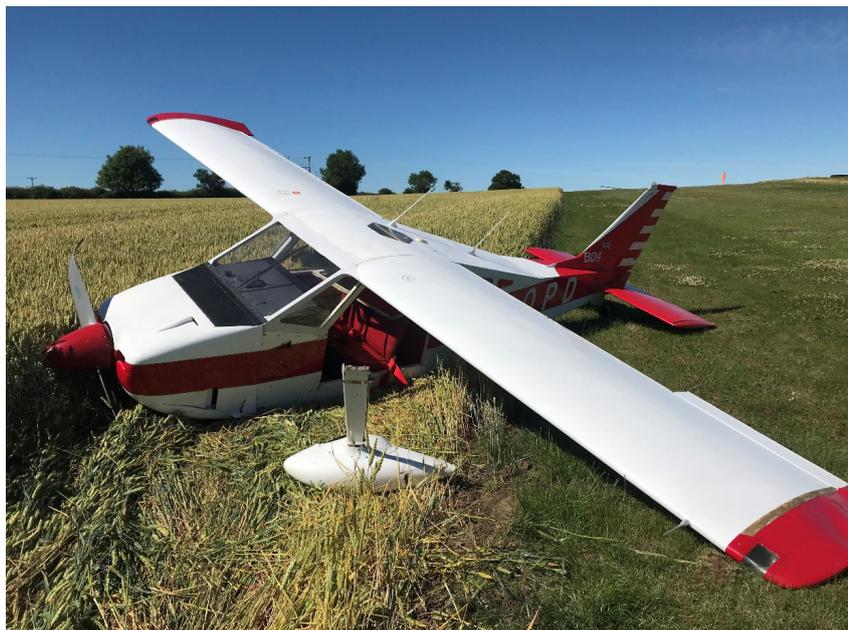
Figure 1

After a normal landing the left landing gear leg detached. The leg fracture surface revealed beachmarks which were consistent with a failure due to metal fatigue. The pilot estimated that the aircraft landing gear had probably made over 2,000 landings, which the manufacturer said was probably the highest number of landings of this aircraft type.

G-BOPD after the accident

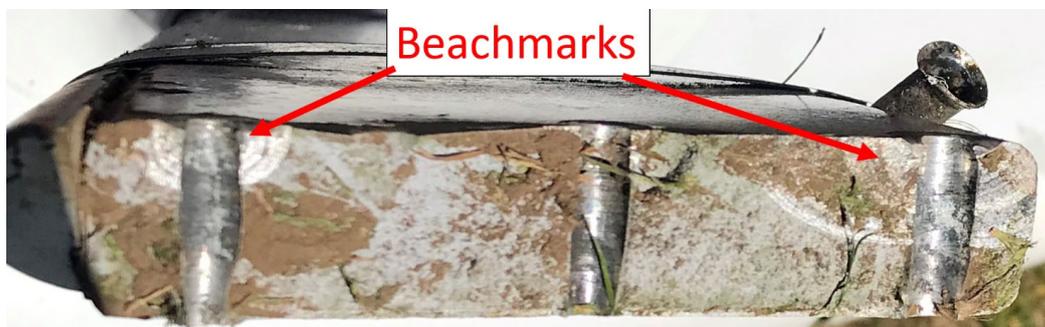
Figure 2

A photograph of the landing gear leg fracture surface revealed beachmarks which were consistent with a failure due to metal fatigue (Figure 2). The pilot contacted the aircraft manufacturer who informed him that they had not seen a fatigue failure in these landing gear legs before. The pilot estimated that he had probably made over 2,000 landings in it which the manufacturer said was probably the highest number of landings of this aircraft type.

The manufacturer no longer makes this landing gear leg type as it has been redesigned.

Landing gear leg fracture surface

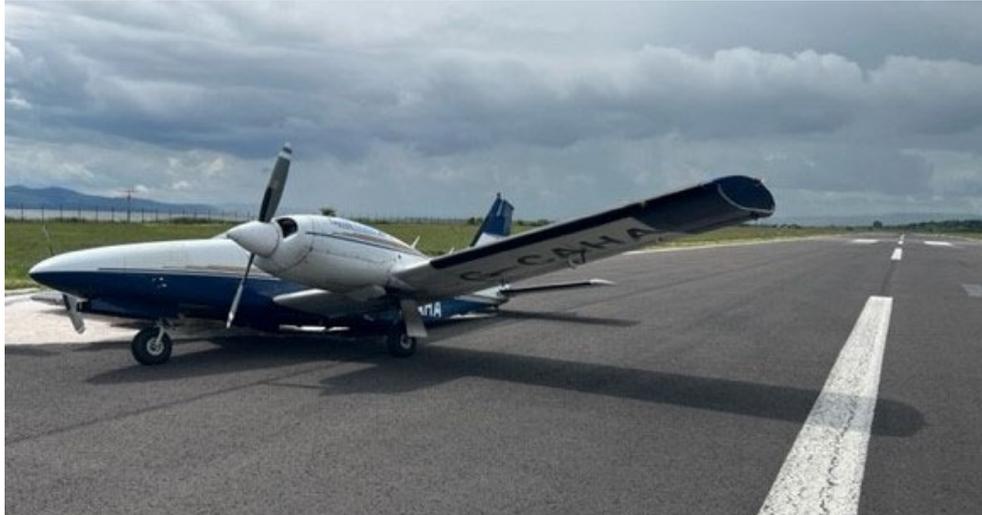
The aircraft had completed a final training flight on a multi-engine pilot (MEP) course and was on final approach at Dundee Airport. The downwind checks had been carried out and the student pilot confirmed "three greens", indicating the landing gear was down and locked. Following what the instructor described as a normal landing, the aircraft began to wobble, listed to the right and the propeller on the right engine and the right wing struck the runway. The instructor took control and managed to keep the aircraft reasonably straight and brought the aircraft to a stop. The occupants escaped unhurt. On exiting the aircraft it was clear the right main landing had collapsed (Figure 1).

After the accident the engineers from the maintenance organisation responsible for the aircraft checked the entire hydraulic and electrical system and no fault could be found. Despite repeated selections of the landing gear there was no evidence of failure of the main and nose landing gear down lock safety mechanism and switches. The aircraft was subsequently not repaired as the aircraft has been written off by the insurers.

Figure 1
G-CAHA post landing (used with permission)

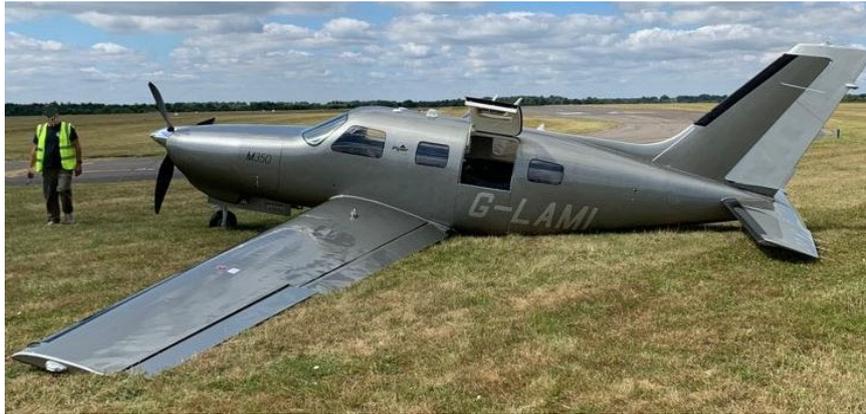
Figure 1

The aircraft decelerated and swung to the right as it ran off the end of the runway onto the taxiway. It continued off the paved surface into the grass and in doing so caused both main landing gears to collapse. The commander estimated they were travelling “not much more than walking pace” as they went onto the grass and came to a stop shortly afterwards (Figure 1).

G-LAMI shortly after the accident

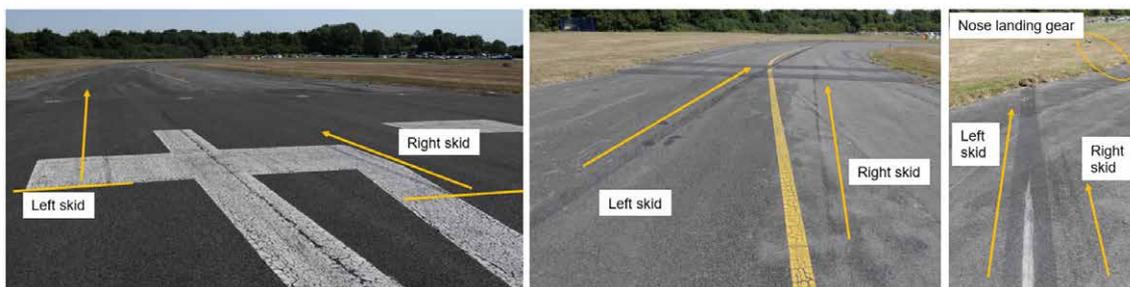
Figure 2

Inspection of the end of Runway 06 revealed two lines of black skid marks starting from the painted Runway 24 numbers (Figure 2 left). The distance between the lines was 3.6 m and were to the left of the runway centreline. The skid marks continued in an arc to the right (Figure 2 centre) and converged at a point where they left the paved surface (Figure 2 right). The left skid mark was darker and there was evidence of the tyre scrubbing sideways, whereas the right skid mark was lighter, and the skid was in the direction of travel. At the point where the main gears left the paved surface there was another skid mark, 4.2 m to the right, from the nose landing gear (Figure 2 right).

Skid marks on the runway

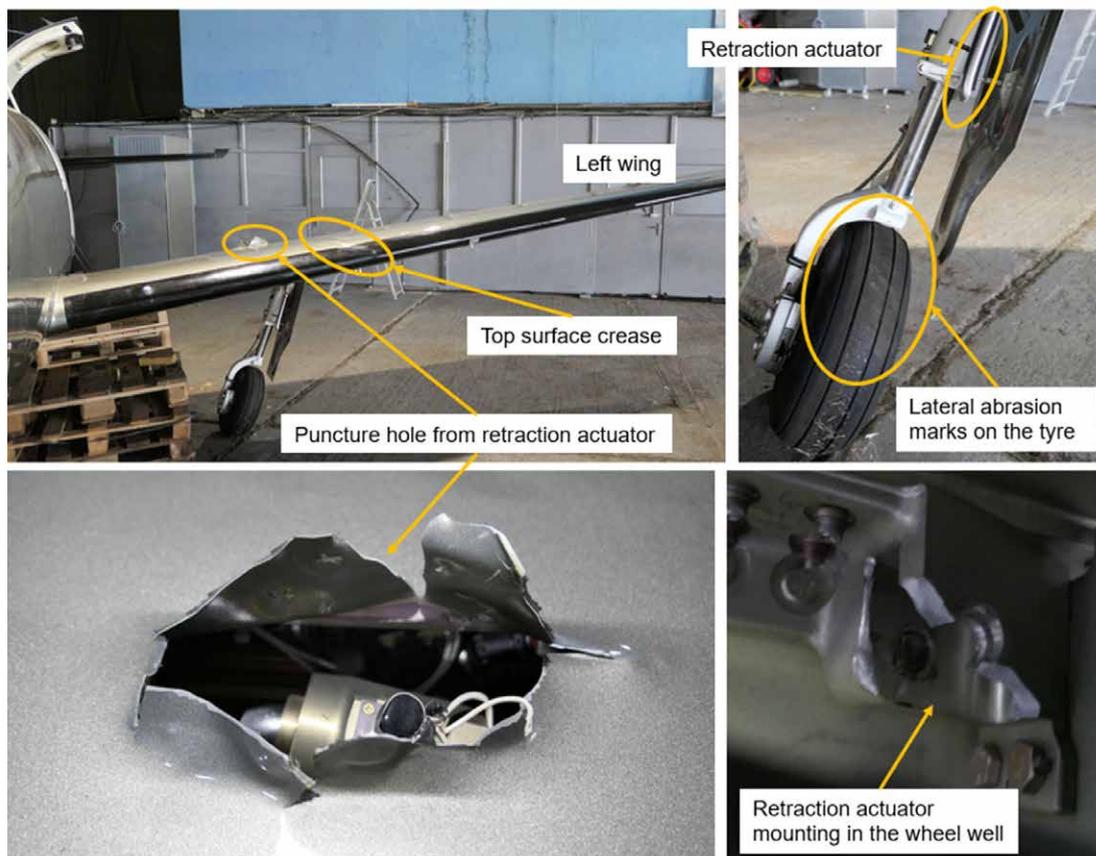
The aircraft was inspected by the AAIB after it had been recovered following the accident. The left-wing top surface was creased outboard of the landing gear attachment with damage to the wing tip structure (Figure 5 top left). There was a puncture hole in the top surface (Figure 5 lower left) near the retraction jack actuator and the actuator had failed in compression and bending (Figure 5 top right). The actuator mounting lug on the wing spar had sheared (Figure 5 lower right) and the tyre had lateral abrasion marks (Figure 5 top right).

Figure 5
Left wing and landing gear damage

As the left main landing gear reached the curb the lateral forces exerted on it caused the retraction actuator to buckle, snap and puncture the wing top skin. The landing gear collapsed causing the left wing to be damaged as it travelled across the grass. The nose landing gear remained intact which resulted in the rear fuselage contacting the ground behind the cabin door. The right landing gear retraction actuator was overloaded in tension as it crossed the curb and when it failed, the landing gear over extended and was damaged by contact with the weather radar pod.

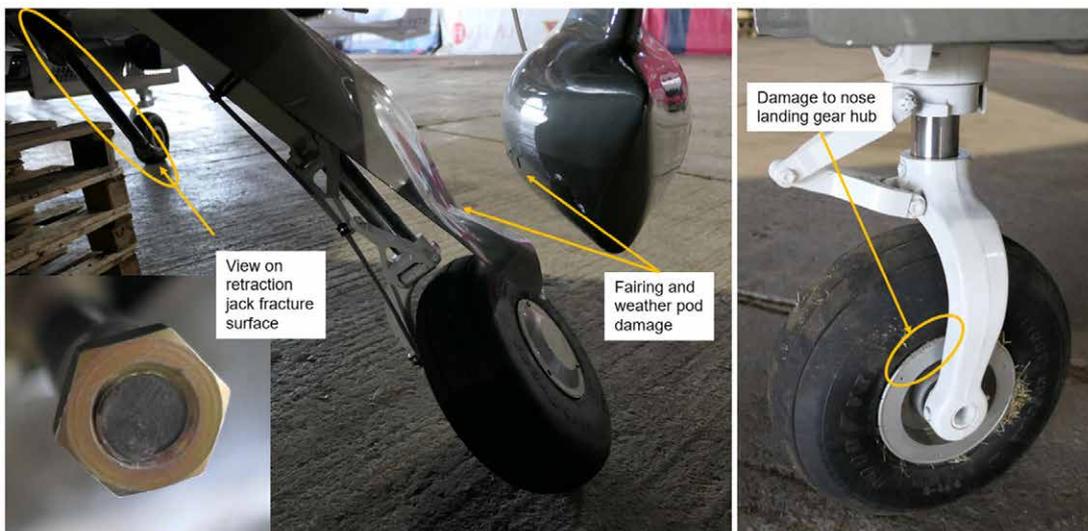
Figure 6

The right landing gear retraction actuator had failed in tension overload and the landing gear fairing had been damaged where it had contacted the weather radar pod (Figure 6 left). There were deep abrasion marks on the left side of the nosewheel rim with corresponding damage to the tyre (Figure 6 right).

Right landing gear damage (left), nose landing gear damage (right)

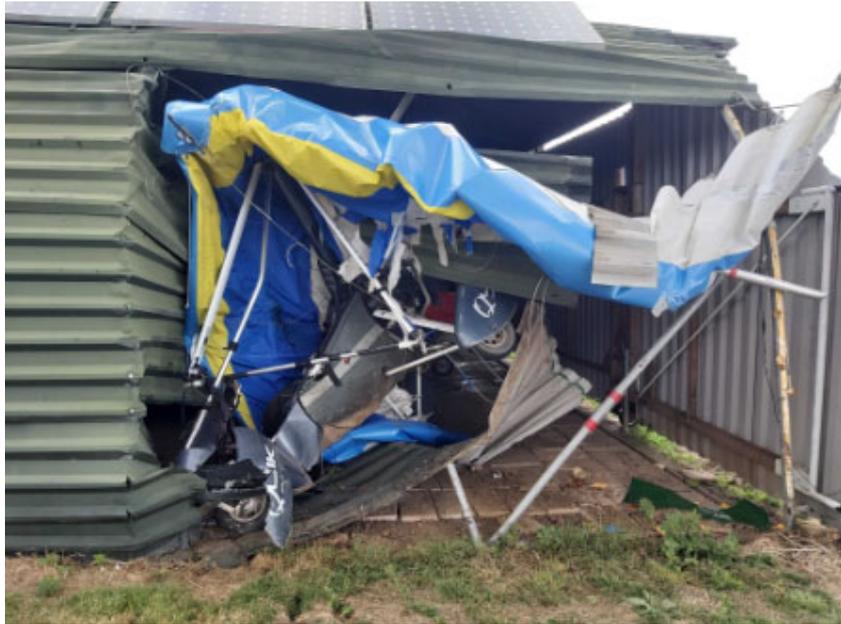
The pilot believed the accident was a combination of a reduction in the headwind and a possible early rotation.

Figure 1
G-EEWZ after the accident

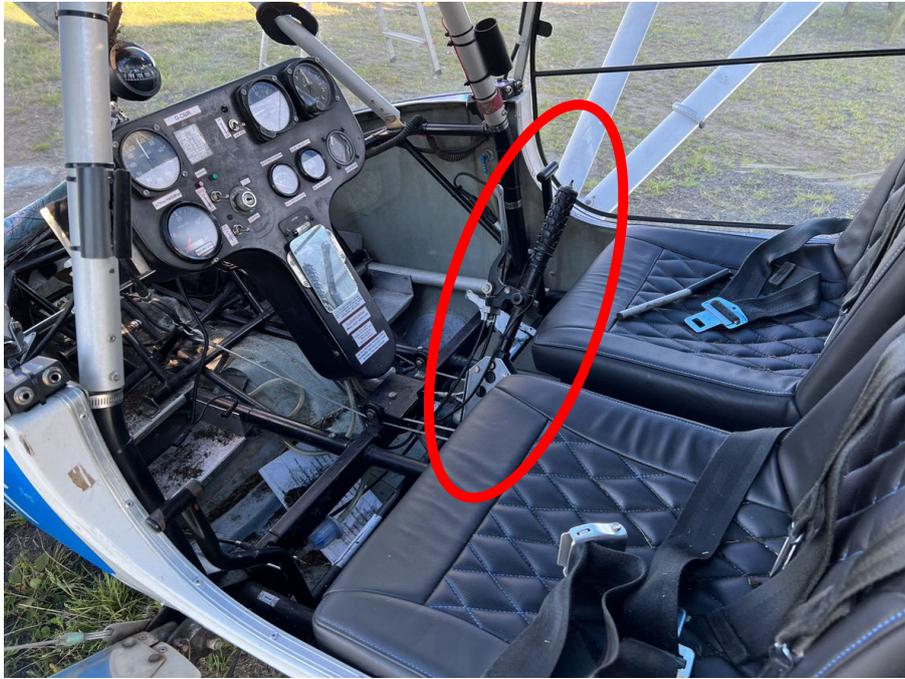
Figure 1

The aircraft landed heavily when the student and instructor both made a nose-down pitch input on the single control stick following a simulated engine failure.

Cockpit of G-CBIR (upright after recovery) showing single control stick

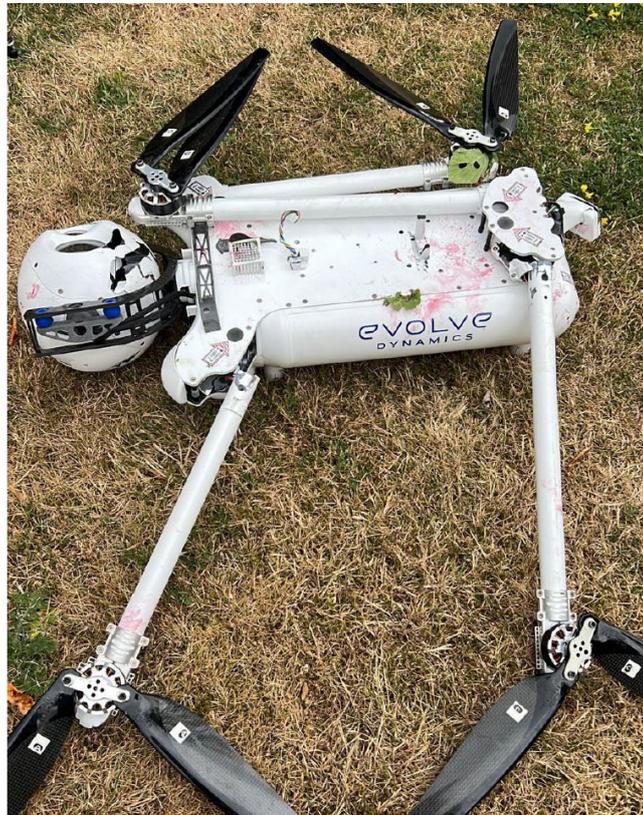
Figure 1

Sky Mantis after the accident

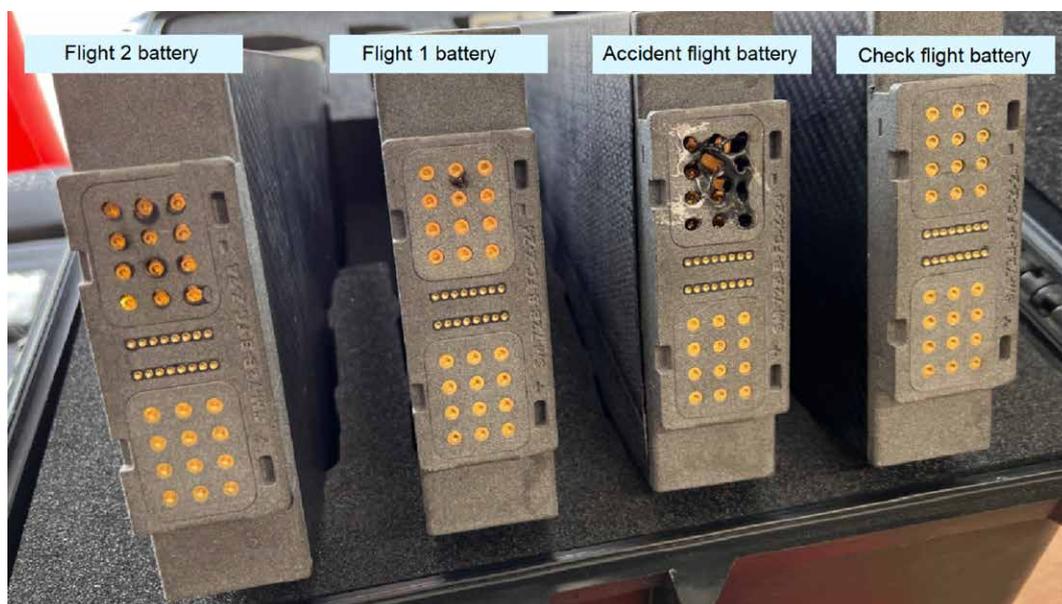
The aircraft and its five batteries were examined by the manufacturer. This showed that the aircraft's battery connector had been extensively damaged by heat, which had caused 12 of its pins to collapse within the connector. The corresponding electrical connector pads on the flight 2 and accident flight batteries also showed varying levels of thermal damage (Figure 4). The flight 2 battery connector pads had receded slightly into the battery, and there were adjacent scorch marks. The accident flight battery was much more significantly damaged, with the pads having collapsed within the battery.

The contacts on the check flight and the unused fifth battery appeared undamaged, but the flight 1 battery showed evidence of scorching near one of its contacts.

Figure 4
Damage to battery connectors

The manufacturer stated that the damage to the connectors was a result of the number of pins in contact within the connector having been progressively reduced, which led to the electrical current through the remaining connections causing sufficient heat to distort the plastic of the connector. This led to the further loss of electrical load sharing between connections and additional heat, until the point where a complete loss of electrical power occurred. The recorded flight logs were also consistent with this, showing that at 13 minutes 27 seconds into the accident flight, there was a complete loss of electrical power. In the final minute of the flight preceding the loss of power, there were also several rapid fluctuations in the battery supply voltage and current flow to the aircraft. These were considered to be related to the connector starting to fail. A check of the battery charge indicator after the accident showed that it was at 75% charge remaining.

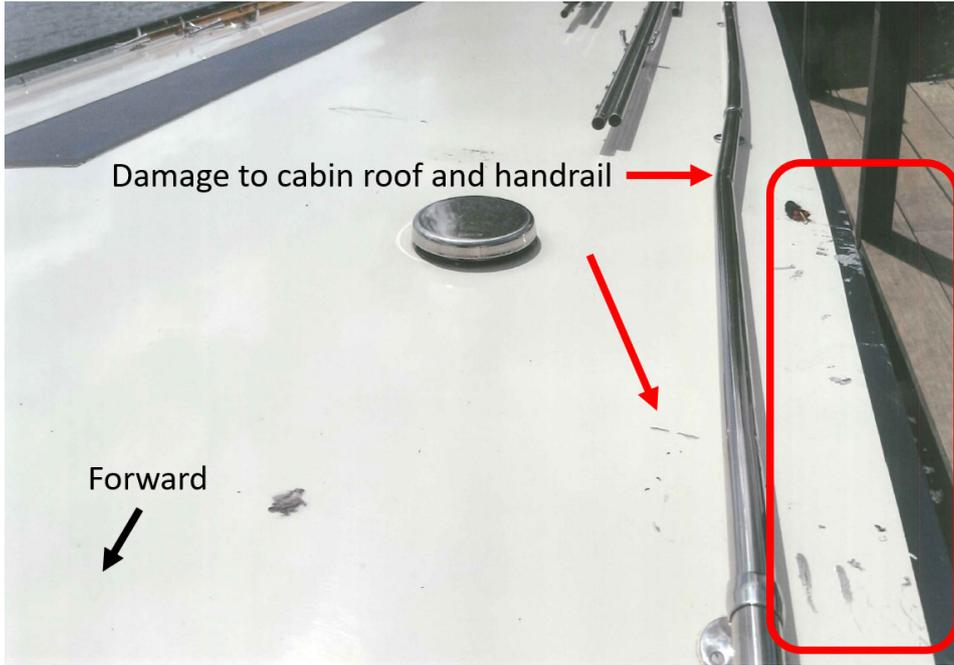
Figure 5

The aircraft had initially collided with the forward left side cabin roof causing deformation in a section of the stainless-steel handrail and damage to the surface of the roof (Figure 5). The aircraft then struck the left side of the cabin and adjacent gunwale, prior to it falling into the river and sinking. Composite material from the aircraft had been embedded into the wooden surface on the gunwale (Figure 6) and one of its batteries had detached from the aircraft and come to rest on the forward deck (Figure 7).

Damage to cabin roof and left side handrail

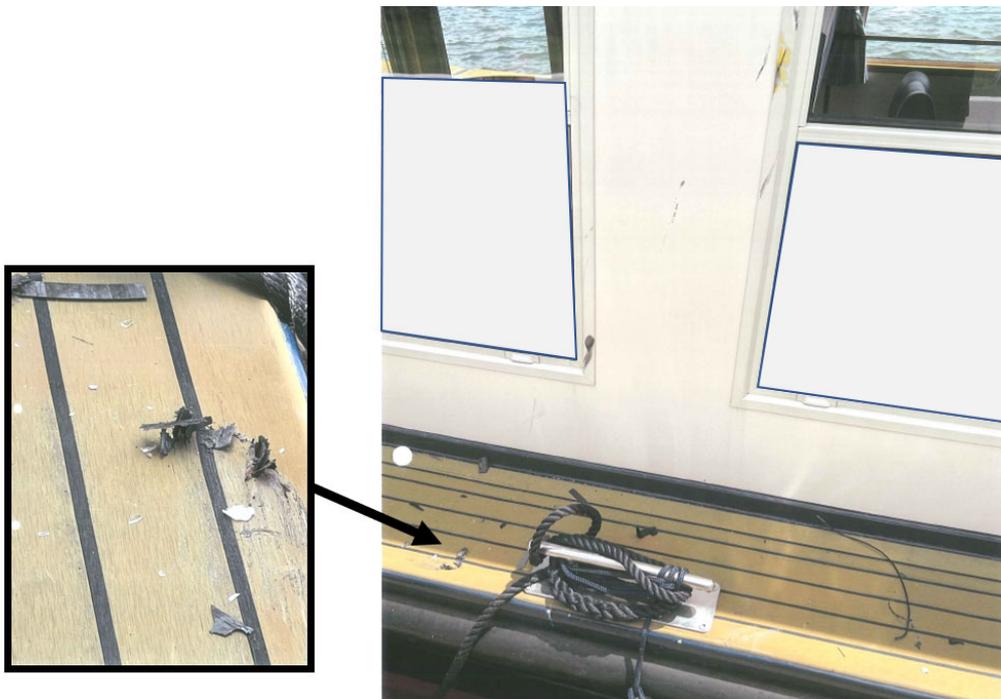
Figure 6

Damage to the cabin and gunwale

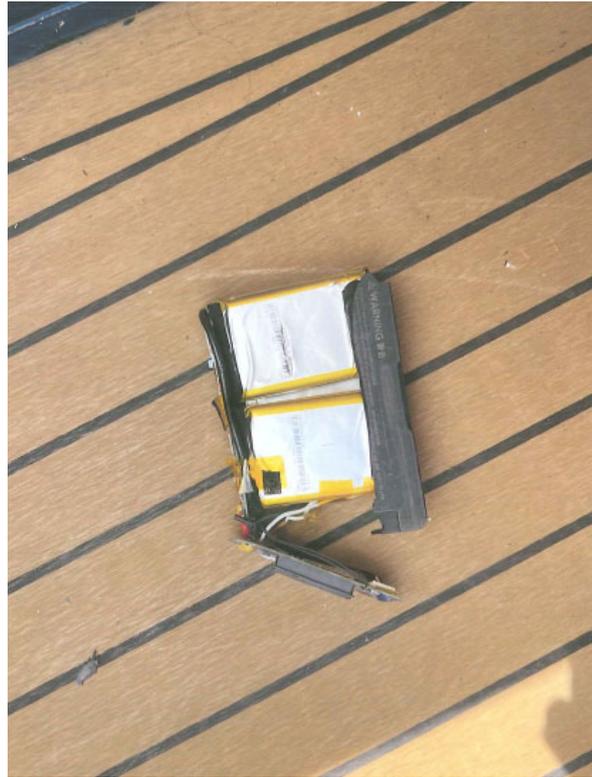
Figure 7

Aircraft battery on forward deck
