AAIB Bulletin

2/2023

Aircraft Type and Registration:	Piper PA-23-250, G-BJNZ	
No & Type of Engines:	2 Lycoming IO-540-C4B5 piston engines	
Year of Manufacture:	1979 (Serial no: 27-7954099)	
Date & Time (UTC):	2 April 2022 at 1535 hrs	
Location:	Enfield, Greater London	
Type of Flight:	Private	
Persons on Board:	Crew - 1	Passengers - 3
Injuries:	Crew - None	Passengers - None
Nature of Damage:	Damage to the engines, propellers, landing gear, left flap and underside of the fuselage	
Commander's Licence:	Private Pilot's Licence	
Commander's Age:	67 years	
Commander's Flying Experience:	1,859 hours (of which 1,090 were on type) Last 90 days - 33 hours Last 28 days - 21 hours	
Information Source:	AAIB Field investigation

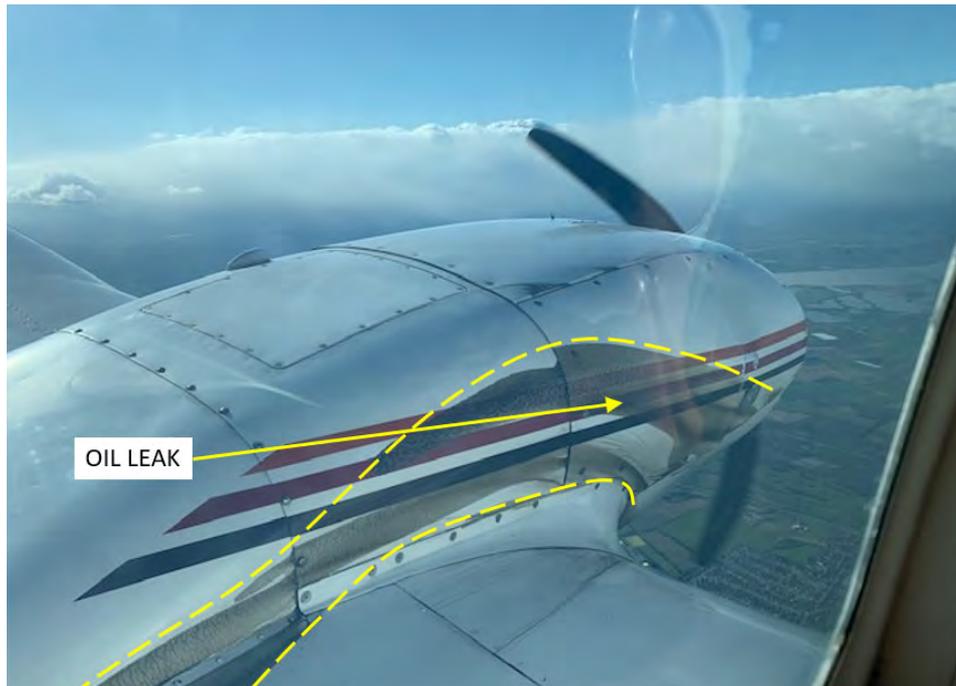
Figure 2

Photograph taken inflight of the oil leak from the left engine

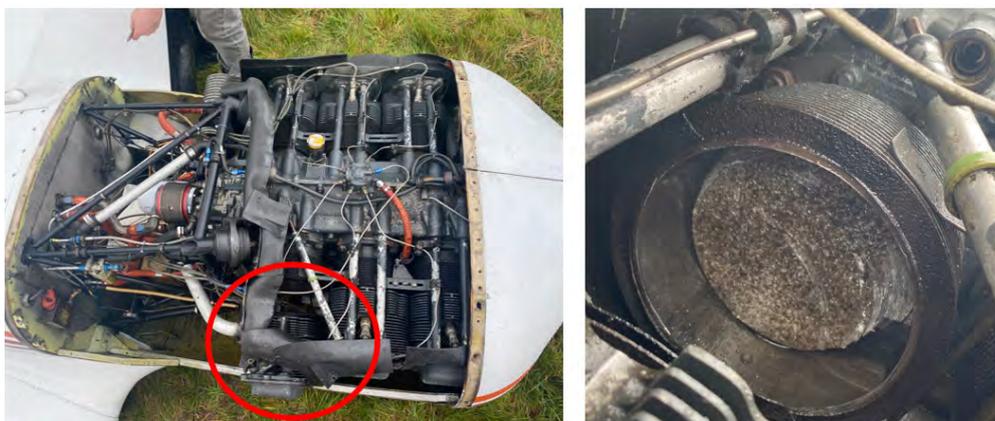
Figure 6

Left engine fractured No 5 cylinder and exposed piston

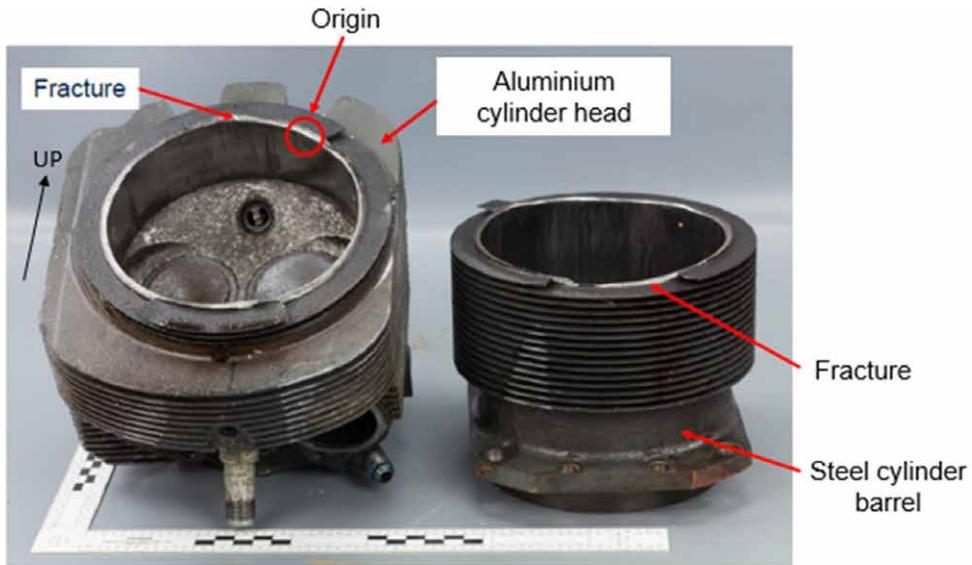
Figure 7

The fracture in the No 5 cylinder occurred in the steel cylinder barrel, 13 mm from the point where the aluminium cylinder head is screwed onto the steel barrel (Figure 7). The crack started at the 1 o'clock point on the barrel section, on the upper part of the cylinder.

Fracture location in No 5 cylinder (image courtesy QinetiQ)

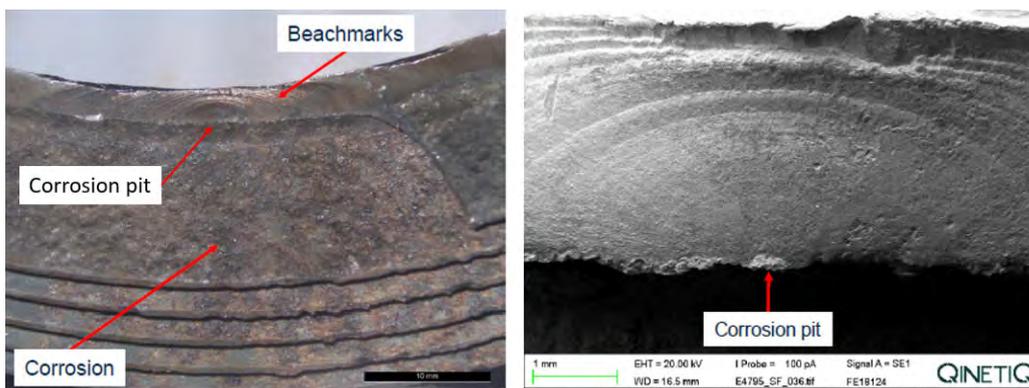
Figure 8

The fractured cylinder was examined by a metallurgist who concluded that the crack originated at a corrosion pit on the cylinder's outer surface (Figure 8). The steel barrels of all the other cylinders of both engines were inspected and all were observed to be corroded on their outer surfaces.

Corrosion pit at crack origin (images courtesy QinetiQ)

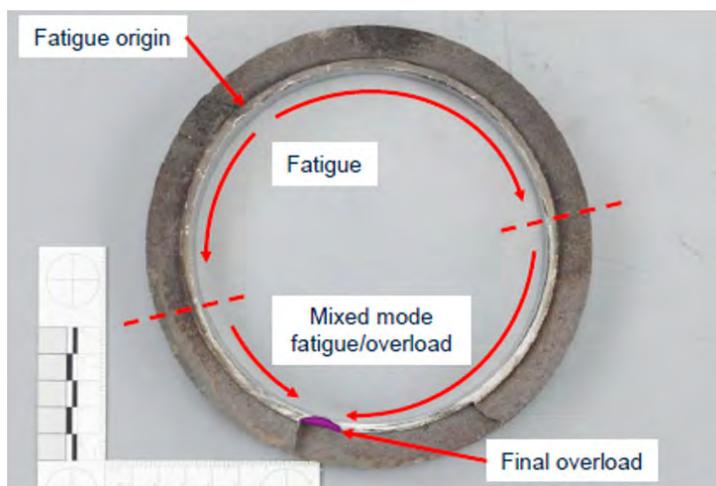
Figure 9

The fracture propagated by fatigue for approximately 50% of the cylinder cross-section (Figure 9). The fracture then continued to grow in a mixed fatigue-overload mode, before the cylinder finally failed in overload.

Crack growth progression (image courtesy QinetiQ)

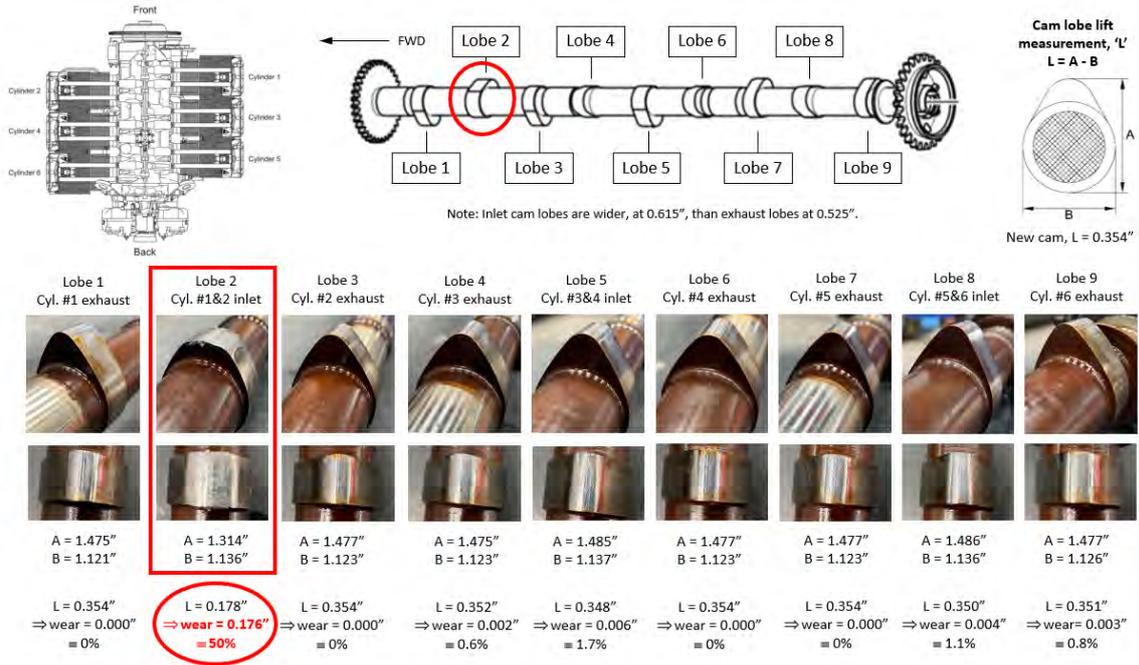
The engine was disassembled to determine the condition of its components. Severe wear was noted on the second camshaft lobe, which actuates the inlet valves for both the No 1 and No 2 cylinders (Figure 10). The lift of this camshaft lobe was measured to be 0.178", which is approximately 50% of the lift of an unworn camshaft. The other eight camshaft lobes showed minor wear that would not have significantly affected the engine's performance.

Figure 10
Measured wear of G-BJNZ's right engine camshaft lobes

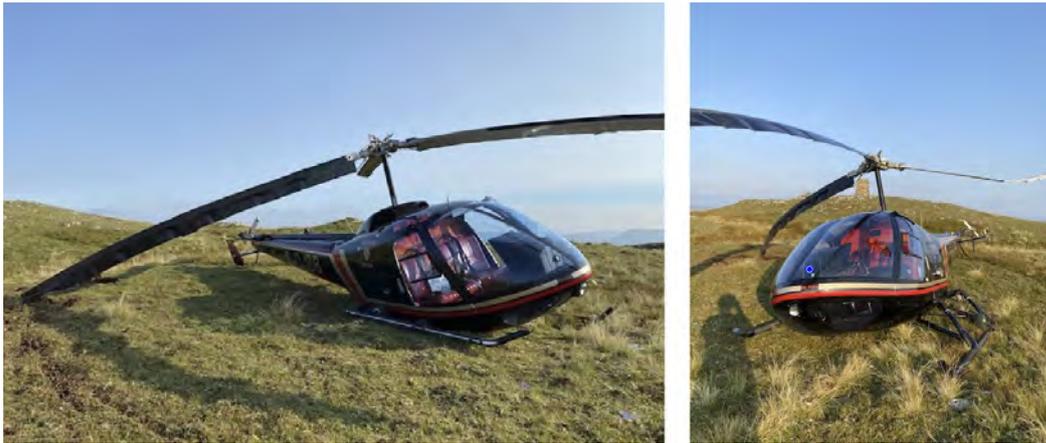
Figure 2

G-OJBB shortly after the accident

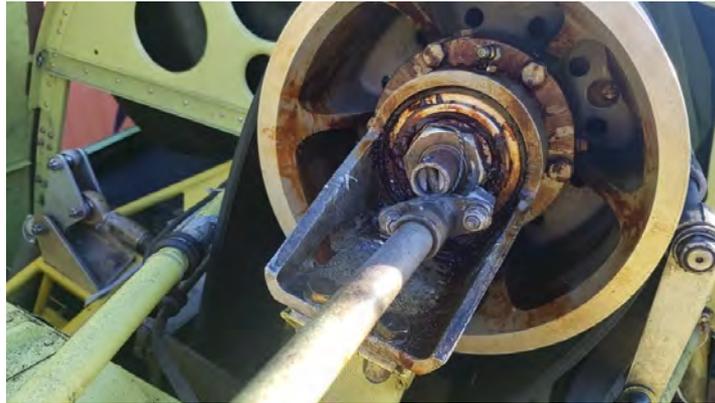
Figure 7

Broken tail rotor driveshaft coupling

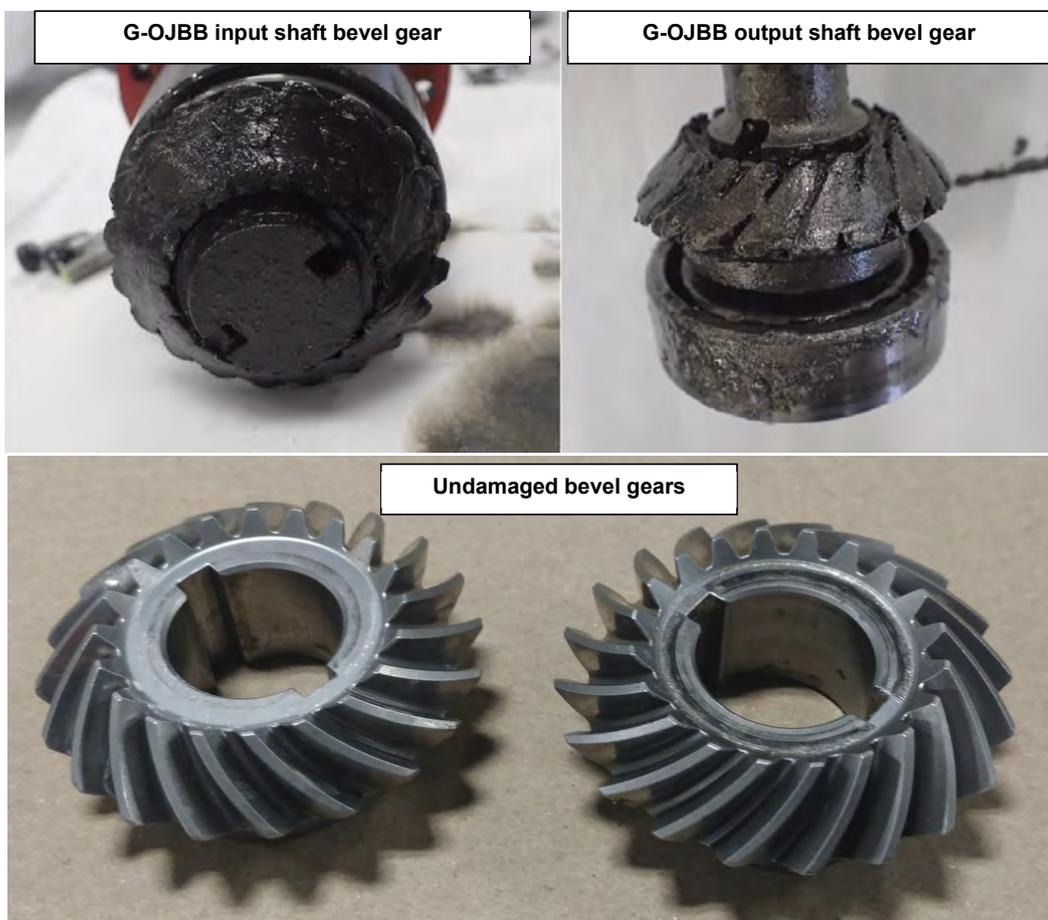
Figure 9

The teeth on both bevel gears were severely deformed to the extent that they had the appearance of an almost toothless cone (Figure 9).

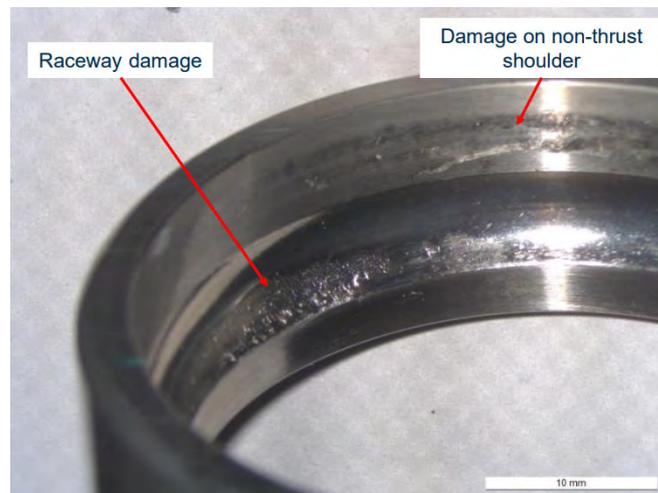
Figure 11

Damage was present on the raceway over approximately one quarter of its circumference. The entire circumference of the non-thrust shoulder also exhibited damage (Figure 11).

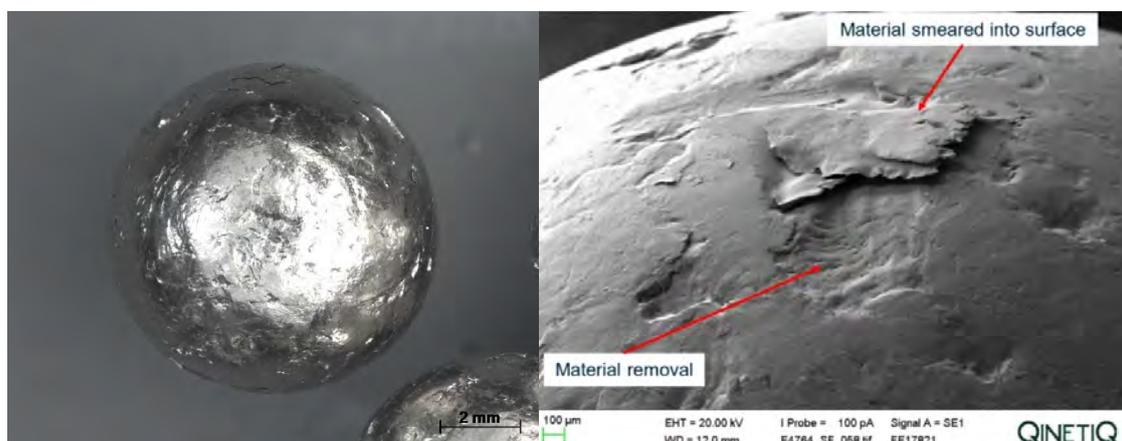
Figure 13

The surfaces of the 10 balls were deformed, with material removal, surface dents and tongues of smeared material present (Figure 13).

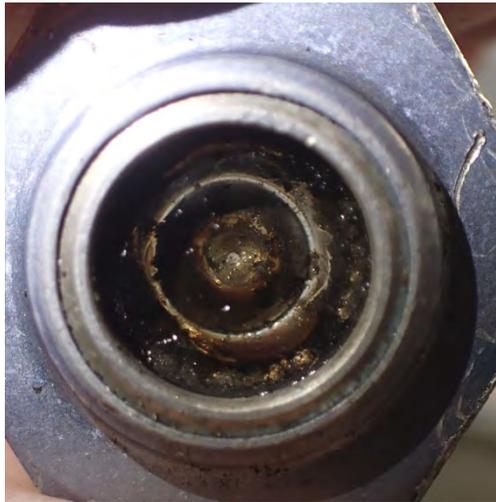
Figure 15

Examination of the oil sight glass showed that it had dark coloured deposits of oil present on the inside of the glass (Figure 15). The sight glass was fitted to a test container and oil was then gradually added so that when viewed from the inside of the container, the oil level could be set at just below the sight, at its centre and above it. However, when viewing the oil level from the outside of the sight glass, its appearance did not significantly alter such that it was unclear as what level the oil was inside the container.

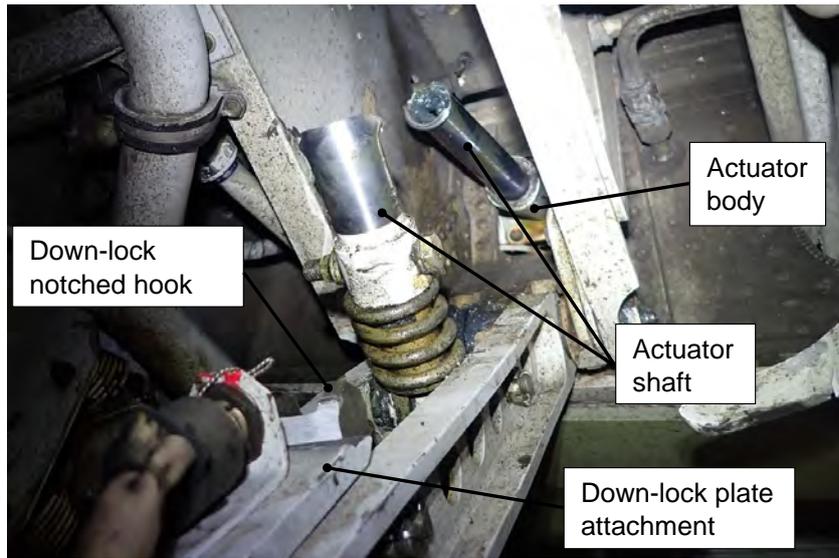
Figure 3

Left main gear fracture actuator and damaged down-lock

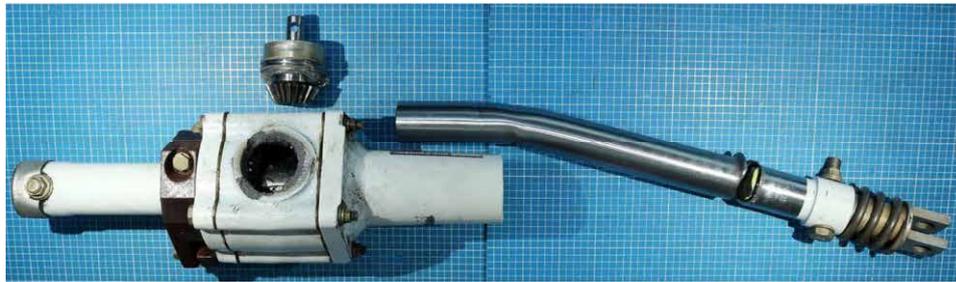
Figure 4

Left main landing gear actuator with actuator shaft removed from actuator body

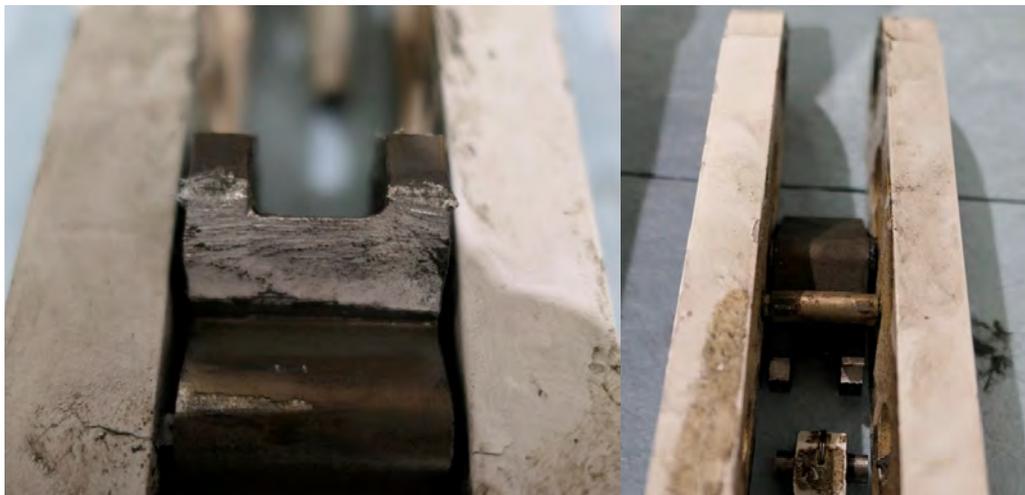
Figure 5

The fractures on the down-lock notched hook were assessed to have been in sheer overload with no evidence of pre-existing cracks (Figure 5).

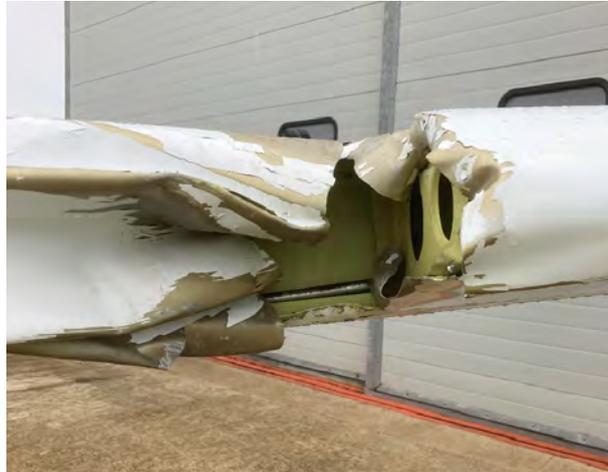
The aircraft was not examined by the AAIB but the airport authority supplied pictures of the damage. Figure 6 shows the damage to left wing believed to have been sustained during the collision with Mast 1.

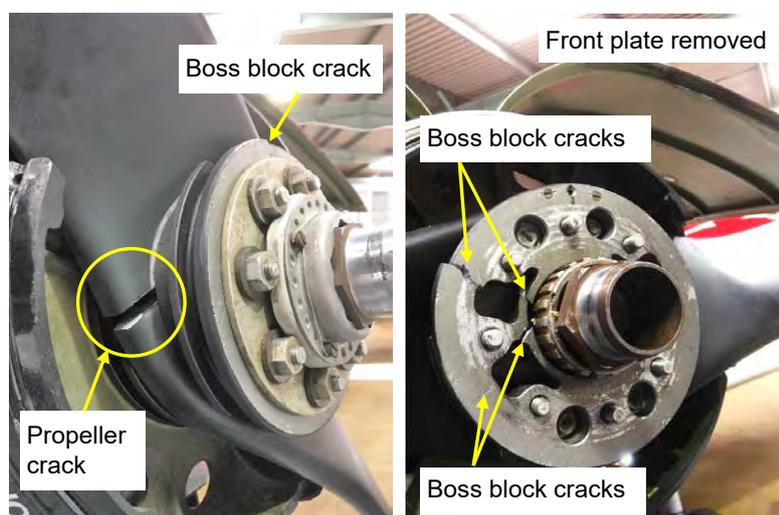
Figure 2

Two cracks were found in the propeller, four cracks in the forward boss block and three in the aft boss block (Figure 2).

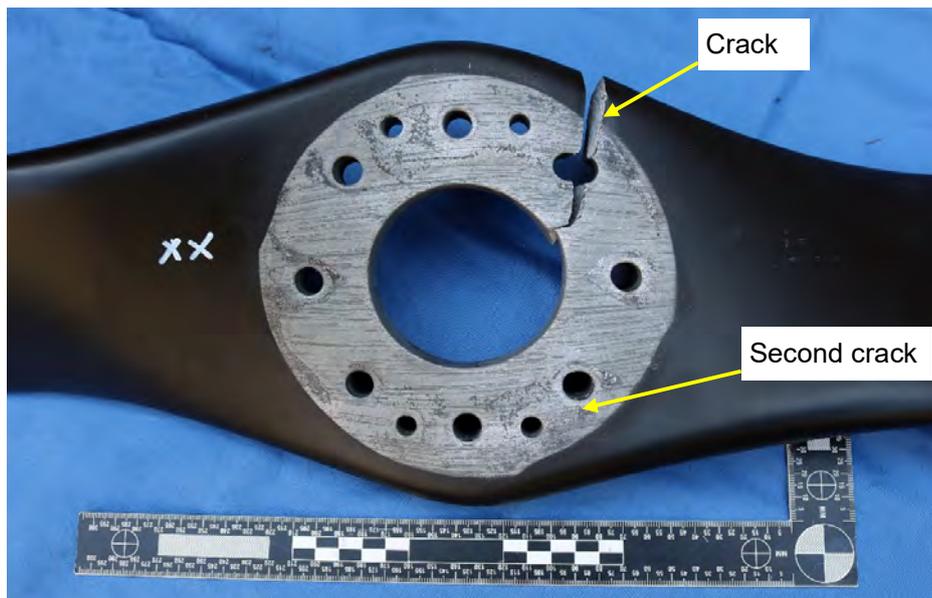
The surface finish of the bolt hole radii² and propeller face were not '*smooth and highly polished*' as specified in the Fairey Reed Repair Specification³.

Figure 3
Cracks in propeller
