Leadon Field Decommissioning Programme Close Out Report

CR5318-LEA-000-PM-RE-5002

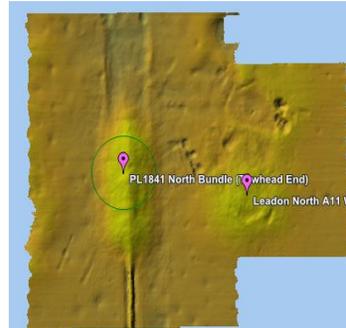
Figure 5 North Towhead Area Post Rock dump

The four bundle ends have been Rock dumped with +600mm DOC (See Figures below). All mattresses have been recovered.

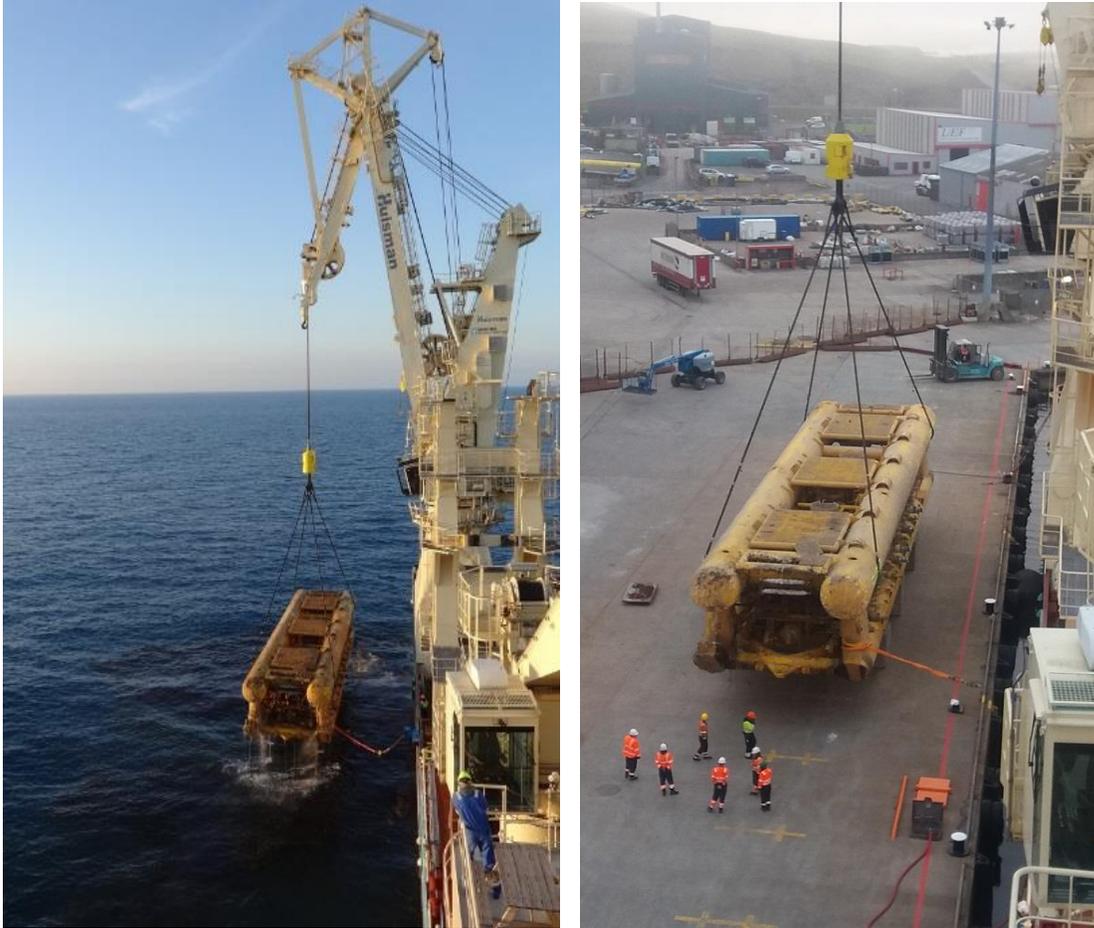
Figure 8: North Towhead Recovery & Offload in Lerwick

The Towheads and midline manifold were challenging to recover due to the added mass of entrained water trapped in the main chords/tanks. A lot of time was spent cutting drainage holes in the tanks to allow water to escape at surface. This could be addressed at the design phase by adding knock out panels or similar.

Cutting the towheads clear of the bundles was very problematic because of ancillary structures which prevented access to the required cut locations. This could be addressed at the design phase by leaving clear vertical access of 2-3m bundle length at the required cut location.

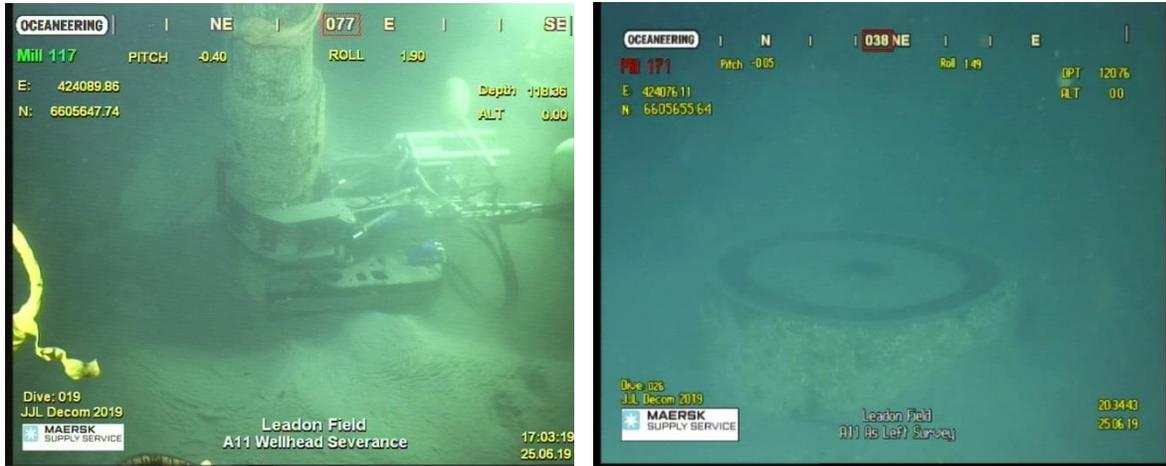
Figure 9: A11 Conductor Seabed Cutting

Using Grit entrained water jetting cutting worked well from the construction vessel for final wellhead severance and recovery. Timings were comparable with doing the work from the rig but with a lower cost base.

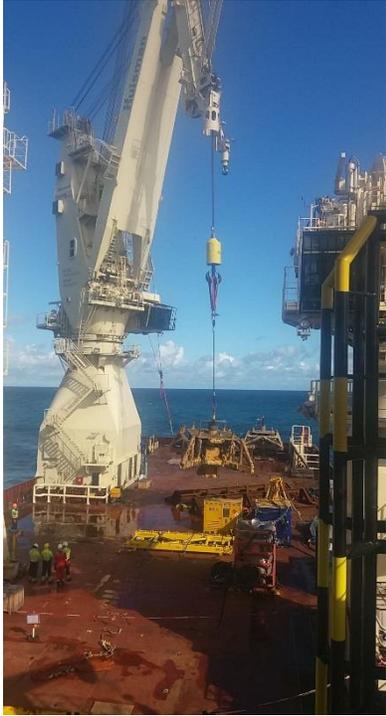
Figure 9: Tree Recovery

Tree recovery using the Construction vessel worked well. The advantages were more with the logistics of handling more than one or two trees with the rig rather than with the disconnection works.
