Rail Accident Report

**Track damage between Pencoed and Llanharan,
South Wales
6 March 2021**

Track damage between Pencoed and Llanharan, South Wales, 6 March 2021

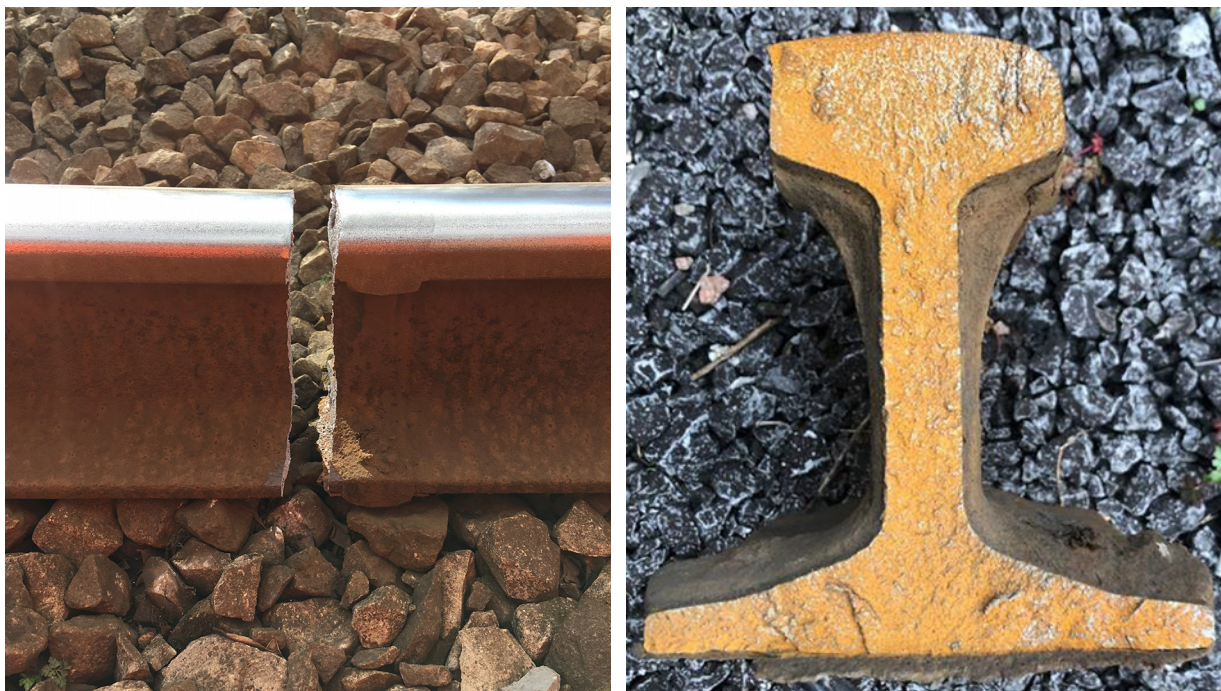
- 43 At 02:45 hrs, in accordance with the Rule Book, the Port Talbot signaller had arranged for the line to be examined by the next train passing through the Pencoed and Llanharan area. At 03:31 hrs, the driver of the examining train reported that there was no issue with the line. The Port Talbot signaller started to allow drivers of subsequent trains to pass the signals being held at red by the track circuit failures. Subsequent investigation by Network Rail identified at 09:32 hrs that the track circuit faults observed by the Port Talbot signaller were the results of two rail breaks (figure 8) and the line was closed at this point.

Figure 8: The rail break at Pencoed, in-situ (left-hand image) and its fracture face (right-hand image) (photos courtesy of Network Rail).

- 52 The high impact forces generated by a rotating wheelset with a wheel flat is a known cause of rail breaks, particularly if the impact occurs near a rail joint, where the strength of the rail is reduced. The repeated impact on the track of a wheel flat also produces a characteristic noise that can be heard as a train passes. The sound is generated as the edges of the wheel flat impact on the rail and is cyclic in nature.

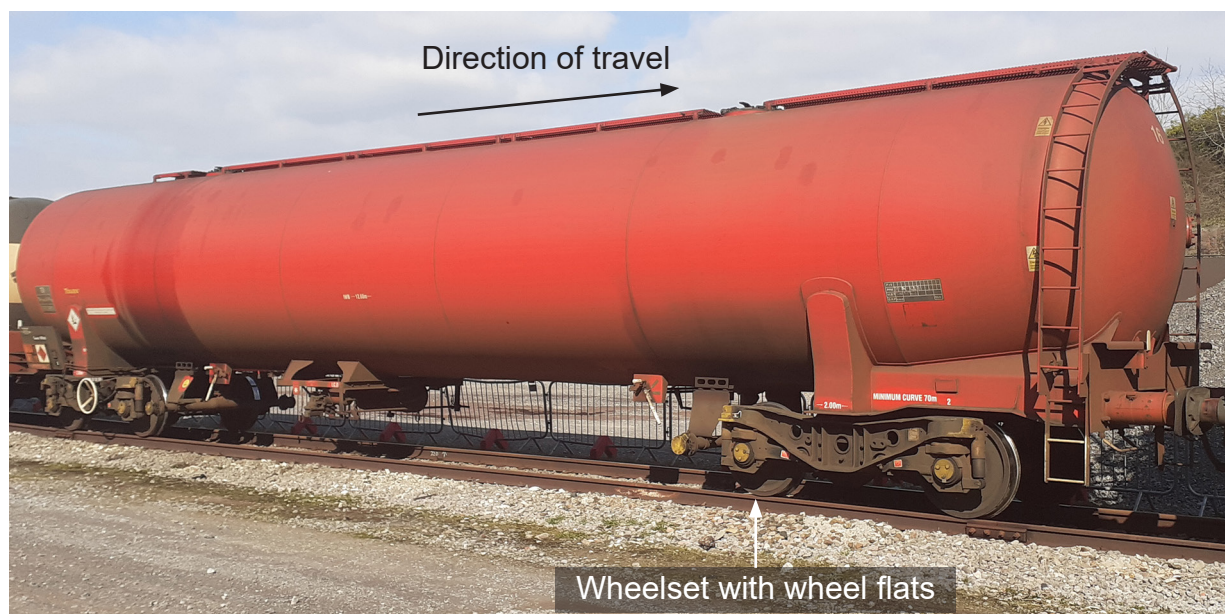
- 44 The inspection of train 6A11 at Bristol East depot took place on 11 March 2021 (figure 9). Wagon GERS89016 was inspected, and the accident wheelset was found to have flats measuring about 185 mm in length on both wheels.
- 45 As well as damage to the trailing wheelset of the leading bogie of wagon GERS89016 (figure 10), wheelset damage was also identified on another eight wagons, as described in table 1. Figure 10 shows the damage witnessed on wagon GERS89016 as well as wagon VTG88111 (the fifth wagon from the front of the train) and wagon 7077920143 (the seventeenth wagon).

Figure 9: Wagon GERS89016 at Bristol East depot after the accident (photo courtesy of DB Cargo).

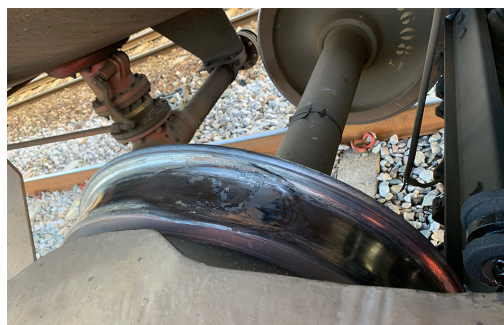
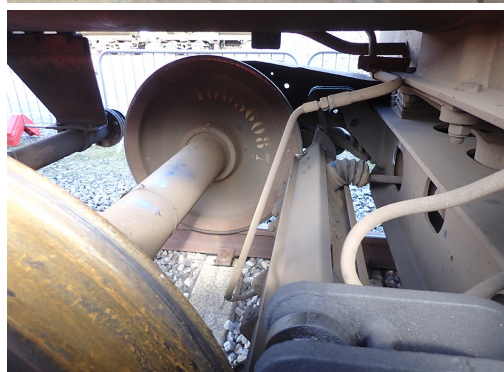
Wagon GERS89016
Trailing wheelset of
leading bogie

Figure 10: Example of wheelset damage on train 6A11 (photos courtesy of DB Cargo).

- 53 The subsequent inspection at Bristol East depot identified damage to the wheels of several vehicles of train 6A11, including the presence of severe wheel flats on the trailing wheelset of the leading bogie of wagon GERS89016 (paragraph 44). RAIB has concluded that the damage to the infrastructure between Pencoed and Llanharan was caused by impact loading from these severe wheel flats.

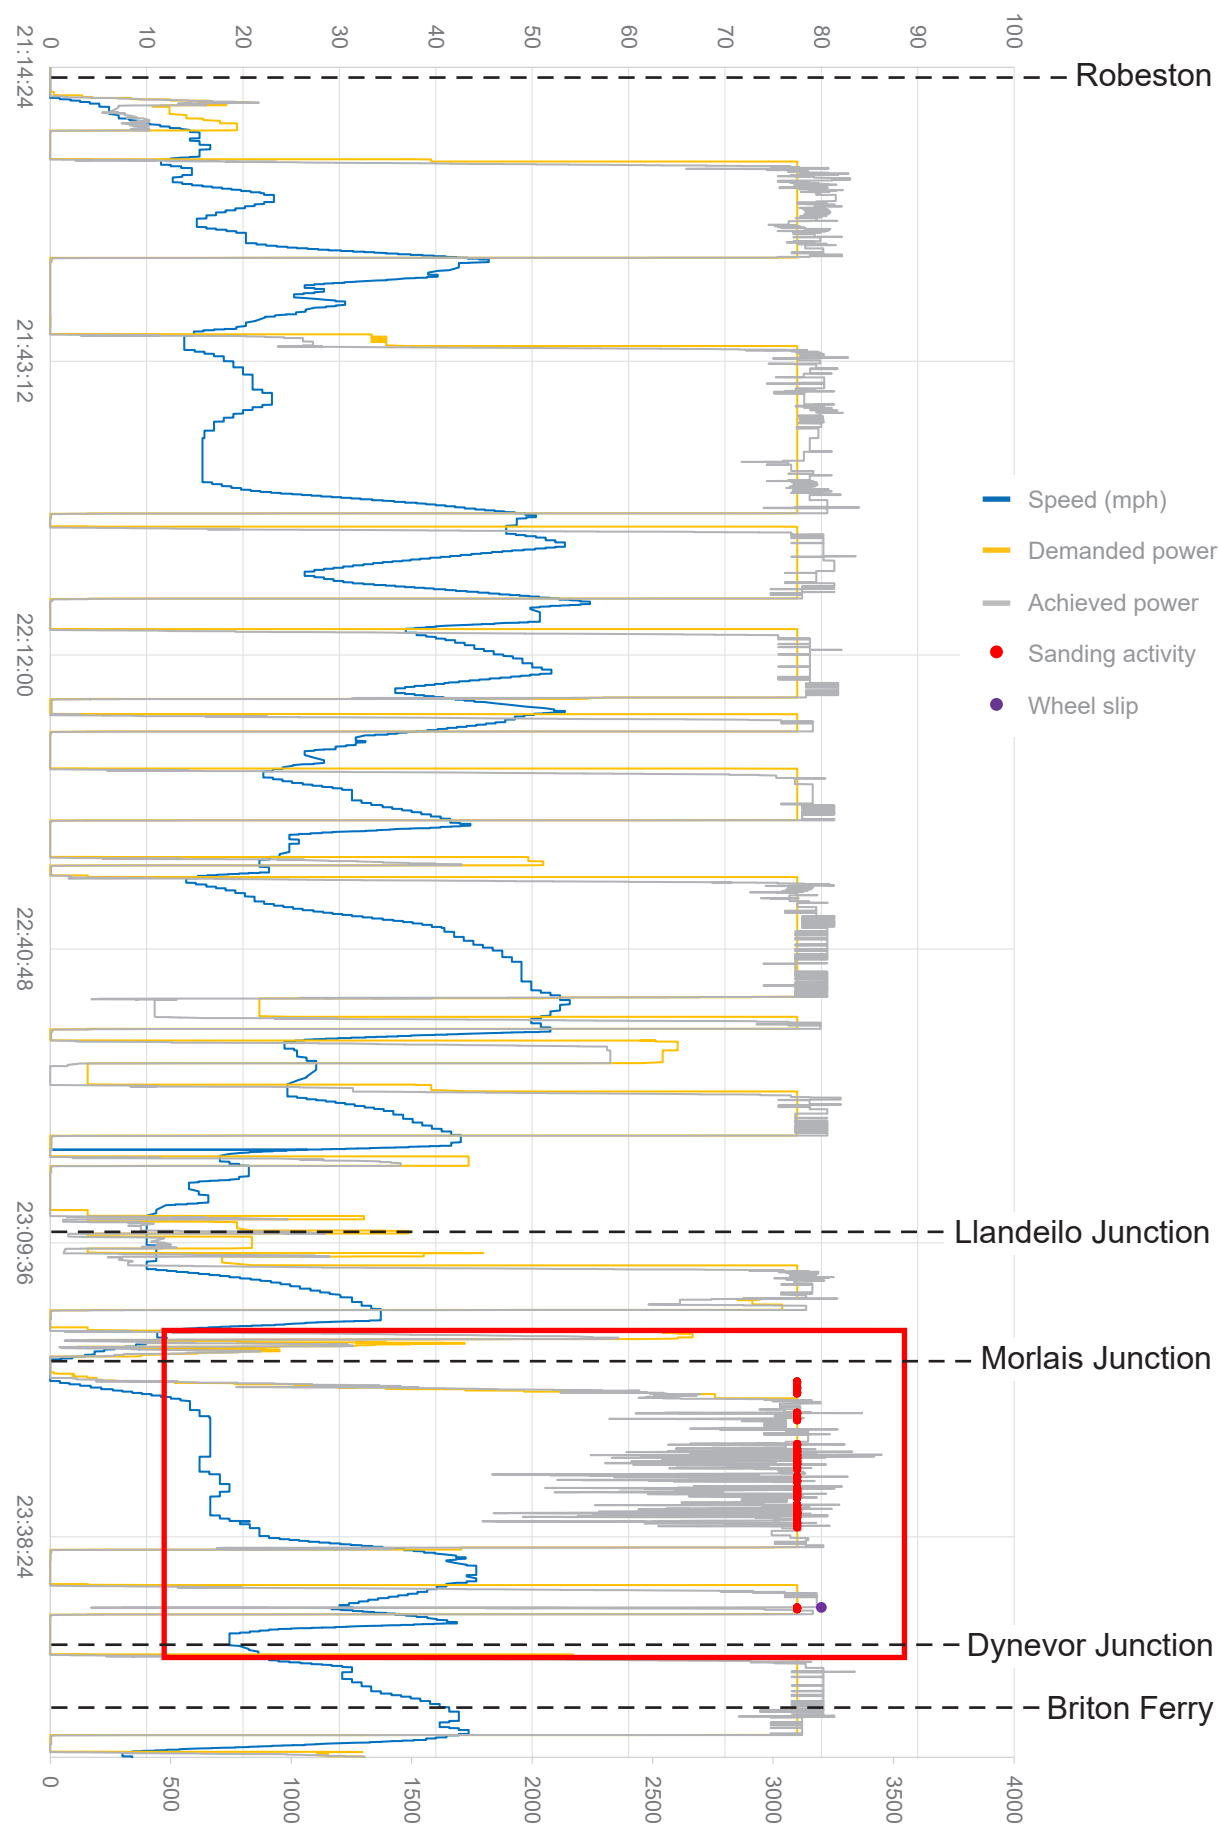
- 85 Figure 14 shows the OTDR data as recorded on locomotive 60015 on 5 March 2021 for the trip from Robeston to Margam. Figure 14 shows:
- the speed trace in mph

Figure 14: OTDR data for locomotive 60015 on 5 March 2021.

- 88 From Morlais Junction to Llangyfelach Tunnel, the driver commanded full traction on the locomotive but train 6A11 initially struggled to increase its speed on the rising gradient and the anti-slip function of the traction control system had to intervene. OTDR data (identified by the red box on figure 14) showed that the torque applied to the wheelset was repeatedly reduced to match the available adhesion and that sanding was automatically activated.

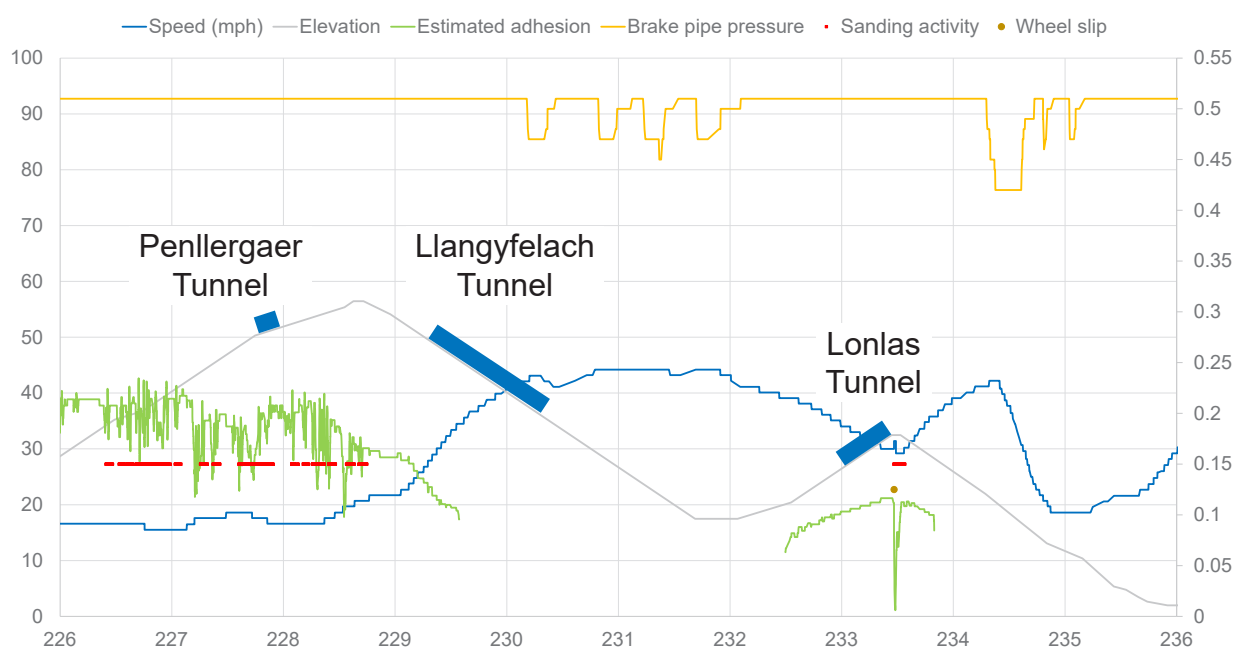
Figure 15: Results of analysis of the OTDR data for locomotive 60015 on 5 March 2021 to estimate adhesion.

- 90 This analysis found that the estimated level of adhesion along the stretch of line from Morlais Junction to the start of the descent towards Llangyfelach Tunnel was between 0.15 and 0.2 (figure 15). This was a time when the locomotive was repeatedly depositing sand on the rails and hence this estimated level of adhesion accounts for the effects of sand. A detailed examination of the adhesion curve (figure 16) shows that some of the lowest points of the adhesion curve occur immediately before sanding takes place. These lowest points of the adhesion curve give an instantaneous estimate of the adhesion that was present before sanding, and indicate that adhesion was as low as 0.1 along the stretch of line from Morlais Junction to the start of the descent towards Llangyfelach Tunnel.

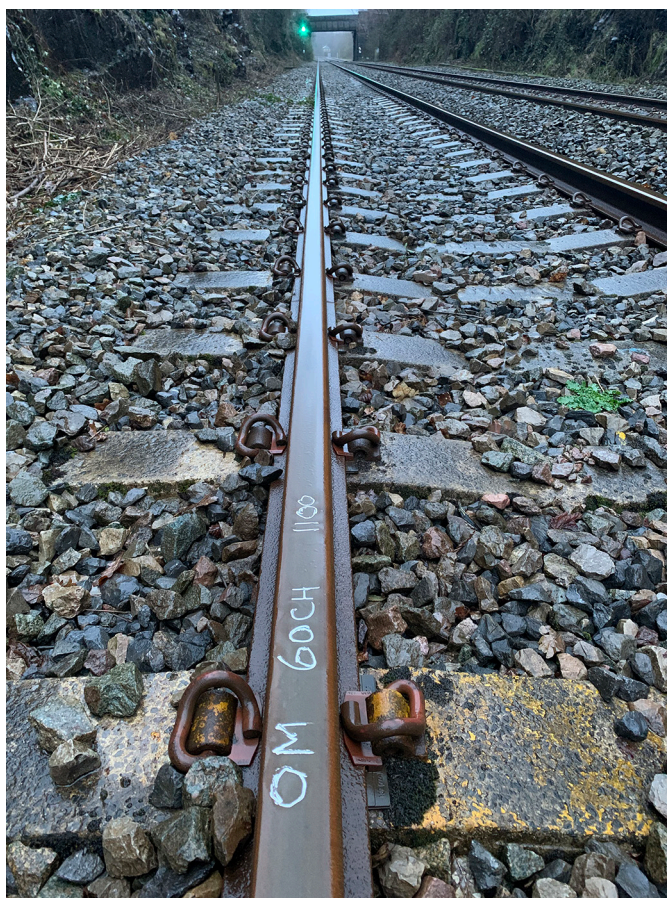
- 104 The Swansea District line is also fitted with traction gel applicators. Traction gel applicators are designed to increase the adhesion on the top of the railhead by applying a traction enhancing material. However, Network Rail only uses them on this line during leaf fall season and the accident took place outside of that season (see paragraph 113).
- 105 Network Rail undertook a visual inspection of the line on 14 March 2021 to assess its condition. This was nine days after the accident involving train 6A11. Figure 18 shows the condition of the railhead on that day at a location between Lonlas Tunnel and Dynevor Junction. The photograph shows a lack of a running band (where the repeated passage of trains normally leaves a shiny band on the railhead as shown, for example, on figure 8). Where the running band would normally be located, the photograph shows rust.

Figure 18: Railhead condition on the line between Lonlas Tunnel and Dynevor Junction (courtesy Network Rail).

- 106 Results from analysis of swabs of the railhead taken by Network Rail during the 14 March 2021 track inspection showed:
- evidence of large amounts of brown dirt/debris and a trace of metallic particles (this is to be expected from a railhead surface but is also consistent with the presence of rust)
