Rail Accident Investigation Branch

# Rail Accident Report

**Track damage between Pencoed and Llanharan,  
South Wales  
6 March 2021**

Report 03/2023  
February 2023

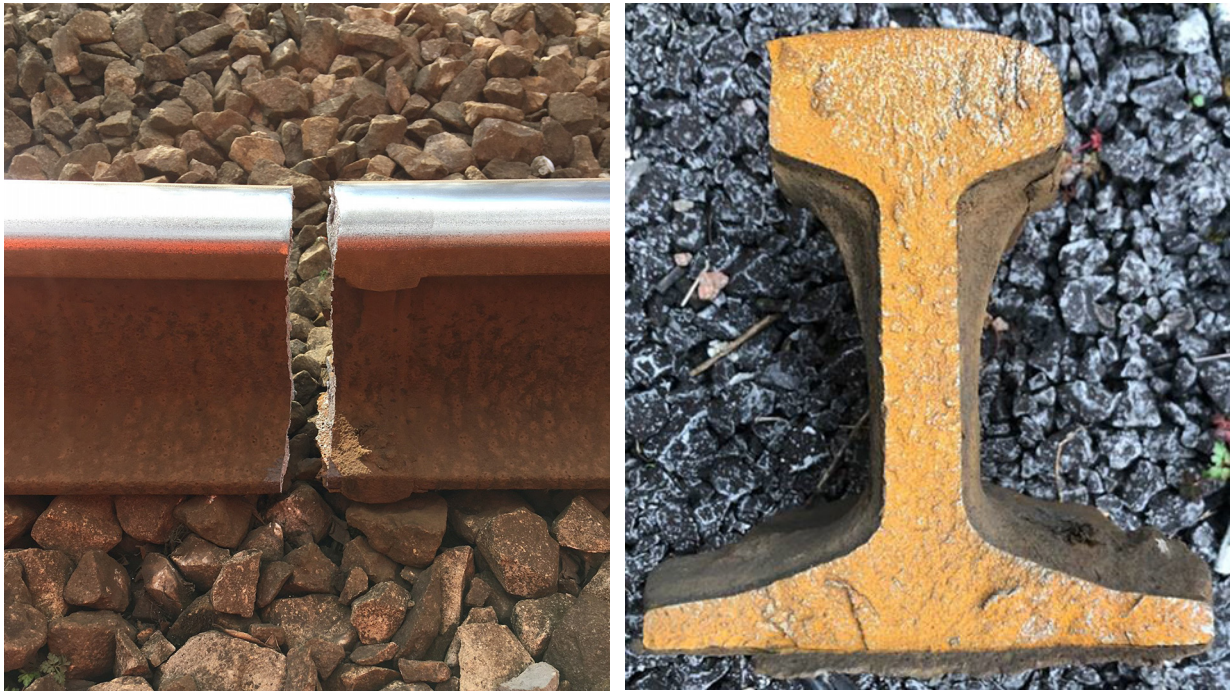
- 43 At 02:45 hrs, in accordance with the Rule Book, the Port Talbot signaller had arranged for the line to be examined by the next train passing through the Pencoed and Llanharan area. At 03:31 hrs, the driver of the examining train reported that there was no issue with the line. The Port Talbot signaller started to allow drivers of subsequent trains to pass the signals being held at red by the track circuit failures. Subsequent investigation by Network Rail identified at 09:32 hrs that the track circuit faults observed by the Port Talbot signaller were the results of two rail breaks (figure 8) and the line was closed at this point.

Figure 8: The rail break at Pencoed, in-situ (left-hand image) and its fracture face (right-hand image) (photos courtesy of Network Rail).

**50 The damage to the infrastructure between Pencoed and Llanharan was caused by impact loading from the rotation of a wheelset with severe wheel flats on train 6A11.**

- 52 The high impact forces generated by a rotating wheelset with a wheel flat is a known cause of rail breaks, particularly if the impact occurs near a rail joint, where the strength of the rail is reduced. The repeated impact on the track of a wheel flat also produces a characteristic noise that can be heard as a train passes. The sound is generated as the edges of the wheel flat impact on the rail and is cyclic in nature.

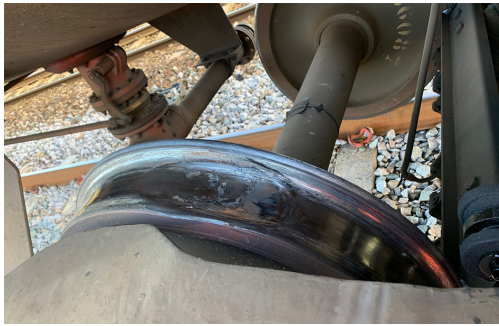
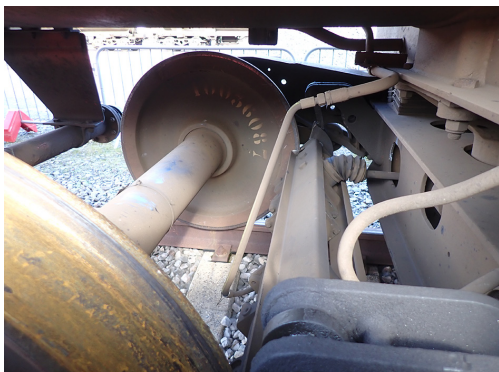
Wagon GERS89016  
Trailing wheelset of  
leading bogie

- 5 The train did not derail because of the rail fractures, and no one was injured in the accident. However, some damage was caused to the bogie-mounted braking equipment and wheelset involved (figure 10).

Figure 10: Example of wheelset damage on train 6A11 (photos courtesy of DB Cargo).

- 53 The subsequent inspection at Bristol East depot identified damage to the wheels of several vehicles of train 6A11, including the presence of severe wheel flats on the trailing wheelset of the leading bogie of wagon GERS89016 (paragraph 44). RAIB has concluded that the damage to the infrastructure between Pencoed and Llanharan was caused by impact loading from these severe wheel flats.

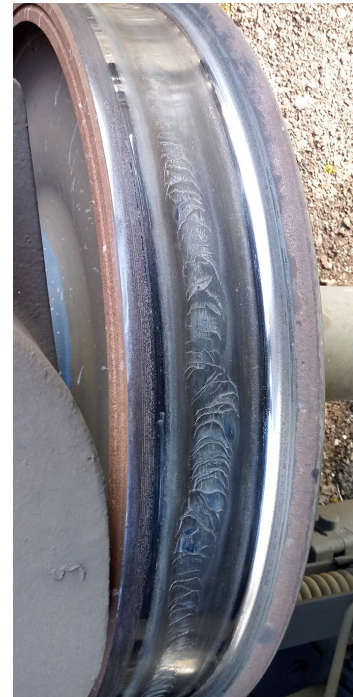
Wagon 7077920143  
Leading wheelset of  
leading bogie

| Summary of damage to train 6A11 | | | |
|---|---|---|--|
| 17 | 7077920143 | Y | 1 <sup>st</sup> wheelset has tread damage for 45°<br>Also 3 <sup>rd</sup> wheelset (both wheels) |

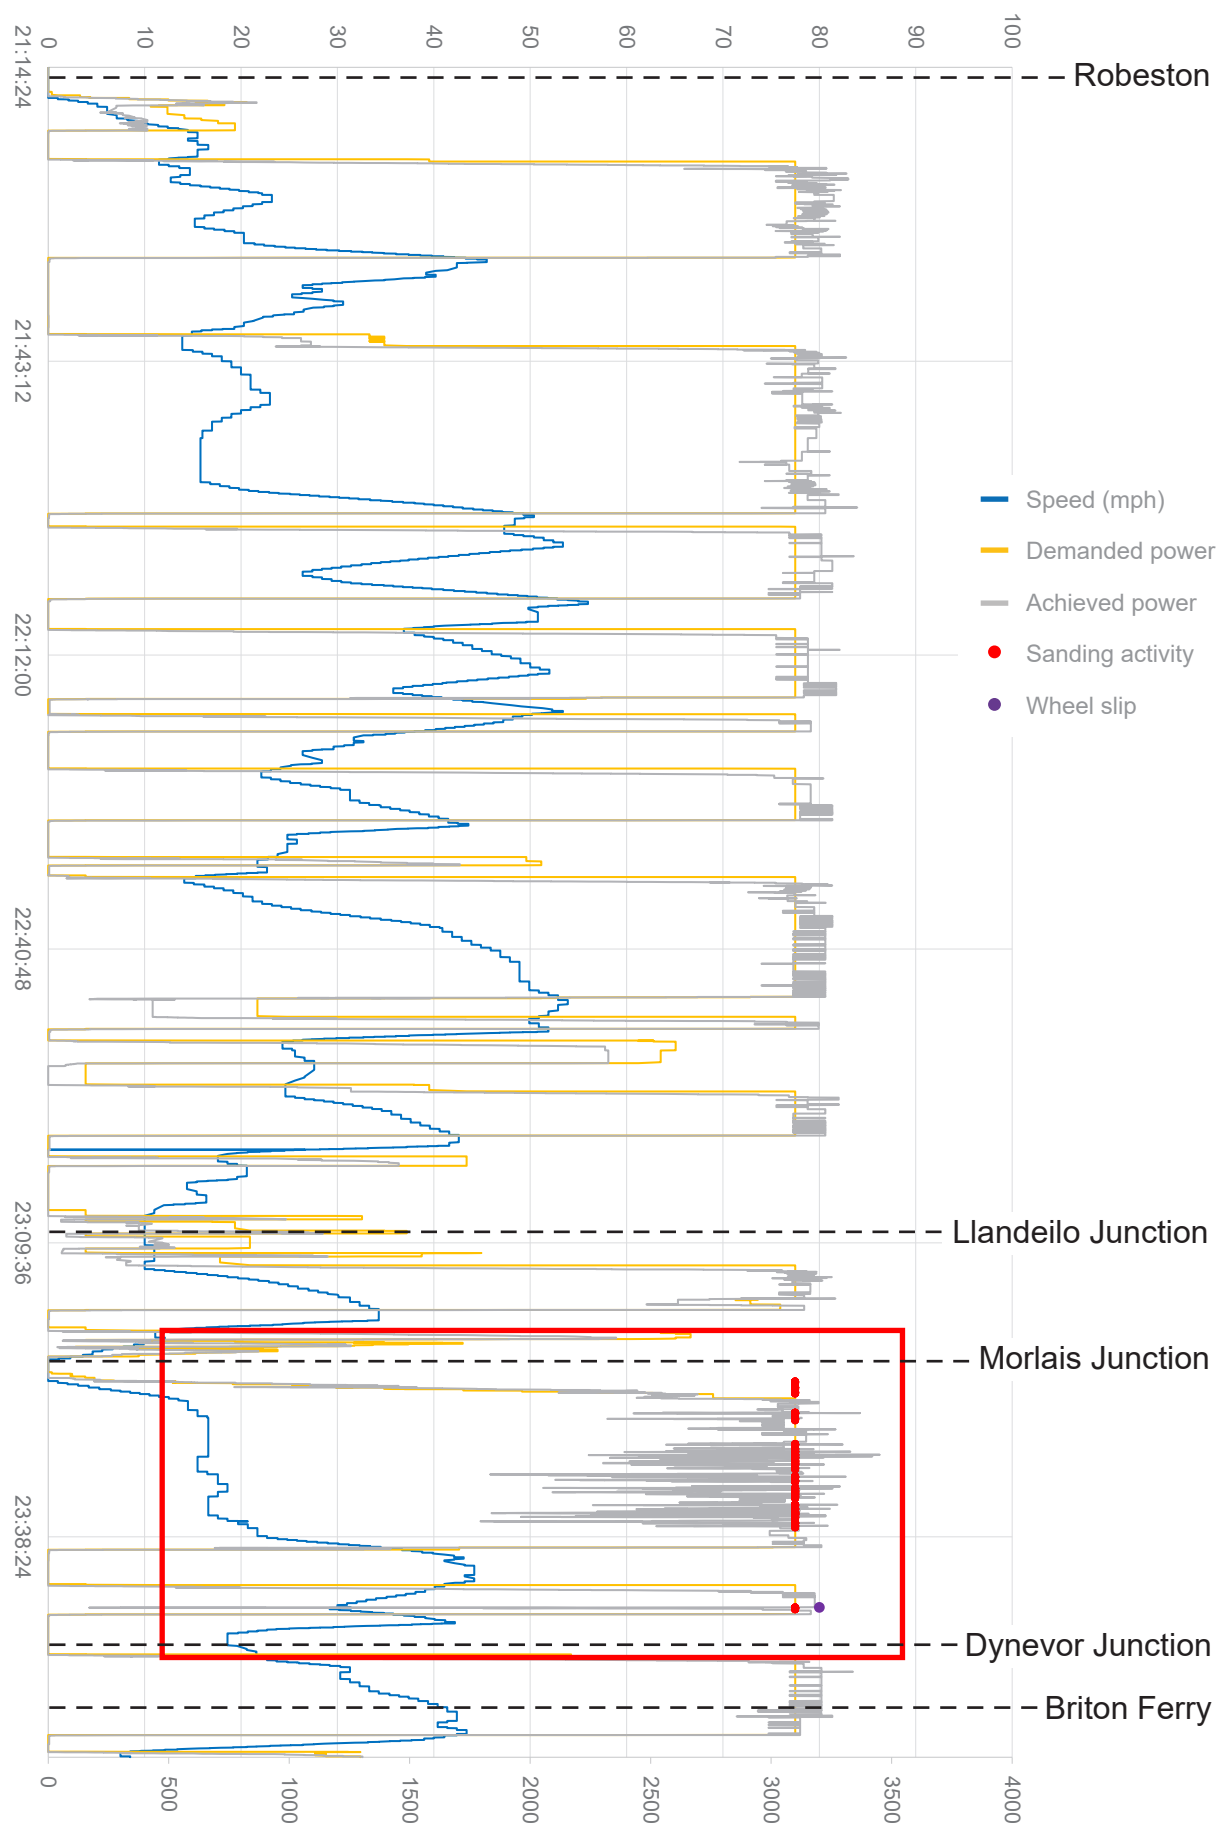
- 13 Train 6A11 consisted of a class 60 locomotive, number 60015, and 23 bogie tank wagons and had a combined weight of 2,417 tonnes. All the wagons in the train were TEA type wagons, except for three TDA type wagons. Wagons 1 to 9, numbered from the front of the train, were carrying heating oil, while wagons 10 to 19 were carrying diesel oil for road vehicles. Wagons 20 to 23 were carrying gas oil.

- 85 Figure 14 shows the OTDR data as recorded on locomotive 60015 on 5 March 2021 for the trip from Robeston to Margam. Figure 14 shows:
- the speed trace in mph

- the power demanded by the driver
  - the power achieved by the locomotive
  - the sanding activity
  - the 'wheel slip' channel as recorded by the OTDR.

Figure 14: OTDR data for locomotive 60015 on 5 March 2021.

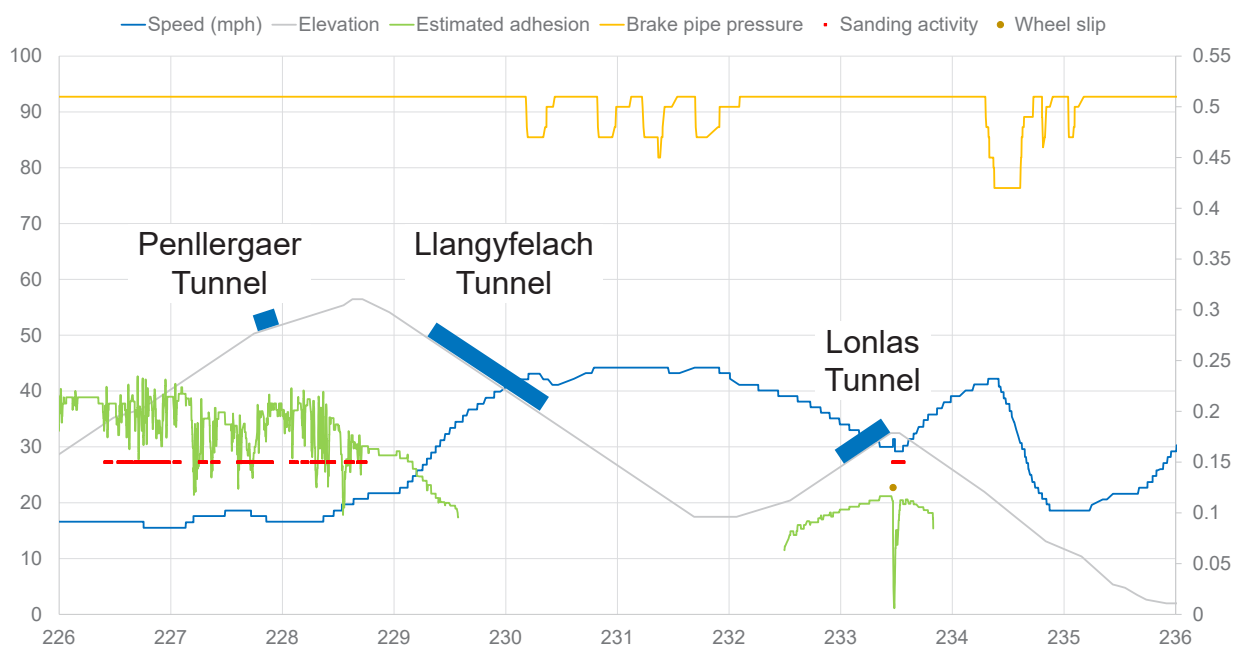
- 89 RAIB used the OTDR data along the Swansea District line to calculate the tractive effort at the rail which, when combined with wheel slip data, allowed the adhesion levels to be estimated (figure 15).

Figure 15: Results of analysis of the OTDR data for locomotive 60015 on 5 March 2021 to estimate adhesion.

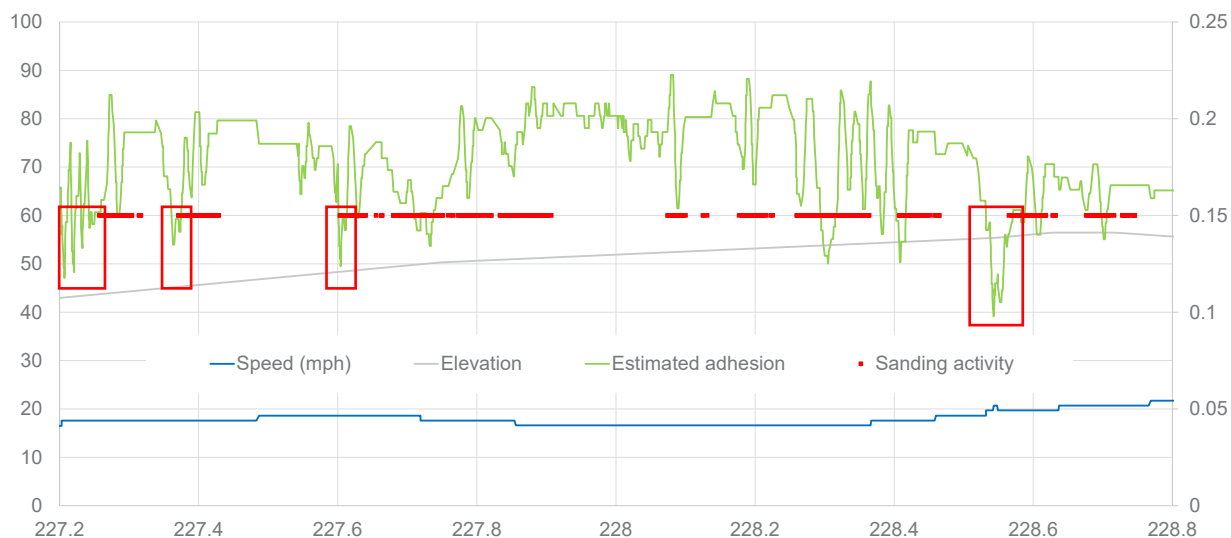
90 This analysis found that the estimated level of adhesion along the stretch of line from Morlais Junction to the start of the descent towards Llangyfelach Tunnel was between 0.15 and 0.2 (figure 15). This was a time when the locomotive was repeatedly depositing sand on the rails and hence this estimated level of adhesion accounts for the effects of sand. A detailed examination of the adhesion curve (figure 16) shows that some of the lowest points of the adhesion curve occur immediately before sanding takes place. These lowest points of the adhesion curve give an instantaneous estimate of the adhesion that was present before sanding, and indicate that adhesion was as low as 0.1 along the stretch of line from Morlais Junction to the start of the descent towards Llangyfelach Tunnel.

Figure 16: Detailed analysis of the adhesion curve for locomotive 60015.

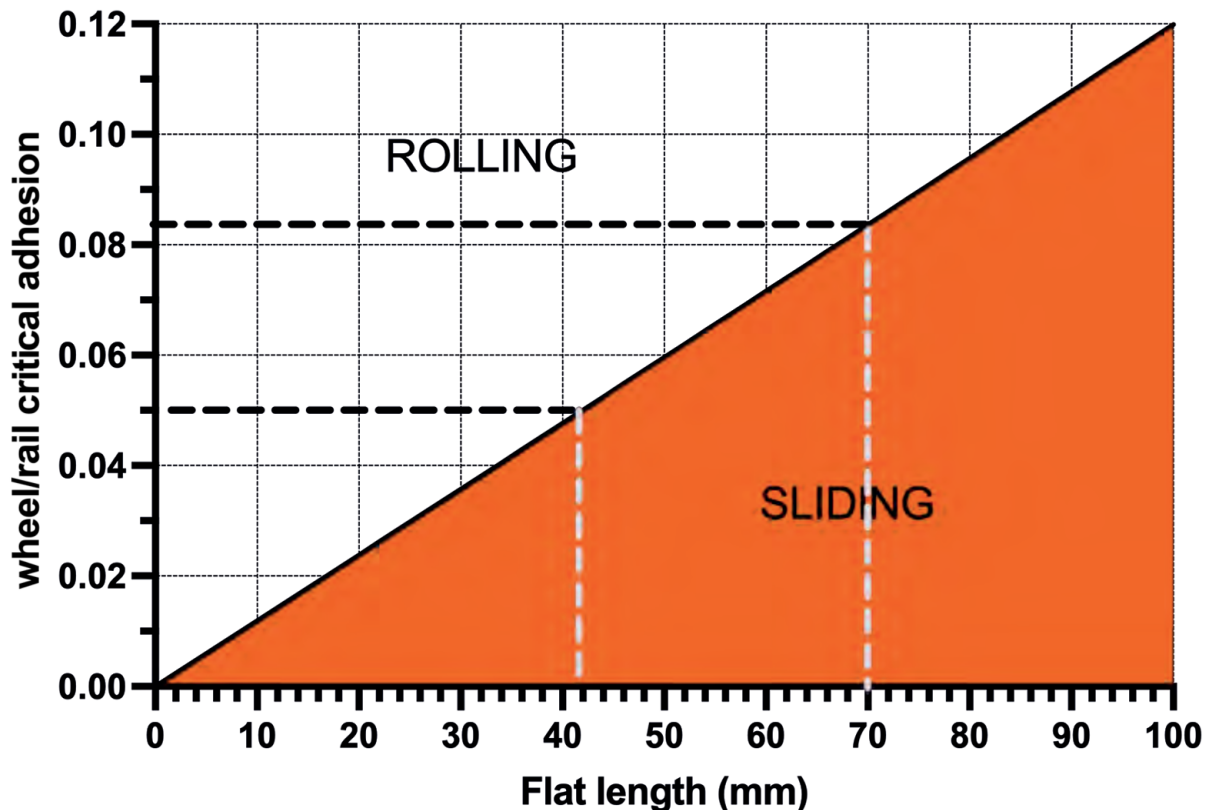
95 The study commissioned by RAIB (paragraph 80) calculated that the wheel flats would have grown to around 70 mm in length by the end of the brake application from Lonlas Tunnel towards Dynevor Junction. Figure 17, developed as part of the study, shows that with a wheel flat length of 70 mm, adhesion would have needed to be greater than 0.08 to get the wheelset to start rotating after the brakes were released. This suggests that the wheelset involved would have stayed locked after the brakes were released, assuming that the adhesion levels remained in a similar range, and that the wheel flats would have continued to grow.<sup>14</sup>

Figure 17: Plot showing the relation between wheel/rail critical adhesion and the flat length.

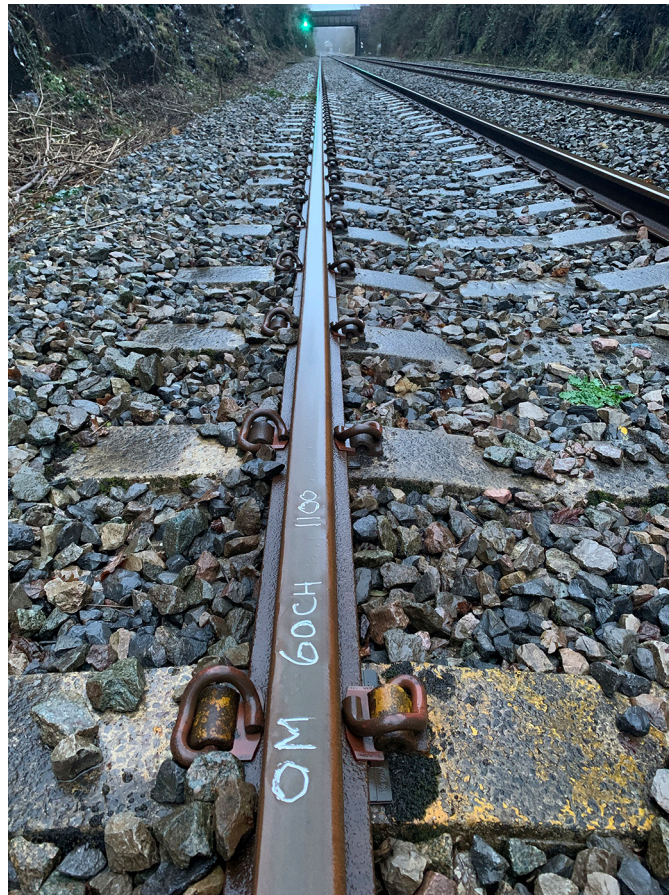
- 104 The Swansea District line is also fitted with traction gel applicators. Traction gel applicators are designed to increase the adhesion on the top of the railhead by applying a traction enhancing material. However, Network Rail only uses them on this line during leaf fall season and the accident took place outside of that season (see paragraph 113).
- 105 Network Rail undertook a visual inspection of the line on 14 March 2021 to assess its condition. This was nine days after the accident involving train 6A11. Figure 18 shows the condition of the railhead on that day at a location between Lonlas Tunnel and Dynevor Junction. The photograph shows a lack of a running band (where the repeated passage of trains normally leaves a shiny band on the railhead as shown, for example, on figure 8). Where the running band would normally be located, the photograph shows rust.

*Figure 18: Railhead condition on the line between Lonlas Tunnel and Dynevor Junction (courtesy Network Rail).*

- 106 Results from analysis of swabs of the railhead taken by Network Rail during the 14 March 2021 track inspection showed:
- evidence of large amounts of brown dirt/debris and a trace of metallic particles (this is to be expected from a railhead surface but is also consistent with the presence of rust)
