## SAFETY FLYER TO THE RECREATIONAL CRAFT INDUSTRY AND PLEASURE CRAFT USERS

**Carbon monoxide poisoning, resulting in two fatalities on board the sports cruiser *Emma Louise* at Port Hamble Marina, River Hamble, England on 11 January 2022**

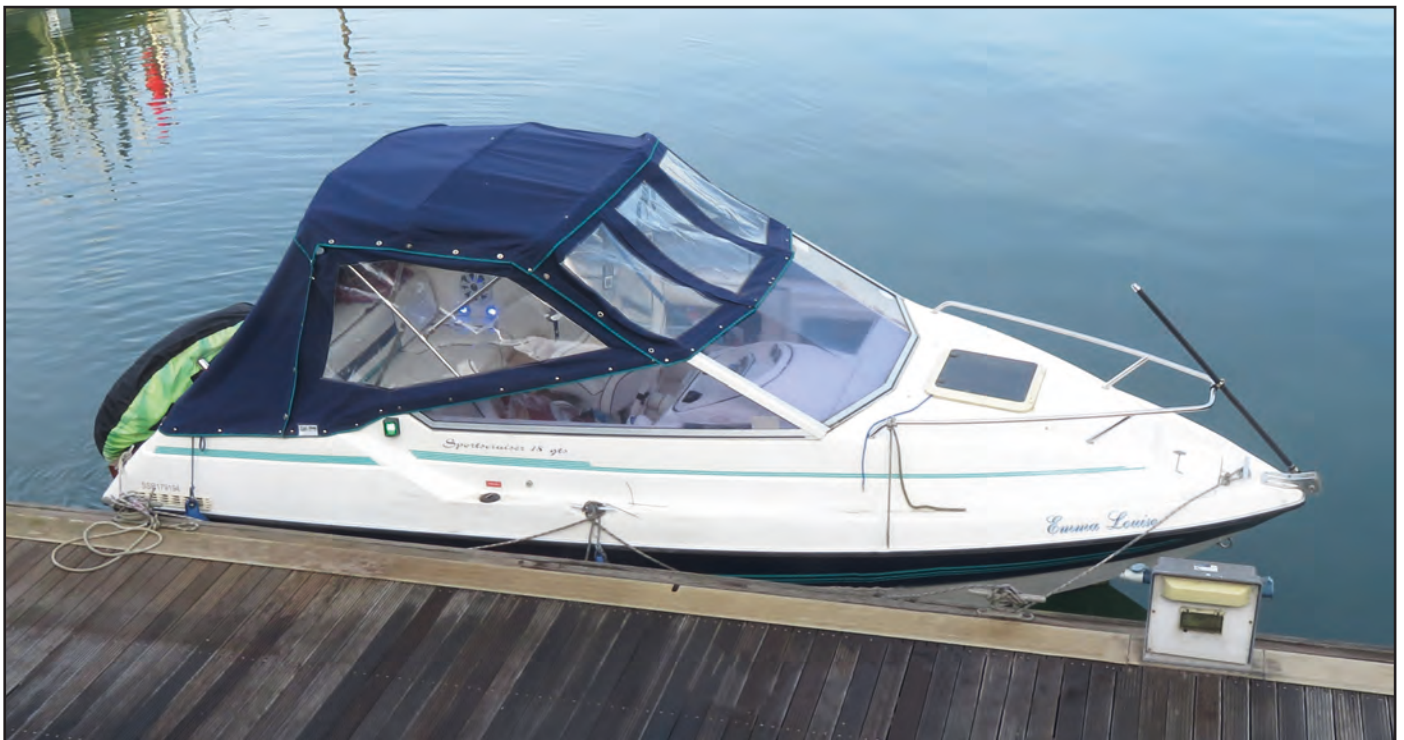
The sports cruiser's 3 litre petrol-driven engine had been started when the two men boarded *Emma Louise* the previous evening and left idling, probably to charge the boat's batteries. Exhaust gas from the waterline exhaust was likely funnelled between an inflatable towable ringo and the boat's transom and seeped into the covered cockpit through small gaps where the boat's canopy was fastened to the transom.

During tests with *Emma Louise* in its as found condition MAIB inspectors measured accumulated CO levels in the covered cockpit that were capable of causing damage to health and collapse within 35 minutes. With no CO detector fitted it is likely that the two men were unaware of the danger and were overcome soon after starting the engine, fell unconscious and died later that evening.
