Defence
Infrastructure
Organisation

Safety Alert Part's A, B & C

Subject: Failure of Reinforced Autoclaved Aerated Concrete (RAAC) Planks

Ref No: SA 2023-01 (revision of SA2019-01)

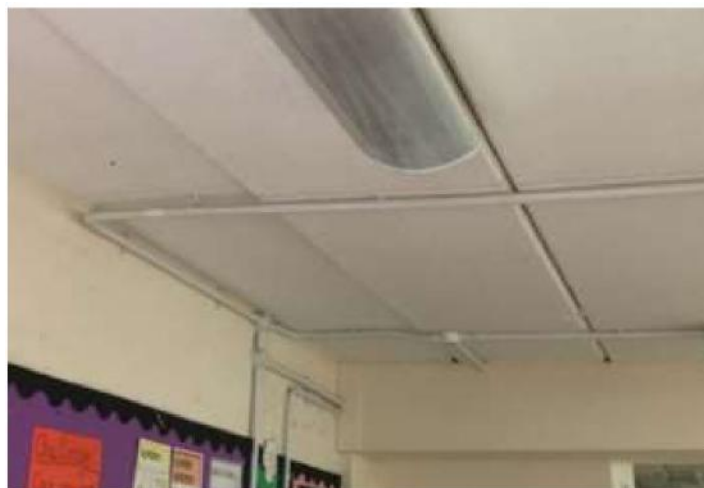
Figure 3 – Differential Deflection of Roof Planks

- Deflection in roof panels, which exceed span/100, could indicate the panels are close to capacity.
- Reinforcement corrosion is a risk and the impact of corrosion on RAAC is far higher than in traditional concrete.
- Modifications to panels, such as cutting or service penetration, either during or post construction may cause overloading and are of high concern.
- Surveys and testing have shown concerns regarding the placement of reinforcement, quality control and end bearing capacity.
- Visual surveys can help assess the condition of panels, however, not all defects are visible. This includes corrosion and the misplacement or omission of reinforcement.
- Failure can be sudden and has occurred in a small number of reported cases.

- Any remedial actions identified from the inspection, by the competent person and the risk assessment, should be implemented as soon as possible. This may include emergency propping, enhanced end bearing, remedial supports, removal of panels. These actions may be in conjunction with the evacuation of the building in high-risk cases.
