Rail Accident Report

Track worker struck by train near Chalfont & Latimer station, Buckinghamshire 15 April 2022

Report 05/2023
May 2023

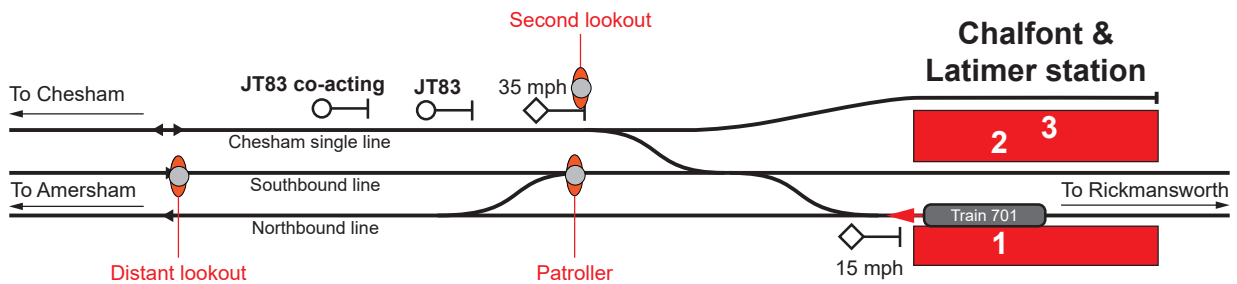
Figure 6: Positions of the track workers when train 701 sounded a warning.

36 The train operator stated that he saw there was one track worker nearest to him in the ten-foot walking northbound (the patroller), one in the Chesham cess (the second lookout) and one further away acting as a southbound lookout (the distant lookout) (figure 6).

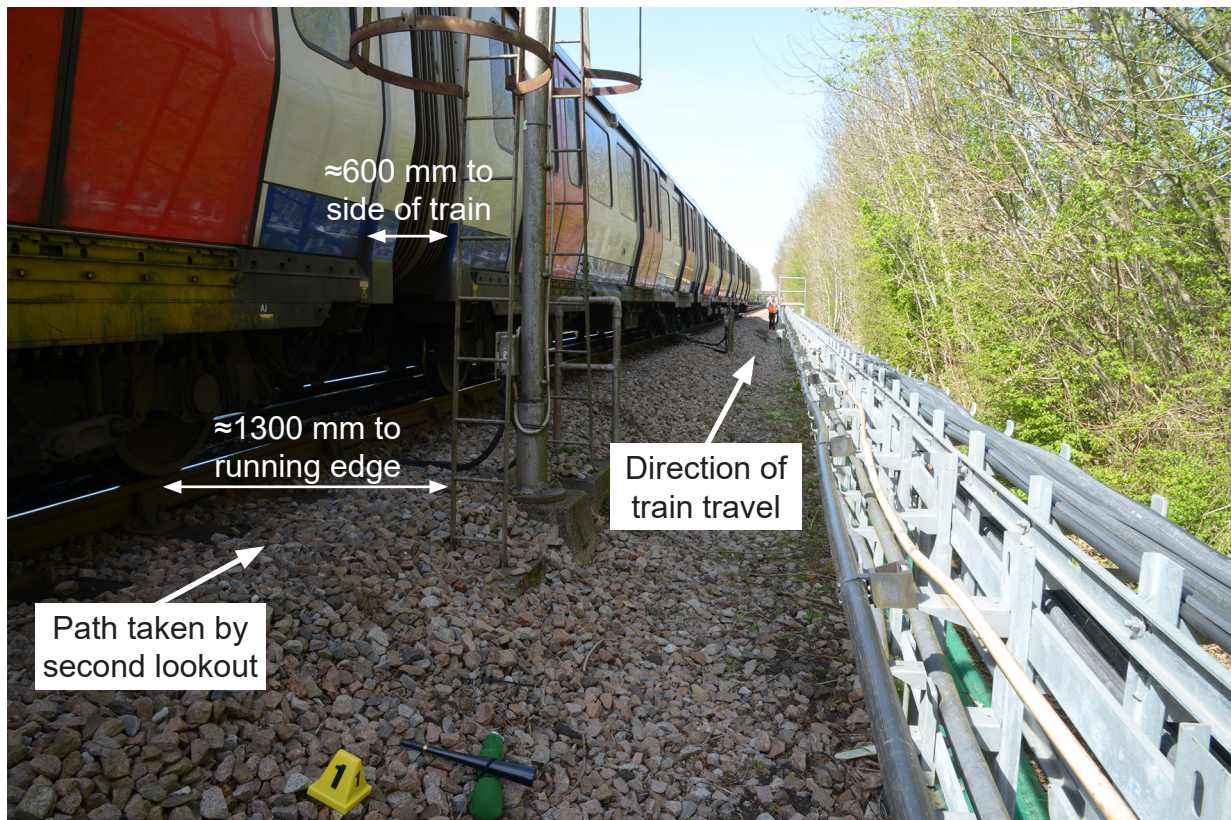
Figure 7: Space in which the second lookout walked as the train approached.

37 The second lookout remained walking in the Chesham single line cess in a position of safety as train 701 approached her. However, in the final seconds of the train’s approach, the second lookout moved from the cess and into a position between a signal post and the track to get a better view of the trains approaching from Chesham as she walked (figure 7). She was not aware that train 701 was approaching her from behind.

- 38 As the train approached the second lookout, the train operator did not realise that she had moved nearer to the Chesham single line and was in the swept path of the train. As the train passed the group, the train operator heard a 'bang' and applied the emergency brake. The train's OTDR showed that the train stopped approximately 8 seconds after the emergency brake was applied, having travelled around 43 metres. At the time of impact, the train was travelling at approximately 27 mph (43 km/h).

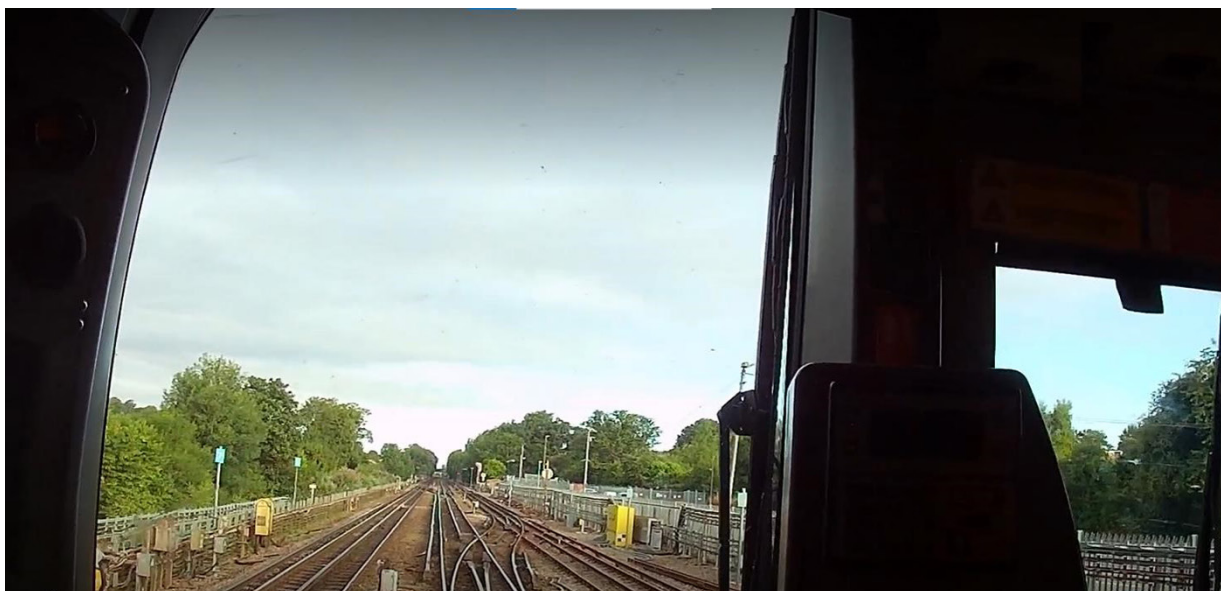
Figure 10: View from S stock train leaving Chalfont & Latimer station.

75 The train operator did not sound an emergency warning as he was approaching the second lookout because he did not believe that the second lookout was at risk of being struck by the train. The train operator stated that he received an acknowledgement² of the warning whistle from the patroller and the second lookout when he was departing Chalfont & Latimer station (figure 10, paragraph 35). The train operator therefore believed that both track workers were aware that the train was approaching them, so concluded that he did not need to take any further action.

76 The train operator was unaware that the second lookout had moved towards the track. This may have been because his attentional focus was no longer on the second lookout, believing that she was safe and had acknowledged the warning whistle, and was switched instead to the view ahead. Alternatively, if the second lookout moved towards the track in the final seconds of the train's approach, it is possible that the train operator's view of her was obscured by the cab structure.

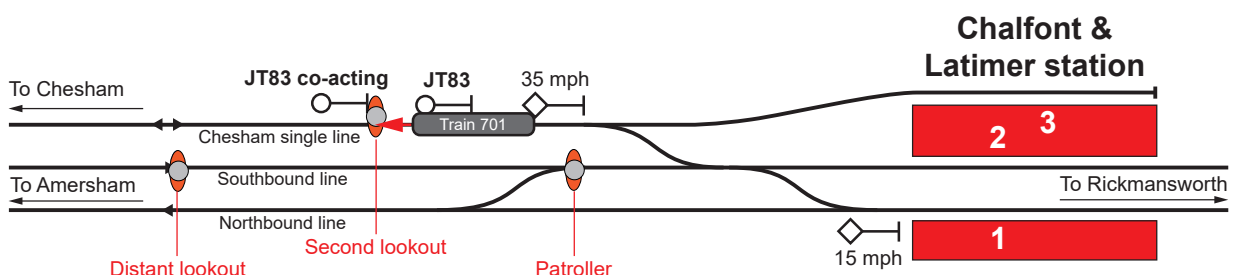
Figure 12: Location of the track workers immediately before the second lookout was hit by train 701.

79 There is no evidence that the second lookout moved from the cess and into the path of the train a long time before being struck. At the time she did move, the patroller was almost certainly involved in a part of the inspection that meant it was necessary for him to bend or crouch down to carry out checks on the junction. At this point, it is likely that he was focused on the work he was doing, rather than monitoring her position. It is also likely that the passing train would have blocked his view of the second lookout (figure 12).

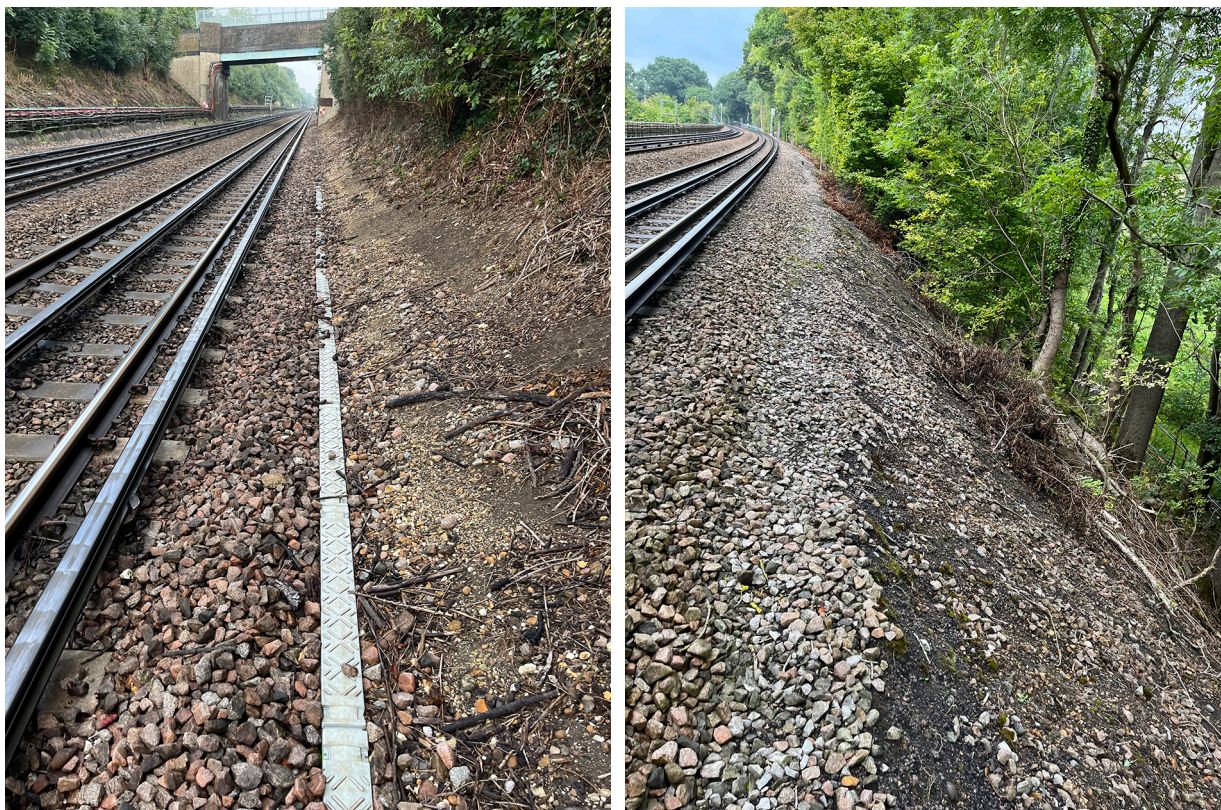
Figure 14: Photographs of the cess on the Metropolitan line north of Rickmansworth.

122 Witness evidence, supported by photographs (figure 14), show that, despite being a designated place of safety for track workers undertaking patrols in traffic hours, some places of safety in the cess do not meet these criteria.

- a. Where designated as a place of safety, the cess on the Metropolitan line is not always suitable for this purpose (paragraph 120, **Recommendation 4**).

- 4 *The intent of this recommendation is that the cess is in an appropriate condition to be used as a designated place of safety on the Metropolitan line.*

- whether there is sufficient space from passing trains
- the condition of the lineside
- obstructions which may cause staff to move closer to lines which are open to traffic on which trains may run.
