AAIB Bulletin

6/2023

Published 8 June 2023

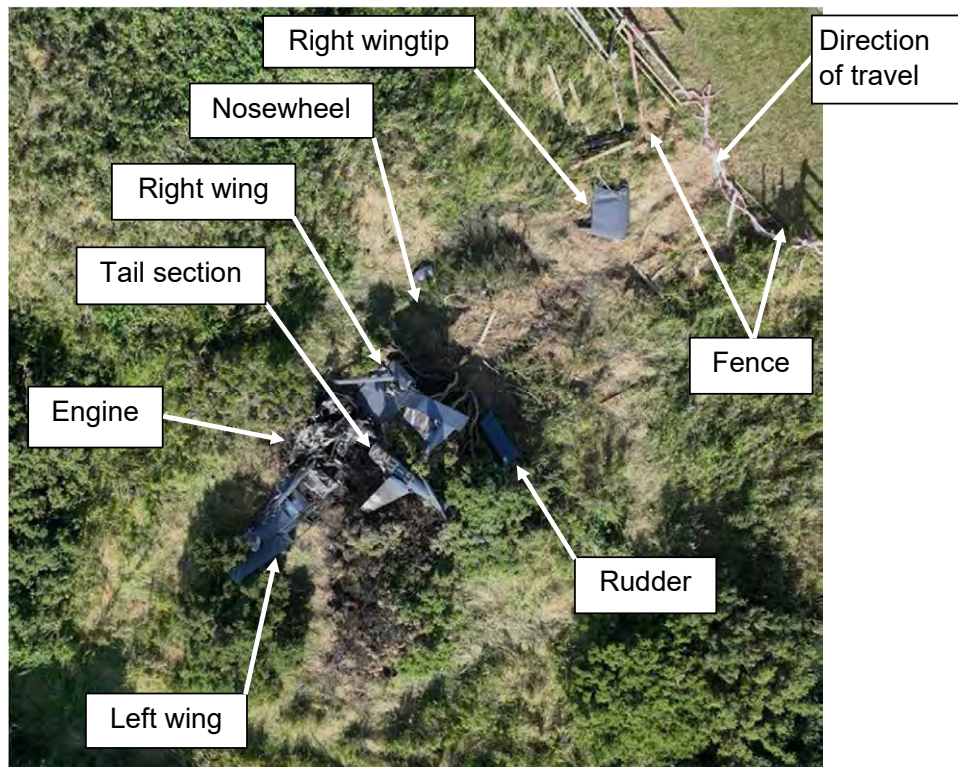
Figure 4
Accident site

G-ENVV struck a wooden fence on the boundary of the airfield close to the clubhouse and its outside eating area, continuing through the fence before coming to rest, inverted, over a gorse bush (Figure 3). There were no apparent ground marks from impact prior to the fence line.

Witness marks matching G-ENVV's paint were found on the fence posts. The right wingtip, some glazing from the windows, and the nosewheel were detached at the point of impact with the fence (Figure 4). The rudder became detached at the point of impact with the gorse bush, and was undamaged by the post-impact fire. The remainder of the right wing, left wing, tail section, fuselage, engine and propeller were all located at the final accident site.

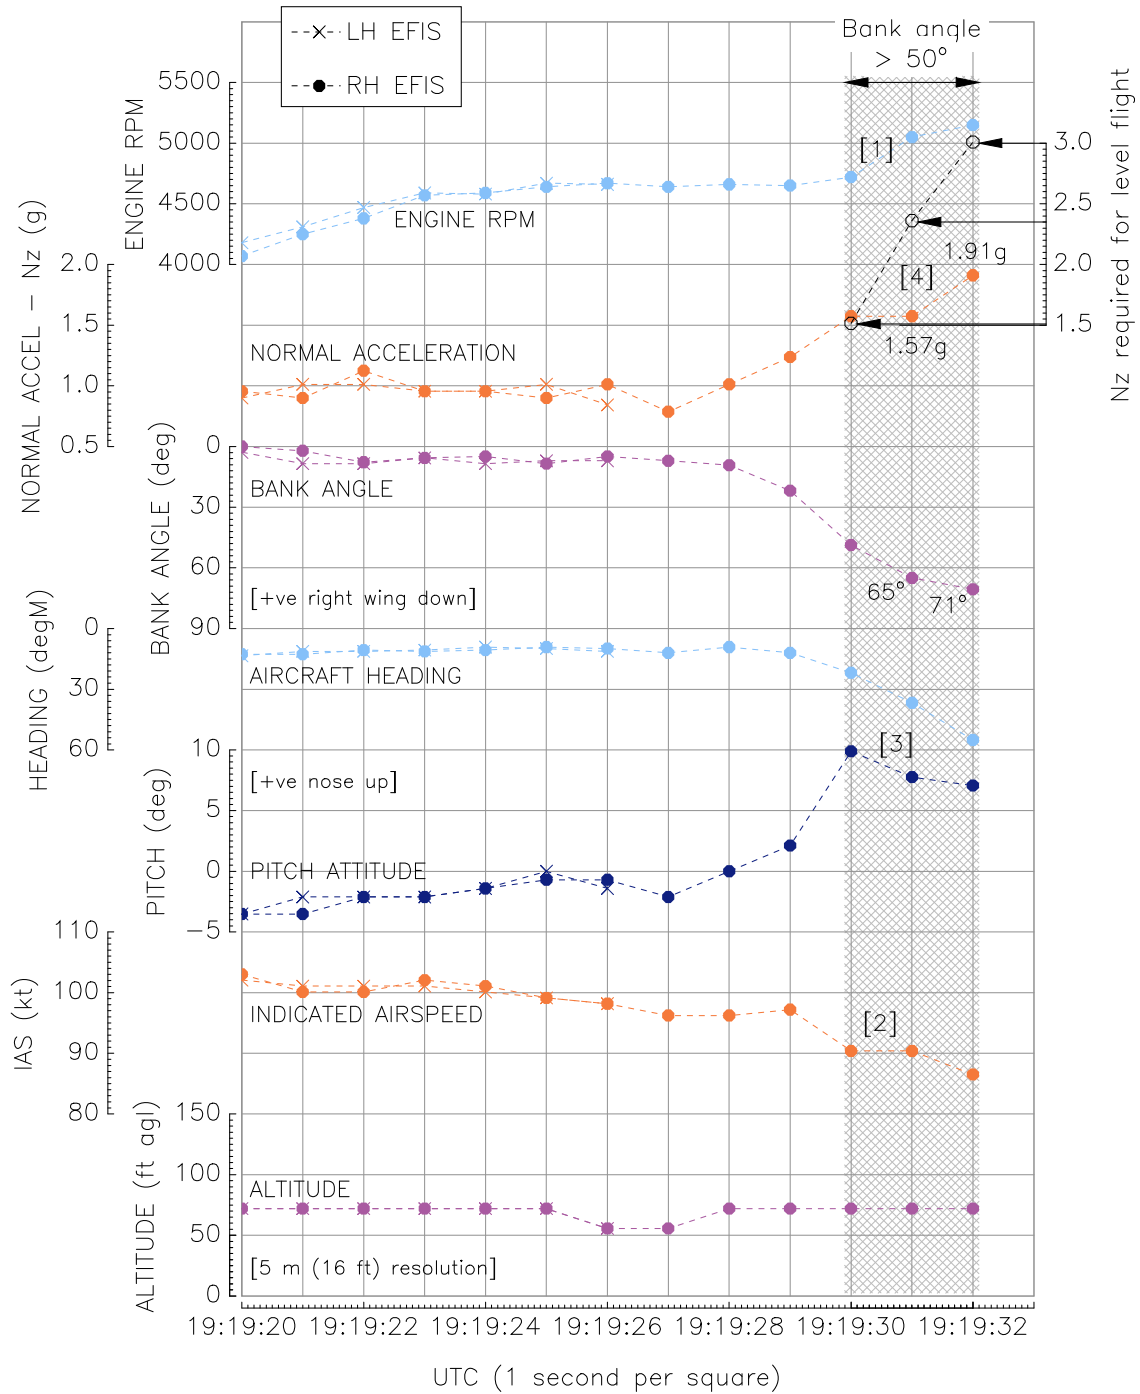
Figure 5
Last 13 seconds of recorded data

Figure 5 plots some of the data from both EFIS units, starting from when the aircraft was flying parallel to Runway 03 at about 72 ft (22 m) above the ground, and ending when the recordings stopped. The close alignment of data between the two units, seen in the figure, indicates that each unit was sampling data to within a fraction of a second of the other. The figure also shows that the recording from the left EFIS stopped six seconds before the end of the recording from the right EFIS. The manufacturer of the units stated that the data is buffered for six seconds before being stored in memory, implying that the left EFIS stopped working up to six seconds before the last data point recorded by the right EFIS at time 19:19:32. (The buffer is volatile memory, so its contents are lost when the unit's power is turned off or disrupted.)

An absence of recorded data from the EFIS units indicates they may have lost power before impact, although it could not be determined why this occurred as battery back-up systems were installed. Had such a failure occurred, it is possible that it captured the pilot's attention and briefly distracted the pilot from the primary task of flying the aircraft.

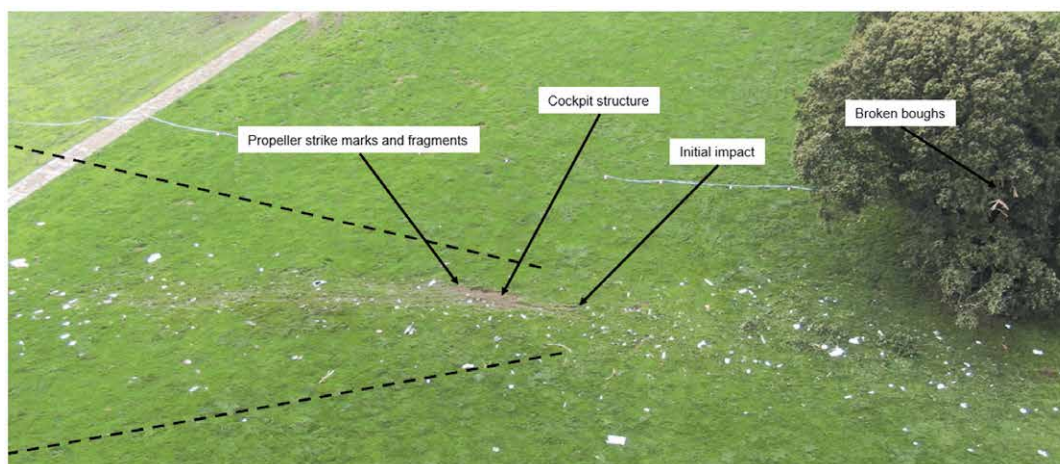
Figure 4
Ground impact marks

The accident site was a field approximately 1.2 km north-west of Buckland St Mary in Somerset. The aircraft struck the boughs of an oak tree and then the ground in the northern end of the field (Figure 4). Around the tree and from the ground impact there were large amounts of debris scattered on a southerly path. Running east-west midway across the field was a concrete single track road bounded on both sides by a single strand, wire fence supported on wooden posts. The wire had been broken and a piece of wire was caught in the tail wheel. The engine, cockpit instrument panels and rear fuselage were approximately 40 m to the south of the roadway and had been arrested by the wire fence. The left landing gear wheel was found in a sunken stream at the southern end of the field, approximately 235 m from the tree.

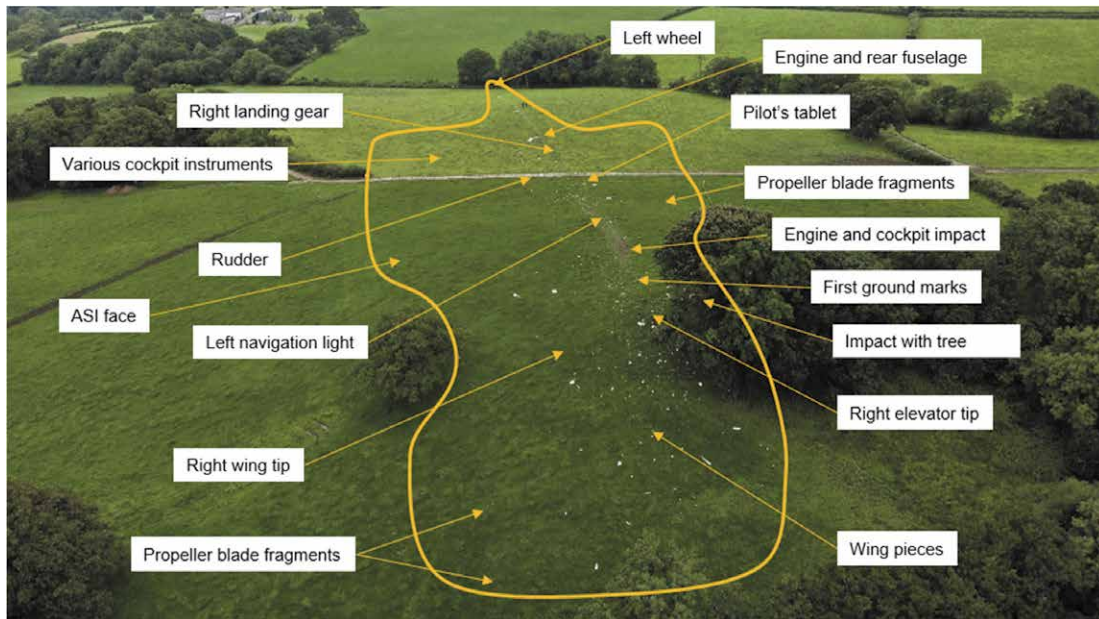
Figure 5

The oak tree at the northern end of the accident site was approximately 20 – 25 m tall with a large swathe cut through it at about 15 m from ground level. Several large boughs had been broken and some pieces of wreckage were lodged in the tree. The ground to the south and east contained broken branches and further wreckage, including wing and fuselage structure, shards of clear plastic from the canopy, and fragments of the propeller (Figure 5).

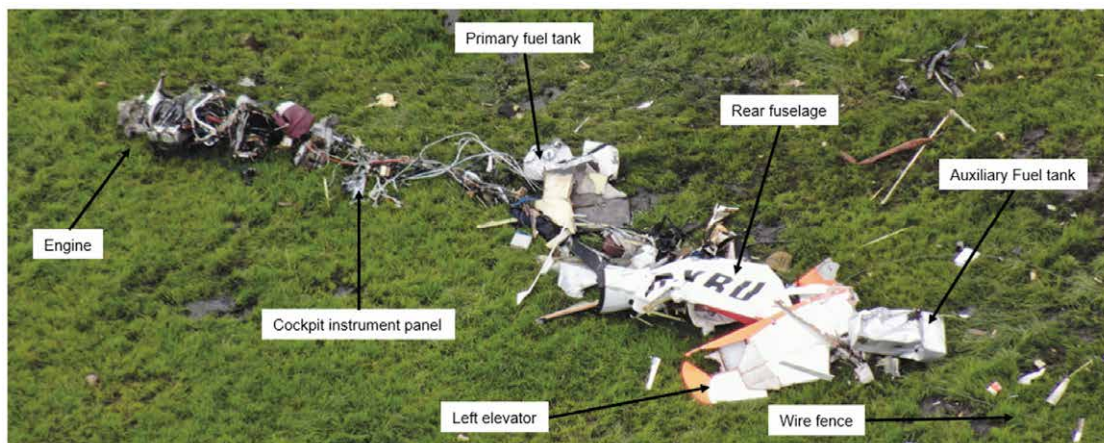
Figure 6

To the south of the concrete roadway was the engine and rear fuselage (Figure 6). The engine was attached to the cockpit instrument panels and rear fuselage by flight control and electrical cables. The primary fuel tank had ruptured and was empty whereas the auxiliary fuel tank was intact and still contained a small quantity of fuel.

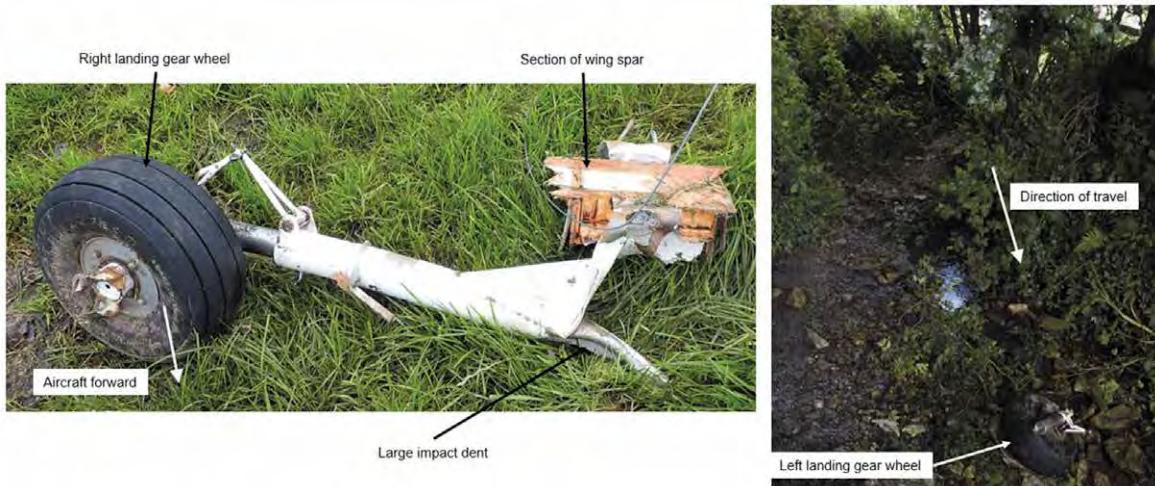
Figure 7
Main landing gear wheels

Inspection of the seat belts revealed they were still done up and that all the structural attachments had either failed in overload or become detached from the structure so that they were no longer capable of restraining the occupants. The right landing gear leg was found close to the rear fuselage section and was complete including a small section of wing spar (Figure 7).

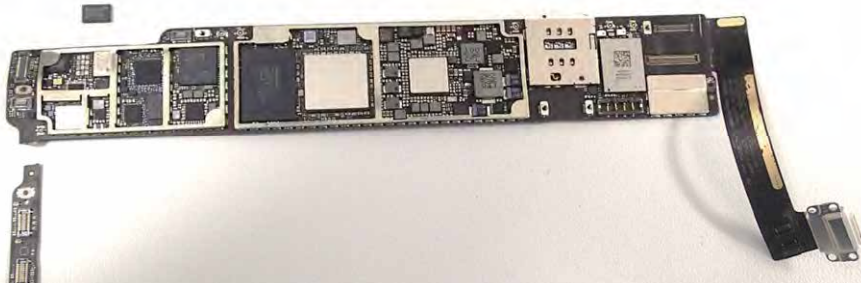
Figure 8
Tablet logic board

A heavily damaged tablet device was recovered from the aircraft. The main logic board had become twisted with a part of it ripped off. Some of the integrated circuits had been damaged and some detached. Damage was largely focused on one end of the board and included a distorted circuit board with the left narrow part detached, a detached chip and a cracked chip (Figure 8). Despite the damage, a specialist organisation was able to recover data from the item.

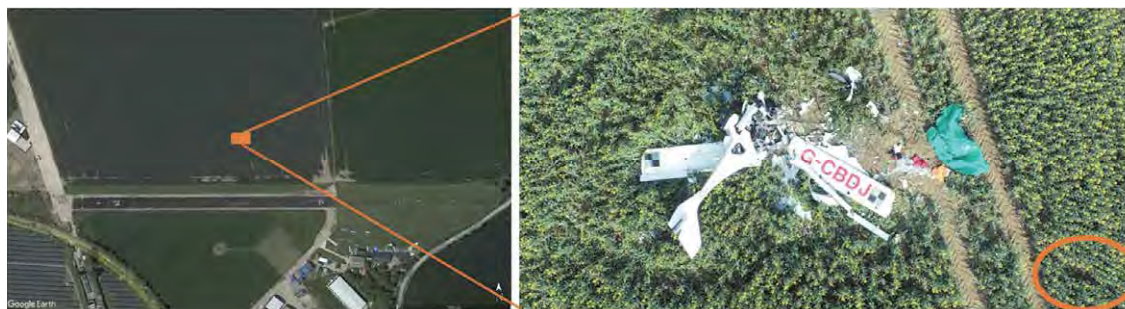
The aircraft came to rest approximately 100 m to the north of Runway 09 and 240 m from the threshold. Both wings had detached from the fuselage, with the lower surfaces upper most. The fuselage was on its right side, on top of the wings with severe disruption to the nose section (Figure 1). The field to the north of the runway was planted with a rapeseed crop which was approximately 1 m in height. The crop was heavily damaged in the immediate area of the aircraft and there was a short visible swath cut into the crop (highlighted in Figure 1 right) that was consistent with the left wingtip being the first part of the aircraft to make contact with the field.

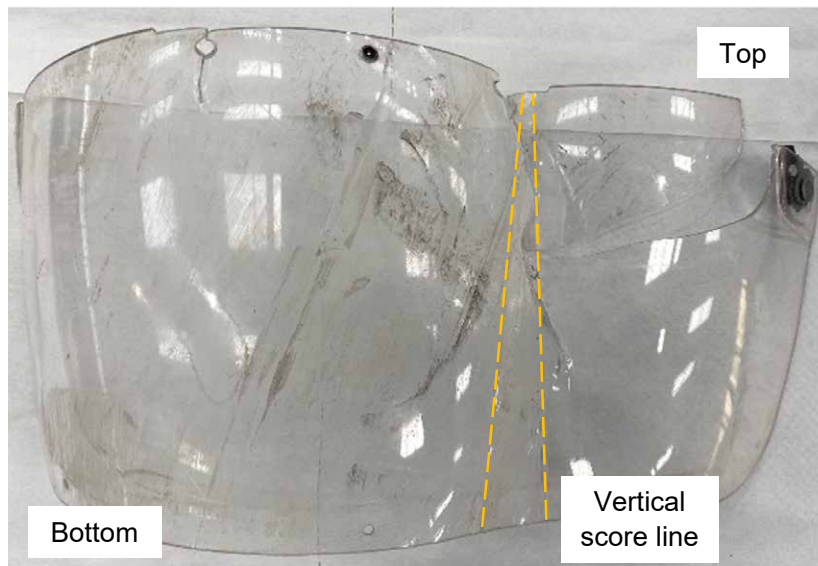
Figure 2
Damaged helmet visor

on its right side. The visor had been badly damaged with multiple scrape marks and a wide vertical line scored from top to bottom to the left of the visor's centre line. The distortion of the visor along the vertical line matched the profile of the front strut. The horizontal curved profile of the visor had bent inwards along this vertical line (Figure 2). A large piece of the visor had broken away from the upper left quarter.

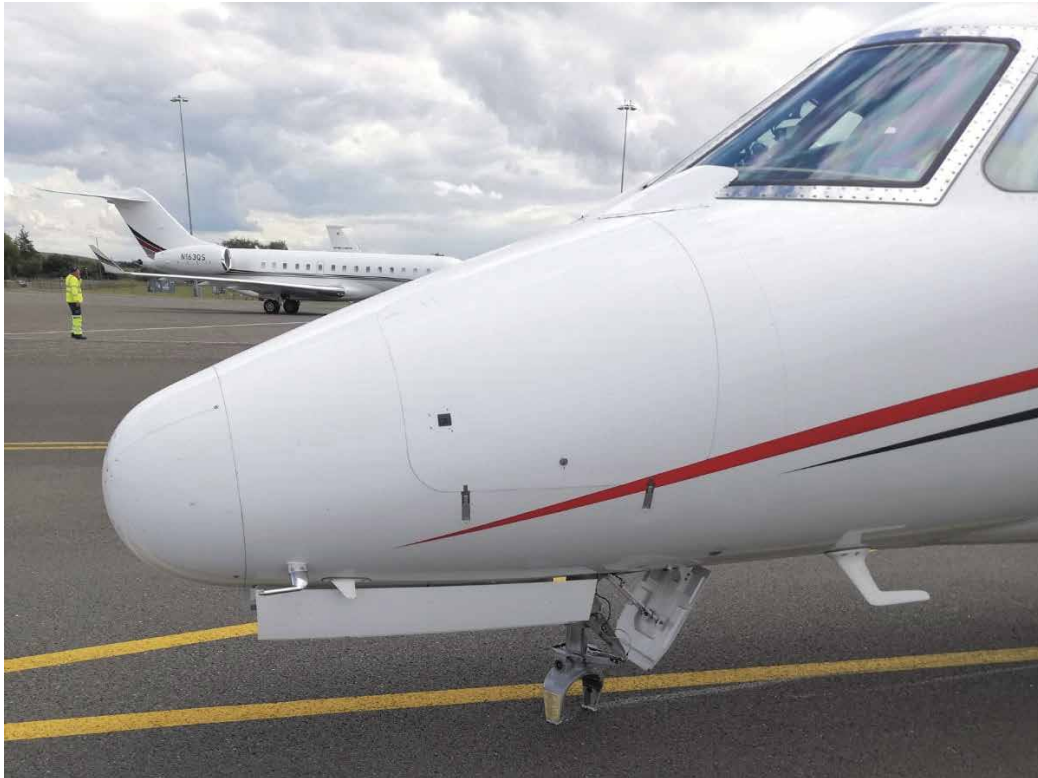
Figure 1

The nosewheel had detached from the nose landing gear (NLG) leg and came to rest in the grass adjacent to the taxiway, leaving the forks on the NLG resting on the taxiway (Figure 1).

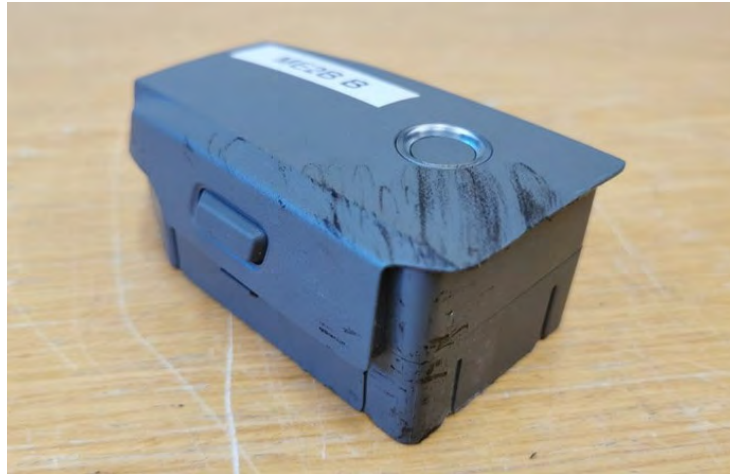
Figure 3

Battery from the accident Mavic
