Service Inquiry

Into the death of a Royal Air
Force parachute instructor at
RAF Weston on the Green

2 September 2021

SERVICE INQUIRY INTO THE DEATH OF A ROYAL AIR FORCE PARACHUTE INSTRUCTOR DURING A FORCE DEVELOPMENT DAY AT RAF WESTON ON THE GREEN ON 2 SEP 2021

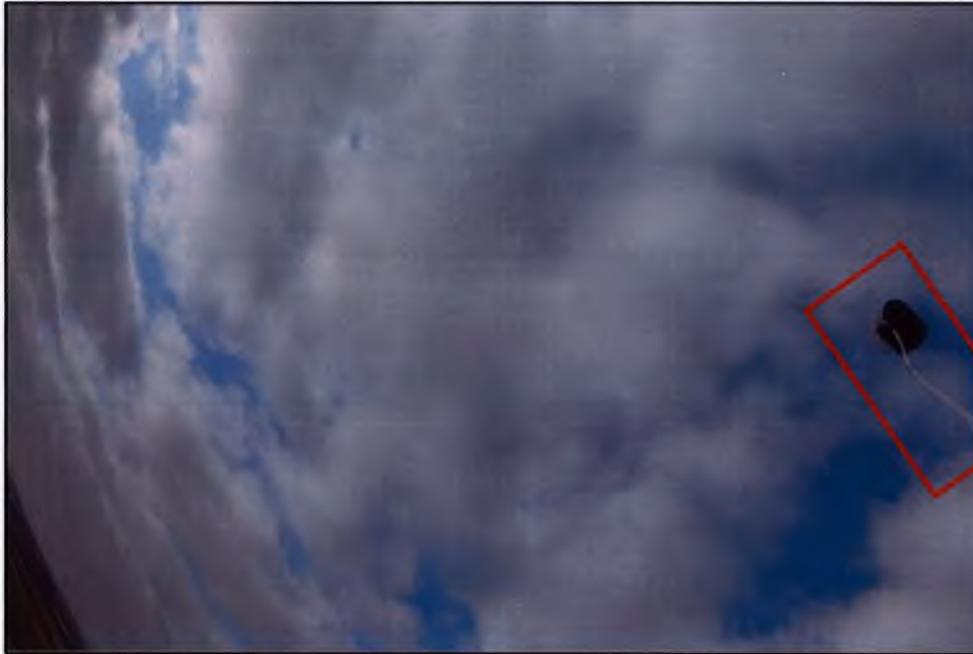
was not seen in the video. Immediately before impact with the ground the pilot chute came back into view in the same configuration (Figure 1.3.10).

Figure 1.3.9 – Reserve Pilot Chute entanglement 2.136sec before impact.

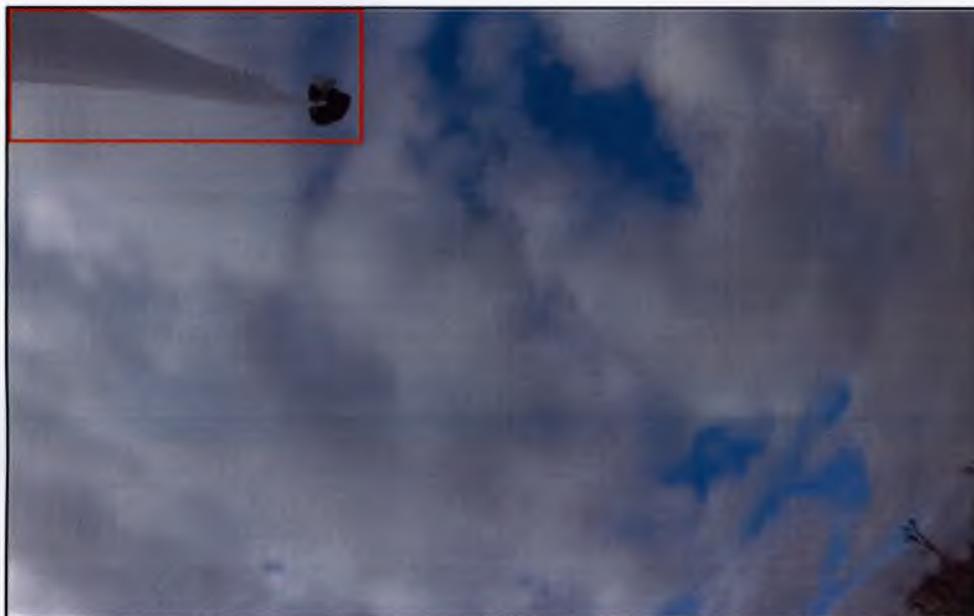
Figure 1.3.10 – Reserve Pilot Chute entanglement 0.034sec before impact.

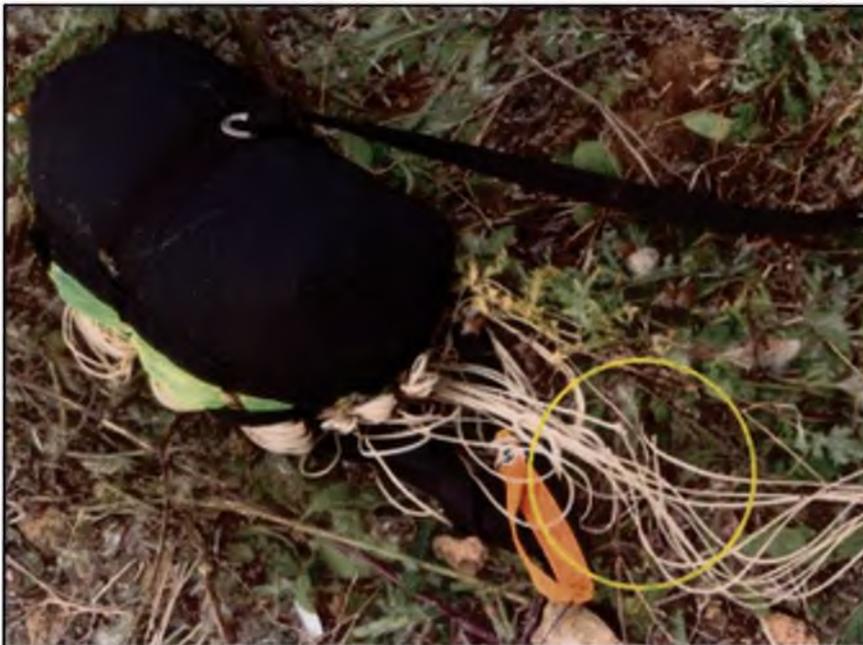
- a. Sgt Fisk's parachute system was a Javelin Odyssey X container; the harness had been cut in several places. A statement from the TVP confirmed that the damage to the harness and canopy rigging lines was attributable to the emergency services actions during the attempt to resuscitate Sgt Fisk.
- b. The base of container (BOC) toggle and main pilot chute were extruding from their pocket.
- c. Both the cutaway and reserve handles had been operated.
- d. The main parachute was out of the container but remained within its deployment bag with all bungees securing the rigging lines.⁹³ Some rigging lines had been cut or showed signs of an attempt of being cut (Figure 1.4.5).

Figure 1.4.5 – Main canopy and damaged lines.

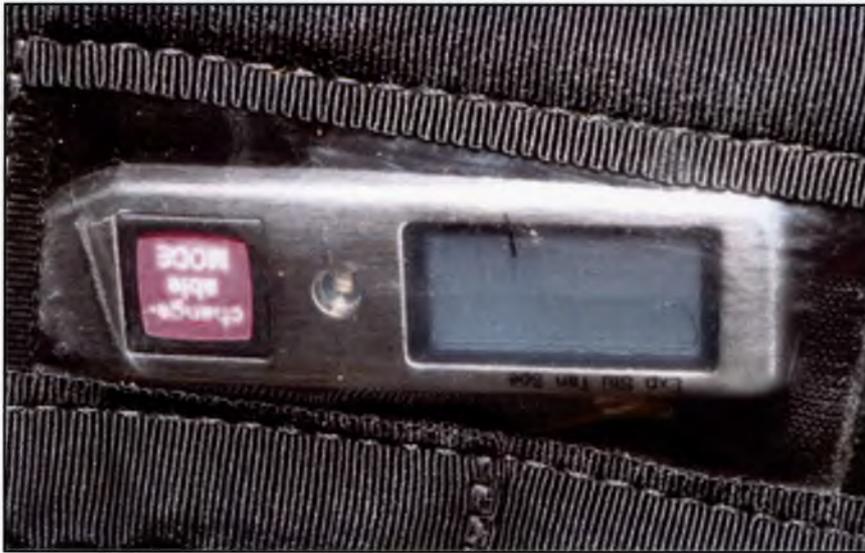
h. The automatic activation device (AAD) (CYPRES) unit had a blank display (Figure 1.4.7).

Figure 1.4.7 – AAD with blank screen.

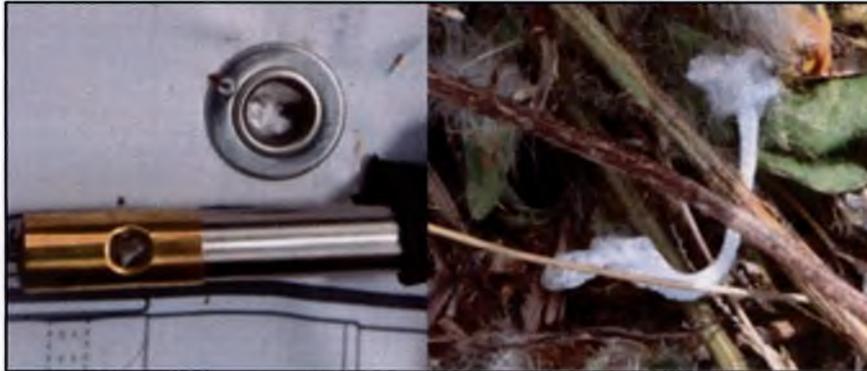
- i. The AAD had activated, with the severed end of the closure loop found near the accident site (Figure 1.4.8).

Figure 1.4.8 – CYPRES cutter and closure loop.

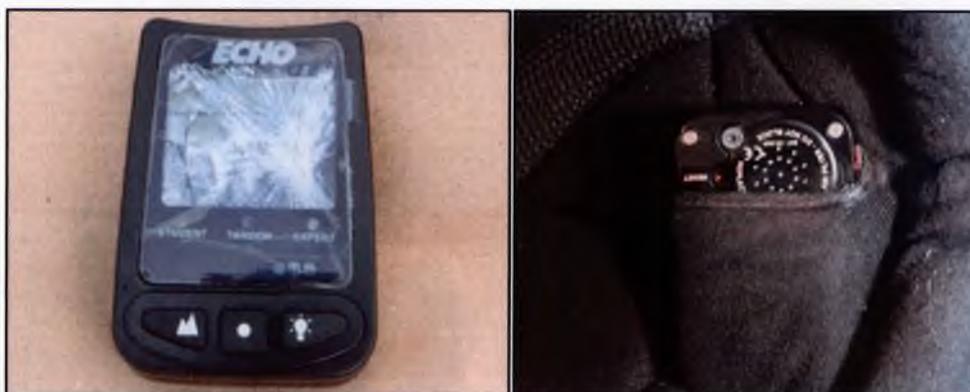
1.4.33. There was notable damage to the ECHO audible altimeter fitted inside Sgt Fisk's helmet (Figure 1.4.9) which made the screen unreadable. However, the manufacturer was able to provide advice to the HSE on how to recover the data. As more than 14hrs had passed since the accident, the unit would have entered standby mode and switched off. An external report from the HSE identified that the ECHO was in 'Expert' mode and that the high-speed warnings had not been changed from the factory settings shown below:

Figure 1.4.9 – Sgt Fisk's damaged Larsen & Brusgaard ECHO (left) and as stowed in helmet pocket (right).

1.4.34. Due to the damage caused to Sgt Fisk's ECHO and the amount of time that had lapsed since the accident before the data was extracted, it was not possible to determine whether the unit was switched on at the time of the accident. However, taking in to account the data extracted from other devices, along with the warning heights set as above, Sgt Fisk's freefall rate of descent would have been sufficient to initiate the warnings at the programmed heights. Of note, the 4th warning would have sounded during the final 4,000ft of the descent.

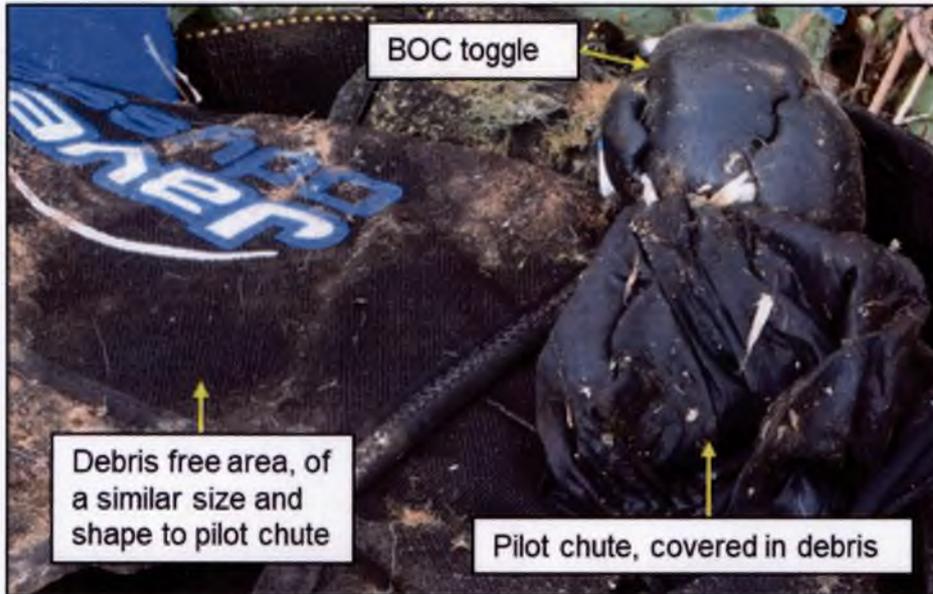
protection by the partially extracted main pilot chute and BOC toggle. This led the panel to conclude that it was extremely likely that the main pilot chute and BOC toggle had been partially extracted during the descent.

Figure 1.4.11 – Partial deployment of Sgt Fisk's main pilot chute.

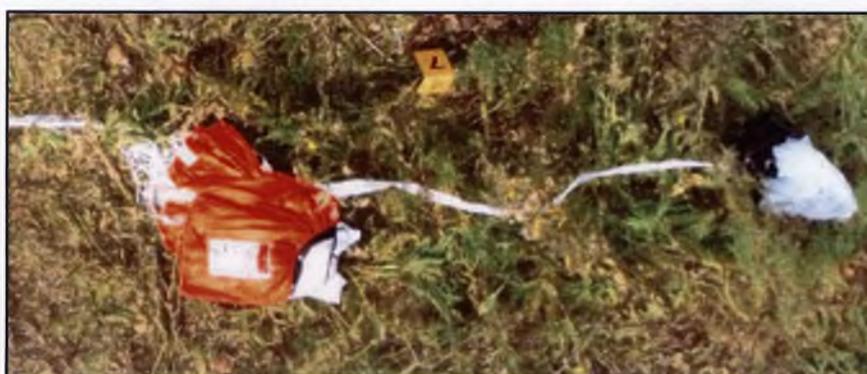
1.4.82. Photographic imagery from the scene showed the reserve free-bag separated from the parachute container with a partial deployment of the reserve canopy (Figure 1.4.6). At 02:00.653 (0.066sec after impact) Sgt Fisk's GoPro™ detached and captured an image of the free-bag separated from the container with further images capturing the reserve canopy rigging lines in the process of extending. The post-accident footage provided by the NPAS helicopter also showed the reserve canopy still packed within the free-bag.

Figure 1.4.16 – Disturbed reserve parachute, free-bag and pilot chute.

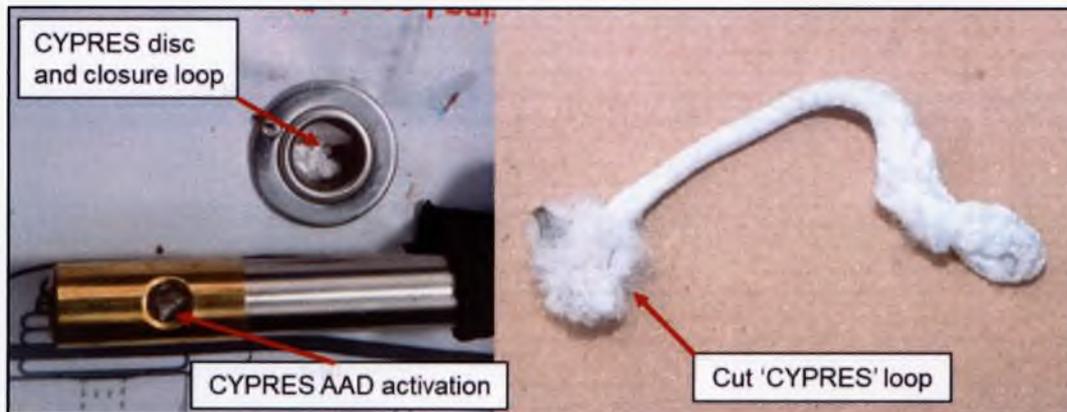
Figure 1.4.17 – The parachute system AAD cutter and CYPRES closure loop.

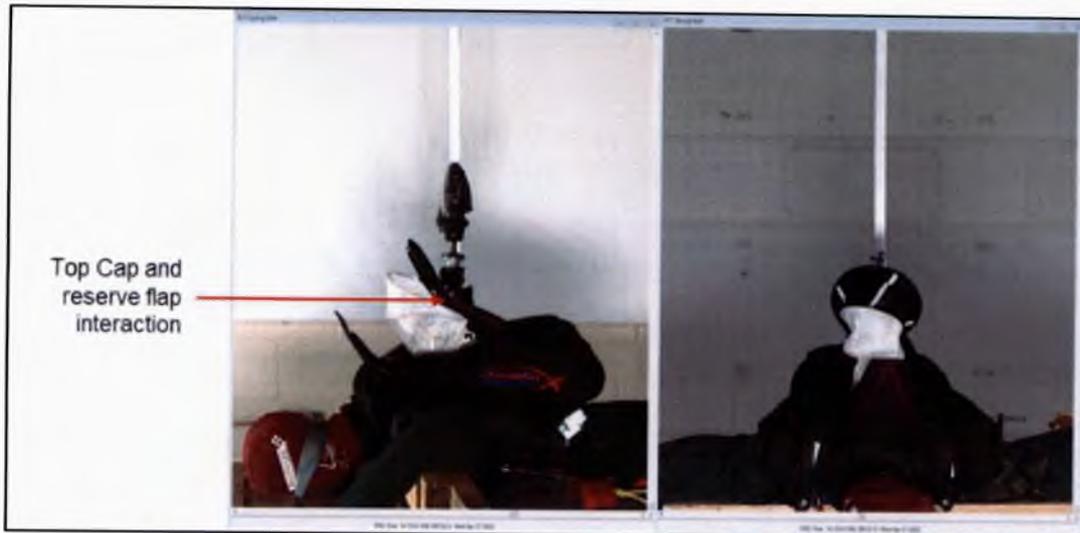
Figure 1.4.23 – HSDV test R17 in a total malfunction configuration, top cap interaction.

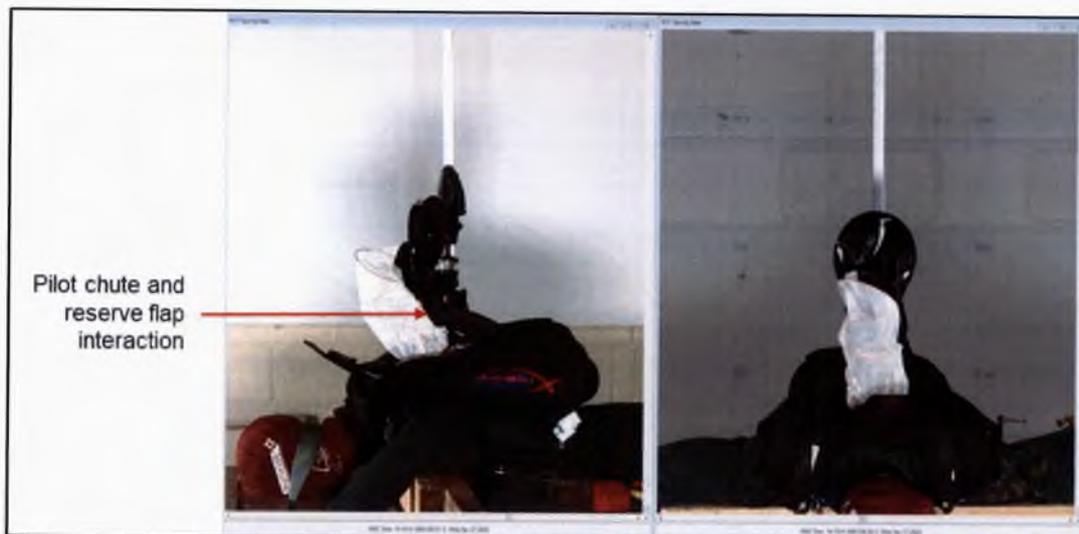
Figure 1.4.24 – HSDV test R17 in a total malfunction configuration, RPC material interaction.

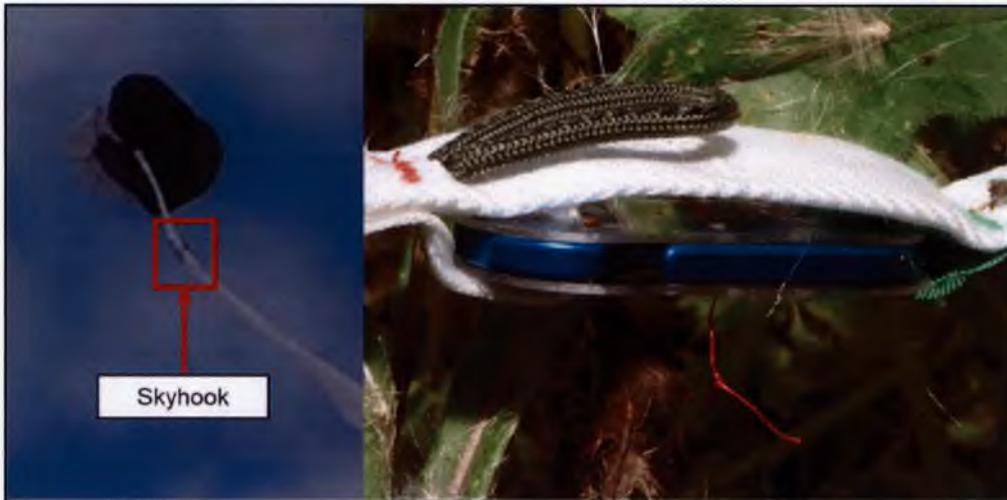
Figure 1.4.34 – Sgt Fisk's MARD (Skyhook).

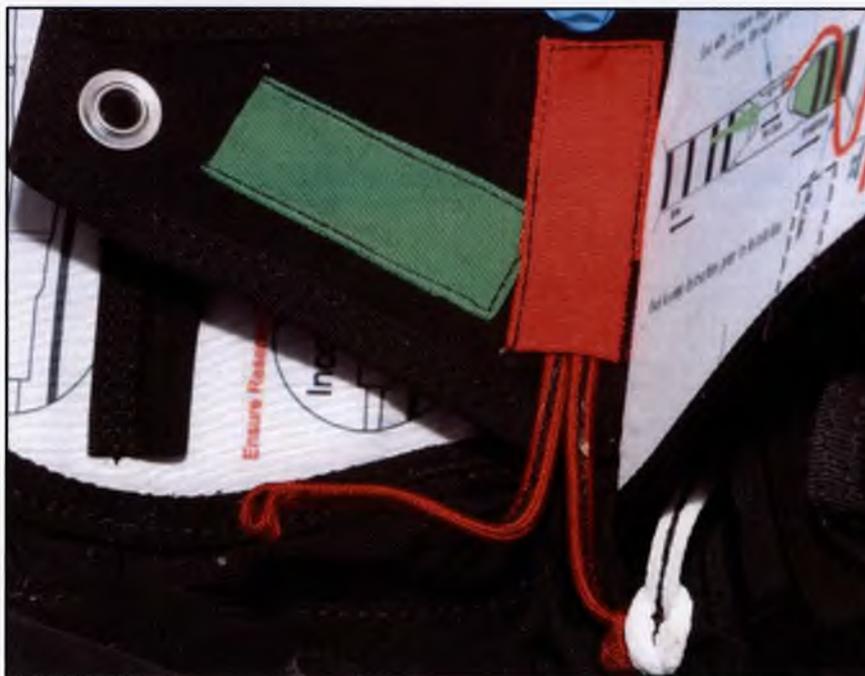
Figure 1.4.35 – Sgt Fisk's MARD (Skyhook) red lanyard.

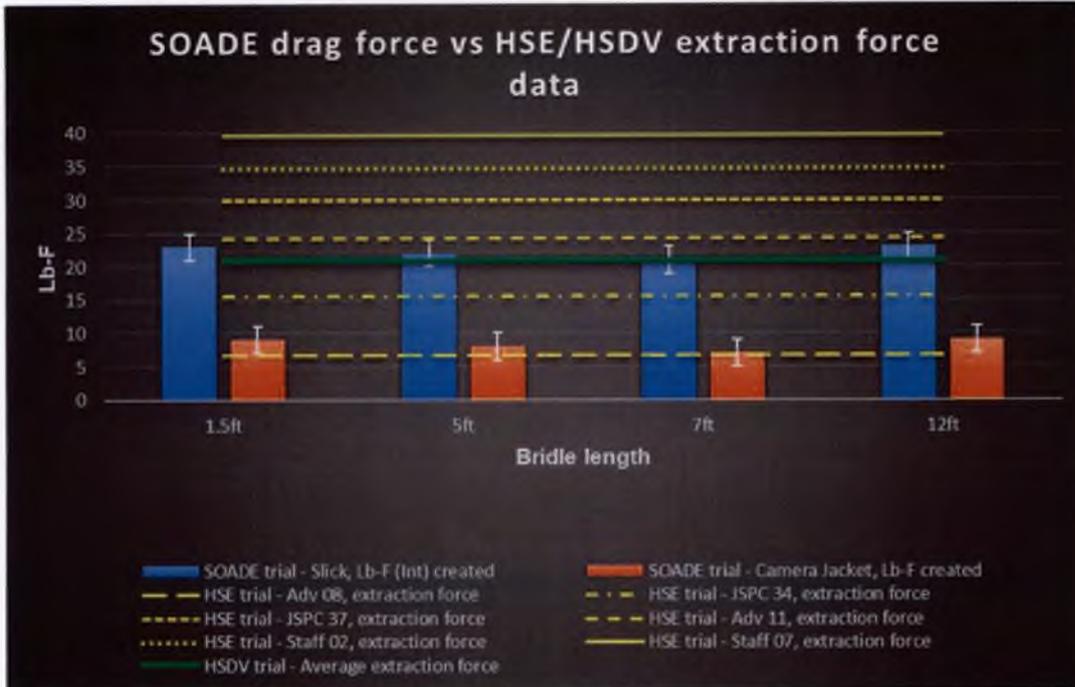
1.4.133. Using the data provided by the SOADE, HSE and HSDV reports, the panel overlaid the pull force of the JPSC(W) and HSDV parachute systems against the force produced by a malformed RPC in the vertical wind tunnel (Figure 1.4.37).¹³⁶

Figure 1.4.37 – Malformed RPC pull force vs extraction force data comparison.
