Interim report on the investigation of the foundering of the fishing vessel *Piedras* (FD 528) south-west of Mizen Head, the Republic of Ireland on 1 June 2022

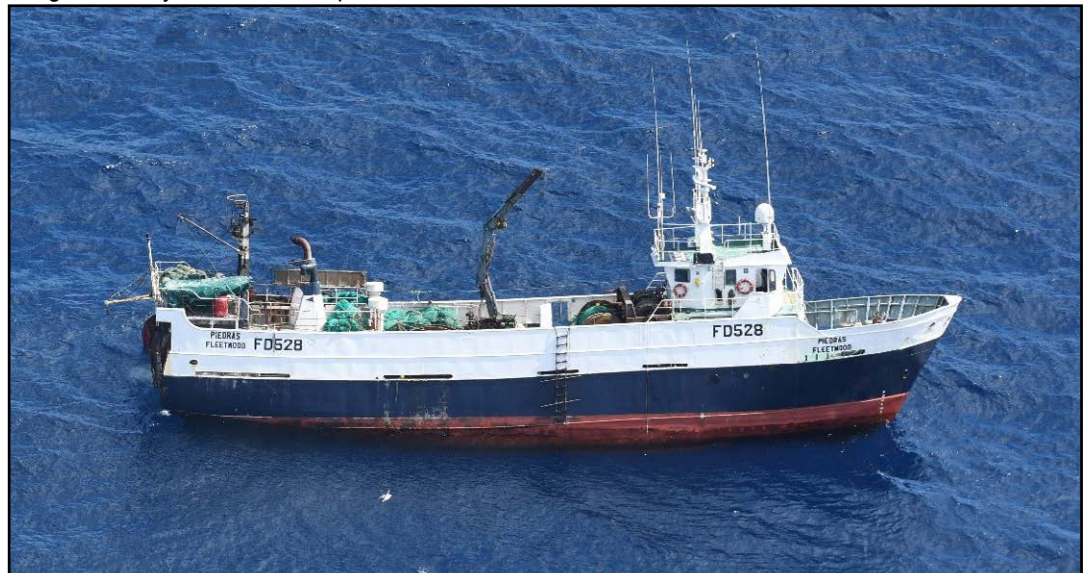
Piedras before capsize
