Rail Accident Investigation Branch

# Rail Accident Report

**Train overspeeding at Spital Junction,  
Peterborough  
17 April 2022**

Report 06/2023  
July 2023

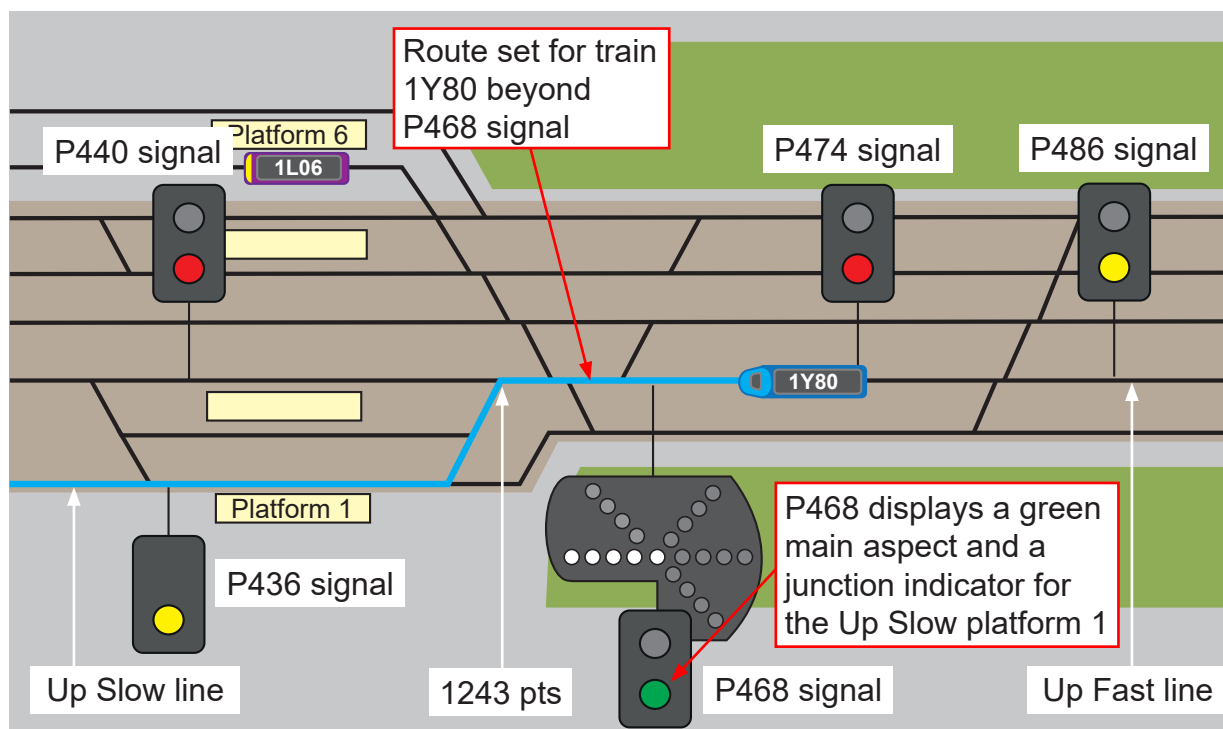
- 74 At 10:19:09 hrs, the JI for the Up Slow line to platform 1 illuminated, followed within a second by the main aspect of P468 signal changing from red to green (figure 5). The train was travelling at around 25 mph (40 km/h) and was approximately 790 metres from the signal when the aspect changed. Three seconds later and with the train approximately 760 metres from P468 signal, the driver applied full traction power to accelerate the train (figure 16). The train passed P468 signal travelling at around 64 mph (103 km/h) and was still accelerating.

Figure 16: The position of train 1Y80 at 10:19:09 hrs.

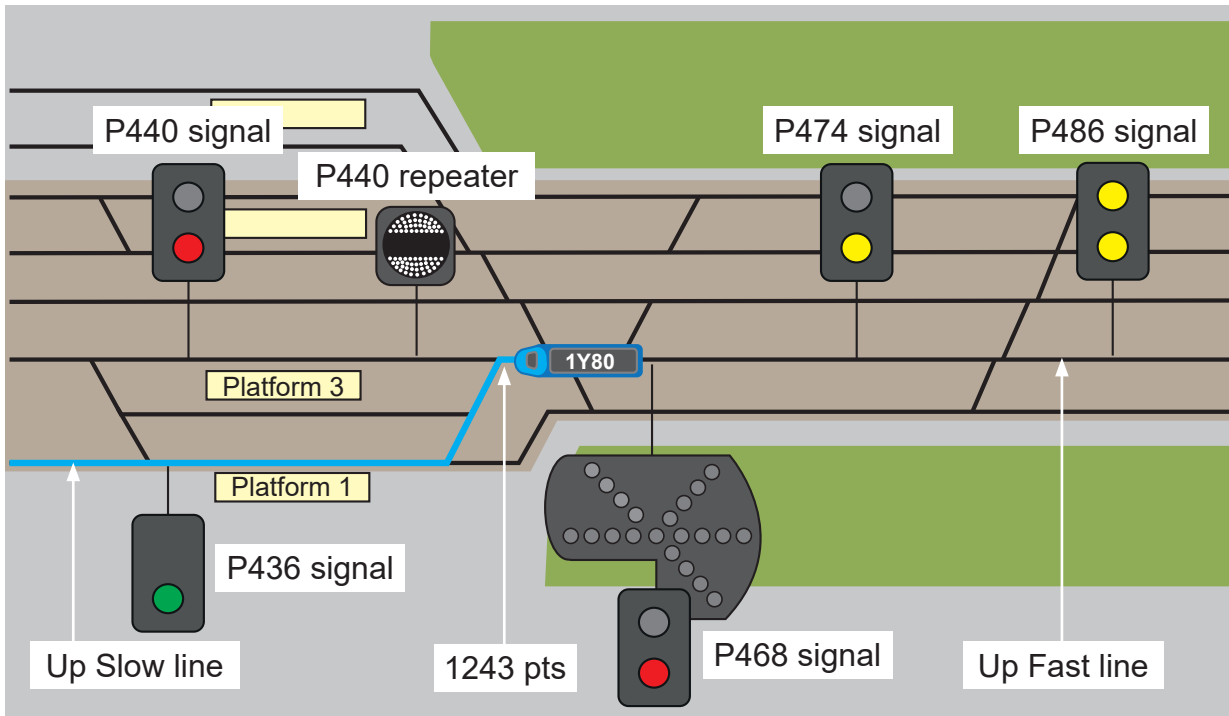
- 75 At 10:20:08 hrs, the train was approximately 160 metres from 1243 points and had reached around 77 mph (123 km/h). The driver stated that they saw the platform banner repeater signal at the north end of platform 3 was 'on', indicating that the route for the Up Fast line through platform 3 was not set. They reacted by applying a full service brake (figure 17).

Figure 17: The position of train 1Y80 at 10:20:08 hrs.

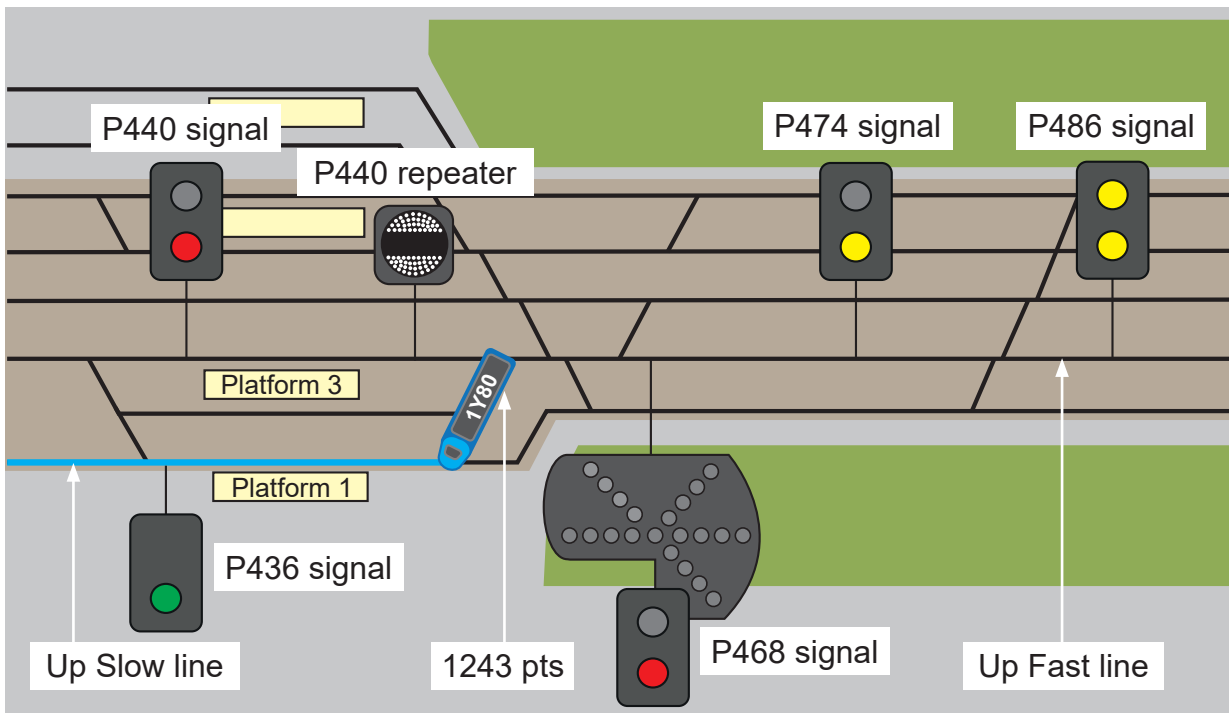
76 At 10:20:11 hrs, the train reached 1243 points at the junction while it was still travelling at around 76 mph (122 km/h) (figure 18). The driver made an emergency brake application around nine seconds later, after the train had passed over all of the points and while it was travelling at around 60 mph (97 km/h).

Figure 18: The position of train 1Y80 at 10:20:11 hrs.

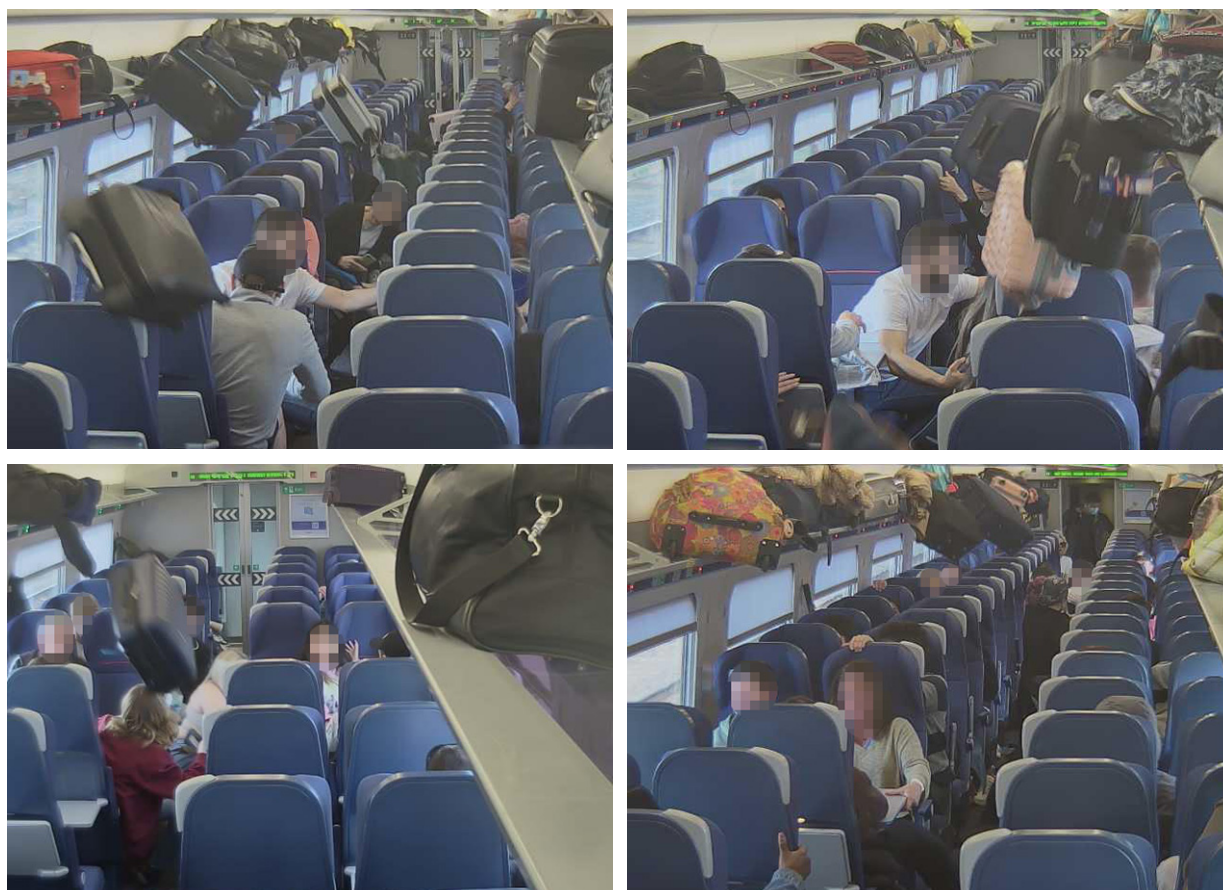
**177 Half of the passenger injuries originated from the luggage stowed in the overhead luggage racks falling on them.**

178 RAIB's review of the train's internal CCTV and the descriptions of the injuries sustained by passengers concluded that half of the injuries were caused by luggage falling from the overhead luggage racks as the train went over the junction (figure 20).

Figure 20: Luggage falling from the overhead racks during the incident.

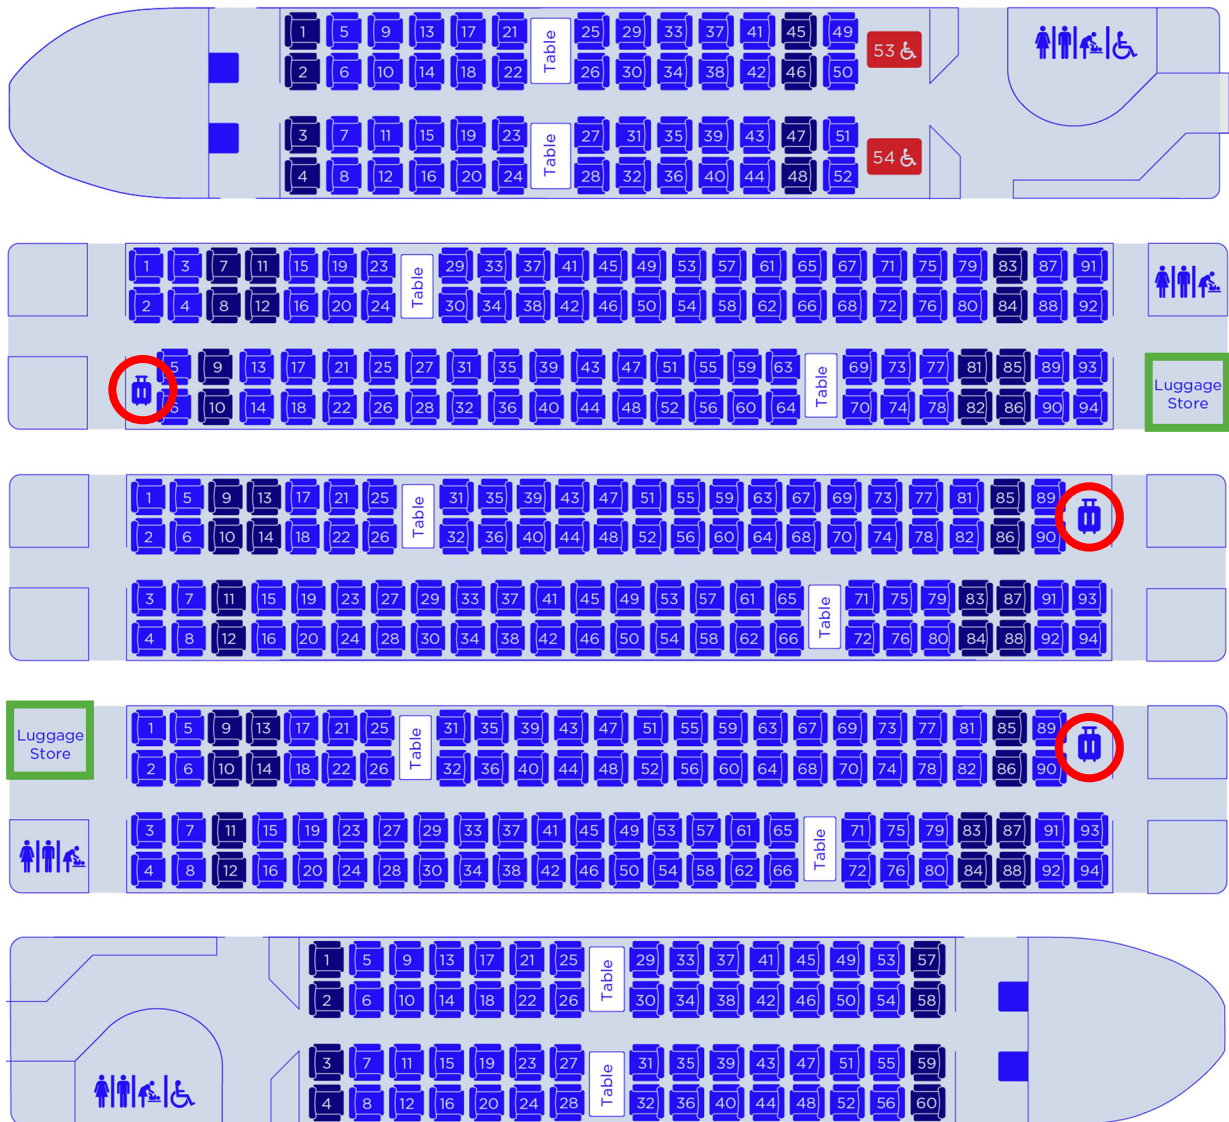
179 Lumo offers less space for passengers to store their luggage in floor-mounted luggage stacks compared to other long-distance operators of the same train type (such as the Great Western Railway (GWR) class 800/0 and LNER classes 800/1 and 800/2 units).

Figure 21: Luggage storage stacks and storage areas on Lumo's trains.

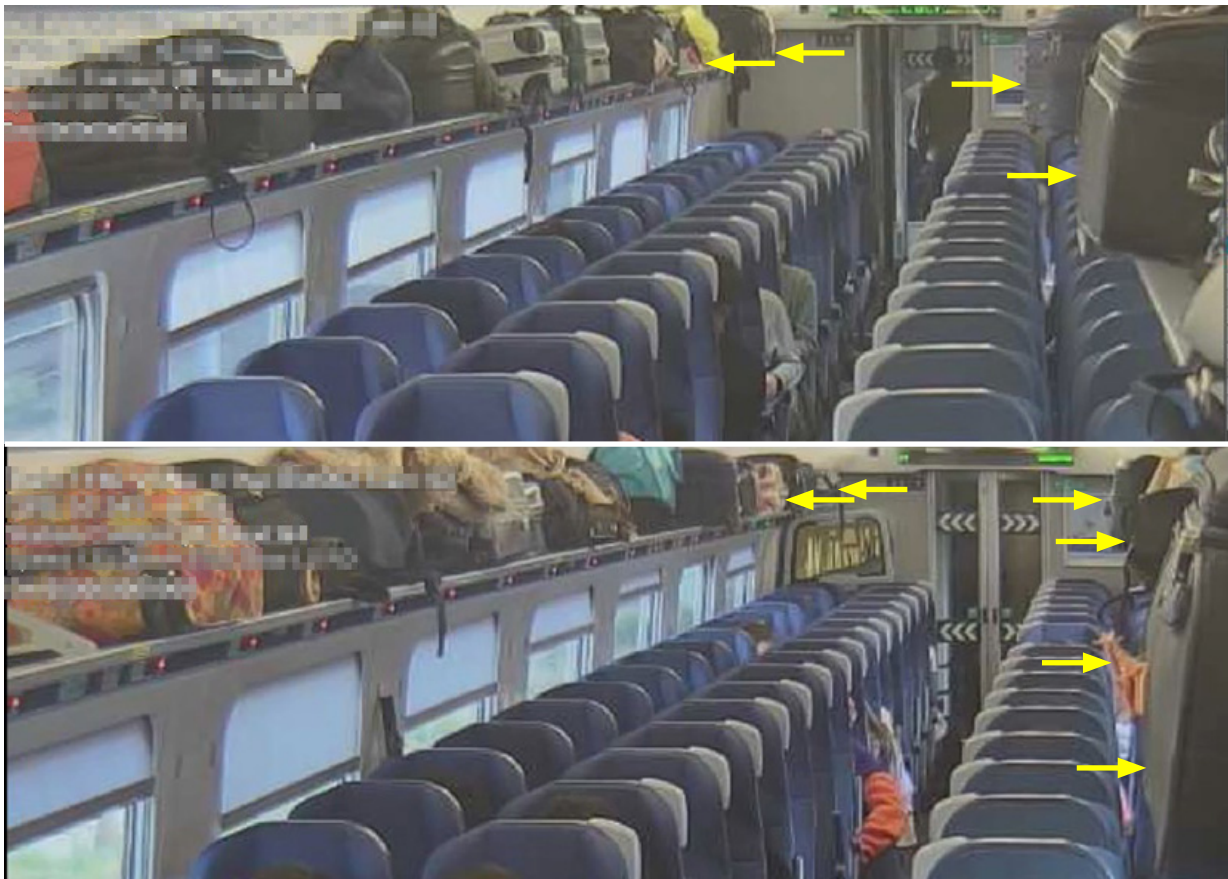
Figure 22: Internal CCTV images showing luggage overhanging edges of overhead racks.
