Rail Accident Investigation Branch

Rail Accident Report

Embankment washout under a passenger train at Haddiscoe 30 January 2022

Report 07/2023
July 2023

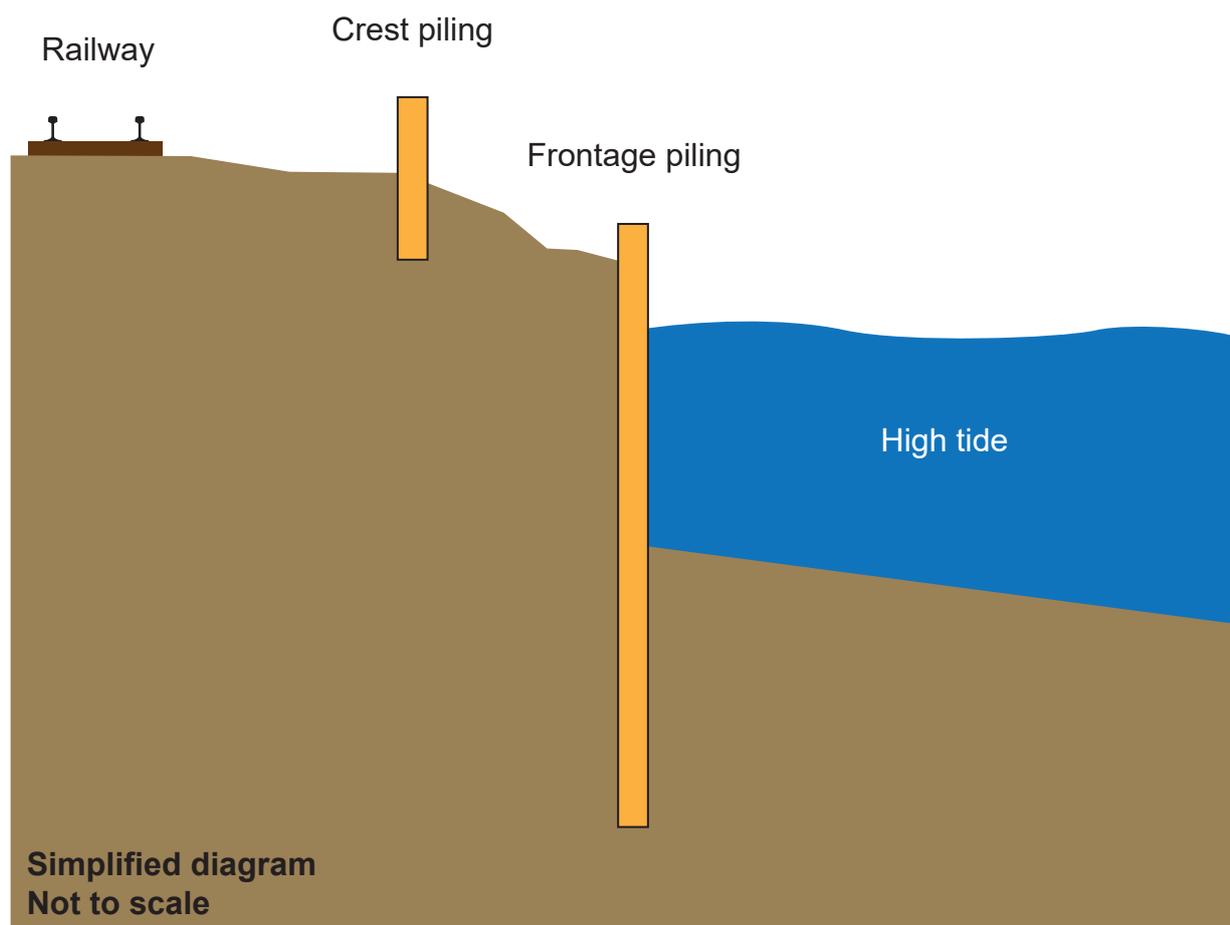
Figure 4: Flood defences and cross section of bank.

- 19 The flood defences along Haddiscoe New Cut comprise a bank supported by frontage piles, which is topped with crest piling. The bank also supports the railway, with the railway boundary fence on the landward side of the crest piling (figure 4).
- 20 Frontage piles, which can be made of various materials including wood and steel, protect the riverbank from the erosion caused by river currents and provide some support to the ground behind them. Steel frontage piling was in use at the location of the incident.

- 21 The crest piling was installed in 2006 to provide a consistent flood defence level in an area where the bank was no longer considered to be at a sufficient height (see paragraph 38). The crest piling was made of plastic.

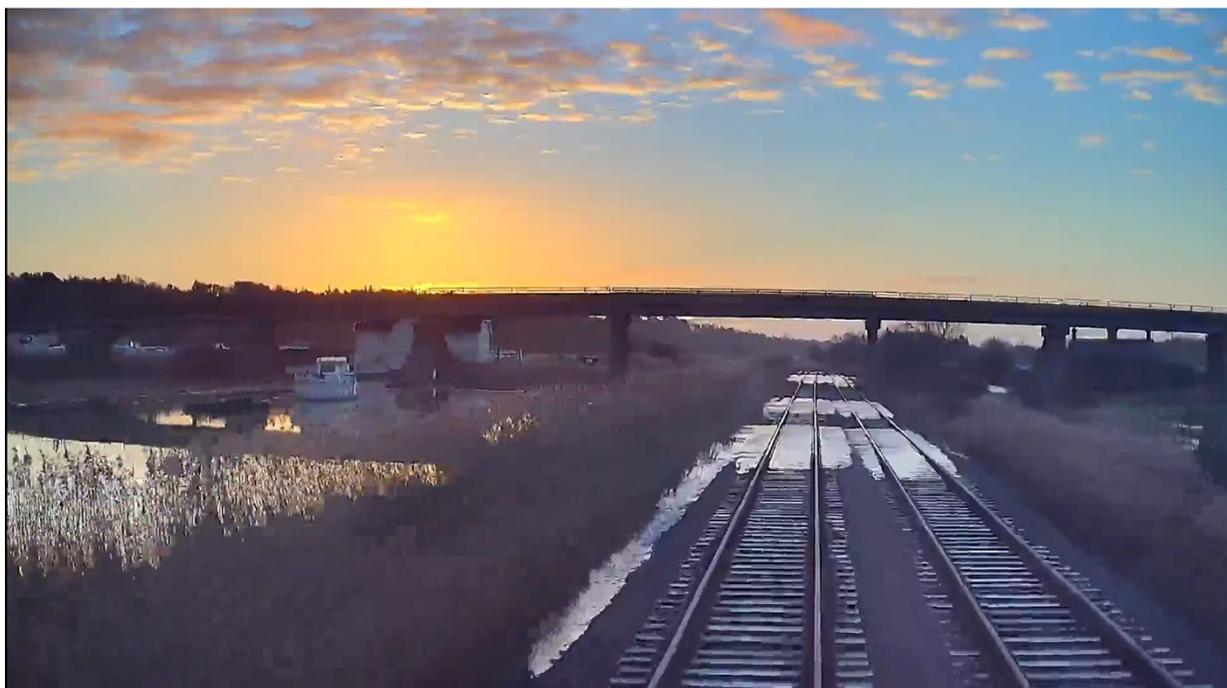
Figure 5: View from FFCCTV just before the driver stopped the train.

- 29 At 07:45 hrs, the driver of train 2J66 made a call to the signaller using the GSM-R³ radio system to report that there was a “tiny bit of water escaping the banks of the river” at a location approximately 0.6 miles (1 km) before the incident location. The train was travelling at around 55 mph (89 km/h) at this point. While still on the radio call, the driver started braking as they could see pooling water on the track ahead. The driver told the signaller they would need to stop the train as water was clearly visible on both lines (figure 5). The railway Rule Book requires the driver to tell the signaller if the flood water is up to the bottom of the railhead, is up to or above the top of the railhead, is moving and likely to dislodge the ballast, or has already dislodged the ballast. The train stopped on the section of pooling water while the driver was still on the call to the signaller.

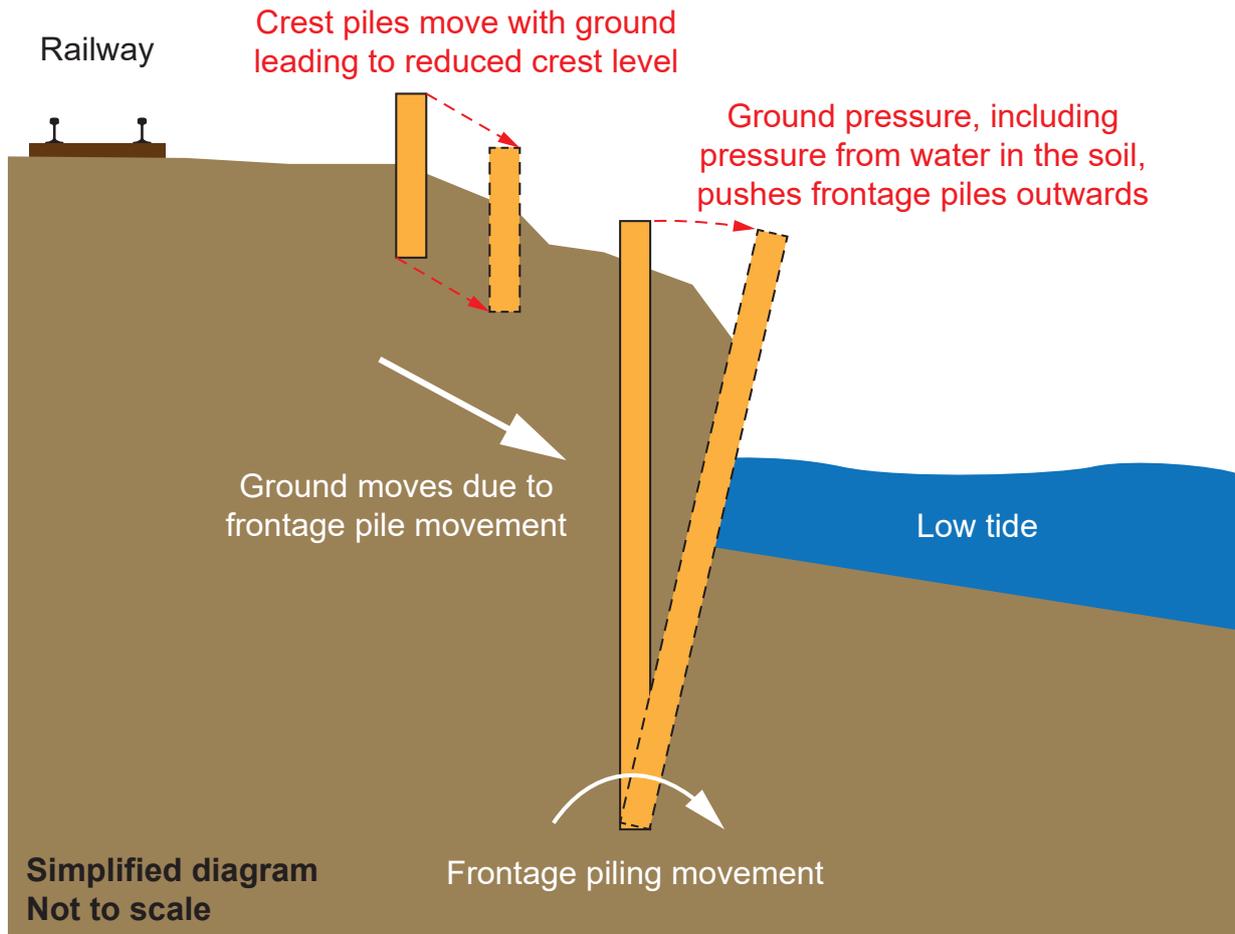
Figure 11: Crest pile movement due to failure of frontage piles.

- 58 Surveys undertaken on the days following the incident showed that the frontage piles had by then moved towards New Cut. This movement of the frontage piles would have caused movement of the ground behind them, which would also have produced some settlement and movement of the plastic crest piles (figure 11). Jacobs reported that the frontage piles had been in place for several decades and had continued to give satisfactory performance. However, they did not accord with modern design standards particularly in respect of their length which, being shorter, would have made them more susceptible to such movement.

- 59 An especially low tide would have been needed to initiate frontage pile movement and this probably would have needed to follow an event, such as a particularly high tide, which allowed an unusually large amount of water to seep into the soils behind the frontage piles and push them towards New Cut. This situation occurred in the early hours of the day following the washout (figure 10), making it possible that the significant frontage pile movement found had occurred after the incident (figure 12). If the frontage pile movement had only occurred post incident, then this means that the flooding of the railway was caused only by ongoing settlement of the embankment and crest piles (paragraph 57).

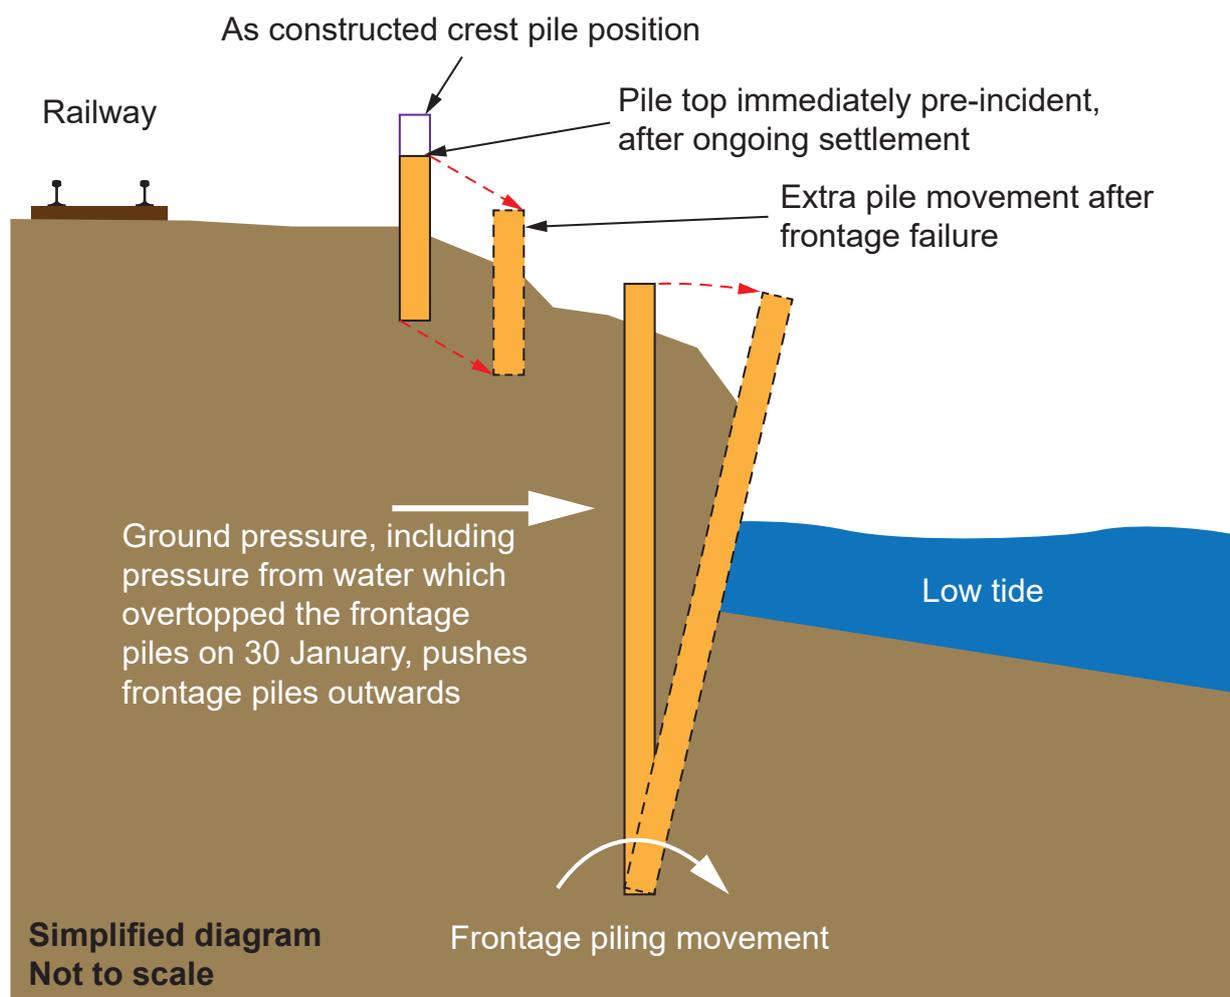
Figure 12: Flooding due only to settlement with subsequent failure of frontage piles.

- 61 The embankment supporting the railway overlies natural soils typical of the Broadlands. In 1934 an exploratory hole was sunk into the ground alongside the railway embankment, about 30 m from the 2022 incident site. The findings from this exploratory hole have been interpreted by RAIB, taking account of information from a hole sunk 470 m from the site in 1995, using modern soil sampling and modern soil descriptors. This interpretation shows that the 1934 hole encountered soft or very soft soils, including a peat band 1.8 m thick, to a depth of 20.7 m below field level. Beneath this, sand, gravel and very stiff clay were encountered.

- 62 The way in which the soft, very soft and peat soils were deposited means that the proportion of each is likely to vary rapidly over short distances and that less compressible zones of silt and sand will sometimes be encountered within this layer of ground. Long-term processes mean that, throughout much of the Broadlands, gradual compression of this layer is causing settlement of the ground surface. The variable soil composition means that the amount of settlement can vary significantly over relatively short distances.

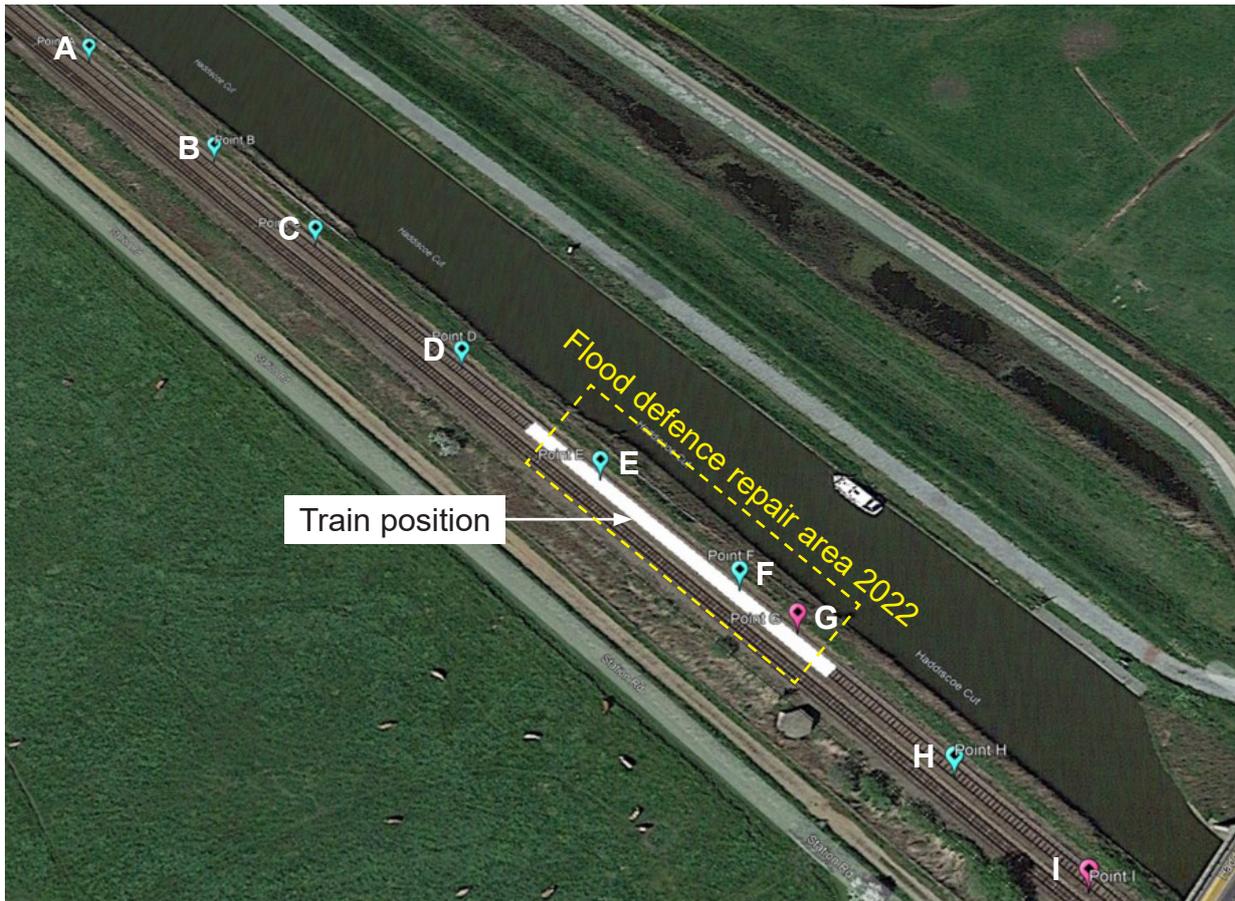
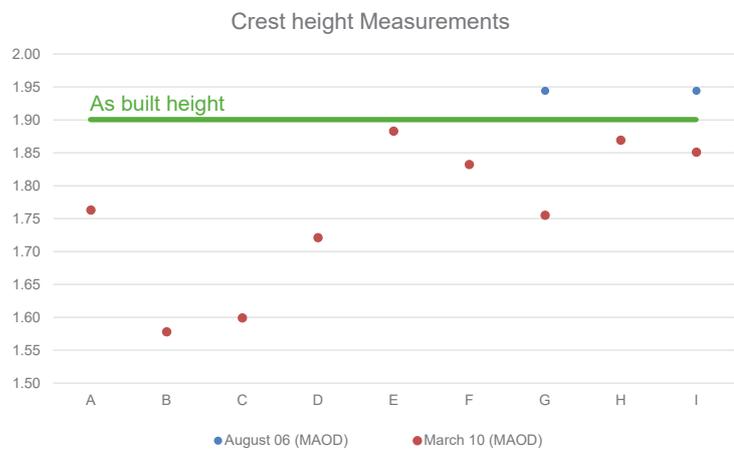
Figure 13: Survey measurement points.

- 64 Post-construction spot checks in August 2006 at two locations found pile tops slightly above this height at 1.94 metres AOD. One of these points was very close to the washout location (figure 13, point G). A survey in March 2010 found that the pile top here had sunk to 1.75 metres AOD, a settlement of almost 200 mm in four years. Other measurements shown on figure 13 demonstrate that the settlement at point G was typical of other nearby points.

- 65 No subsequent survey data of the pile tops is available after this date. However, as there is no evidence to suggest a sudden change in ground behaviour, it is probable that compression of the underlying natural soils continued between March 2010 and the day of the incident.

Chainage	Point	August 06 (MAOD)	August 10 (MAOD)
12400	A		1.76
12410	B		1.58
12419	C		1.60
12422	D		1.72
12450	E		1.88
12475	F		1.83
12500	G	1.94	1.76
12523	H		1.87
12537	I	1.94	1.85

- 83 The crest level measurements carried out by BESL from March 2010 show that some areas were below the service level of 1.7 m AOD (paragraph 64 and figure 13). These measurements were considered acceptable as the location of the measurements would not, until water levels exceeded the service level, lead to amounts of overtopping with adverse effects on settlements or property. RAIB has found no evidence that, when accepting this overtopping risk, BESL considered risk to the railway or that EA expected it to do so.

- 101 Following the flooding incident on 30 January 2022, the crest piling was re-instated along a 50 m length at Haddiscoe. The levels were checked in June 2022 and the crest height was found to be around 1.8 m AOD in the repair area.

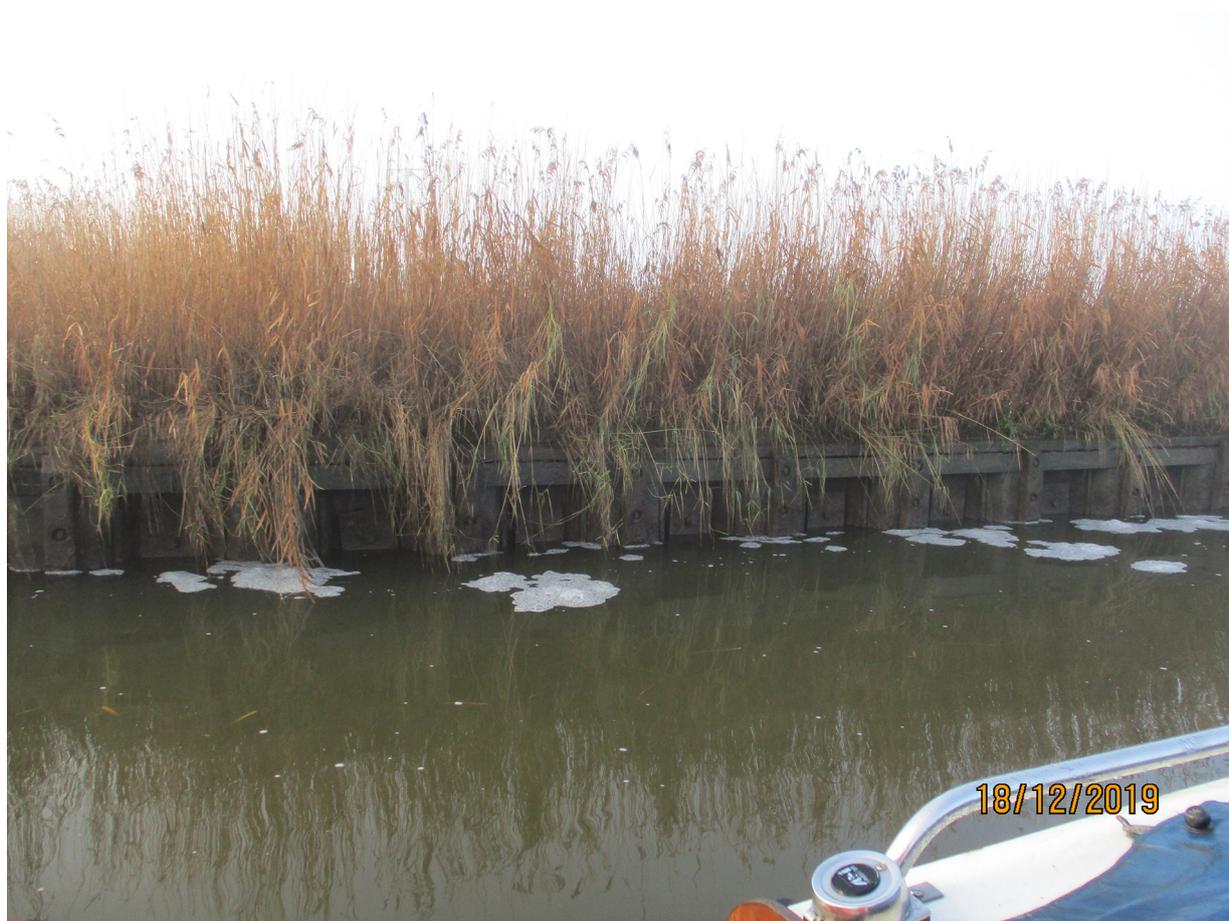
Figure 14: View from visual inspection boat (courtesy of BESL).

- 68 Visual inspections were carried out by boat and were supposed to be performed annually. BESL has stated that visual inspections can be challenging due to vegetation obscuring visibility, and minor deflections in the frontage piling being difficult to see (see figure 14). Before the incident, the last visual inspections in the area of the washout were carried out in December 2019. No deficiencies were identified, and the frontage piles and crest piles were deemed to be in good condition. Inspections were not carried out in 2020/21 for reasons recorded by EA as *'flooding elsewhere on the broads causing "complications and difficulties" and the coronavirus pandemic'*.
