## TECHNICAL ADVISORY SECTION (ROYAL ENGINEERS) (TAS(RE))

### RANGE ADVICE NOTE 8/09

#### UPDATE ON USE OF GRANULATED RUBBER

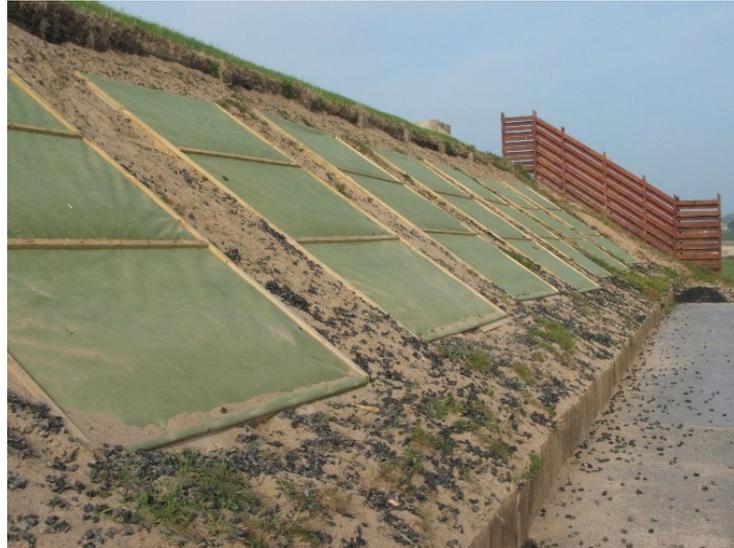
solution that allows granulate to cool after heavy range use. See photo of covers used at Penally. The granulate spill is from a time before the covers were installed.

5. Until more detail is available the advice currently in Reference A stands. This calls for granulate to be used on gallery ranges only in shooting in boxes behind the targets to minimise the impact should there be a fire (para. 0295). Reference A also advises on the use of additional fire prevention measures where tracer is used (0292d).
6. Heavy dense rubber tiles should be removed from large areas of granulate except in smaller areas of granulate such as shooting in boxes in mantlets. Light rubber or woven fabrics in timber frames to retain granulate and keep out target debris has proven a cost effective

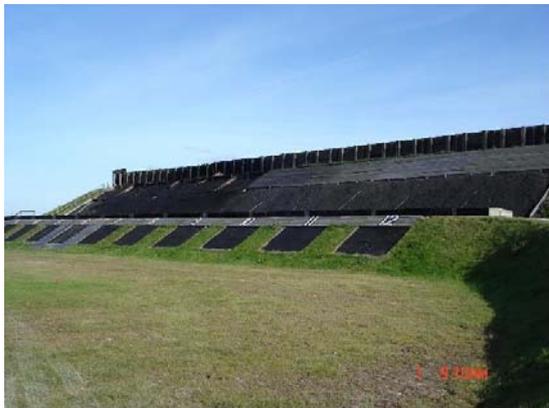
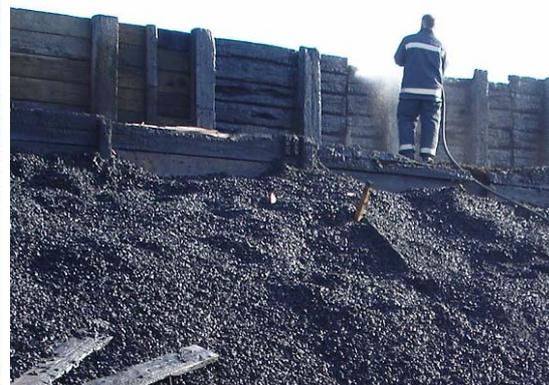
7. The fire at Strensall was in part at least caused by tracer in treated timber. Timber is being used more and more on ranges to minimise the need for grass cutting. At Strensall the timber was placed over granulate at the top of the stop butt; this allowed air to flow up under the timber that was engaged with tracer ammunition. Had the timber been set into earth or sand the outcome might not have been so drastic.

8. Heavy use ranges with large volumes of granulate and particularly those where tracer is fired should ensure that orders for the range warden include checking granulate after each days firing and if there is any sign of latent heat in the rubber, dowse with water. This precaution includes barrack ranges with granulated rubber bullet traps as well.
