TECHNICAL ADVISORY SECTION (ROYAL ENGINEERS) (TAS(RE))

RANGE ADVICE NOTE 8/09

Date 27 Oct 09

UPDATE ON USE OF GRANULATED RUBBER

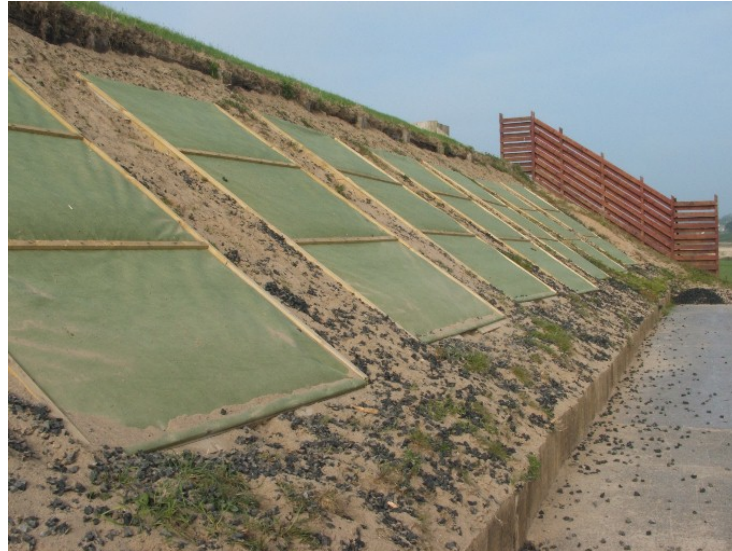
solution that allows granulate to cool after heavy range use. See photo of covers used at Penally. The granulate spill is from a time before the covers were installed.

5. Until more detail is available the advice currently in Reference A stands. This calls for granulate to be used on gallery ranges only in shooting in boxes behind the targets to minimise the impact should there be a fire (para. 0295). Reference A also advises on the use of additional fire prevention measures where tracer is used (0292d).
6. Heavy dense rubber tiles should be removed from large areas of granulate except in smaller areas of granulate such as shooting in boxes in mantlets. Light rubber or woven fabrics in timber frames to retain granulate and keep out target debris has proven a cost effective

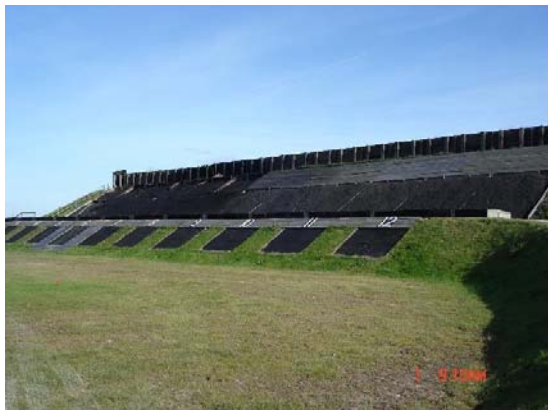
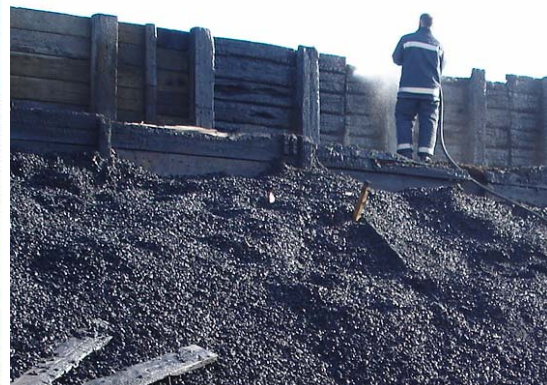
7. The fire at Strensall was in part at least caused by tracer in treated timber. Timber is being used more and more on ranges to minimise the need for grass cutting. At Strensall the timber was placed over granulate at the top of the stop butt; this allowed air to flow up under the timber that was engaged with tracer ammunition. Had the timber been set into earth or sand the outcome might not have been so drastic.

8. Heavy use ranges with large volumes of granulate and particularly those where tracer is fired should ensure that orders for the range warden include checking granulate after each days firing and if there is any sign of latent heat in the rubber, dowse with water. This precaution includes barrack ranges with granulated rubber bullet traps as well.
