DECOMMISSIONING, DISMANTLING and DISPOSAL of the MCP-01 INSTALLATION

MCP-A-RP-00009

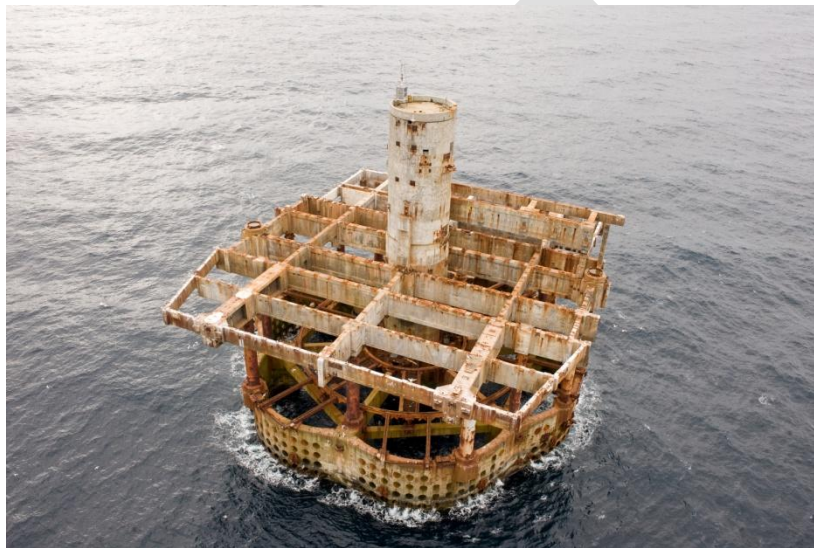
- The topside steel structure has been removed
- A concrete core cap with a Nav-Aid has been installed
- Agreed steel on the breakwater has been left in place
- All stairs and ladders from sea up to break water have been removed, as have staircases and ladders from break-water and further up to main deck.

MCP-01 - All topsides removed

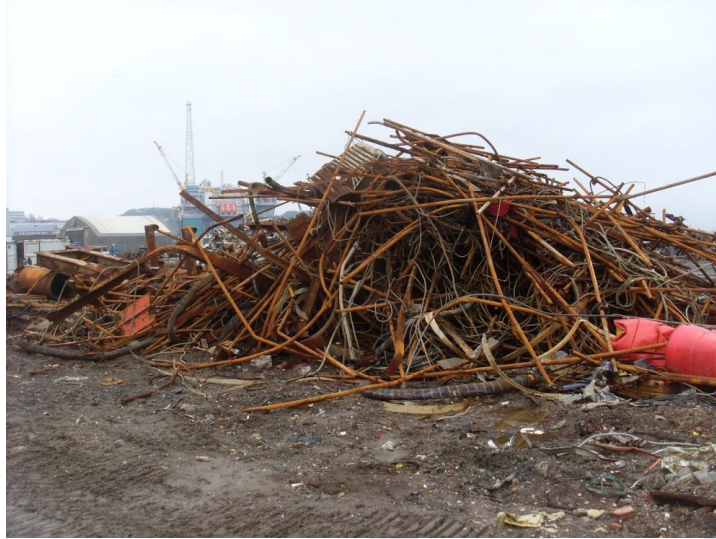
Recovered seabed debris awaiting recycling in Stord

For MCP01 the initial survey identified 164 potential targets. Ultimately, 100.2 tonnes of debris was recovered being a total of 641 individual items. Some small items, originally flagged were not ultimately recovered due to the object not being relocated in the recovery phase or having broken up when being handled by the ROV manipulator.

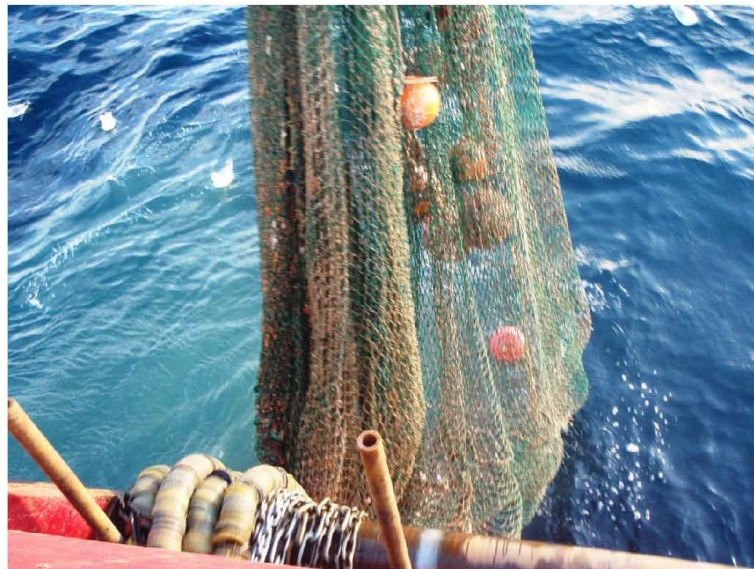
Trawling commenced at about 08:00hrs. and at 09:20hrs. the vessel came to a stop. The trawl was 'held fast'. After a short delay, the vessel moved again and the skipper surmised that the chain net had become stuck in mud on the sea bed. Three trawls were completed during the day, again following the grid pattern and recording the positioning of the vessel. When the last trawl was hauled onboard at 19:50 it was discovered that the chain net had entangled what appeared to be a complete trawl net from a fishing vessel. The net looked as though it had been on the sea bed for some time due to the organic growth on it. The assumption is that a fishing vessel had got too close to the platform and had entangled their net on the base of MCP01 and subsequently lost it.

Trawl net recovered from the sea bed around the base of MCP01

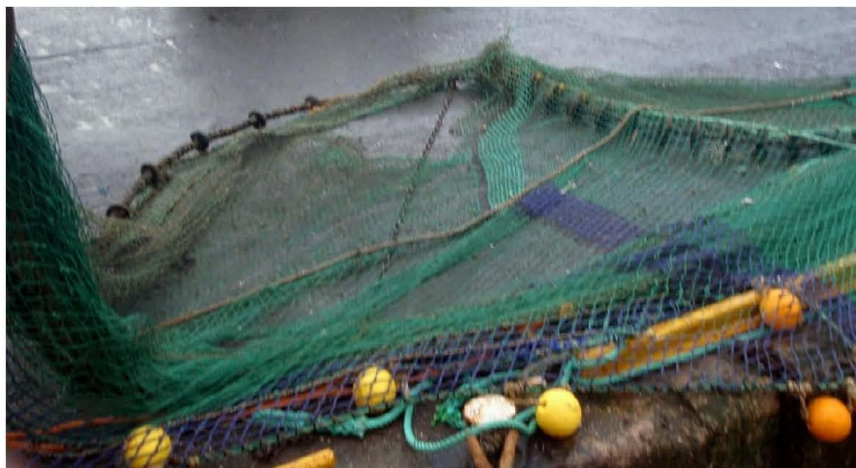
Following the three days of trawling with the chain net it was concluded that the sea bed was fairly clear of platform related debris, so the decision was taken to perform fish trawling to establish if there were fish in the area of the Safety Zone and if there were, to give an indication of the variety of species. The fish trawl was started at 08:00hrs. and hauled onboard about 11:30hrs. The trawl net showed some damage, possibly caused by platform debris or stones on the sea bed. Several varieties of fish had been caught, even though the net was damaged.

'Rebecca's' damaged trawl net on the quayside at Fraserburgh

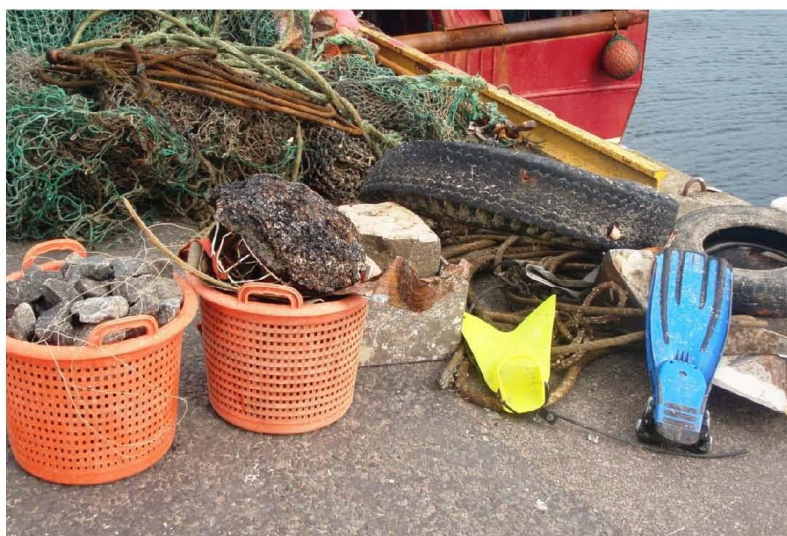
Platform debris, including stones, wire rope and diver's flippers.

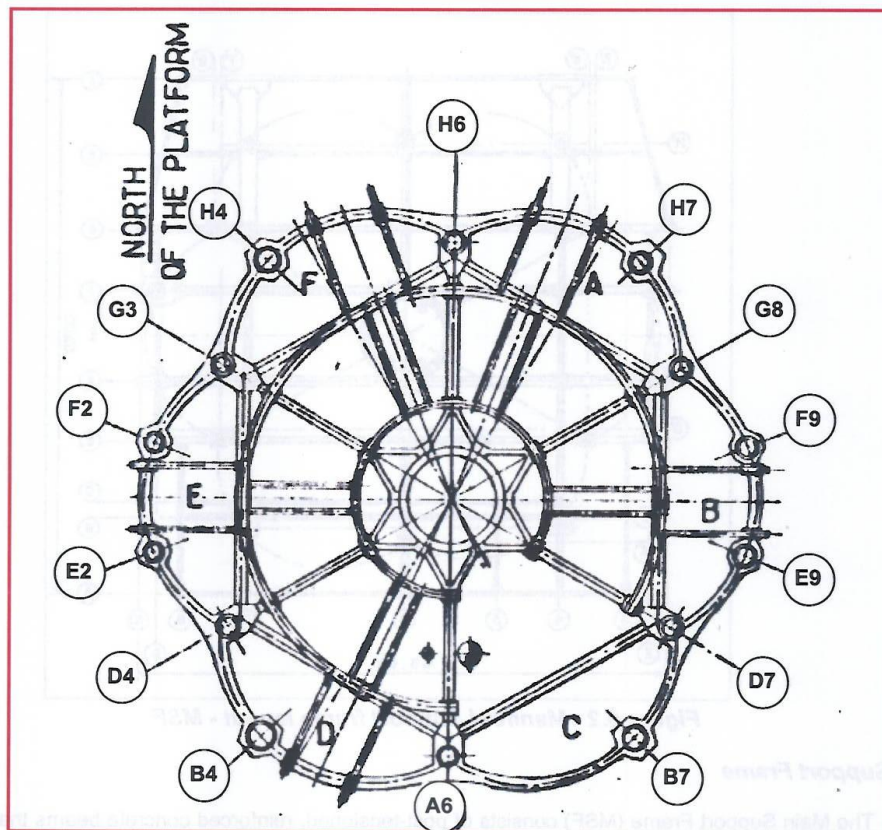
Figure 6.1 MCP01 breakwater level – Identification of Columns and Layout of Diving Rails

The 14 columns have a steel tubular outer sheath but the internal is of reinforced concrete. There is extensive corrosion evident on the steel outer but failure is not considered imminent. There were some decommissioning project lighting fittings for which the removal presented unnecessary risk. The small weight and dimensions of these meant they were left in place on the columns.
