# Estates and Facilities Alert

Ref: EFA/2011/004 Issued: 29<sup>th</sup> November 2011  
Gateway Reference: 16958

High-Voltage (HV) 11KV Switchgear –  
Schneider Electric (Merlin Gerin) Ringmaster  
RN2c, RE2c and RN6c ring main units

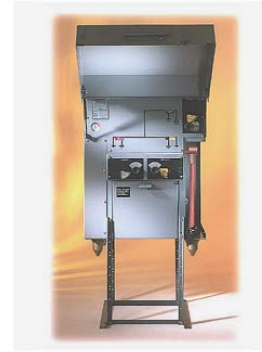
- Potential failure of the Merlin Gerin Ring Main Unit to isolate and Earth as shown on the position indicator window.
- Cable can still be **LIVE** even when switching indicator shows the switch gear in each the positions OFF and EARTH ON.

3. A bolt had failed and fallen out of the mechanism that connects the output of the mechanism to the drive shaft that controls the movement of the electrical contacts inside the switching device.

All work on this equipment or the equipment connected to Merlin Gerin Ringmaster RN2c, RE2c and RN6c switchgear shall, have at least TWO earths applied to the section being worked on.

Where two earths cannot be readily applied, isolation shall be made by additional LV and HV points of isolation shall be established, to ensure there is no single switch failure risk. In all cases, before work is carried out the cable connects to the ringmaster unit shall be spiked.
