THE NIMROD REVIEW

An independent review into the broader issues
surrounding the loss of the RAF Nimrod MR2
Aircraft XV230 in Afghanistan in 2006

Charles Haddon-Cave QC

REPORT

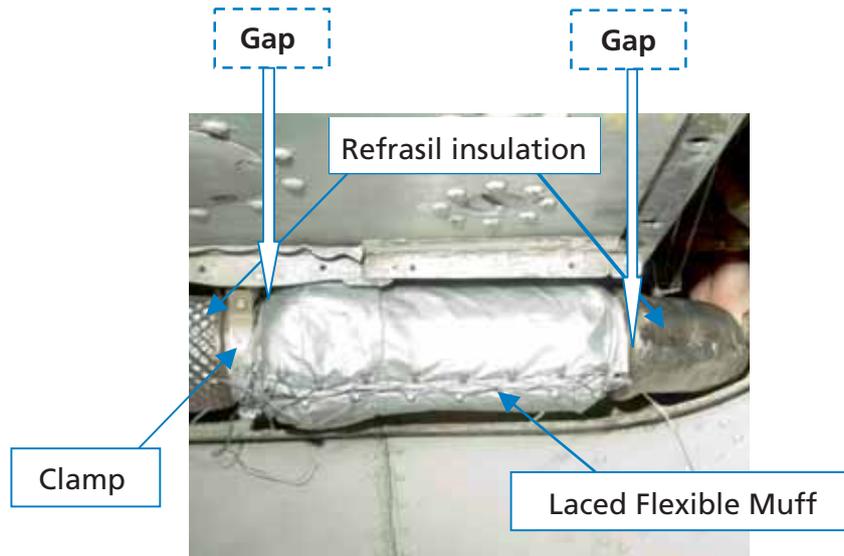
Figure 4.8: SCP Expansion Bellows – Flexible Muff (new)

mean that any attempted seal between the muff and the Refrasil will not remain complete. Even in its ‘as designed’ state, the muff cannot form a completely liquid-proof seal between the Refrasil sections.⁴⁸ This is apparent to the eye and when one pours water from a glass over it. Furthermore, the design of the SCP muff is such that, even if the laces are facing downwards, an internal flap or ‘tongue’ prevents fuel escaping once it has entered. The BOI noted a number of aircraft in which there was a gap between the Refrasil insulation and the edge of the muff (as seen below); this left a small area of ducting surface exposed, which would have been at a temperature of over 400°C when operating.⁴⁹ In some of these aircraft, the wire holding the muff was also loose, further increasing the possibility of liquid ingress (see generally Figure 4.8).

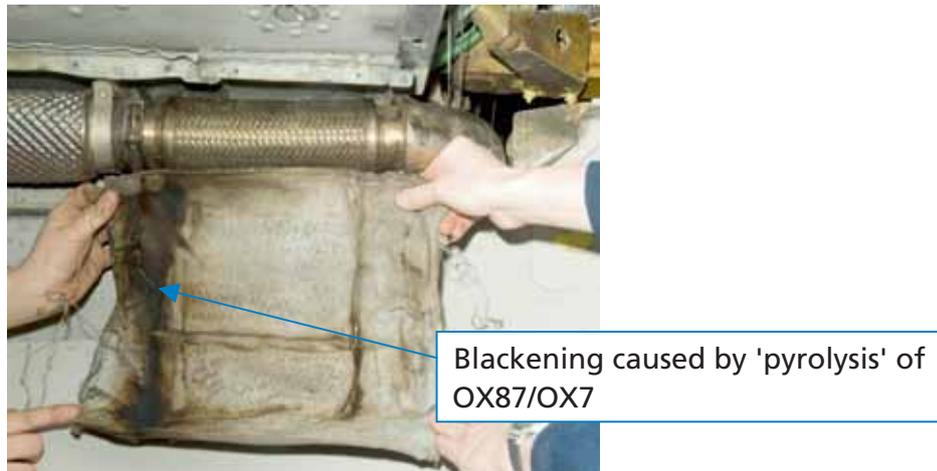
Figure 4.9: XV255 Flexible Muff

4.36 This confirms that combustible fluids can gather under the muff; both hydraulic fluid and fuel in this case. Since the SCP has not been used since September 2006, it is difficult to determine when this incident may have occurred. Regular maintenance checks of the SCP on the ground were carried out until July 2008 and would only have used low engine power settings consistent with the results of the chemical analysis. It remains a possibility that, under the normal operating temperatures of the SCP pipe experienced before September 2006, the hydraulic fluid could have been ignited, as indeed would fuel. The precise sequence of events will never be known but, in my view, it is powerful corroboration of the BOI's finding on likely ignition point and proof that fluids can, and do, enter the SCP elbow muff (see Figures 4.9 and 4.10).

Note: the muff shown on the photograph was the item taken off XV255 and shows the scorching. The part is, however, not the correct muff for this bellows and is in fact 6cm longer than the correct part. Thus, it may give the incorrect impression that the muff is designed to cover the gap between sections of Refrasil.

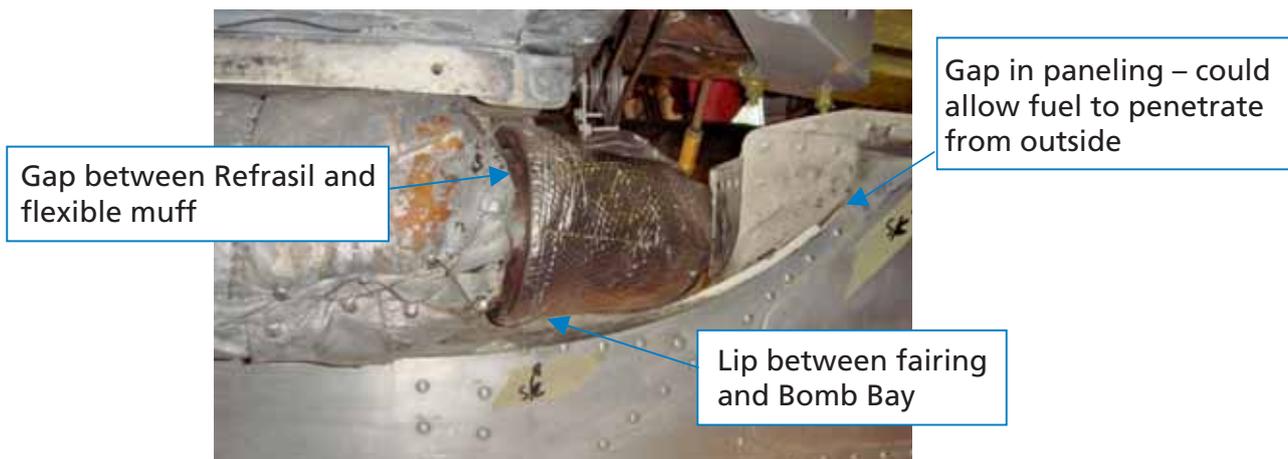
Figure 4.14: SCP Elbow

- 4.65 First, BAE Systems suggested that the muff on the SCP elbow was itself shrouded by panelling above it and any fuel dripping down from a failed fuel coupling above would not affect it. This is obviously wrong. Fuel dripping or pouring onto the SCP elbow would easily find its way into the gap between the Refrasil and the muff. This is obvious to the naked eye. It is also obvious when one pours a bit of water onto the elbow.⁷⁰ Further, the videos amply demonstrate that fuel goes everywhere in the event of a significant fuel coupling failure in this area. Second, BAE Systems suggested that fuel finding its way into the bottom of the SCP fairing would simply pour into the bomb bay. This ignores, however, the ½ inch lip which runs between the fairing and the bomb bay and would enable fuel to pool in the lower section of the fairing. It also ignores the risks of fuel pooling in the ribbed panelling above. Third, BAE Systems suggested that the distance between the No. 7 Tank Dry Bay lower panel and the elbow and muff was too great to allow a fire to propagate. However, the QinetiQ combustion experts, with significant experience in such matters, believed that the wetting of many areas by leaking fuel would provide a relatively simple path for the fire to spread (see Figure 4.14).

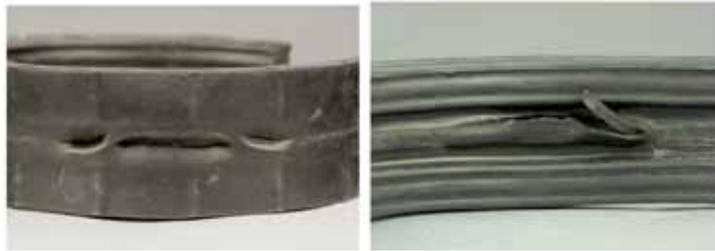
Figure 5.10: Avimo Seal Damage

XV240 inboard seal split through
 Seal exhibited deformation consistent with surrounding components
 Failure occurred in the central band, between the pipe ends

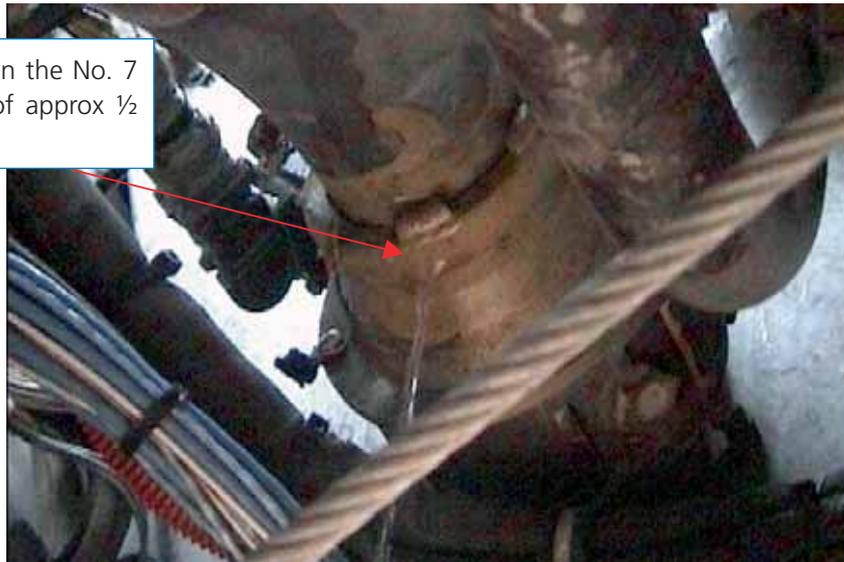
Figure 5.13: Leaking fuel coupling

Fuel leak from coupling in the No. 7 Tank Dry Bay at a rate of approx ½ pint per minute

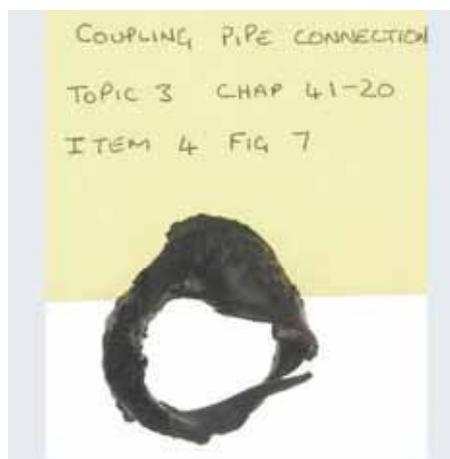
Figure 7.1: Shriveled fuel seal from XV227 showing effects of severe heating

7.48 The UI into XV227 concluded that the expansion bellows had failed due to corrosion and caused a leak of very hot bleed-air, for up to 40 minutes. Significant damage had been caused to the adjacent airframe structure and systems. In particular, the fuel seals in adjacent pipework were shrivelled almost to the point of destruction (see below). The fuel from the No. 7 tank had been used at an early stage in the flight and there was no evidence of any leakage of the small amount of residual fuel remaining in that tank. However, when fuel was subsequently transferred from the No. 7 tank, damaged seals in surrounding FRS couplings were observed to leak. One of the damaged seals is shown in Figure 7.1. Figure 7.2 shows an undamaged/unused seal. Furthermore, the minimum static reserve factor of the aircraft’s rear spar had been reduced by approximately 25%, *i.e.* below the level which *“is normally accepted for safe unrestricted operation of the aircraft”*.⁶⁰ Indeed, as stated above, the damage to the aircraft was so serious that it was subsequently cleared for one flight only *“in clear and calm conditions”*,⁶¹ with restrictions applied to its operating envelope, in order to re-locate to BAE Systems Woodford, to join the MRA4 programme.
