PART 1.4 - FINDINGS

1. Given the technical nature of the accident involving ZG792, the Panel elected to present a chronological description of its findings. A modified version of the James Reason model is then subsequently used to categorise the various factors identified by the Panel.

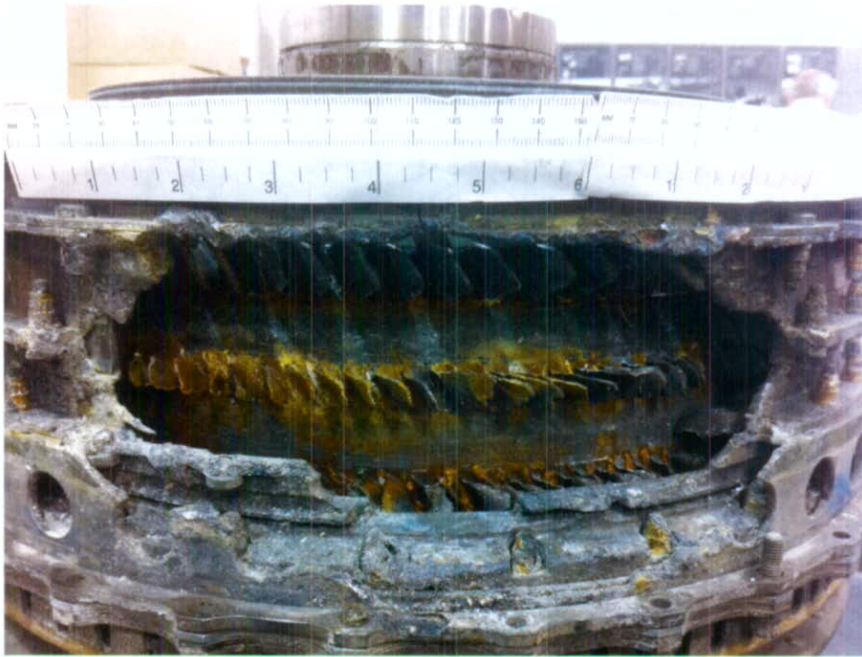
Figure 1 - HPC Casing Damage

7. **Right engine examination.** Following initial interviews with the crew of ZG792, the Panel focussed its initial investigation on the right engine. On recovery, it was found to be approximately 1 meter shorter than its original design length and debris from the ac intake was found in the LPC stage; both of which were attributable to impact damage with the sea. Evidence of burnt wiring looms were evident and clear evidence of breakout was found in the HPC casing, as shown in Figure 1.

breach of the HPC casing as shown in Figure 1 were found to be molten in appearance. This type of breach with molten edges is typical of a Ti fire. The Panel are of the opinion that debris, which had originated as a consequence of the initial failure, became lodged in the stage 2 stator vanes, overlapping into the stage 3 rotor blades path and was caught on each blade as it rotated. Titanium ignites at a lower temperature than it melts and has a low conductivity of heat. Hence, heat will not have been readily conducted away from the initial source and the titanium components will have rapidly risen in temperature to the ignition point. Ti fires are fast burning with a high heat intensity and contain molten particles. In-service experience shows that the time taken between the start of a Ti fire and breakout of the engine casing on Tornado can be in the region of 2 to 3 seconds. Given the damage observed, it is highly probable that molten particles found in the Ti fire burned through the compressor casing resulting in a radical expulsion of molten or incandescent metal which originated from the HPC.

11. **Breakout.** Analysis of the engine examination indicated that there was a breach in the HPC casing, the Combustion Chamber Outer Casing (CCOC) and the by-pass duct. The Panel concluded that the Ti fire containing molten particles which originated in the HPC, burned through the CCOC and then the by-pass duct. The breakout location was in the region of the engine main and reheat fuel lines, highlighted in Figure 2. Optical pyrometer lines which run through the breakout area were recovered with fire damage to the outer braiding, supporting the conclusion that the fire broke out of the engine outer casing. The Panel were unable to locate the main fuel supply line, however 2 segments of the reheat fuel supply line were recovered originating from the breakout area; the material in the centre of this area, the direct path of the Ti fire, was not recovered. On examination of these segments, perforations in the pipeline wall and evidence of fire damage on both internal and external surfaces were found. Deposited titanium was also discovered on the pipeline outer surface. Hot spots were identified on both pipe sections; further sectioning revealed cracks emanating from the hot spots. Given the available evidence, the Panel considered a number of possible scenarios that may have caused the fuel line rupture:

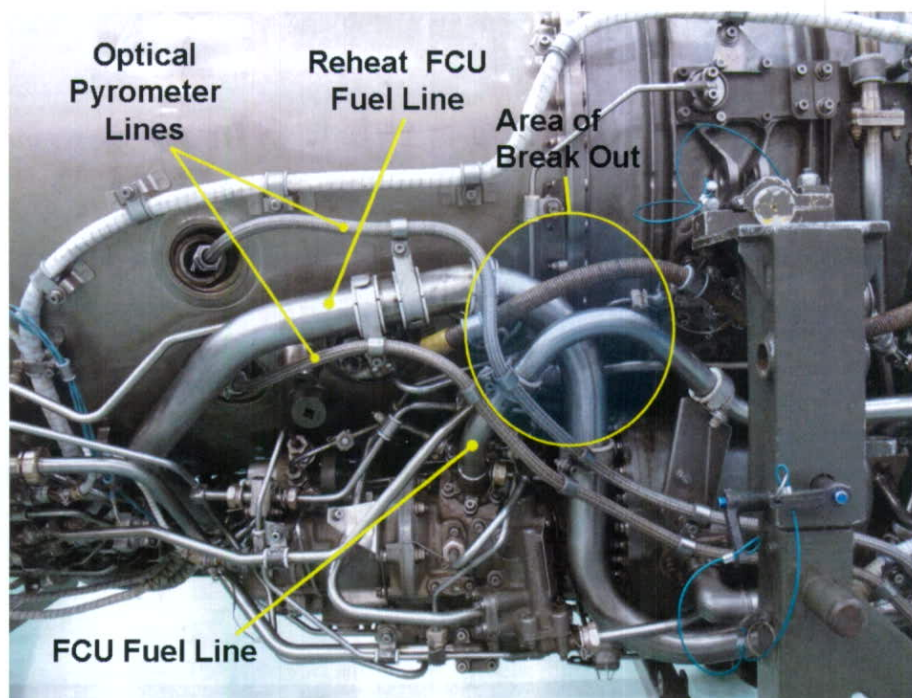
Figure 2 – Area of breakout indicated on a serviceable engine

- a. The Ti engine fire may have penetrated outboard to the reheat fuel line causing it to rupture at a hot spot.
- b. Violently ejected heated material impacted the fuel line causing failure at a hot spot.
- c. Violently ejected material impacted the fuel line causing overload failure.

The Panel could not positively determine the exact cause of the fuel line failure.

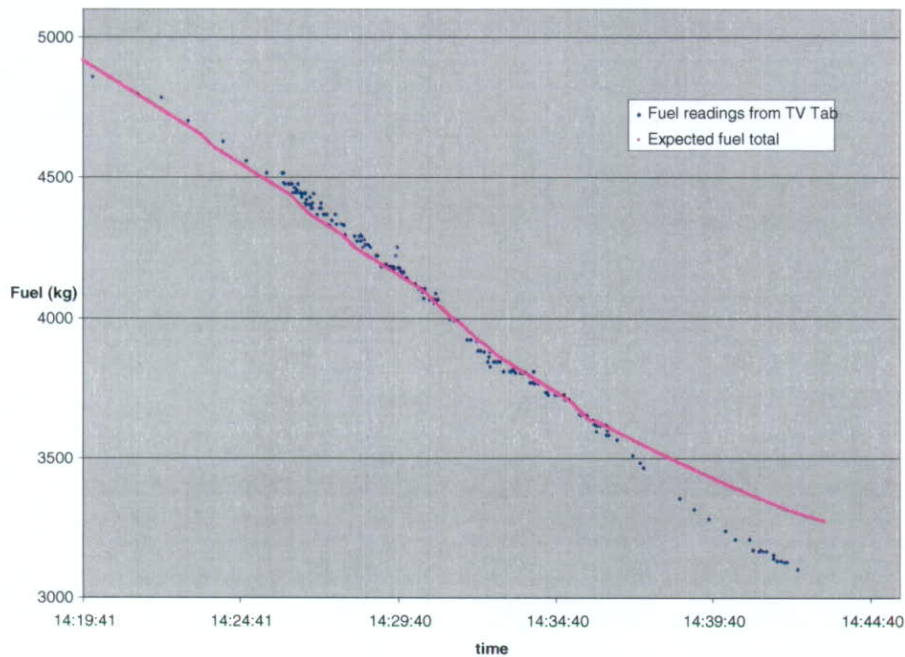
Figure 3 - Predicted and actual fuel use

Figure 3 shows the predicted and actual fuel usage from 1420:00 (T-15:46) onwards, covering the low-level portion of the sortie, through the initial point of the Mech fail at 1435:46 (T0:00) through to 1442:23 (T6:37) of the accident sequence, which is the last usable fuel figure available from the VRS.

13. Figure 3 clearly shows that the fuel usage rate is as would be expected in normal flight up until the initial point of the Mech fail. From T0:00 onwards, however, the predicted and actual fuel usage rates diverge, with approximately 200kg more fuel being used than would have been expected. This can be more clearly represented in Figure 4, which shows the time from T0:00 onwards. This graph shows 2 predicted fuel lines, one calculated from the previous figures, and the other showing the calculation worked backwards from the last known fuel totals. The delta between the lines represents the fuel discrepancy of approximately 200-250kg.

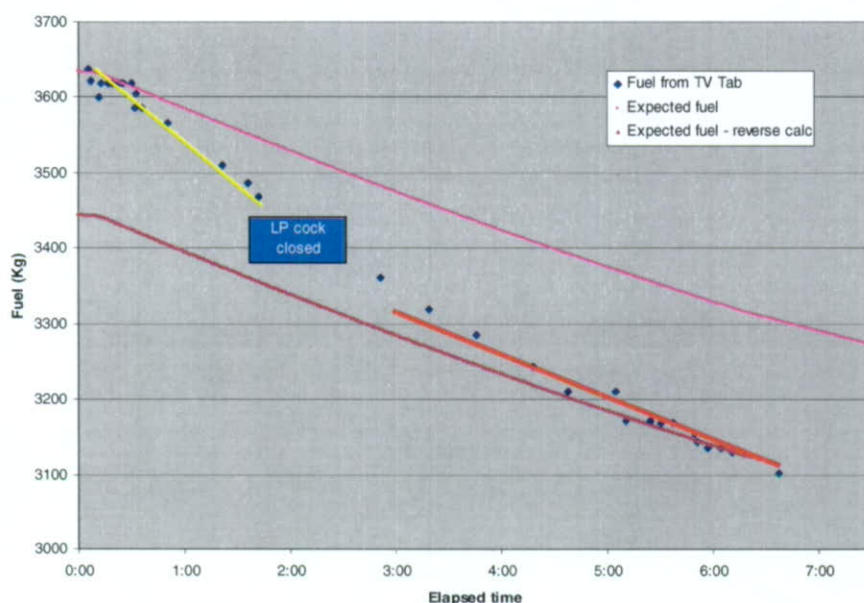
Figure 5 - Fuel Flow graph - LP Cock closure at T1:00 theory

The rate of fuel flow can be drawn at the rate shown in Figure 5. The actual fuel usage shown in this figure indicates that the majority of the abnormal fuel usage occurred in the early stages of the accident sequence. This theory is supported by the evidence of fuel pooling found in the right engine bay door, which suggests fuel pooling fed the left engine fire. In this presentation, by approximately T3:00 the fuel usage rate had returned to that expected of an ac running with one engine at max dry in the same flight conditions as CACTUS 2 prior to the ejection. Allowing some time for the fuel figure to catch up with the correct fuel total and for the fuel already in the pipe downstream of the LP cock to leak, the Panel concluded that if this theory is correct, the pilot closed the LP cock at some point around T1:00 just before he pressed the fire buttons.

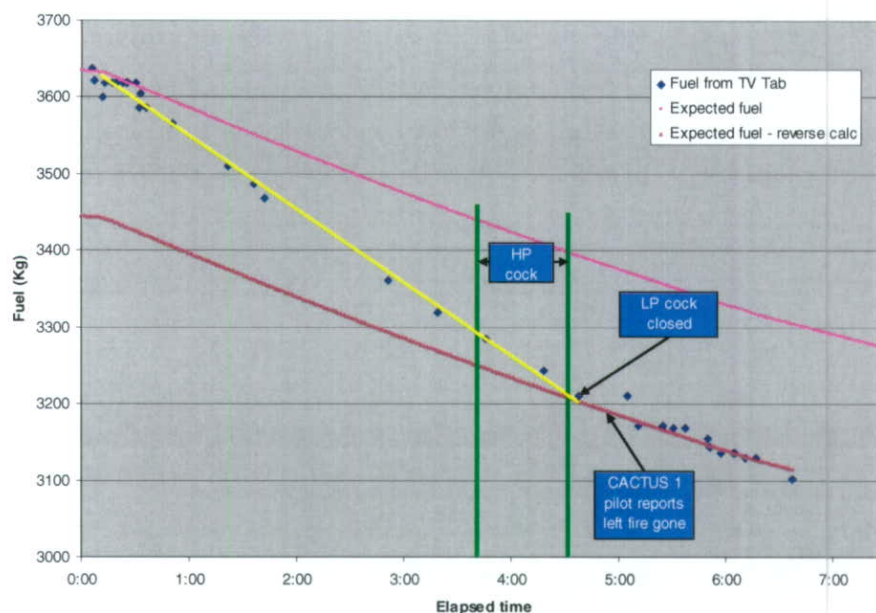
Figure 6 - Fuel flow graph - LP Cock closure at T4:30 theory

The average rate of fuel flow can also be drawn as in Figure 6. This shows that the actual fuel consumption is relatively constant up until the point the re-light is aborted, implying a steady and continuous leak. Had the LP cock been left open, it is possible that any damage sustained by the main and reheat fuel lines could have been the continuous source of fuel into the right engine bay. It is possible that, in the confusion that the pilot felt during the initial stages of the accident sequence, he omitted to shut the LP cock as his natural flow would have been interrupted by the emergence of the L FIRE caption. During interviews with the Panel, the pilot stated that the onset of the L FIRE caption happened just as he closed the HP cock on the right engine. He used this to explain how his drills had become delayed. However the Panel was able to ascertain from R-ADR data that there were 8s between closing the HP cock and the onset of the L FIRE caption. Whilst it may be reasonable to expect the pilot to have spent some of this time observing the right engine instruments (to ensure the engine was correctly winding down) it could not explain this process taking 8s. The Panel opined that there was sufficient time in the 8s gap, between HP cock shut and L FIRE, to have made the selection of LP cock shut. Although the pilot commented that he completed most of his drills silently, he actually verbalizes more than he recalled. During the initial onset of the emergency he verbalizes all his diagnosis and his actions (such as selecting 25° wing sweep). He also verbalizes the action of closing the HP cock (T0:38), and confirms this action when it is complete (T0:43). Later on during the emergency, at T2:25, he further runs through his actions with the crew of CACTUS 1. He states that he has shut down the right engine, the cross drive has closed and then, at T2:40, that he had pressed both fire buttons. At various stages throughout the emergency he verbalises every one of his actions, apart from the shutting of the LP cock. This action is not mentioned at any stage in the emergency. When the pilot attempts to relight the engine at T3:40, a few seconds after opening the HP cock (T3:44) the Panel believe

the crew received a R TBT caption, audible on the CVR and reported by the WSO at T3:58. The Panel could not rule out the possibility that this caption was spurious; however, we determined it was also possible that the R TBT caption may have been an indication of fuel flowing back into the engine and igniting. This action would have required the LP cock to have been open, yet in his formal interview the pilot stated that he did not re-open the LP cock at this stage. The pilot abandons his relight attempt at approx T4:34. At this stage it is possible that after closing the HP cock the pilot now shut the LP cock, as per the Mech fail IA drills. 20s later, at T4:53, CACTUS 1 reported that there were no more visual indications of fire, indicating that there was no longer fuel feeding the fire.

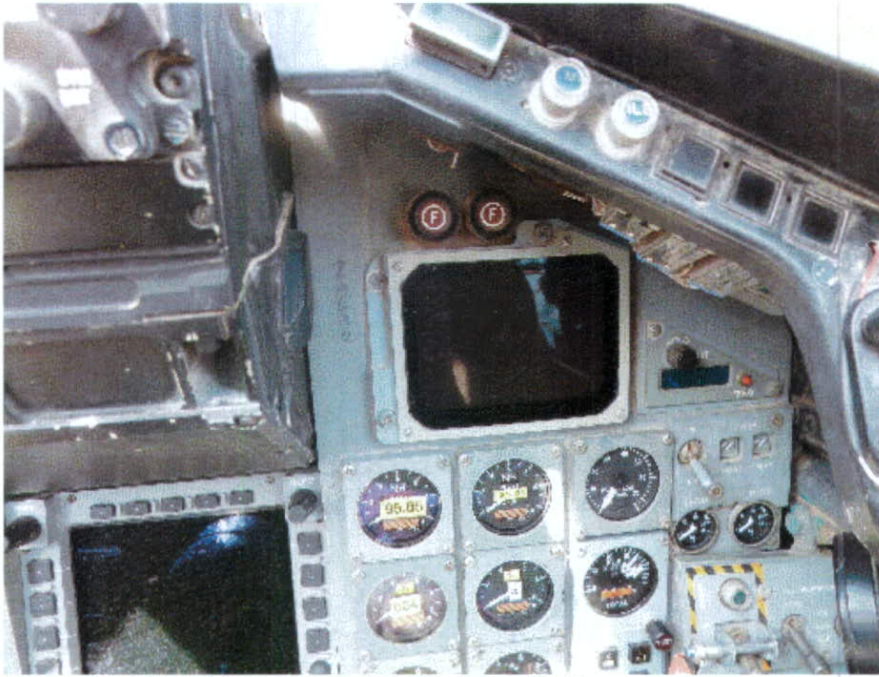
Figure 7 - Fire buttons on right side of cockpit

17. **GR4 cockpit ergonomics.** In his formal interview the pilot stated that he had pushed both fire buttons with his left hand. Given the position of the fire buttons (see Figure 7) this would have been an unnatural hand to have used. The LP cocks are positioned on the left side coaming of the cockpit, just below eye-level but both easily accessible and obvious (Figure 8). Had the pilot only operated the fire buttons the Panel believed it would have been more natural to have used his right hand (Figure 10). However, if his left hand was already available from having just closed the LP cock, the Panel reasoned that it would be understandable to use the same left hand to reach across and push the fire buttons (Figure 11, Figure 12). This would speed the process up and avoid the pilot having to swap hands on the control column. The fact that the pilot used his left hand to activate the fire buttons suggested that he may have previously used it to close the LP cock. Just prior to receiving the L FIRE caption, the pilot initiates a right hand turn. This action would have required a positive control input from him. Given that the Panel believe the pilot actioned the fire button press during the turn, it is also possible that he failed to close the LP cock but used his left hand as his right hand was occupied flying the ac. The HF report also alludes to the fact that this unnatural use of his left hand could have made the omission of the LP cock more likely, as his use of the left hand may have convinced him that the action was done. The Panel was unable to determine which of these sequences was correct.

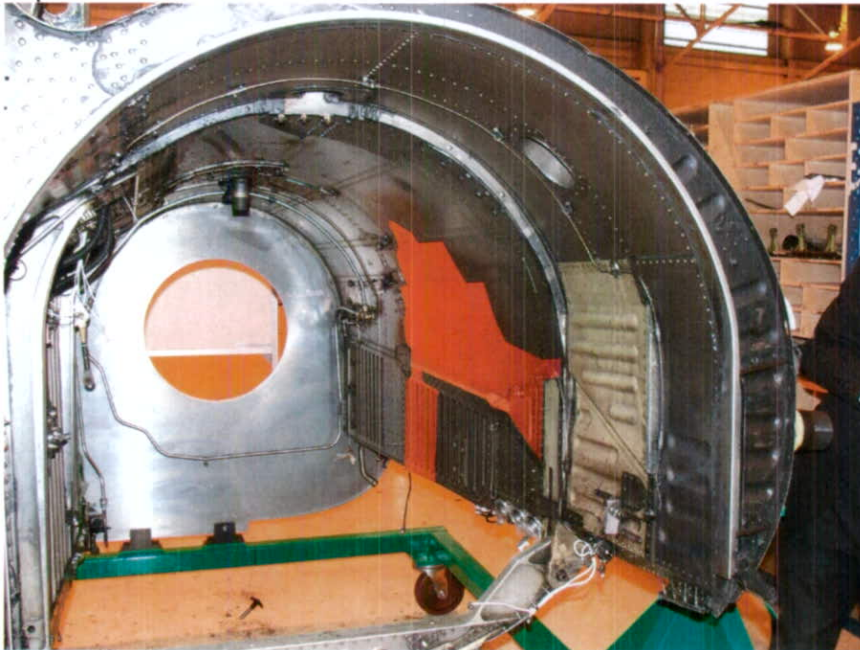
Figure 15 - Representative area of right firewall recovered

intense fire reached in excess of 635°C and destroyed much of the aluminium structure on the engine bay doors, on which a large section of the fire wire is mounted. It is therefore highly likely that the fire wire was damaged, resulting in intermittent warnings, and then final failure. Ongoing investigation by MilAAIB aims to engage with the fire detection system manufacturers in order to assess the effects of fuel cooling on the fire wire and the effects of radiated heat on the controller.

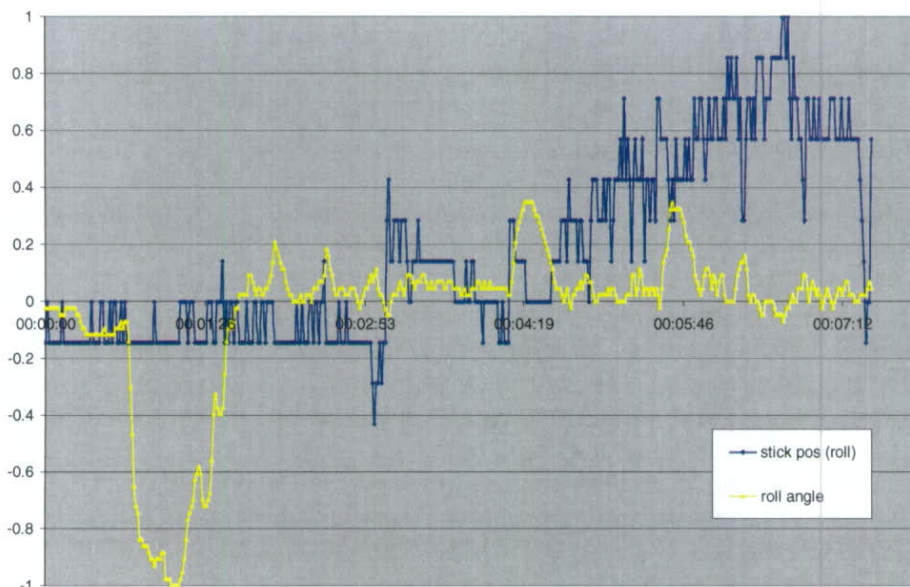
Figure 16 - Normalised lateral control data (+ve = right)

30. **Control degradation.** Sections of right taileron control rods were discovered in the wreckage. Examination of these showed that they had failed whilst the material was soft and under load, suggesting that they had been damaged by a fire in the equipment bay. As discussed previously, the Panel can confirm that the temperature within the hydraulic bay areas reached at least 635°C. All mechanical control rods in this area are manufactured from an aluminium alloy, which has a melting point of approximately 650 °C. This alloy would begin to start losing its material properties at approximately 530°C, suggesting that the rods in this area gradually deformed as the fire and heat intensity increased. In his interview, the pilot described how, in the later stages of the emergency, he felt the ac develop a tendency to roll to the left. This was controllable initially, but he feared a total loss of control was imminent and thus decided to eject. The R-ADR lateral control parameters show clear evidence of the increasing right control column inputs. Figure 16 shows the stick position and roll angle throughout the accident sequence on a normalised scale. At T5:00 the stick position moves progressively further to the right, despite the ac remaining roughly wings-level.

Given the pilot's recollection of events shortly before ejection and the data displayed in Figure 16, the Panel conclude that there was a gradual loss of control of the right taileron, as the mechanical control rods deformed due to heat damage. This gradual loss of control ultimately led to the decision by the pilot to eject.
