PART 1.3
NARRATIVE OF EVENTS

1. RAF Tutor aircraft G-BYUT and G-BYVN of the University of Wales Air Squadron (UWAS) No 1 Elementary Flying Training School (EFTS) departed MOD St Athan on the morning of 11 Feb 09 to conduct Air Experience Flights (AEF) for 2 Air Training Corps (ATC) cadets. An earlier sortie corroborated that the weather forecast and conditions in the local flying area were good, with visibility in excess of 10 km and very little cloud. The Volunteer Reserve (VR) pilot of G-BYUT was an experienced ex RAF Fast Jet (FJ) pilot and he sat in the primary (right hand) seat with the cadet in the left hand seat. The pilot of G-BYVN was awarded his wings upon graduation from RAF Linton-on-Ouse in Nov 08 and was waiting to commence FJ trg at RAF Valley; he also occupied the right hand seat with the cadet in the left hand seat. The aircraft took off at 1037Z and 1038Z with G-BYUT ahead and maintained a separation of approximately 1 min during a standard visual departure to the west. Radar trace recordings confirm that both aircraft adhered to the published procedure, making radio calls at Nash Point, a local visual reporting point, and then continuing west until clear of the

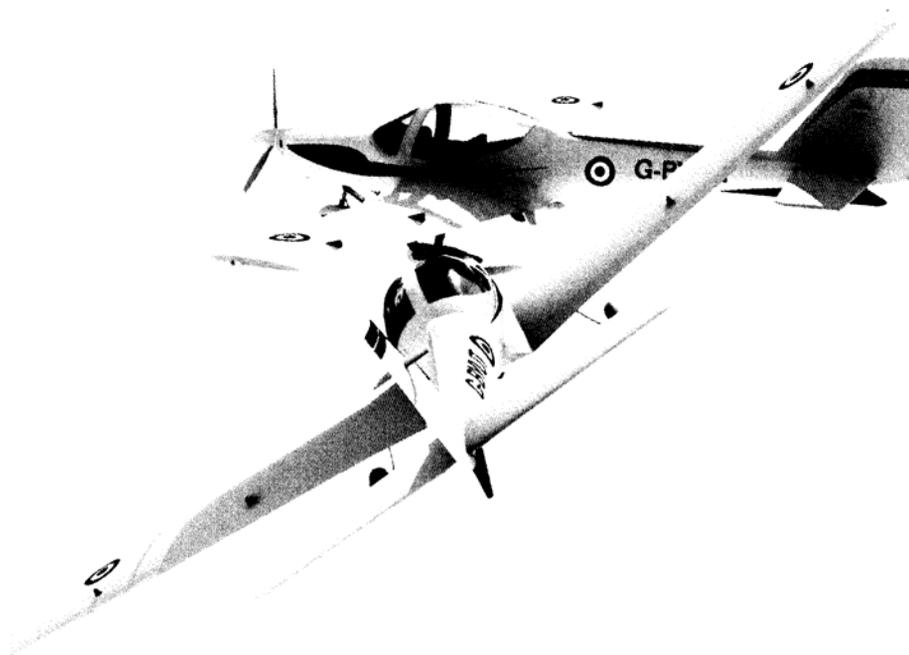
to be G-BYUT maintaining a moderate angle of left bank which brought the nose area of G-BYUT into contact with the left main gear of G-BYVN and the right wing of G-BYUT striking the tail of G-BYVN. The Panel concluded that only the engine of G-BYUT would have been substantial enough to bend the sprung-steel port undercarriage leg of G-BYVN, which is corroborated by a rubber scuff mark on G-BYUT's blade root and counterweight and the separation of its propeller blades during the mid-air collision. The undamaged outboard section of G-BYUT's starboard wing helps to establish an orientation that accounts for the inboard section of the starboard wing connecting with the fuselage of G-BYVN. The estimated collision orientation is depicted in the diagrams below but it must be recognised that this static representation does not portray the dynamic element of the collision:

Figure 3. Collision orientation: starboard wing of G-BYUT impacting rear fuselage of G-BYVN.

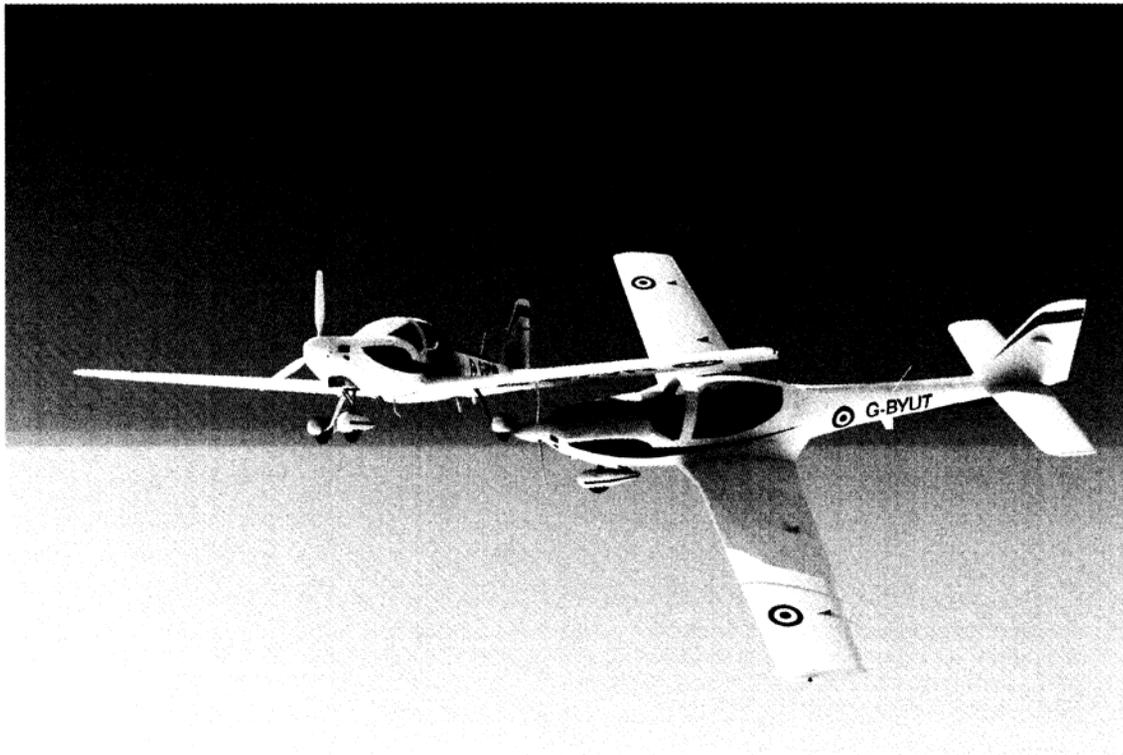
Figure 4. Collision orientation: nose of G-BYUT impacting port main wheel of G-BYVN.

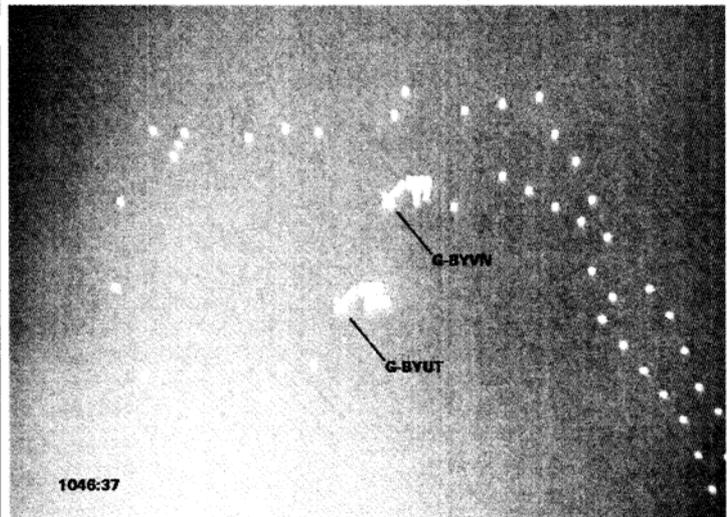
Figure 7. Screenshot of Cardiff radar approximately 6 secs prior to collision.

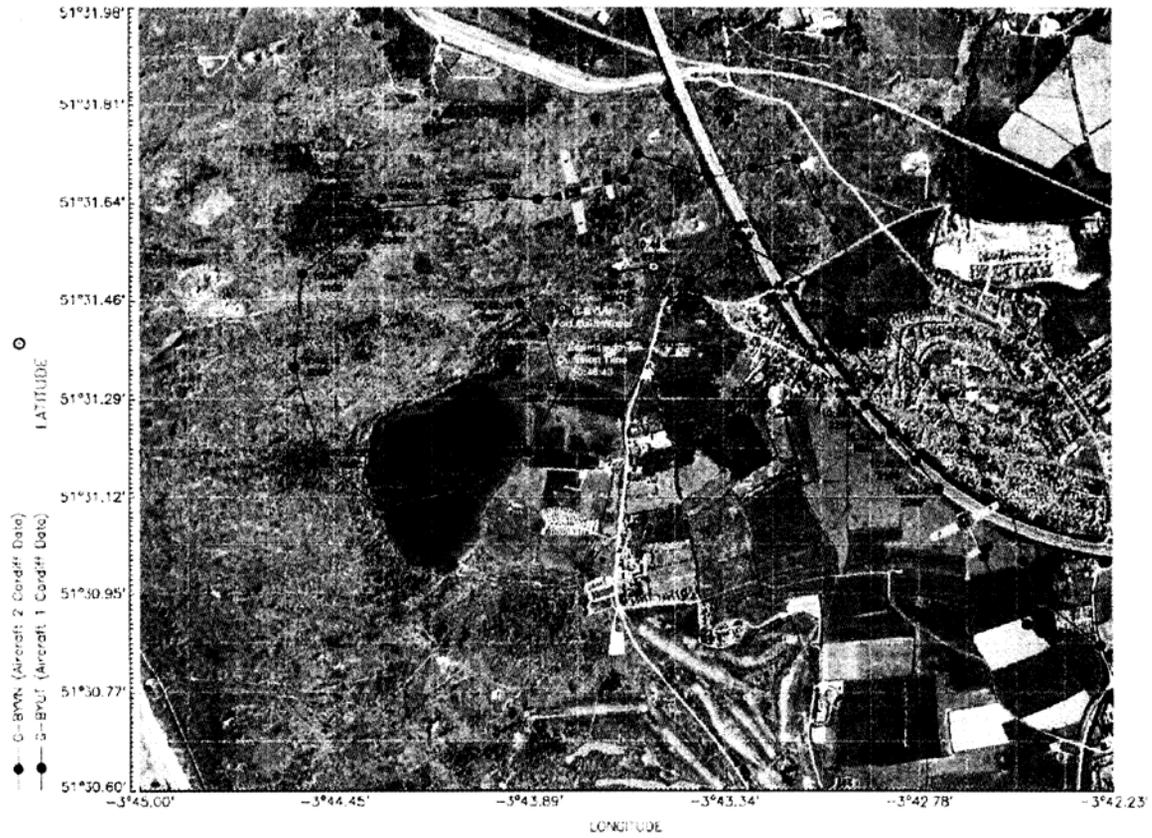
Figure 9. Screenshot of the QinetiQ GDAS plot of the Cardiff radar returns.

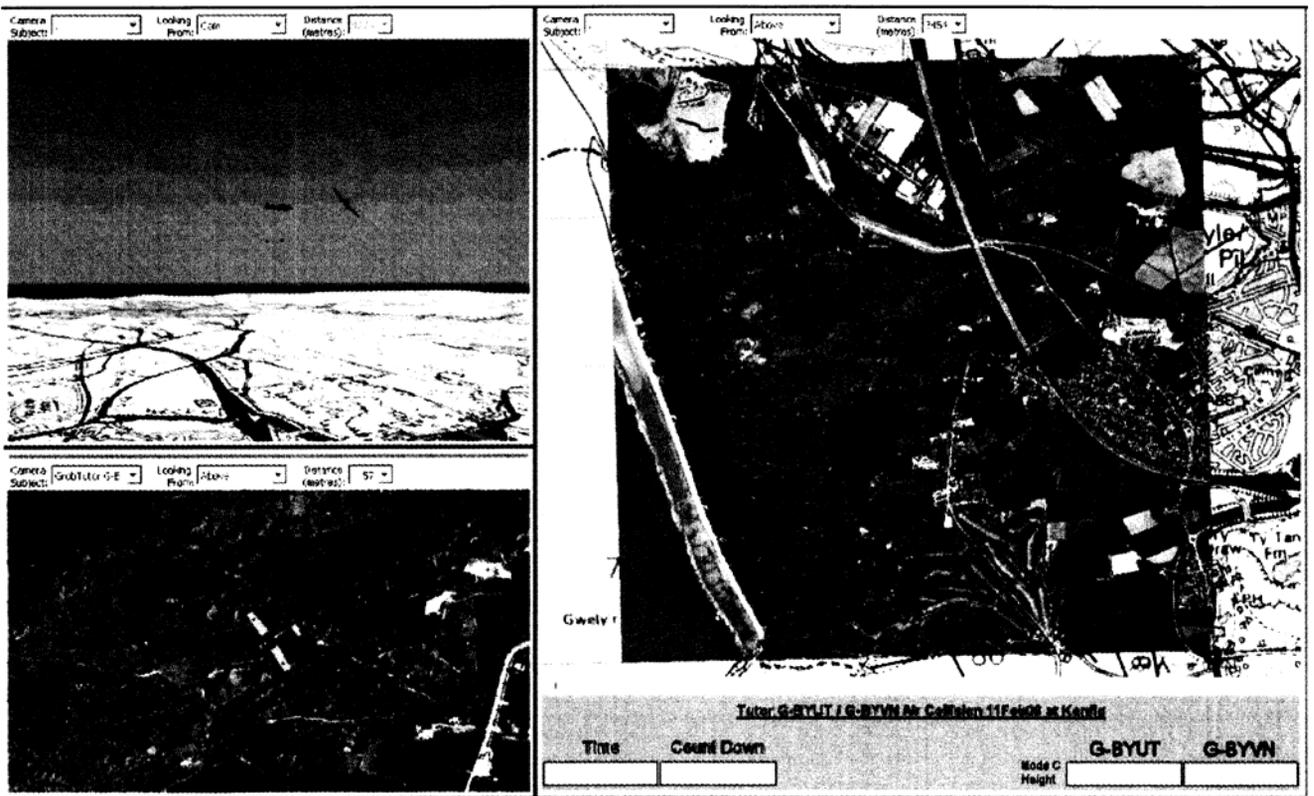
Figure 10. Screenshot of the QinetiQ GDAS modelling of the collision profile.
