Lessons from historical dam incidents

Project: SC080046/R1

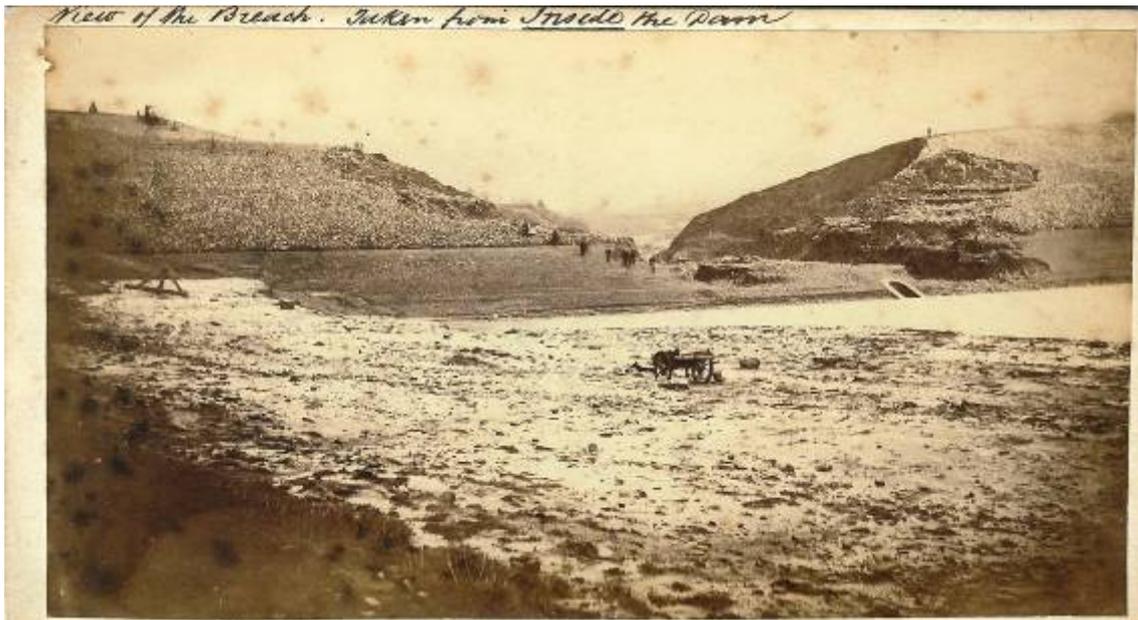
However, the cause or causes of the disaster have continued to be disputed (Binnie, 1978). It has, however, been established that the core was susceptible to hydraulic fracture.

Figure 2-3 Postcard photograph of the Dale Dyke dam breach (courtesy of C Hoskins)

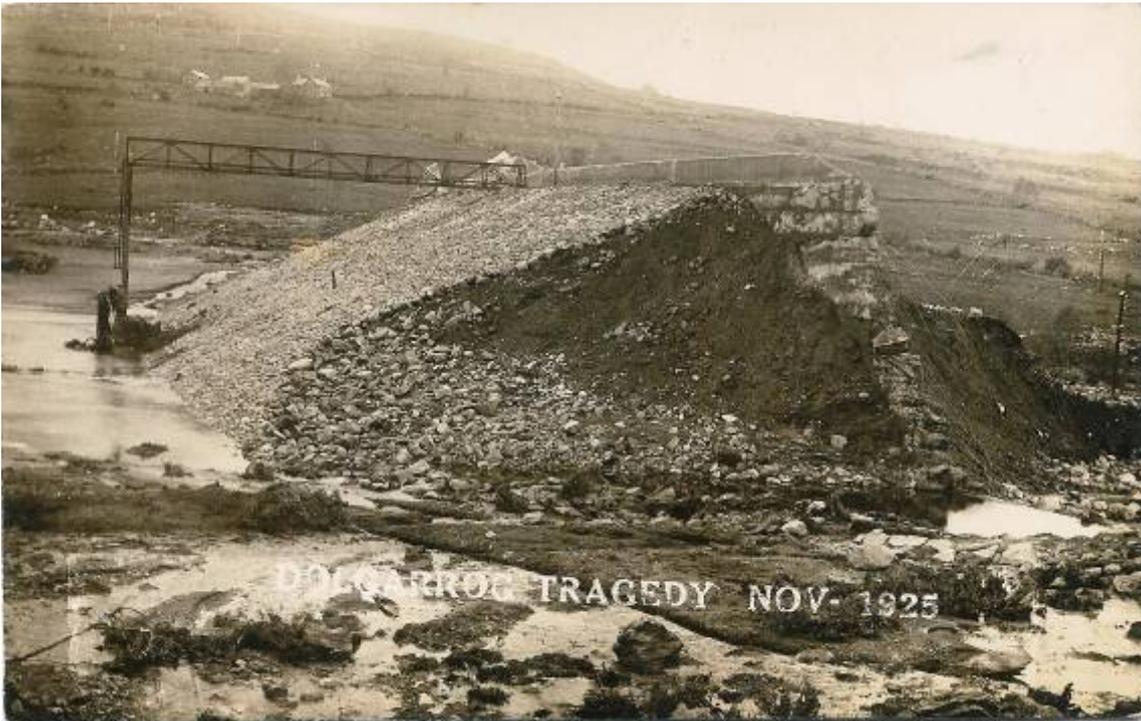
On 2 November 1925, the remote concrete Eigiau dam collapsed, where it was only five metres high, due to a blow-out of the lower part of the dam wall at a point where there had been a seepage path for several years. The reservoir water was released and surged into the nearly full Coedty reservoir below. The 11-m high Coedty dam had been constructed in 1924 with earthfill shoulders supporting a central concrete core wall. When the dam was overtopped, the material supporting the core wall on the downstream side was washed away and the core wall collapsed. Sixteen people were killed in Dolgarrog by the resulting flood. Technical evidence at the inquest was given by Ralph Freeman to the effect that the foundation of the dam had not been sufficiently deep. The jury returned a verdict of accidental death "*caused by the bursting of the dam under the wall in consequence of the wall lacking a proper foundation.*" The coroner's jury recommended regular government inspection.

Figure 2-4 The breach in Coedty dam (courtesy of Chris Hoskins)

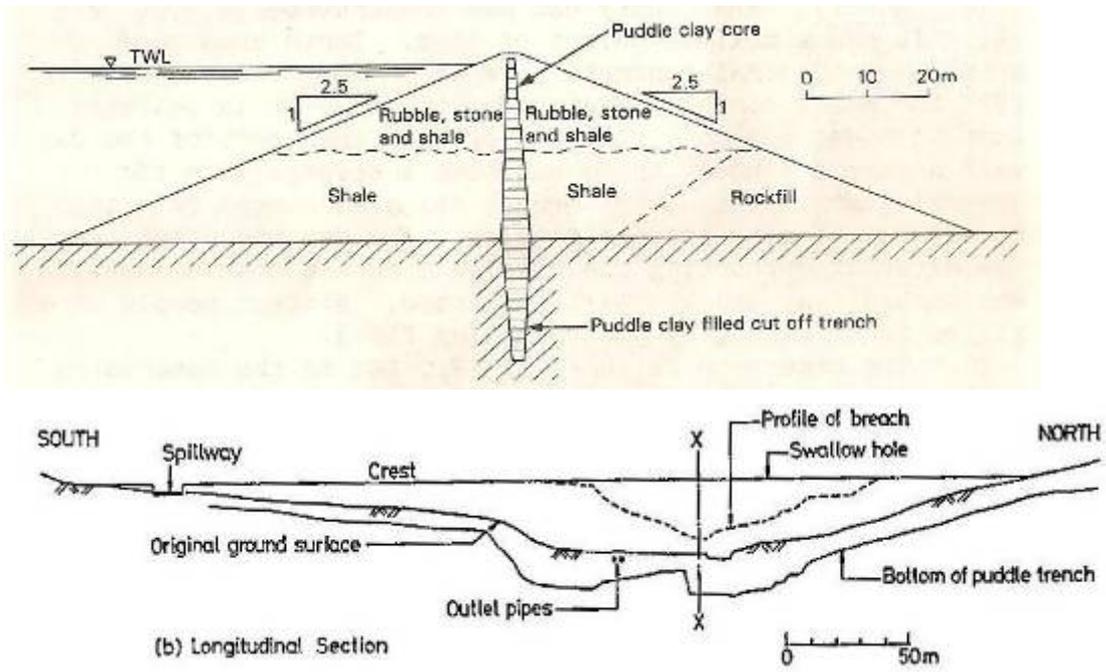
Figure 5-4 Cross-section and longitudinal section of Dale Dyke (after Skempton, 1989)

The dam was rebuilt in 1875 about 300 metres upstream of the failed embankment.

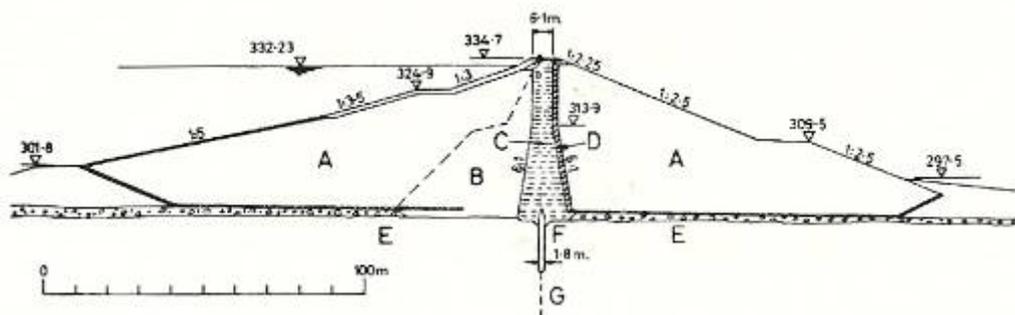
It was concluded that the leakage at Balderhead was initiated by hydraulic fracture. The narrow width of the core may have been a contributory factor leading to hydraulic fracture. The maximum hydraulic gradient across the core was approximately three, which is less than at other rolled clay core dams.

Figure 5-5 Cross-section of Balderhead dam (after Vaughan *et al.*, 1970)

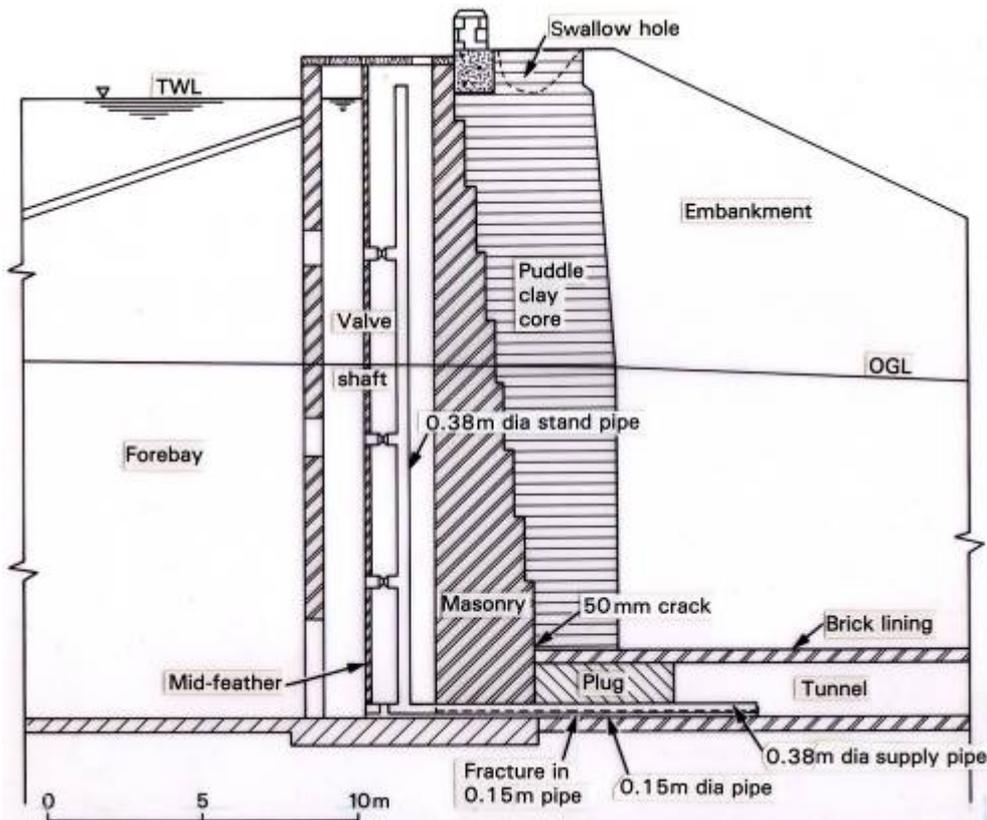
Figure 5-6 Section through the valve shaft at Llest Wen dam (after Little 1977)

It was established that reservoir water pressure had extruded puddle clay from the core into the outlet tunnel, firstly through a 5-10 mm wide gap at the junction between the downstream wall of the valve shaft and the tunnel lining, and then via a 150-mm drainage pipe leading from the base of the valve shaft through the tunnel plug, the pipe having parted and fractured at the junction. At the time there was a 0.06 m³ pile of puddle clay at the end of the 150-mm pipe.

With the emergency over, grouting of the core was undertaken involving 50 tonnes of clay cement grout. A subsequent borehole investigation found the puddle clay to be soft to very soft with pockets of silt or sand (Little, 1977; Twort, 1977). Many open fissures, iron-stained by the passage of seepage water, were also present. The core was very soft in the vicinity of the valve shaft. In view of these findings, it was decided that grouting alone could not be relied upon and a 0.6 m thick plastic concrete diaphragm wall was constructed. The diaphragm wall was built through the core over the full length of the dam in 4.8-m panels. The wall penetrated the bedrock by between one and four metres, the maximum depth being 34.8 m. Falling head tests on drill holes into the wall gave a permeability value of 1×10^{-8} m/s.

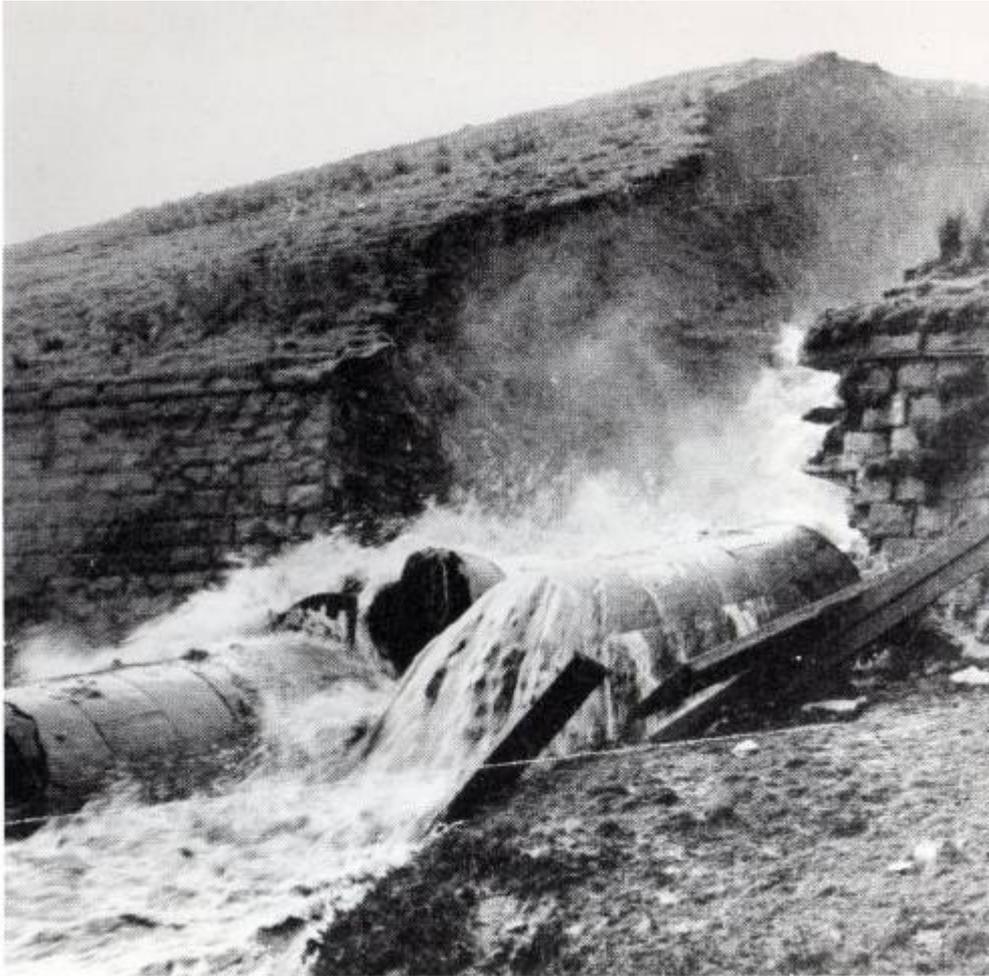
As far as is known, the embankment had performed satisfactorily for 100 years before the incident. Construction of a new draw-off tunnel through the embankment very likely provided leakage paths along the tunnel. Tunnelling always reduces the stresses adjacent to the tunnel to zero, which may have led to hydraulic fracture between the lining and ground. Annulus grouting will not necessarily re-establish sufficient earth pressure to prevent hydraulic fracture. This internal erosion incident shows the speed with which this type of failure can develop, and emphasises the need for careful monitoring and interpretation of seepage flows. Remedial works to embankment dams need to be carefully designed and executed with full understanding of how the work could change the behaviour of the dam in terms of stress changes and stability.

Figure 5-7 Breach of the embankment along the line of the recently constructed draw-off tunnel at Warmwithens (from *Engineering Now*, No.4, December 1970)

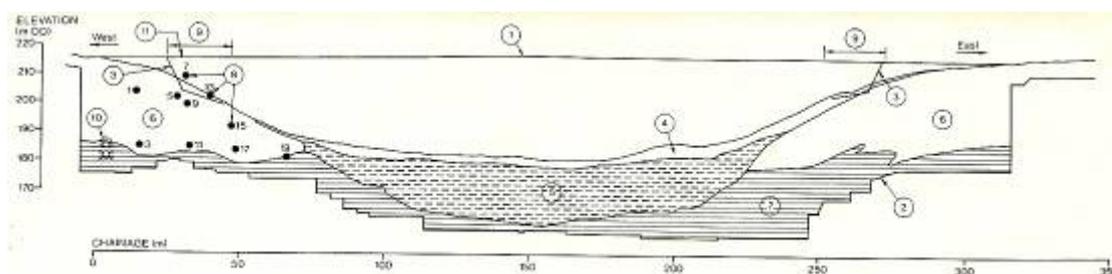
The downstream fill and/or the adjacent abutment were not able to behave as a filter to halt erosion. However, it took some 20 years from the end of construction for the internal erosion to manifest itself as a visible defect, although settlements were noticed 14 years after construction.

Figure 5-8 Simplified longitudinal section show geology of Greenbooth dam showing steep abutments and location of depression (after Flemming and Rossington, 1985)

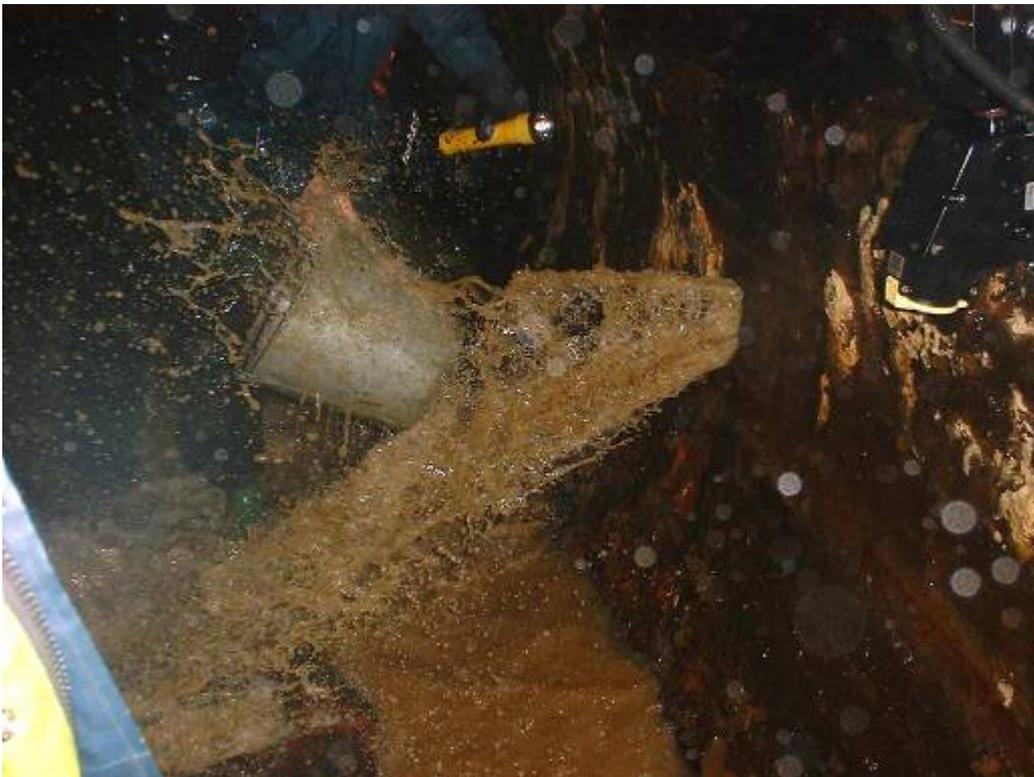
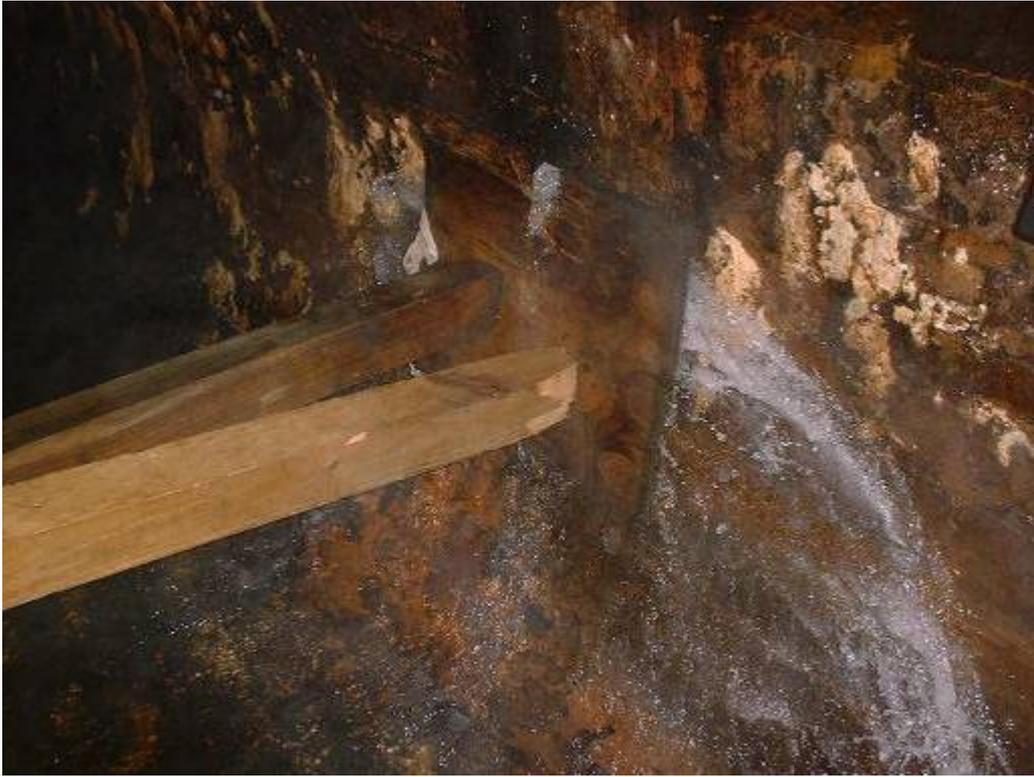
Figure 5-11 Leakage in the draw-off culvert at Yarrow embankment and temporary plug (after Gardiner *et al.*, 2004)

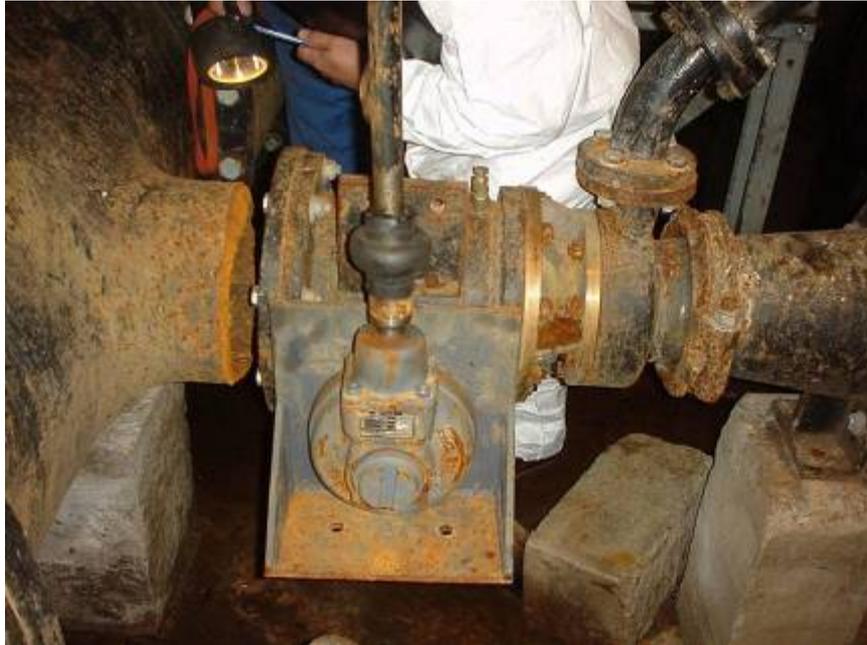
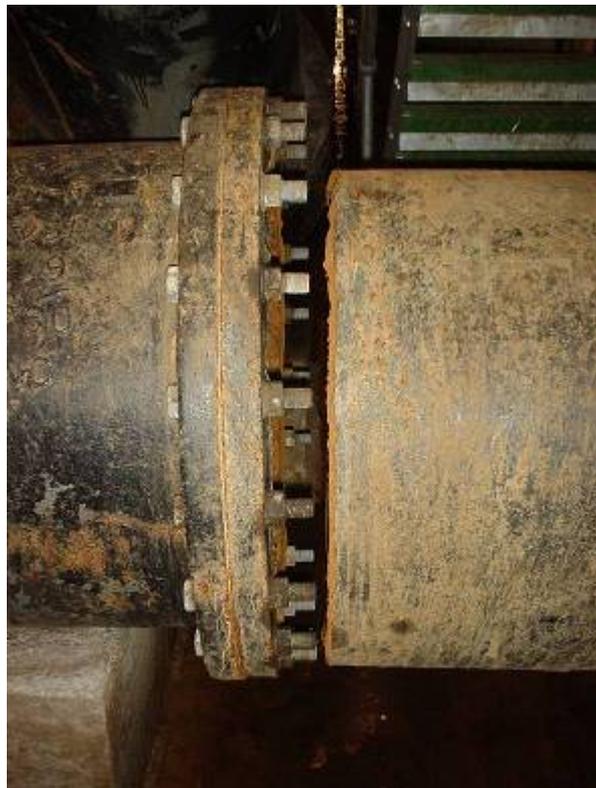
Failure was caused by fitting an inappropriate valve and undersize gearbox for the required duty and configuration. Engineers should understand how various valves work and consider their modes of failure. A Larner Johnson streamline valve incorporated into the scour pipework was replaced with a butterfly valve. A key feature of the Larner Johnson valve is that it can handle high flow velocities. The basic operating principles of the valve are described by Reader *et al.* (1997) and Lewthwaite *et al.* (2008). In the case of butterfly valves, failure of the connection between the gate and gearbox will lead to sudden closure and possible generation of high surge pressures. Grey cast iron pipes and fittings are brittle and are therefore susceptible to fracture from sudden surge pressures or impact loading.

Figure 5-12 Fractured compensation pipework (above) and fractured 30-inch (769-mm) diameter scour pipe (below) adjacent to bolted flanges (after Hughes *et al.*, 2004)

If valves are difficult to operate, seek out the reason why rather than reverting to more force.

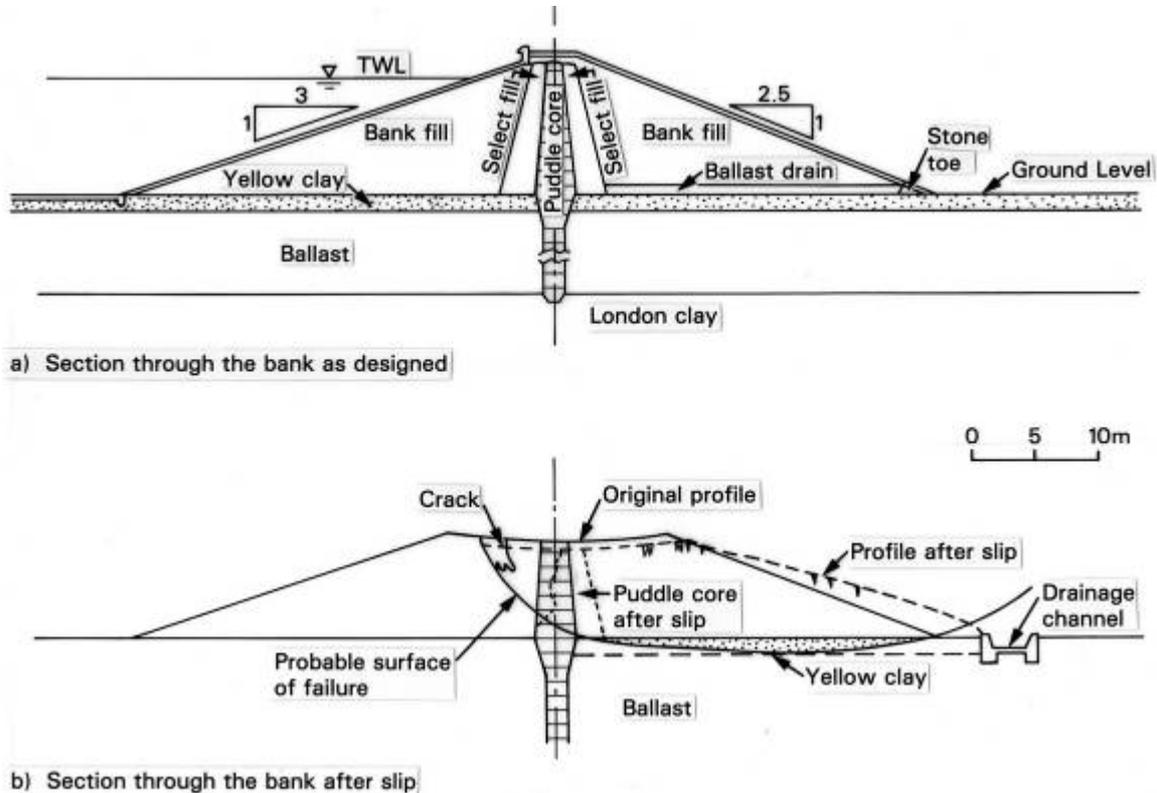
Figure 5-13 Shear failure during the construction of Chingford embankment (after Coosing and Golder, 1942)

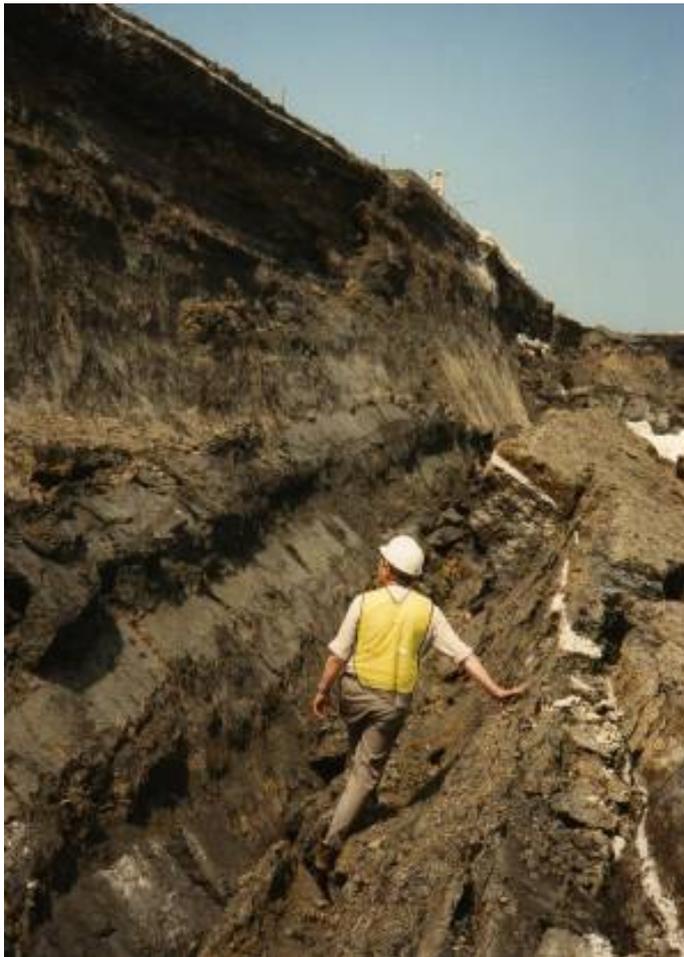
A similar rotational failure occurred at Acu dam, Brazil in 1981 during construction which was due in part to the core shape.

Figure 5-15 Failure of Carsington dam

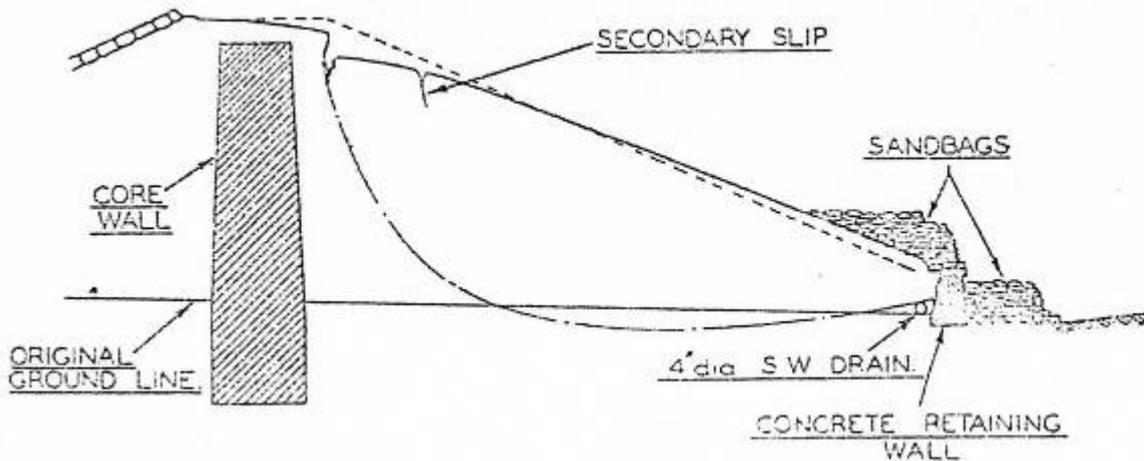
Figure 5-16 Section through the major slip at Harlow Hill (after Davies, 1953)

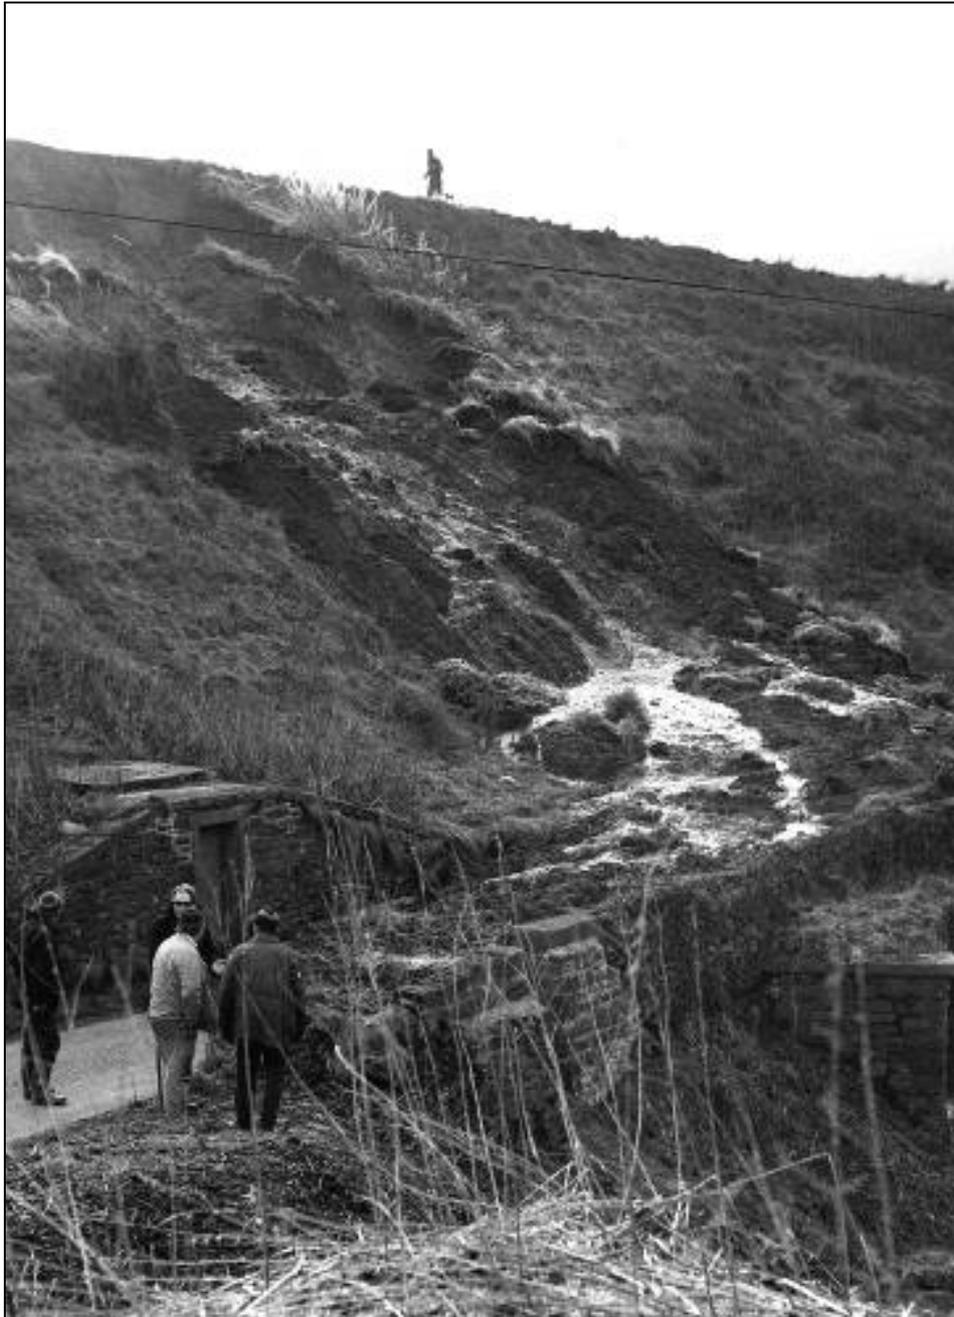
This incident provides another case of marginal slope stability at a dam which had behaved satisfactorily for 150 years; a major slope instability was waiting to be triggered by some event. In this case, a combination of water being forced by wave action through cavities at the base of the masonry wave wall and spray being blown over the wave wall resulted in the localised saturation of the downstream slope and ice forming on the slope. The cavities had not been identified despite regular inspection and maintenance.

Figure 5-17 The downstream slip at Combs dam (after Dutton, 2001)

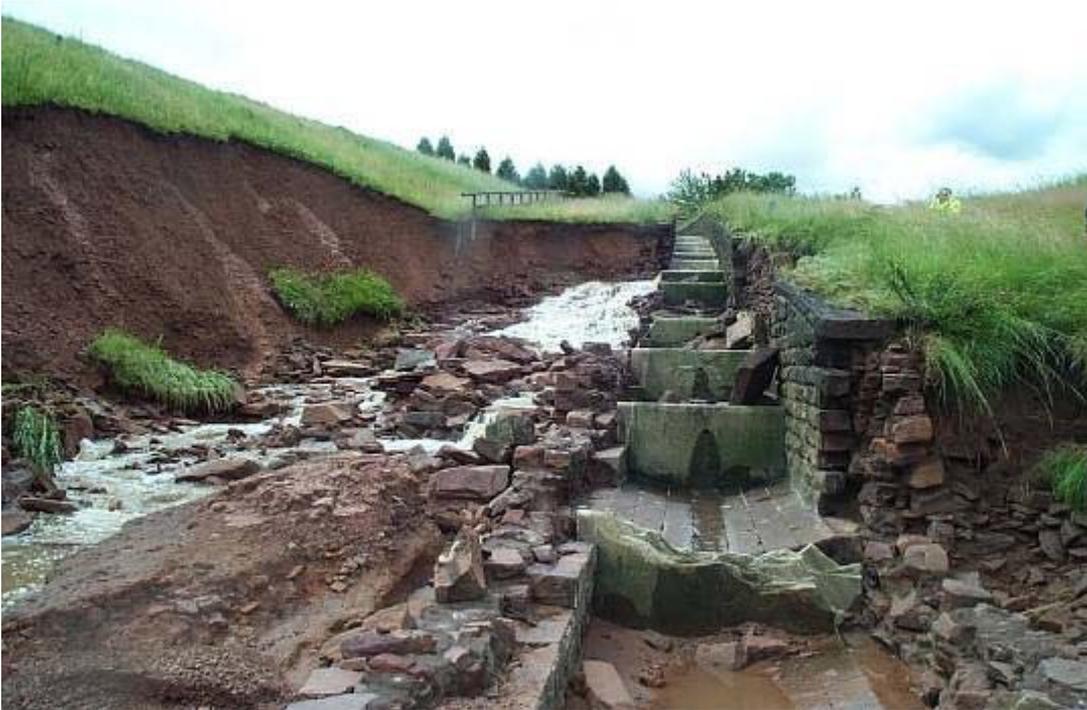
Figure 5-18 View of collapsed stepped masonry spillway and adjacent erosion of embankment fill at Ulley dam

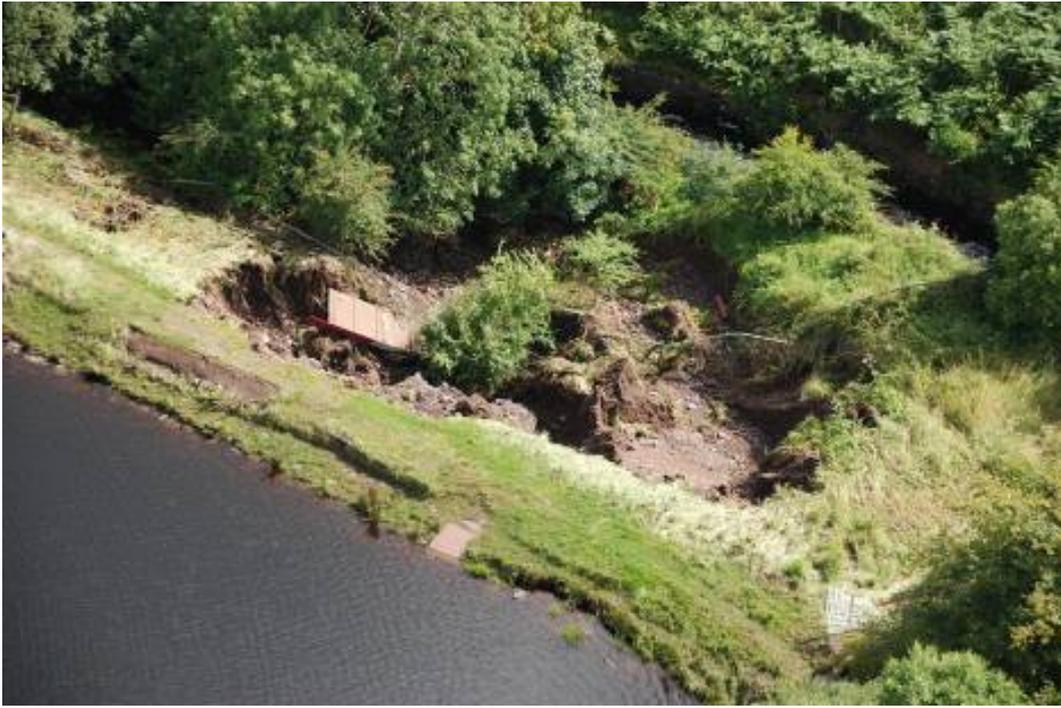
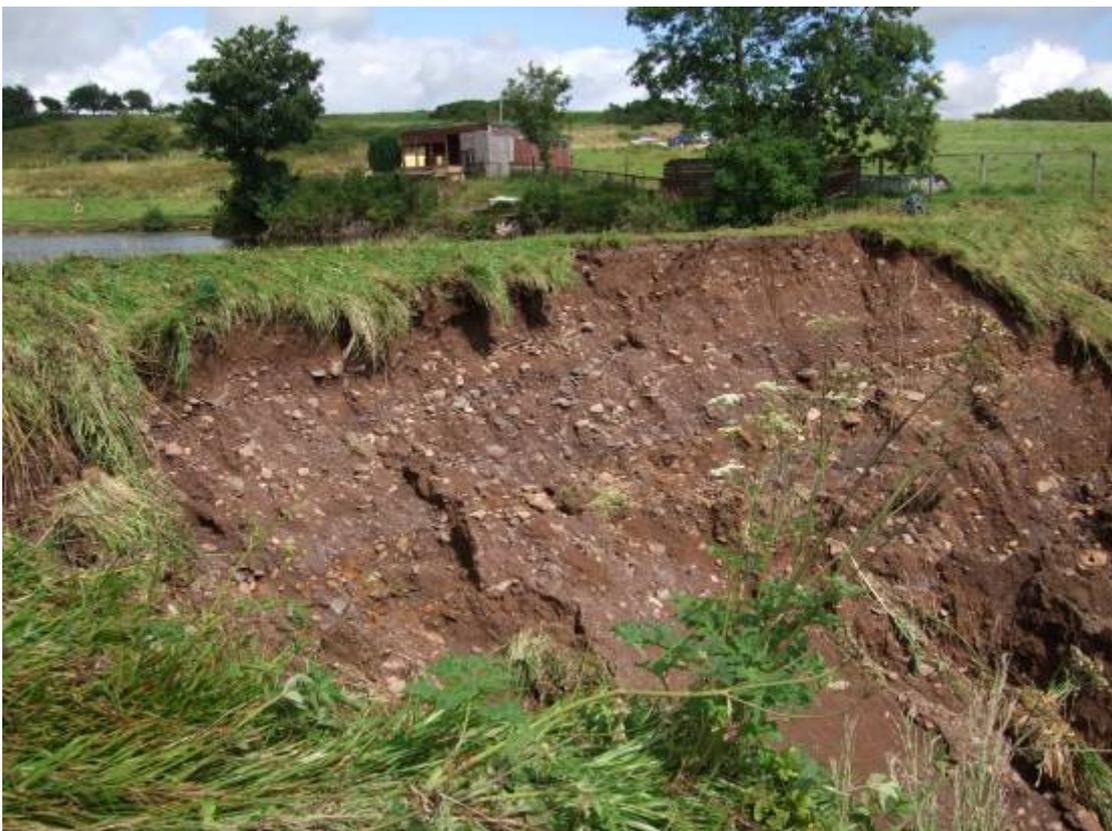
Figure 5-20 Erosion of the downstream shoulder fill due to overtopping at Maich Water

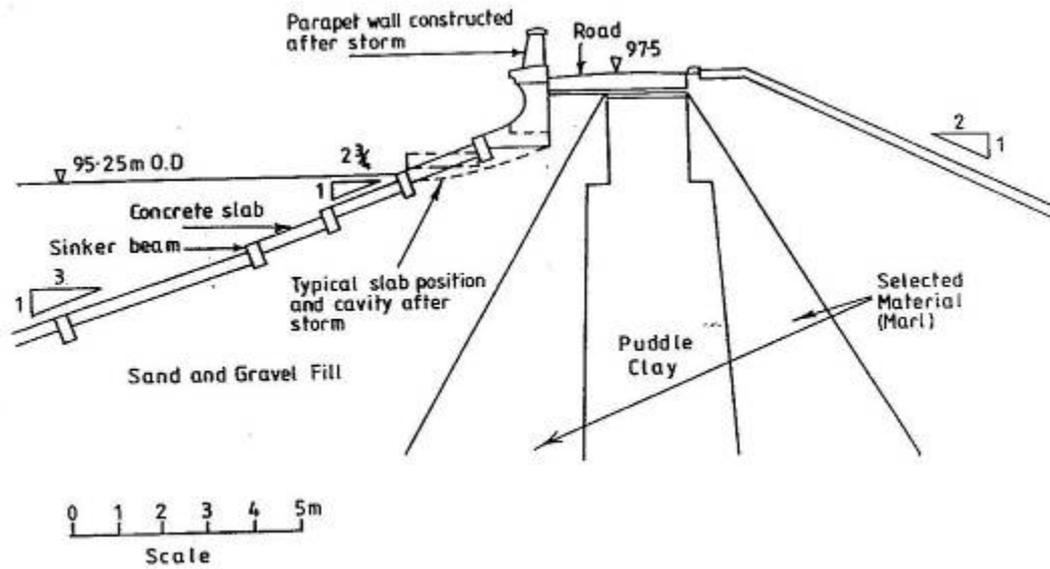
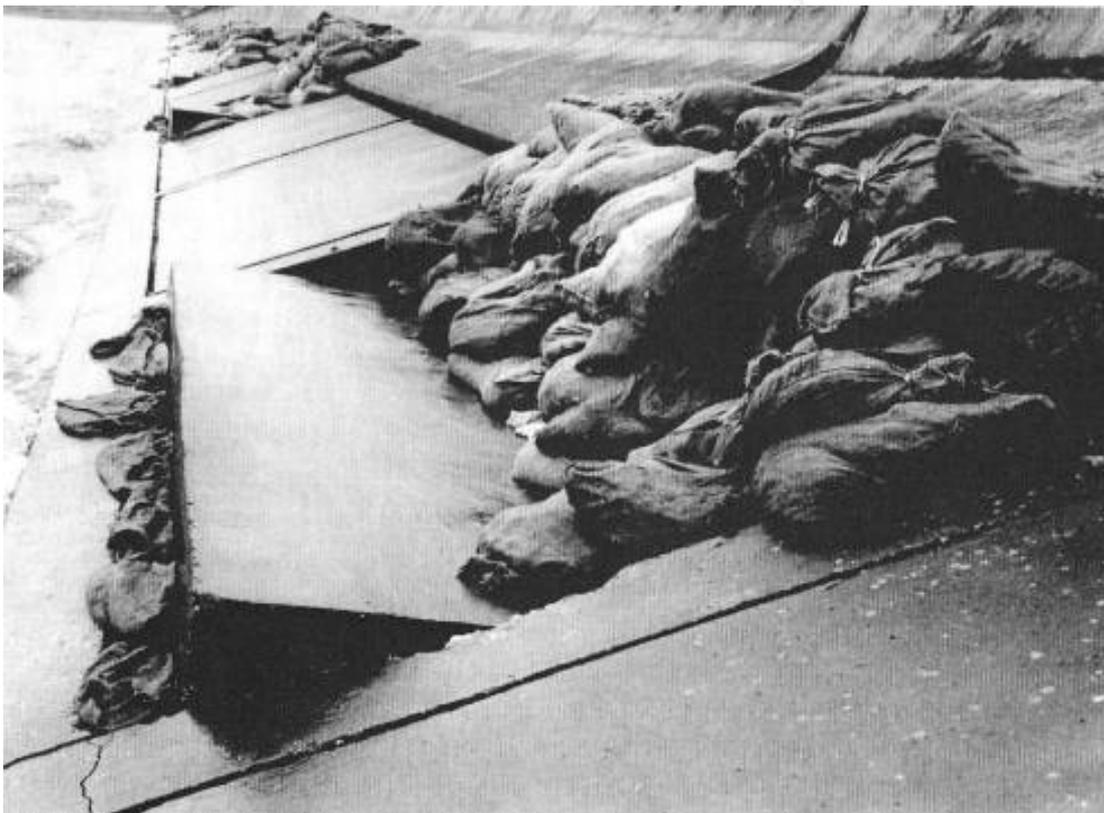
Eight other incidents from 1962 to 1990 involving concrete slabbing are described by Herbert *et al.* (1995). The incidents highlight the inadequacies of the original construction.

Figure 5-21 Section and damage to the upstream protection at Blithfield dam (after Herbert *et al.*, 1995)

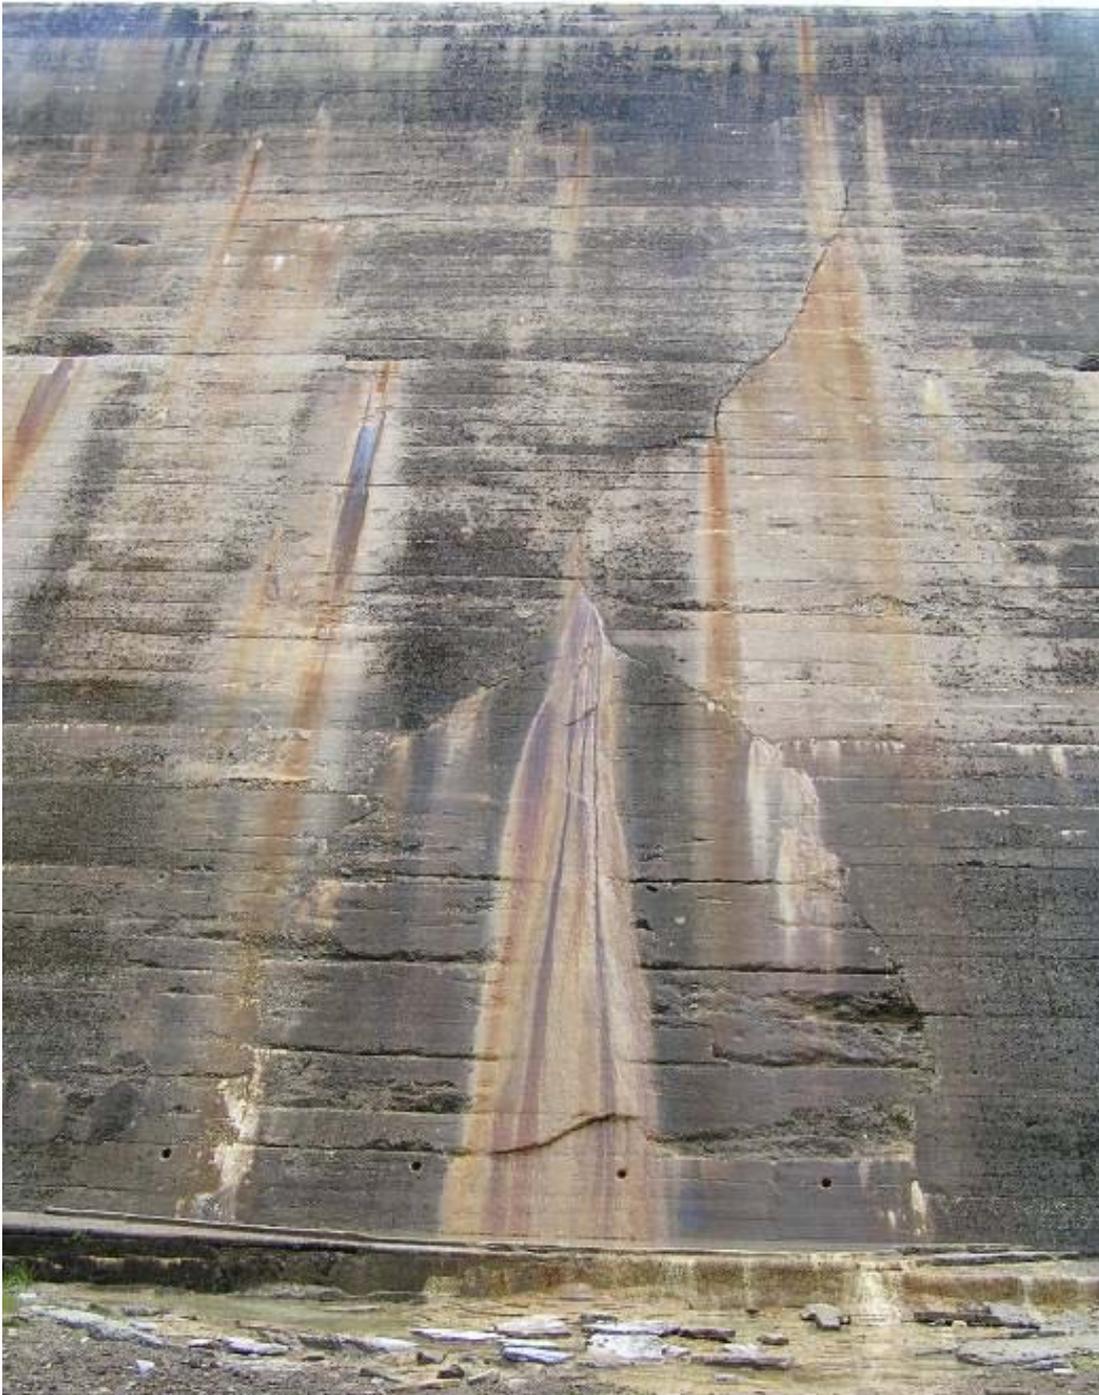
It was concluded that the cracks resulted from heat of hydration and resultant cooling and that expansion joints would have alleviated the problem. It is believed that the cracking at Blackwater was one of the cases that instigated the introduction of expansion joints in later dams. Uplift was not taken into account in the design of the dam.

Figure 5-22 Vertical cracks in Blackwater dam

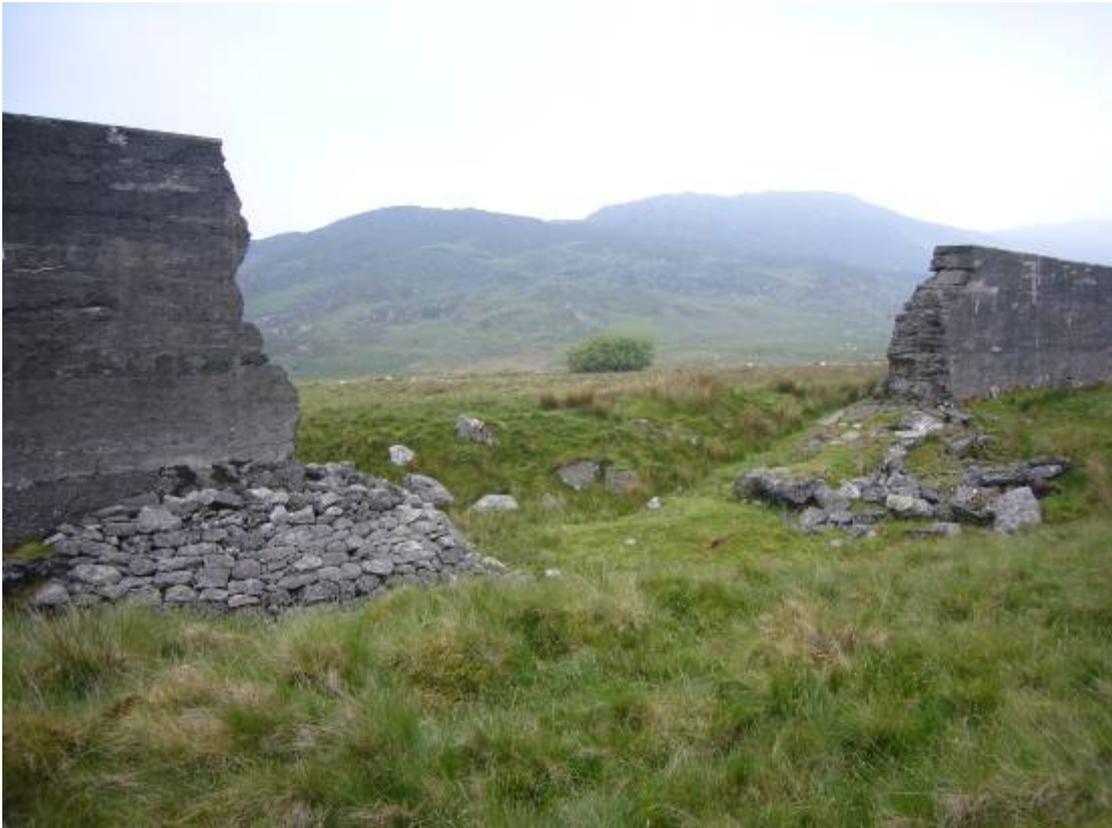
Figure 5-24 The breach at Eigiau dam (taken 2009)

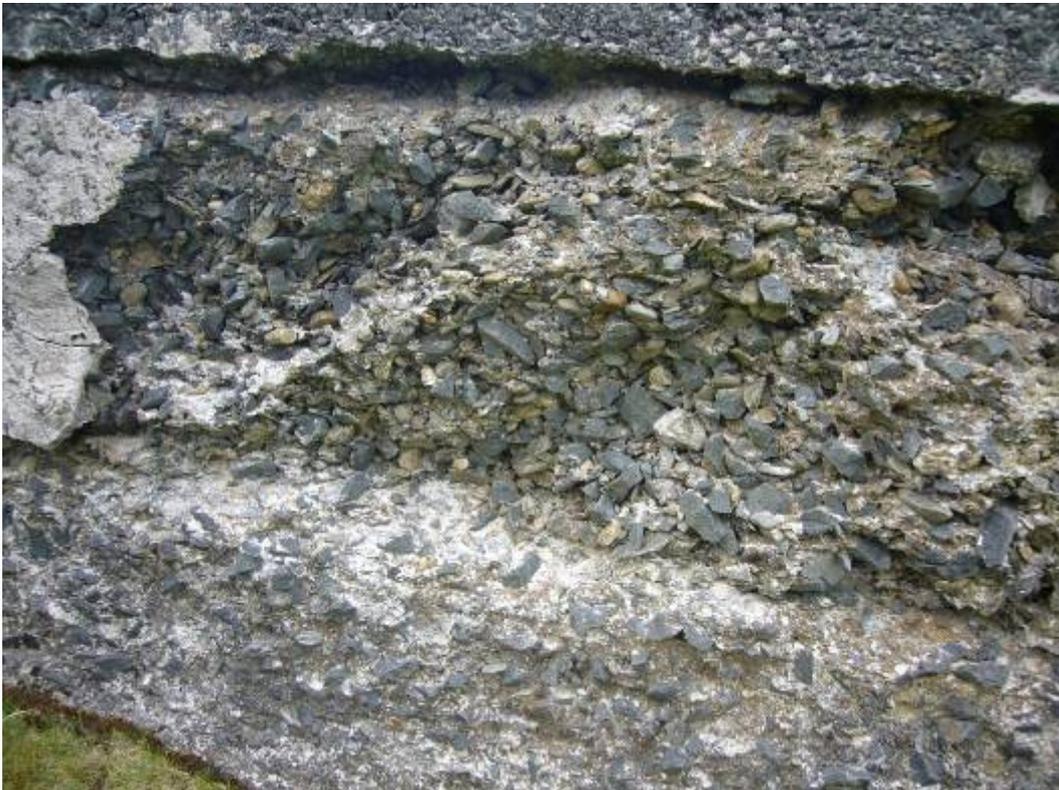
Figure 5-25 Typical poor concrete of Eigiau dam showing honeycombing and lack of fines

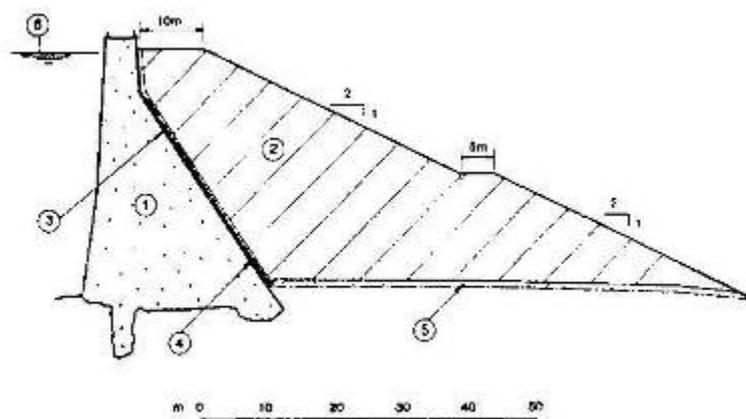
The quality of the concrete was poor, with segregation evident. It was identified as fissured and honeycombed in places, with water seeping through the cracks. The waterstops were ineffective between monoliths and there was a lack of effective cut-off.

Figure 5-26 Section of Glendevon Upper and the remedial rockfill embankment (after MacDonald *et al.*, 1994)

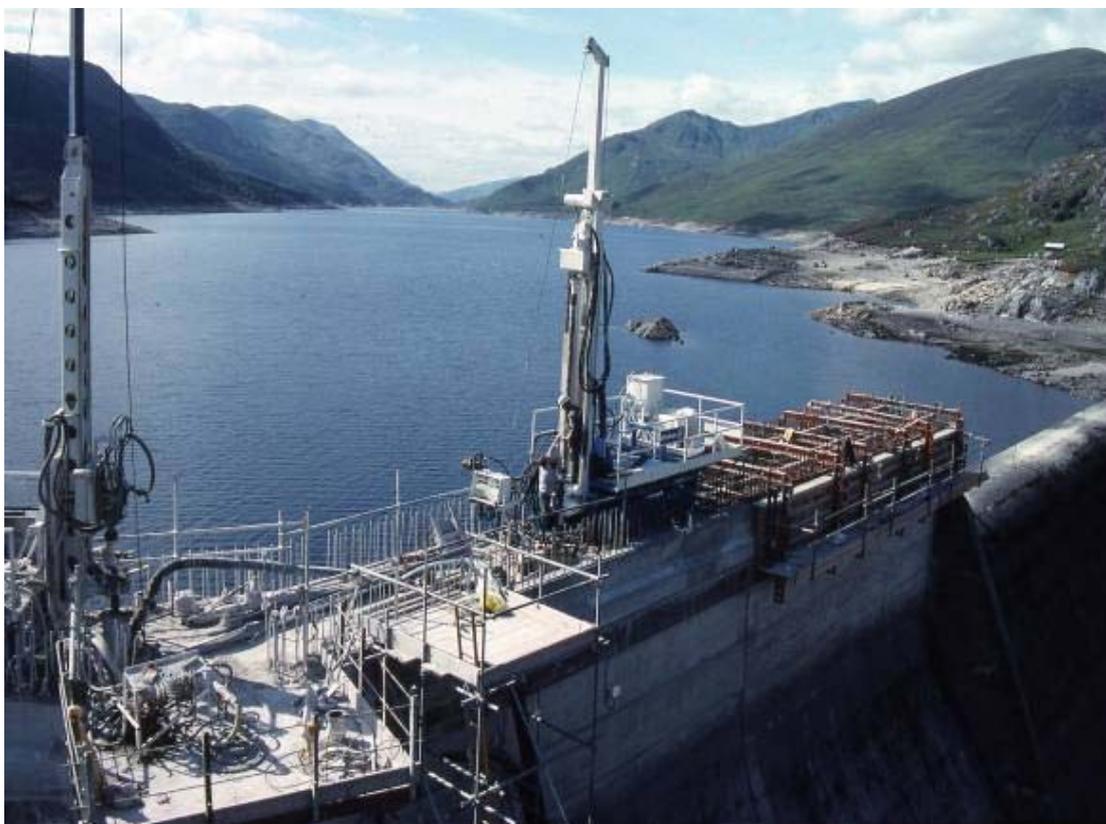
Experiences at Mullardoch dam and elsewhere (Abraham and Sloan, 1978) suggest that sharp changes of alignment should be avoided.

Figure 5-28 Post-tensioning works at Mullardoch dam

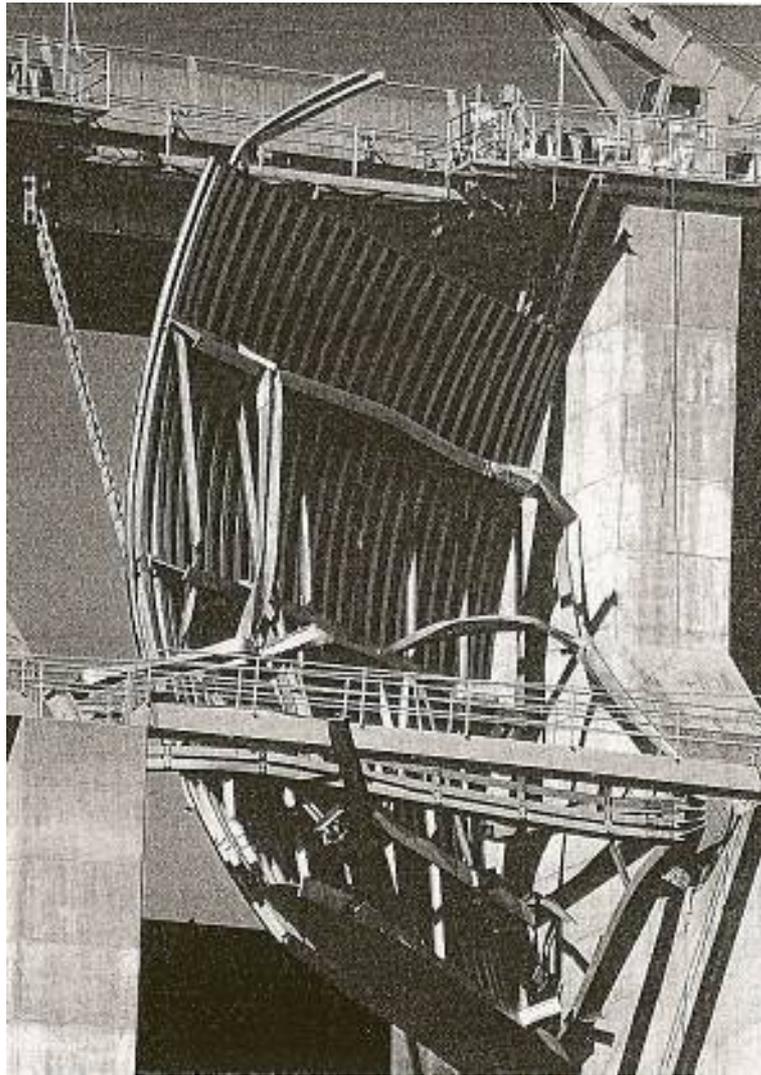
Figure 5-30 Failure gate at Folsom dam

- All radial spillway gates that could involve loss of human life in the event of failure should be inspected thoroughly and design calculations reviewed to ensure the gates meet current design standards.
- Trunnion moments were not considered in many gate designs prior to the mid-1960s and therefore reinforcement may have to be added where trunnion moment was overlooked.
- To prevent possible self-excited vibrations which can cause fatigue damage and damage to the hoisting system, gates should be made adequately stiff.
- Monitoring of a gate's condition over time should be undertaken every five years and could include loading on the hoist, changing geometry of the arms and strain gauge data to check changes in the trunnion moment caused by corrosion.
