Lessons from historical dam incidents

Project: SC080046/R1

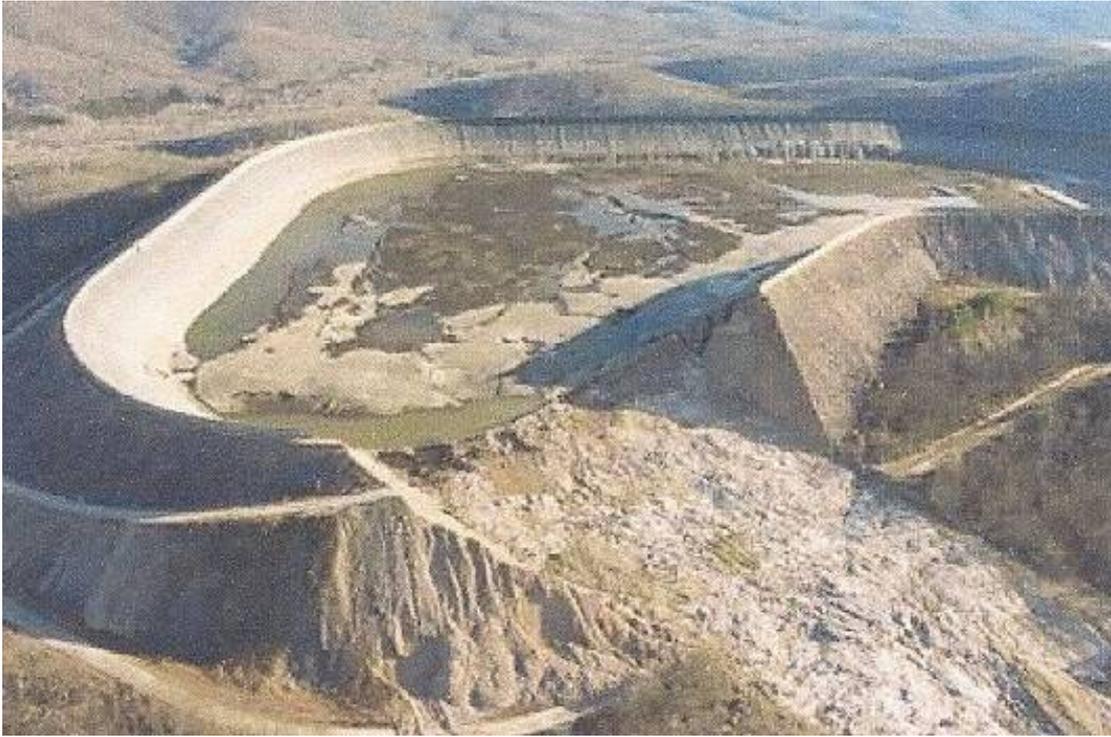
Construction of any dam without an adequate spillway is a potential hazard to the safety of the dam, even when the reservoir is non-impounding.

Figure 5-32 Breach through Taum Sauk embankment
