SS RICHARD MONTGOMERY SURVEY REPORT 2011

Maritime and Coastguard Agency
October 2012

1. EXECUTIVE SUMMARY

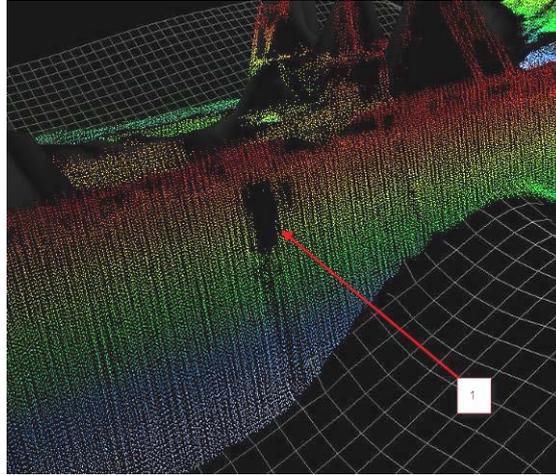
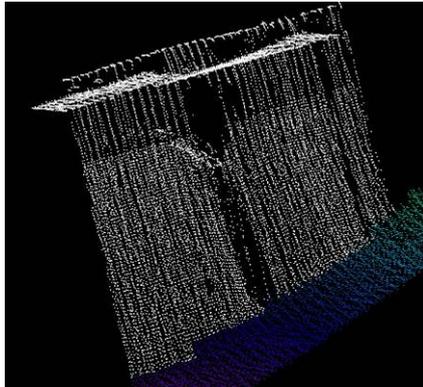
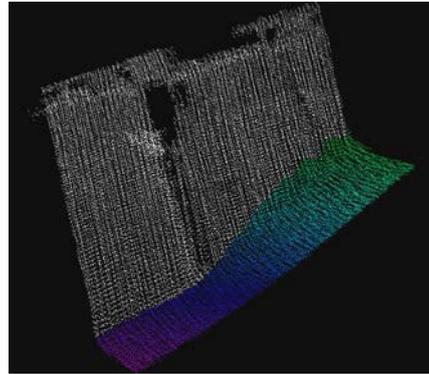
4.4.1 The crack in the hull plating on the forward port side of the wreck has been noted in surveys since at least the 1970s. When the 2010 survey data was compared with that collected in 2009, no apparent change in the size of this crack was noted. The crack measured approximately 1.27m by 2.20cm. Data collected in 2011 suggests that the width of the crack has not changed, but the vertical length of the crack may be approximately 27cm longer than in 2010.

Fig. 3, 4 & 5 Area 1) Crack in hull plating at Hold 2, point cloud data of crack from 2011.

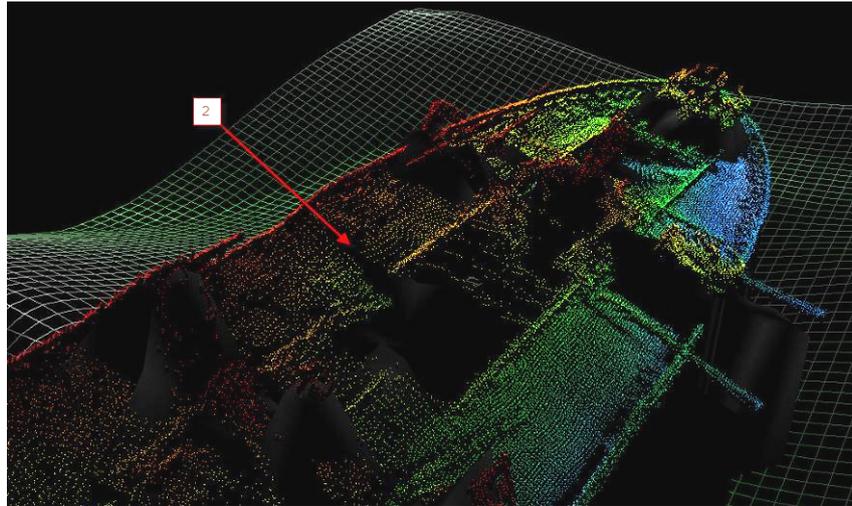
4.5.1 This section of the hull has shown the greatest change over time. Measurements taken as part of the 2006 data set showed the difference between deck levels to be 0.35m. This difference increased to 0.5m in 2008 and effectively doubled to 1.10m in 2009. The results from the 2010 data set showed that the rate of collapse had slowed with the difference being just a few centimetres increase from the previous year. The data from 2011 measured the height difference to be 1.41m, which is a change of 23cm from 2010. However, there was a low density of data collected from this area of the wreck during the 2011 survey so it is not as easy to visually note any changes as it has been in previous years.

Fig. 6, Deck plating at Hold 2, 2011

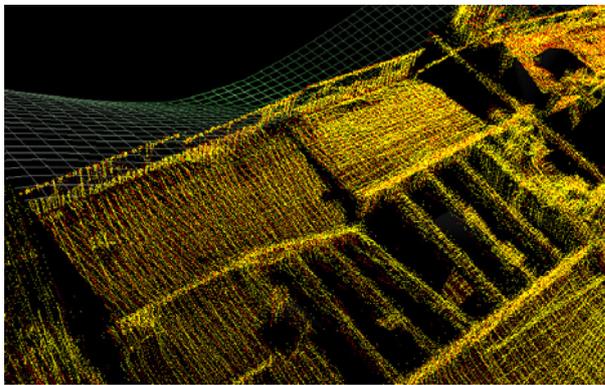
Fig. 7 Hold 2 2009 (Yellow) – 2010 (Red)

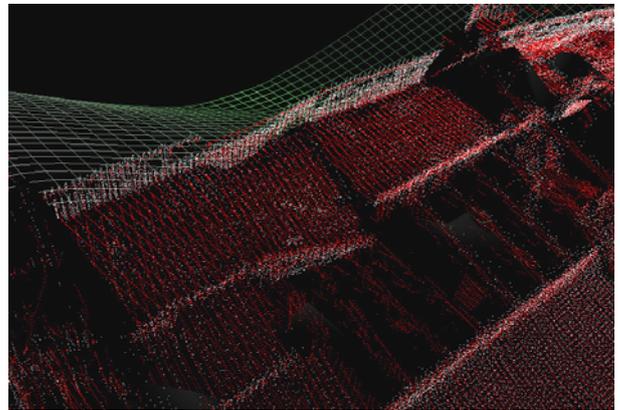
Fig. 8 Hold 2 2010 (Red) – 2011 (Grey)

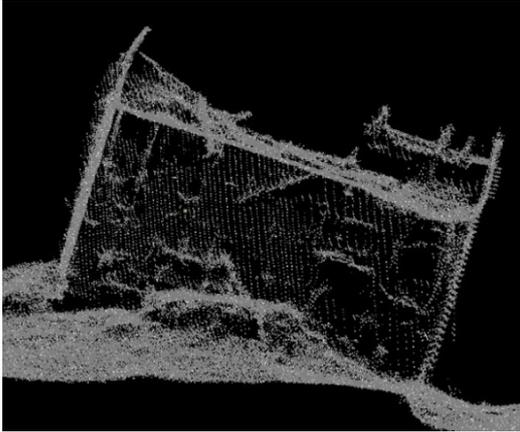
4.6.1 The aperture in the bulkhead at Hold 3 is highlighted as an area that should be monitored as a key feature of the wreck structure. Out of the 4 areas highlighted, this remains the most stable as, over a number of surveys, there has been no noticeable change in the size or shape of the opening.

Fig. 9 Bulkhead Hold 3, 2010

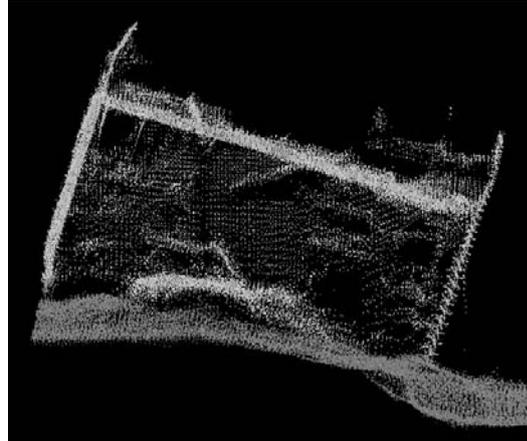
Fig. 10 Bulkhead Hold 3, 2011

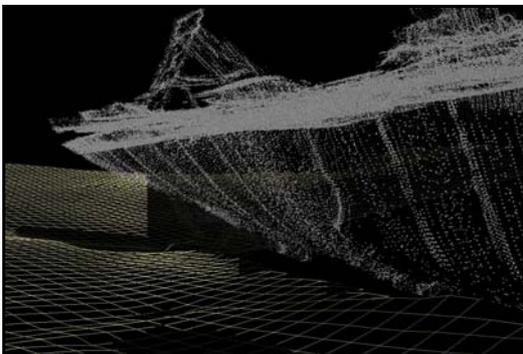
4.7.1 Using the multibeam unit in tilted mode during the 2009 survey, a crack in the hull on the starboard side of the stern section was noted. Survey data from 2010 showed no evidence of this crack. It was thought that this feature may not have been insonified in 2010 due to the lack of a tilted function on the multibeam unit. However, the data collected in 2011, using the tilted head mode, also shows no indication of a crack at this location. It is therefore likely that this was a misinterpretation of the 2009 data set caused by shadowing of the multibeam swath by overhanging debris.

Fig. 11 Hull plating stern section, 2009

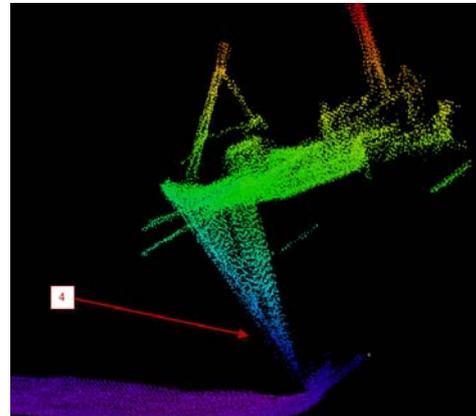
Fig. 12 Hull plating stern section, 2011

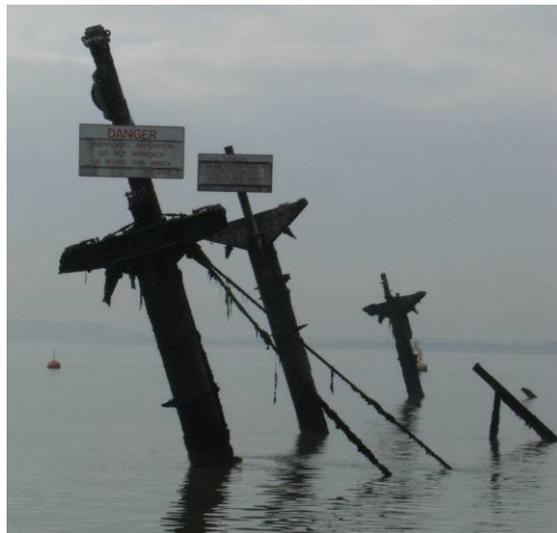
compared with 2009 survey data. Similarly, data gathered in the 2011 survey did not note any changes, indicating that the masts have so far remained structurally stable. It should be noted that using the multibeam unit in tilted mode allows more of the mast structure to be ensonified. The multibeam data clearly identifies the masts below the water level and a photographic survey shows the masts above the water. There was no laser scanning as part of the 2011 survey.

Fig. 13 The masts at low tide, 2011

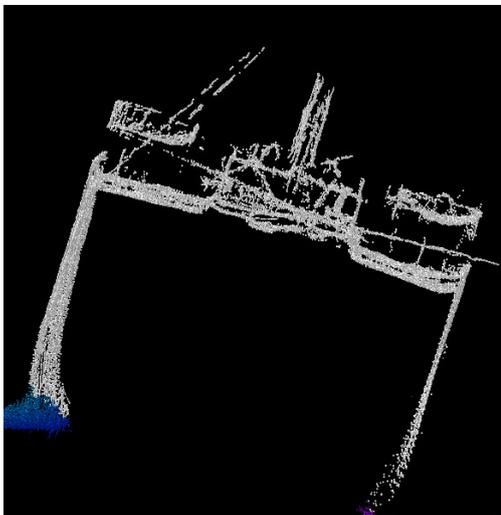
Fig. 14 Mast, bow section, 2010

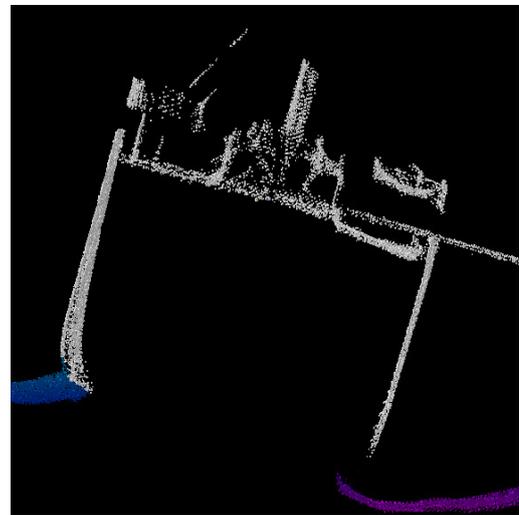
Fig. 15 Mast, bow section, 2011

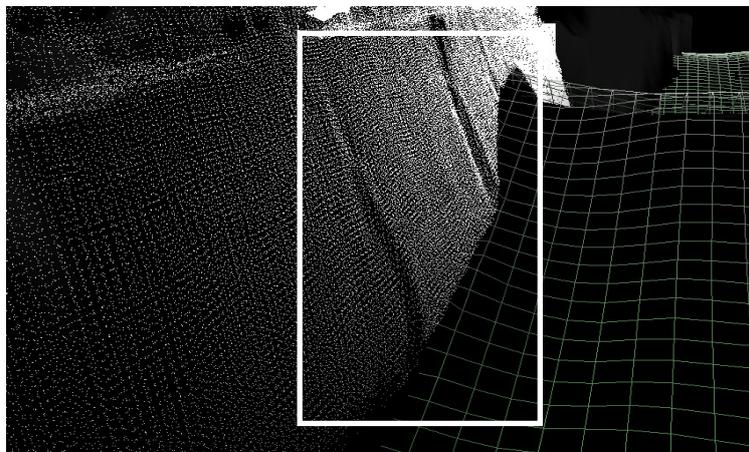
4.9.1 Multibeam data sets show that there is some deformation of the hull, particularly in the area around Hold 2. In fact, the vessel showed signs of hogging when it first went aground in 1944 and, over time, this has become evident in the survey data. This deformation takes the shape of bulging and

buckling in the hull plating and is probably due to weakening of the hull structure and stresses such as the weight of the cargo and possibly the weight of sediment build-up on the port side of the wreck.

4.9.2 Data gathered from the port side of Hold 2 in 2010 did not show any measurable change in the bulging of the hull plating since 2009. However, it is acknowledged that this bulging can be difficult to accurately measure. In order to quantify any changes evident in the 2011 data set, the point cloud was extracted and gridded at 5cm. The profiling tool was then run over the surface to show the extent of the buckling on the side of the hull. This shows that the hull is buckling outwards by approximately 15cm closer to deck level and by almost 40cm closer to the seabed.

Fig. 16 Hull deformation port side bow section, 2011

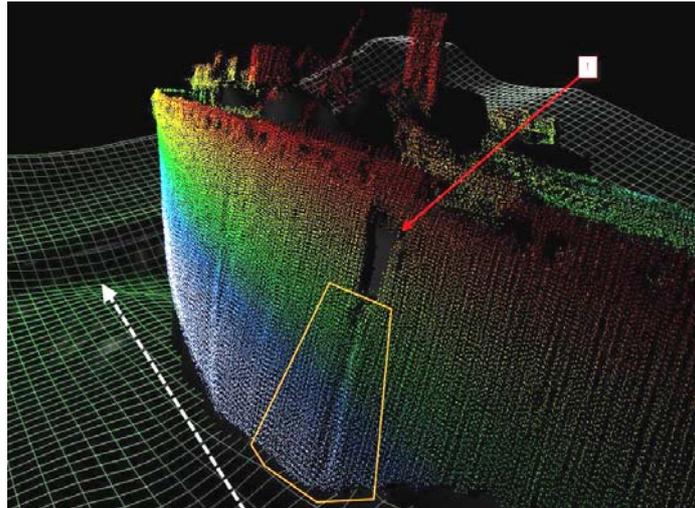
4.9.3 As noted in previous surveys, below the crack in the hull plating at Hold 2 (area 1), a split runs from the bottom of the crack down the length of the hull plating to the seabed. Previous multibeam data indicates that there is a deformity in the hull plating directly beneath the crack (highlighted in orange in fig. 17). Using the point cloud data from this area it was possible to produce a surface gridded at 5cm which shows this area of deformity. This data indicates that the hull is bending inwards by approximately 15-20cm.

Fig. 17 – Deformity in hull at Hold 2

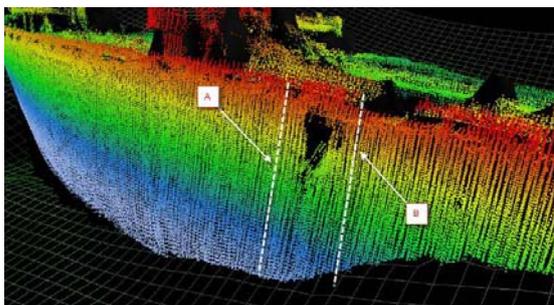
4.9.5 Two measurements were taken either side of the crack at Hold 2 at locations A and B (see fig. 18). The results show that, during the course of this three year time period, the angle of the hull either side of the crack has not changed significantly. Two measurements were also taken on the aft section of the wreck at locations C and D (see fig. 19).

Fig. 18 – A & B measurements, bow section

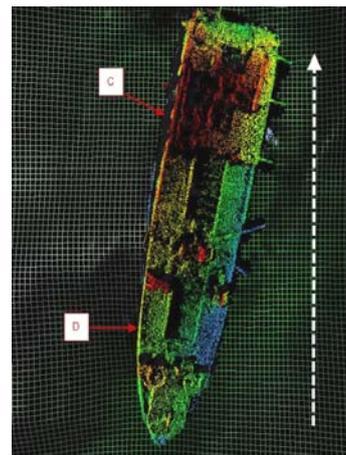
Fig 19 – C & D measurements, stern

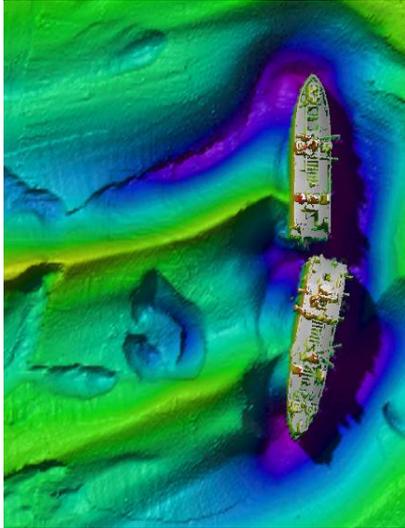
Fig. 20 Seabed survey 2010

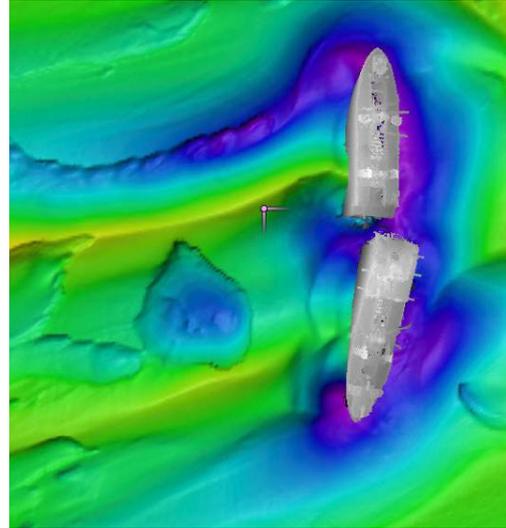
Fig. 21 Seabed survey 2011

4.10.3 The results of the seabed survey showed no change in the seabed dynamics around the foot of the bow. Overall, the scour pattern around the wreck remains similar with the distinct horseshoe shape evident in 2009, 2010 and 2011. A number of variances were observed. The scour pattern to the west of the wreck is still present and its general shape and position remain the same, however, the depth and dimensions have increased and the scour now measures 48m x 40m (dimensions in 2010 being 45m x 35m). The sand waves directly to the north showed signs of erosion in 2010 and this appears to have continued, with the 2011 data showing the sand wave to have a depth of 4.96m when compared to 4.62m in 2010.

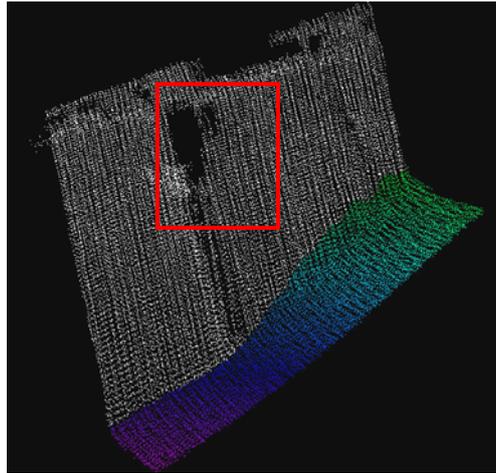
1. Hole in lower hold cover of Hold 2 – this is not evident in the 2011 survey data and it may be that there was insufficient beam coverage in this area to visualise the hole.
2. Indications of 'tween deck cargo – this has been variously interpreted as indications of the cargo inside the wreck or as part of the hull plating.

Fig. 22 2011, 'tween deck cargo (?), port side

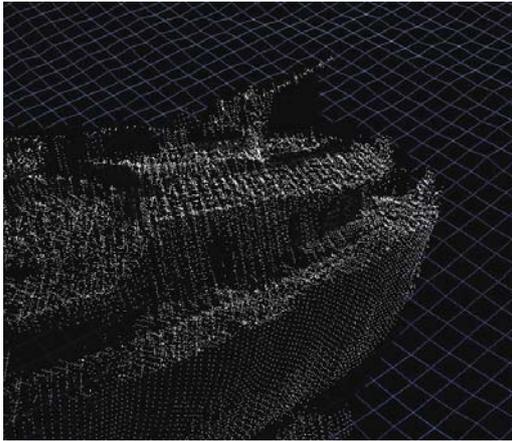
Fig. 23 Stern gun 2010

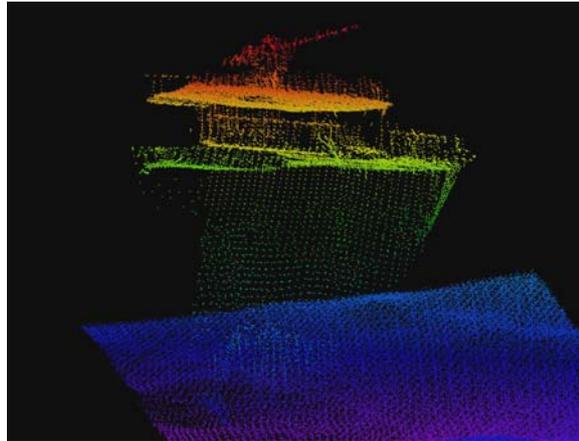
11. Boiler room casing - the 2011 data set seems to confirm that this area is still intact, although it is a difficult area to check because of the complex surroundings.
12. Stern gun - the stern gun and gun tub look to be in a similar condition to that observed in the 2010 survey. The shape and location of the gun remain constant with the barrel of the gun pointing upwards at an angle of 17°.

Fig. 24 Stern gun 2011
