Maritime &
Coastguard
Agency

SS RICHARD MONTGOMERY SURVEY REPORT 2012

Maritime and Coastguard Agency
October 2013

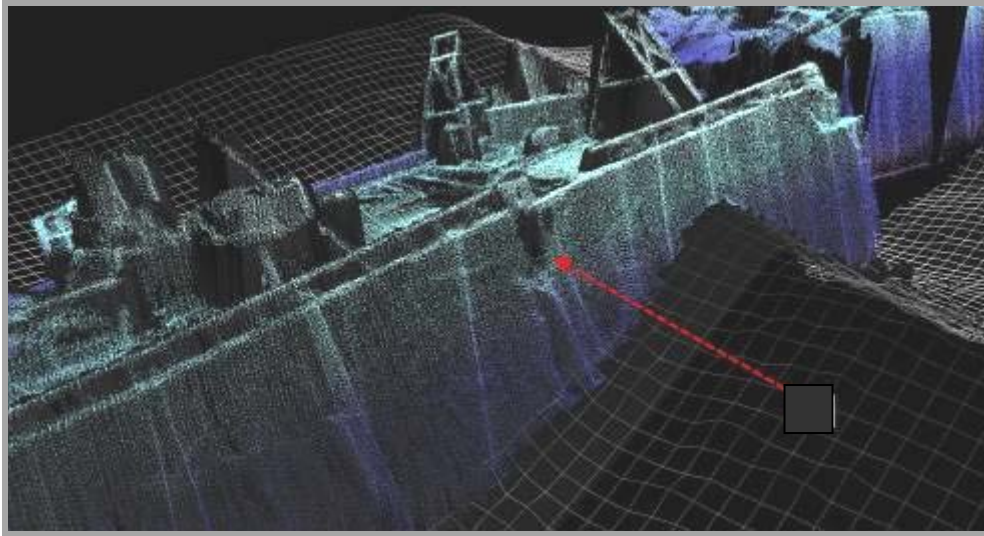
4.3.3 Area around Hold 2 continues to show levels of deterioration. This area has shown slow but continual deterioration across previous surveys. Data from the 2012 survey shows that the crack at Hold 2 has increased in length by 16cm since 2011 although the width remains unchanged. The dimensions of the crack were measured as 2.53m vertical and 1.22m in width from the 2011 survey. From the 2012 survey results the crack has increased to 2.69m in the vertical and remains almost unchanged in its horizontal measurement at 1.29m.

Fig. 2 Crack at Hold 2 – 2012 data

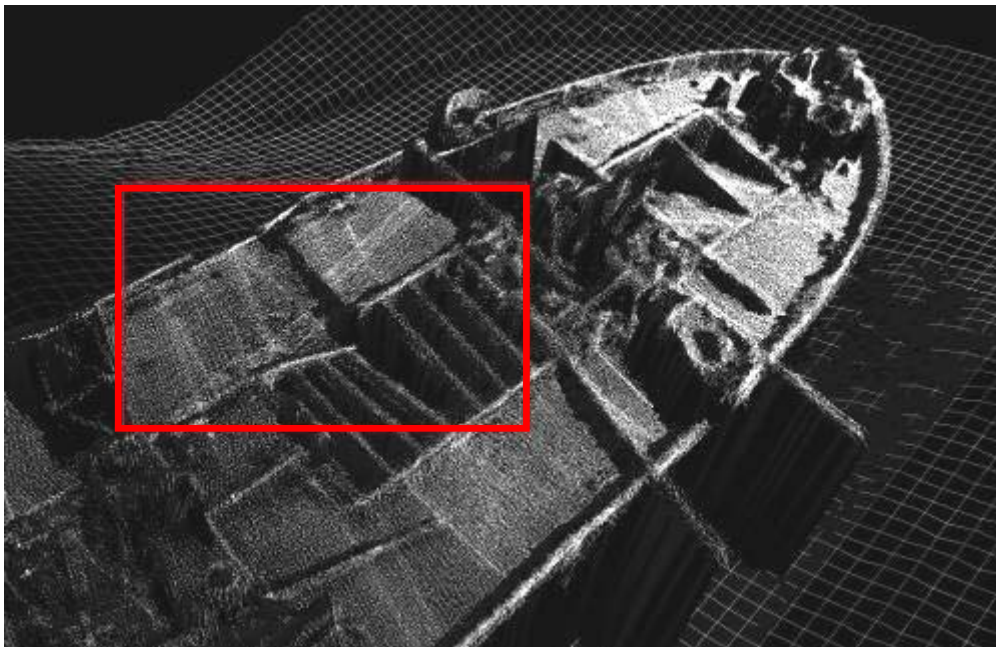
4.3.4 The deck plating at Hold 2 has also shown evidence of gradual collapse over previous surveys. It was not possible to accurately measure the 2011 survey data from this area, therefore, the 2012 data has been compared to that collected in 2010. Over this two-year period, the deck plating has dropped by 30cm. In total, the distance between the two deck levels can be measured at 1.5m.

Fig. 3 Collapsed deck plating at Hold 2 – 2012 data

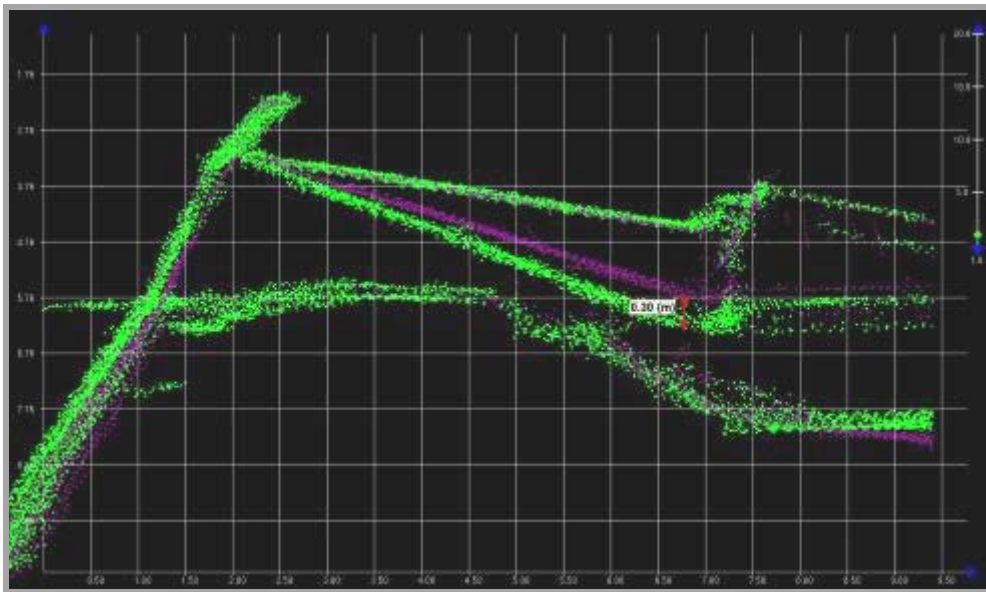
Fig. 4 Difference in height between 2010 [purple] and 2012 [green] data sets

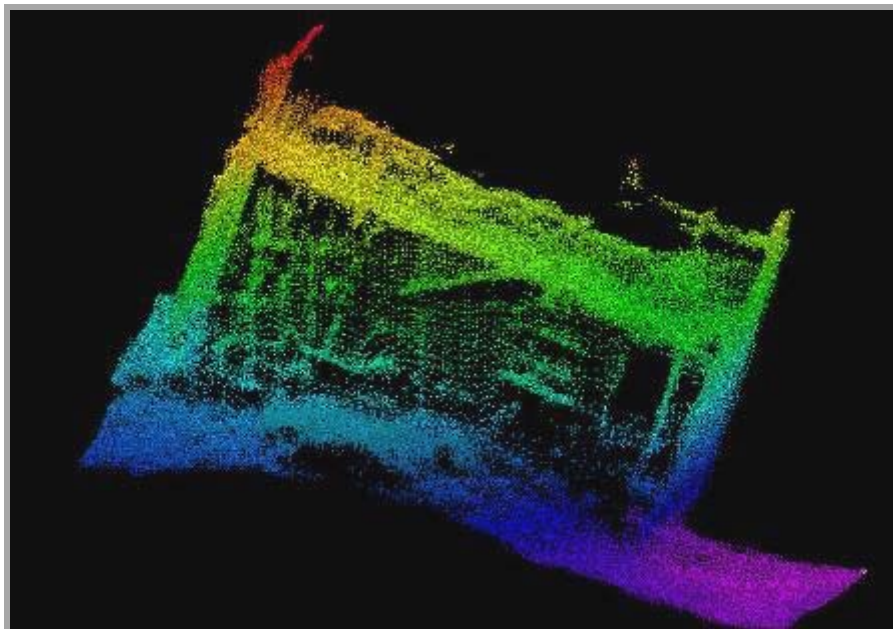
4.3.5 The third key area is the bulkhead aft of Hold 3. On one side of this bulkhead was the engine room and on the other side is Hold 3. This bulkhead is where the vessel broke in two. The bulkhead remains predominantly intact but there are known to be apertures in it. One large aperture was first noted in the 2008 survey data and this has been monitored since that time. The 2012 survey data indicates that there is no visible change in this section.

Fig. 5 Bulkhead aft of Hold 3

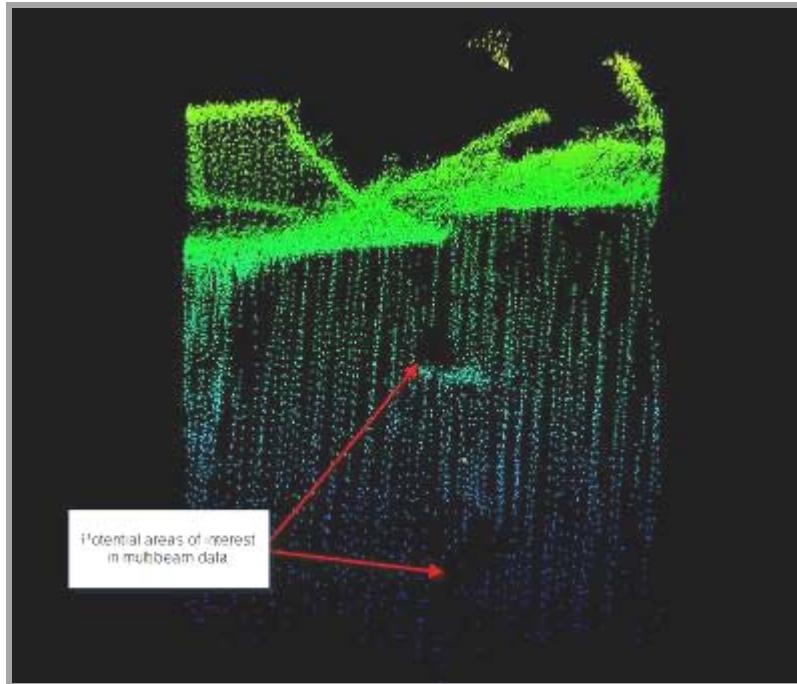
4.3.6 The final key area has been previously described as severe splitting of the hull located on the starboard side of the stern section. This feature was identified in 2009, however it was not found in survey data from 2010 and 2011. It was thought likely that this

feature was caused by shadowing of the multibeam by overhanging debris which gave the appearance of a split in the hull. The angle of list and overhanging debris at this section of the hull present a challenge for multibeam systems and it has yet to be insonified to any significant level of detail. However, the data from 2012, similar to 2009, indicates the presence of a feature in this location and, from some angles, the multibeam data indicates there could be holes in the hull. However, it is difficult to analyse and, as such, it remains inconclusive.

Fig. 6 Severe splitting in Aft section - side view

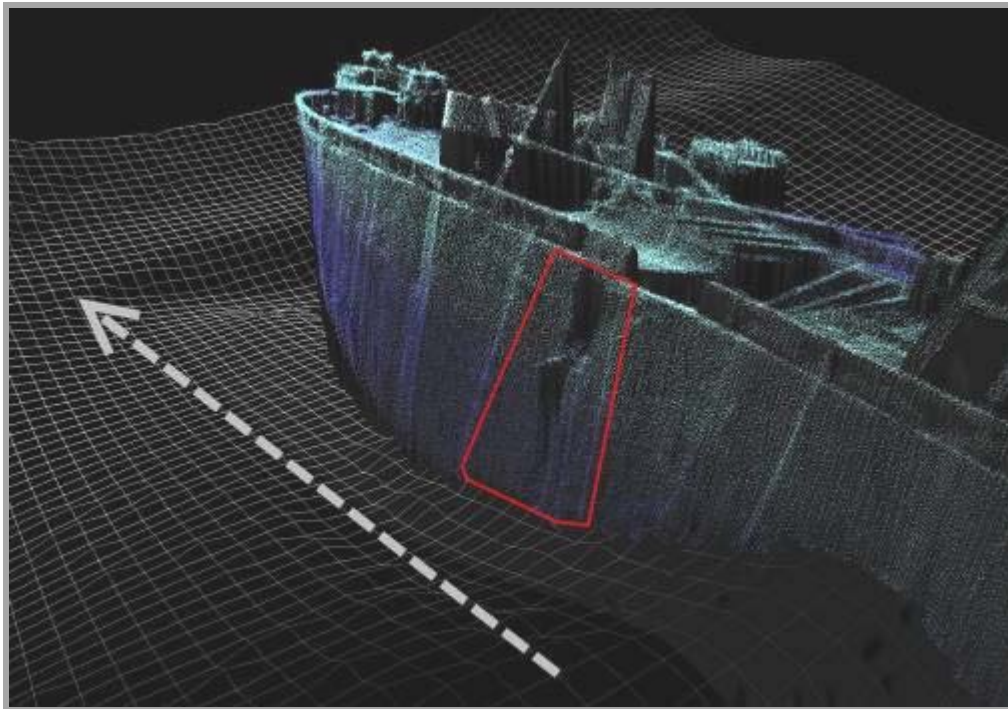
4.4.1 The vessel reportedly showed signs of hogging immediately that it went aground in 1944, and successive surveys have noted evidence of deformity in the hull. However, the level of deformity and any increase is difficult to measure. For the 2011 survey report a surface of the hull was generated and gridded at 5cm and the profiling tool was used to ascertain the level of deformity in the hull directly below the crack at Hold 2. Data from 2011 indicated that the hull was bending inwards by 15-20cm beneath the crack and outwards by approximately 40cm closer to the seabed. The gridded data from 2012 shows that the level of deformity of the hull remains similar to that found in 2011. Directly underneath the crack at Hold 2, a bend of approximately 20cm is evident, whilst nearer the base of the hull the profile remains unchanged at 40cm

Fig. 7 Section of hull that has been gridded into a surface

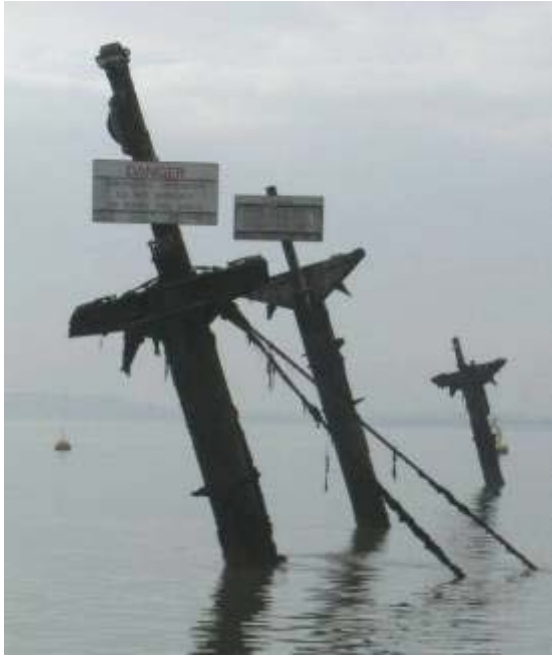
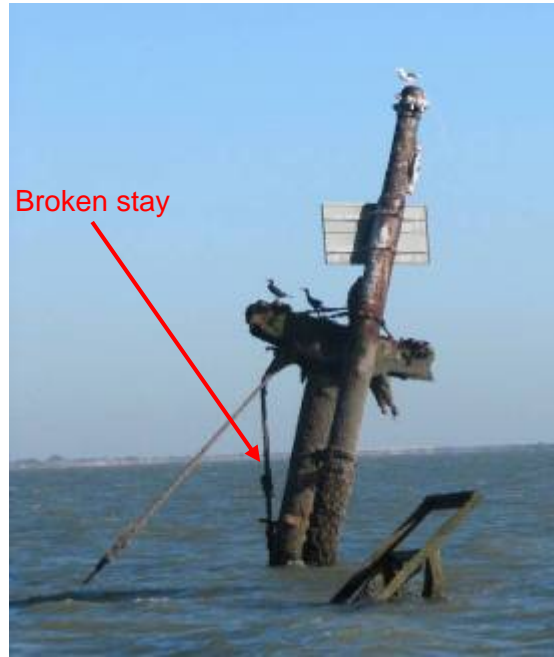
4.5.2 The fore mast cargo handling booms can be easily seen in the point cloud data. One boom is lying across the deck and the point cloud data shows that it protrudes over the starboard side by 4.5m. Another extends over the side of the wreck by 3.6m and the third boom appears from the data to be lying across the corner of Hold 1. This feature remains constant when compared with historical point cloud data and is approximately 10m in length. The fore mast and mast house are clearly visible in the 2012 data. There are no visible signs of deterioration in the multibeam data, but the photographic survey revealed that one of the two mast stays on the forward mast has become detached at deck level since the 2011 survey.

Fig. 8 2011 – fore mast, both stays attached

Fig. 9 2012 – fore mast, one stay attached

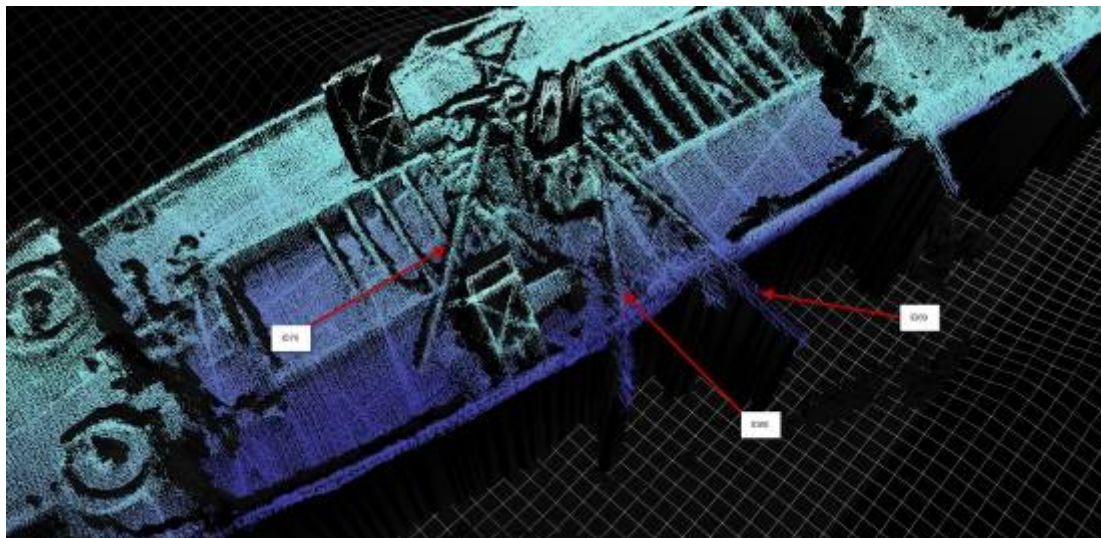
4.5.4 Mizzen mast house is well defined in 2012 data set. The feature is supporting the mast situated on top. Point cloud data from 2012 shows all 3 booms in good detail. One lies across the deck and two extend over the side of the hull. All three remain in the same position and show no sign of change from previous data sets.

Fig. 10 Mizzen mast booms - 2012

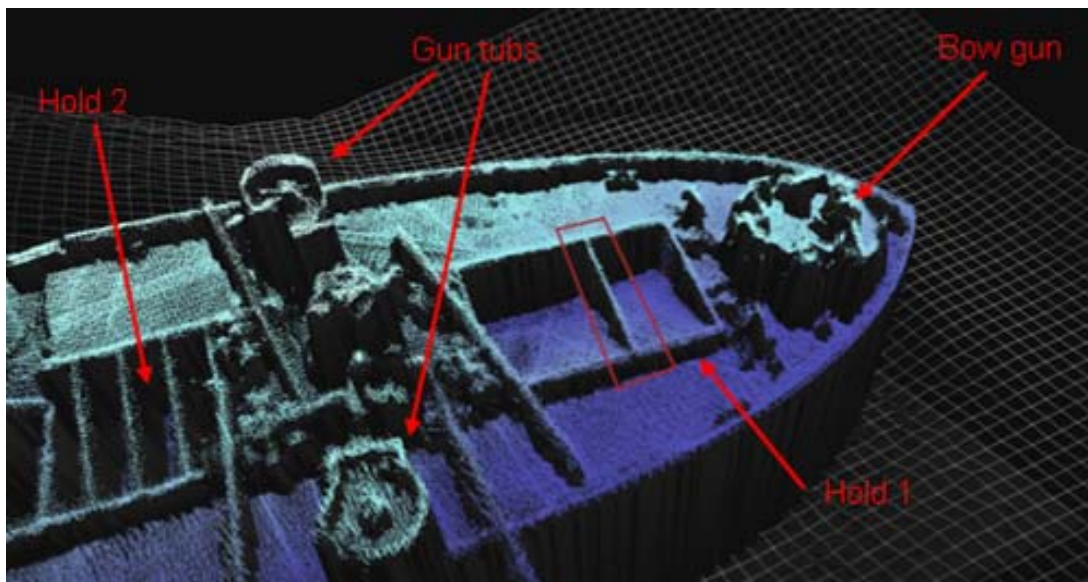
8. Lower hold cover at Hold 4 - data from 2012 survey shows no signs of deterioration from the 2010 data.
9. Hold 1 hatch cover support - no change is seen in this section of the wreck and the hatch support remains the same when compared to the 2010 data.

Fig. 11 Hold 1 hatch cover support and other features - 2012

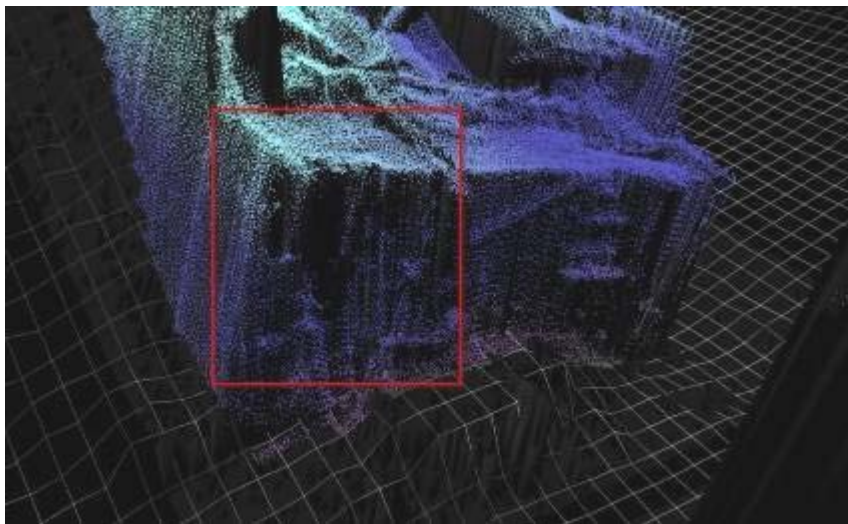
4.7.4 The area around Hold 3 is where the break between the two sections of wreck occurred. Although the bulkhead at Hold 3 remains predominantly intact and is containing the munitions, the deck, hatch and 'tween deck area of Hold 3 were heavily damaged when the vessel broke in two and this area is full of debris. The multibeam data shows this debris and shows no signs of deterioration since 2011. Previous survey data has been interpreted as showing outlines of cargo material through an aperture in the bulkhead. This is not visible in the 2012 survey data.

Fig. 12 Bulkhead at Hold 3 - 2012

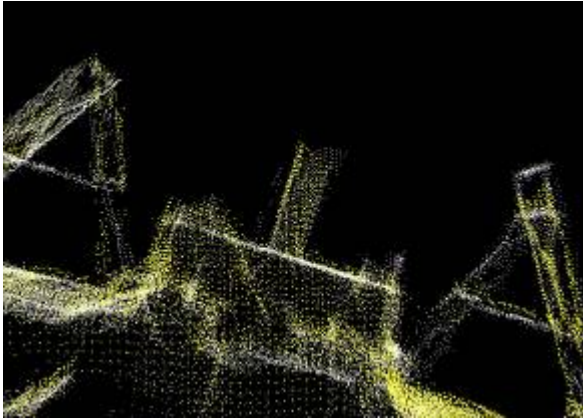
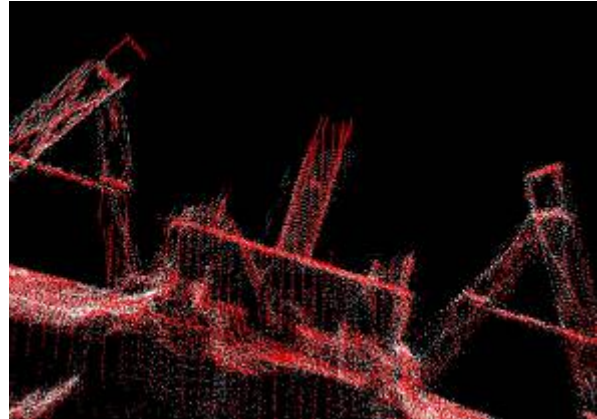
4.8.2 As can be seen from the images below, comparisons of the 2012 point cloud with data from the 2010 and 2011 surveys show that the vessel has not moved in terms of its relative vertical axis. This alignment gives confidence that the wreck has not changed its list or orientation over the course of the last three surveys.

Fig 13 2012 data (white) -2011 data (yellow) – main mast area

Fig. 14 2012 data (white) -2010 data (red) – main mast area

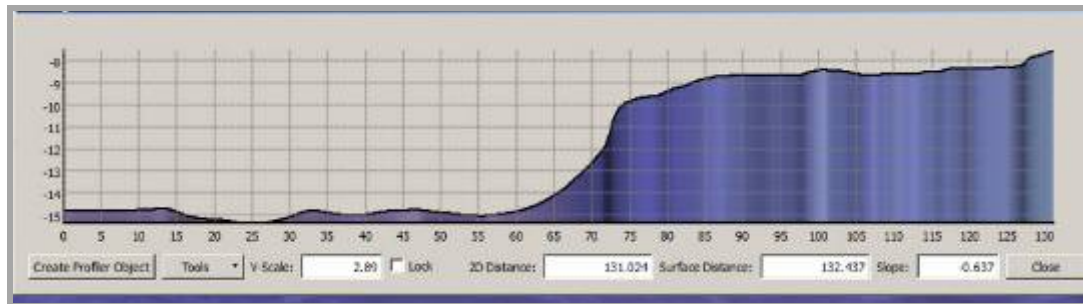
5.3 Area A - Survey data from the edge of the dredged channel indicates that there has been a small reduction in sediment deposits. There is no evidence to suggest that the wreck is having an influence on this area and the channel is surveyed and dredged by the port authority.

Fig. 16 Profile of edge of dredged channel

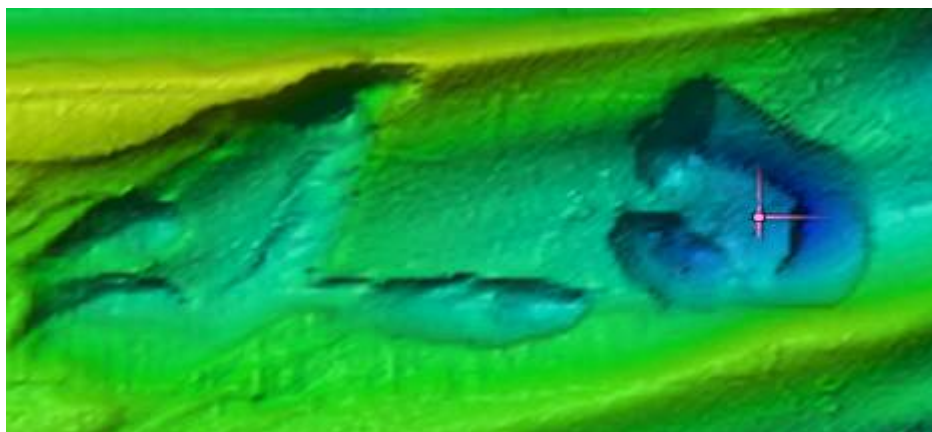
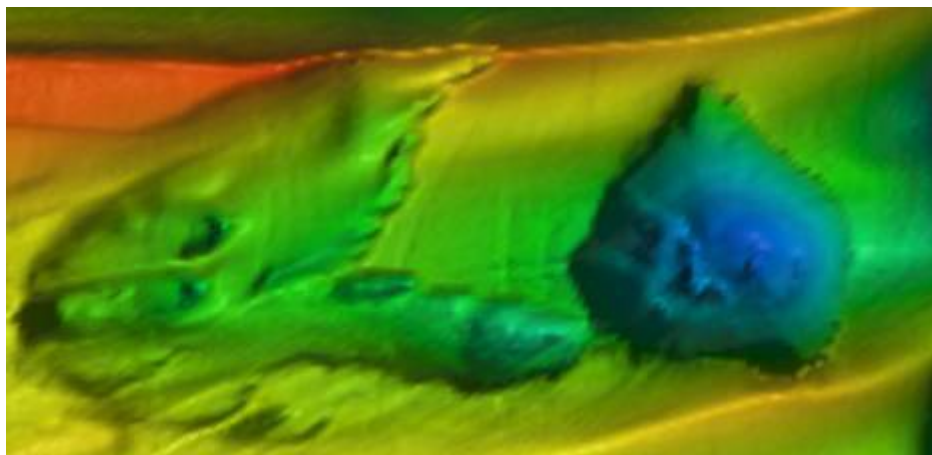
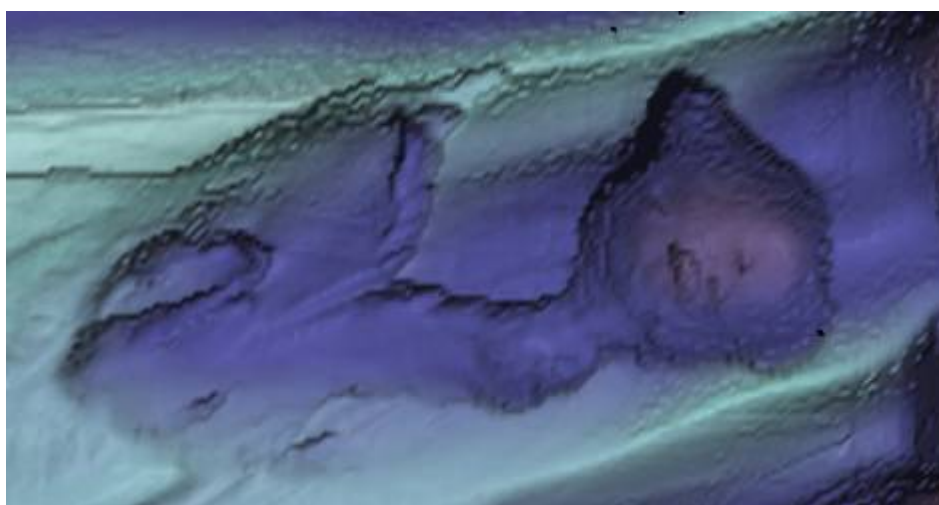
5.4 Area B – The scour around the wreck retains its same general shape year on year but the sediments are mobile and some changes are to be expected. From the 2012 data, it can be seen that the scour marks to the west of the wreck appear to be growing in size and scour marks that were previously two distinct shapes have, over time, merged in to one. Analysis of the scour to the west of the wreck shows that, although the scour mark retains the same depth along the profile length, it has changed in dimensions in north-south and east-west directions. In 2010 the scour was measured as 45m x 35m. In 2011 the survey data measured the dimensions of the scour as 48m x 40m and the 2012 data shows the dimensions of the scour as 51m x 45m. The scour is measured at a distance of 40m away from the wreck and data analysis indicates that it has extended towards the wreck at a rate of approximately 1 metre per year since the 2009 survey.

Fig. 17 Scour to west of wreck - 2010

Fig. 18 Scour to west of wreck - 2011

Fig. 19 Scour to west of wreck - 2012

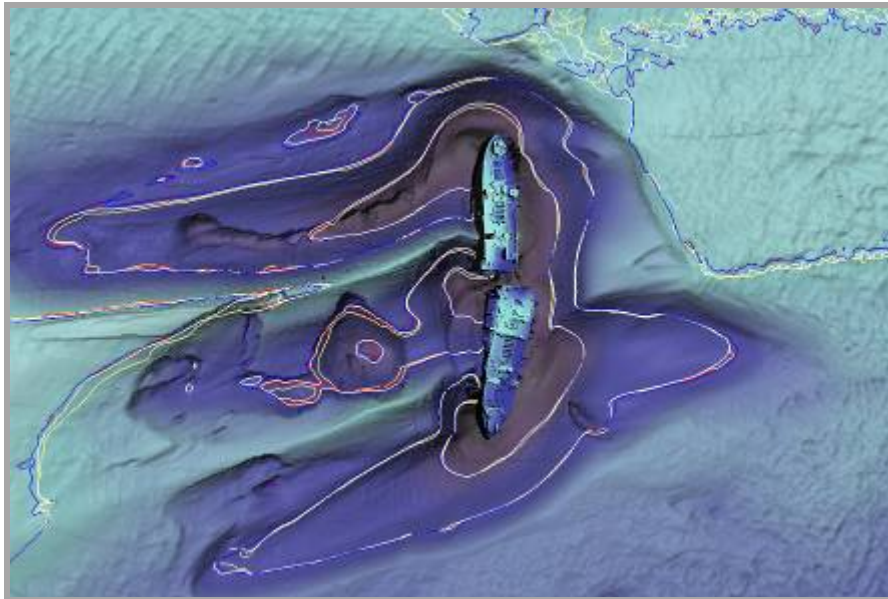
5.7 Across the whole site, the average surface difference is 0.13m, an element of which is due to the tolerance levels of the equipment used to collect and process the survey data. Looking at the seabed contours around the wreck, these remained consistent between 2009 and 2011. The contours generated in 2012 are again consistent with previous surveys, with only small deviations visible on closer inspection. The overview of the surrounding seabed suggests that the dredged channel directly to the south remains unaffected by the presence of the wreck on the sandbanks.

Fig. 20 Survey Contours: 2009= Yellow, 2010 = Red, 2011 = White, 2012= Blue
