MINISTRY OF DEFENCE

SAFETY ALERT

Inspection of Runway Surfaces around Rotary Hydraulic Arrestor Gear (RHAG) cables

Number: SA 04/11

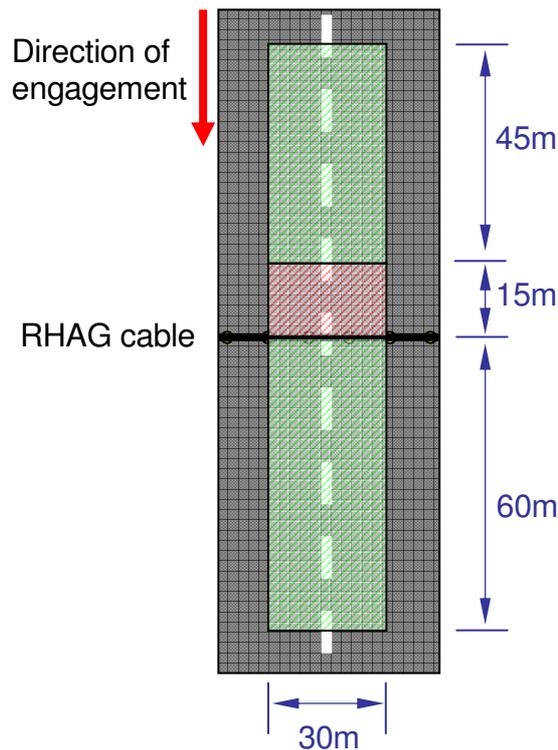
Detailed inspections of suspect areas can be performed both longitudinally and transversely using a 3m straight edge without feet. A 3m x 3m grid covering the width of engagement extending 15m from the RHAG cable before engagement (red area, see below). High spots exceeding 3mm are to be removed; depressions exceeding 3mm are to be rectified. Engineering judgement must be exercised for areas between the grid and ad hoc readings taken if needed.

The area 60m either side of the RHAG cable (green area, see below) should be visually inspected looking for defects as specified above.
