INFORMATION NOTE

Subject: FAILURE OF AN EXPANSION BELLOWS ON A MEDIUM TEMPERATURE HOT WATER SYSTEM

Number: 07/12

23 November 2012

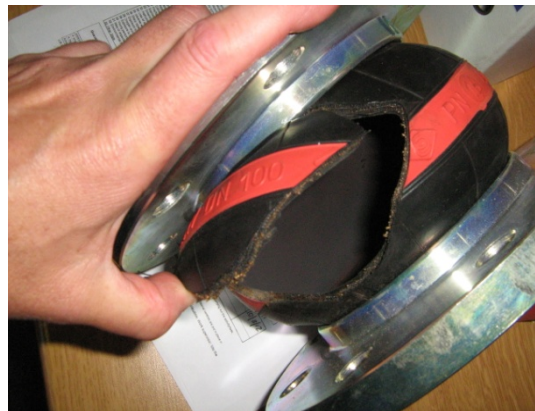
This Information Note is raised following a potentially serious incident on a MTHW system.

Figure 1 - Single red band - LTHW rated expansion bellows

In all cases of doubt, the manufacturer's performance specifications for pressure and temperature should be consulted. Where an incorrect fitting is found it must immediately be isolated and made safe, ready for replacement with the correctly rated fitting.

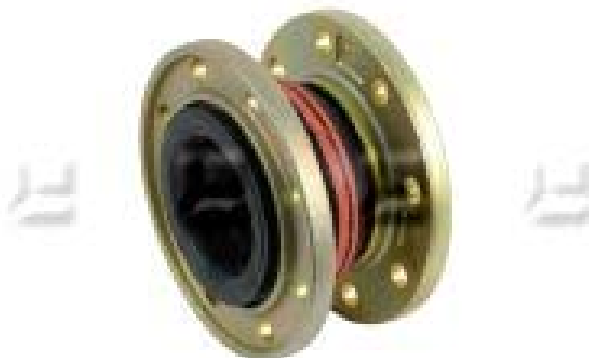
Figure 2 - Double red band- MTHW rated expansion bellows

It is good practice to check that new installations and replacement fittings are properly rated for the systems they will be required to serve. Generally, manufacturers use a red marking for fittings compatible with primary heating. This can be in the form of a dot or single band of red for LTHW and double red banding for MTHW.
