1.4.160. **H450 GTOLS Re-implementation. (S26)**

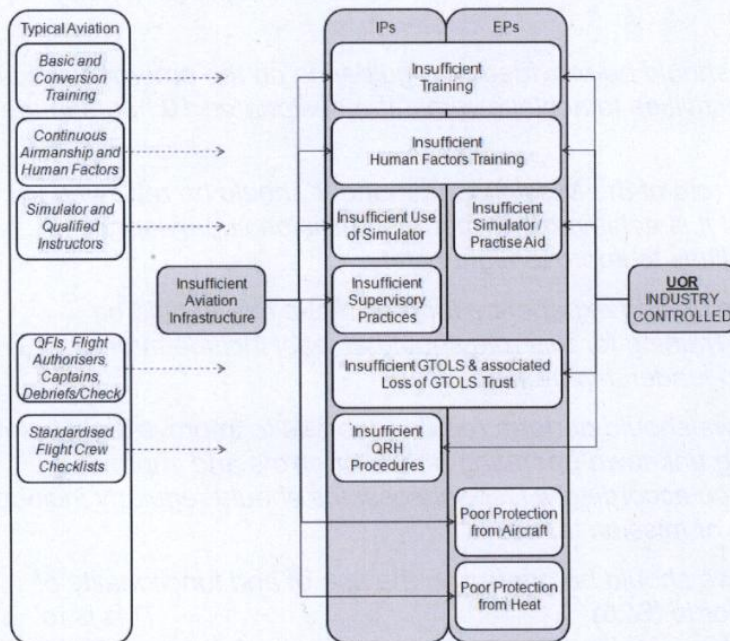
**Figure 15 - Summary of identified factors**

*The identified factors may influence the likelihood a H450 crew would enter a hazardous scenario and the likelihood that crew may fail to recover from that scenario, should these factors not be addressed. A summary of the factors raised are provided in Figure 15.*

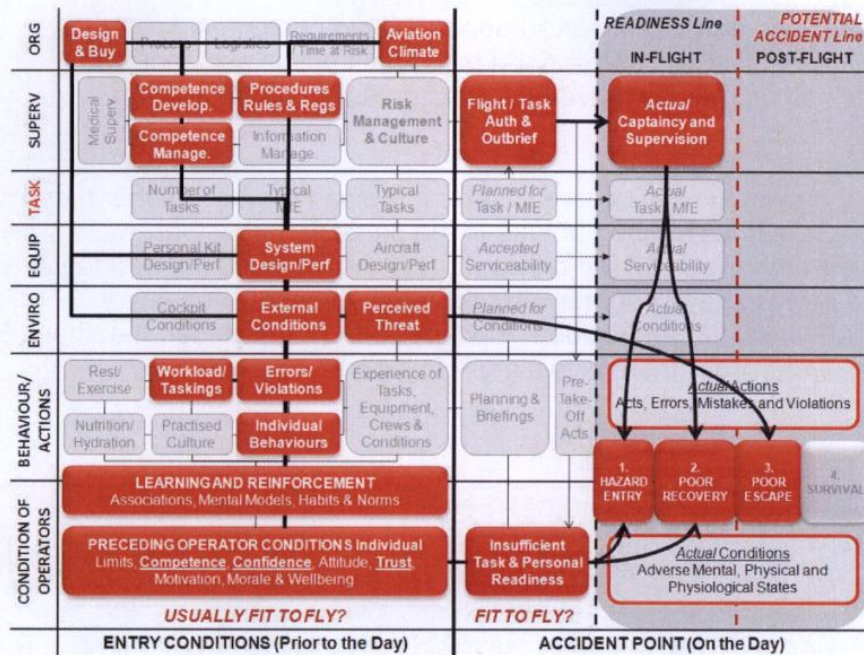
**Figure 16 - Identified factors on the Accident Route Matrix - showing potential accident route in Jun 11**

*These factors have been highlighted on RAF CAM's Accident Route Matrix in Figure 16 to illustrate a potential route to another H450 incident or accident.*

1.4.164. From the potential accident route matrix above, identified by RAF CAM in Jun 11, 4 months before ZK515's accident, it can be seen in the Accident Point (on the day) section that the identified factors were very close to predicting what happened in this accident. In this respect, the predicted accident factors can be matched against the entry conditions for ZK515's accident:

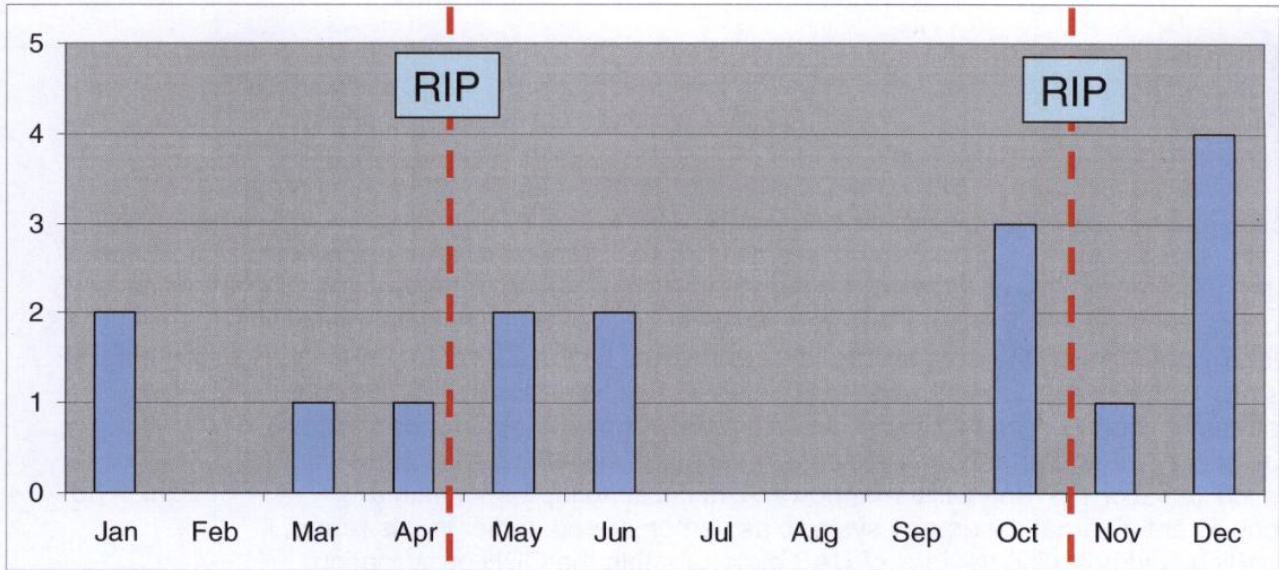
Figure 18 - Graph showing when H450 incidents have occurred over the last 5 years

1.4.170. The requirement to maintain flying currency for a large pool of H450 pilots with no live flying in the UK and only one simulator is extremely difficult; the system is flawed as pilots on the Bty most recently returned from Theatre are not maintaining the 1 Arty Bde FOB currency requirements. Once promoted past Sgt, a H450 pilot would not expect to be employed in this role again, so flying experience is mainly limited to Bdr and LBdr. The Panel believes that consideration should be given to modernising the structure of a UAS Regt to contain a smaller, centralised pool of UAS operators with a larger rank range and within a specialised aviation Career Employment Group (CEG). This approach would focus the operational experience within the Regt and decrease the training burden which at present is inefficient; roulement of a Bty every 6 months is not an efficient or intrinsically safe way to conduct flying operations. Figure 18 below shows that over the last 5 years, the majority of incidents are concentrated either side of the Bty changeover period 'Relief-in-Place' (RIP), when the outgoing Bty is likely to be suffering from skill fade and the new Bty is inexperienced. The Panel believes a UAS Regt should comprise of more typical aviation squadron structure consisting of a pool of pilots who can rotate through for shorter periods (for example 2-3 months) to maintain the pool of experience and currency in theatre. This would avoid the lengthy ThQ process every 6 months and prevent skill fade between tours. The transport and subsistence savings from continuous refresher training in (S26) is also thought to be worthy of investigation.
